Maine Geologic Facts and Localities
September, 1997

Aftermath of the 1996 Rockland Landslide

Text by
Maine Geological Survey

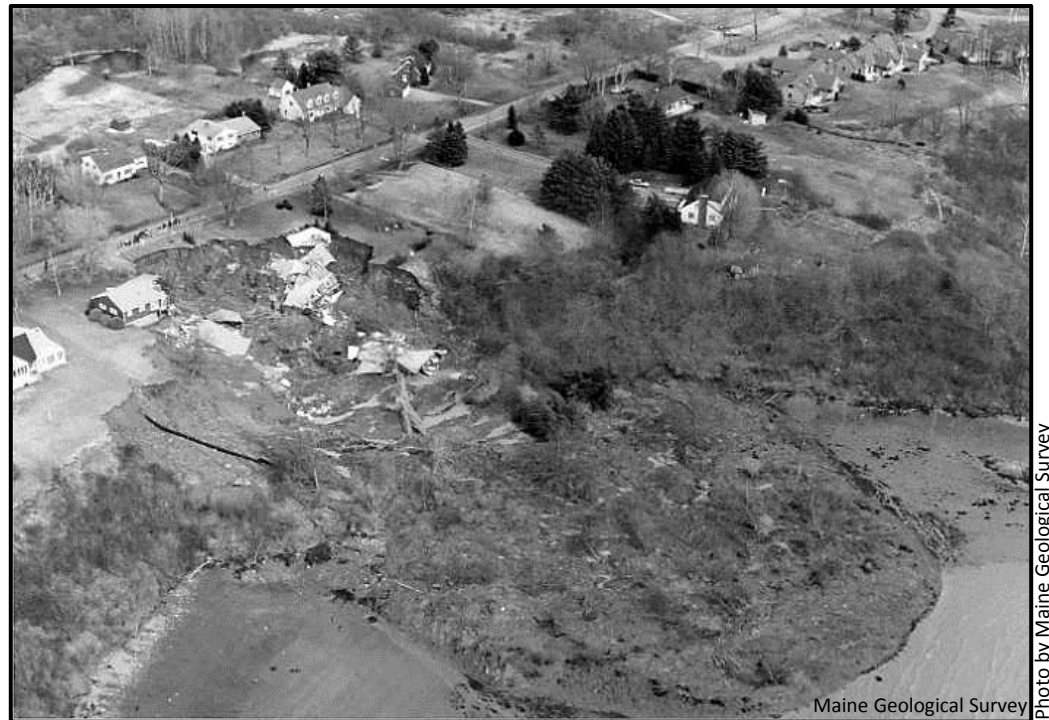
Early in the morning of April 16, 1996, a steep bluff along the north shore of Rockland Harbor slumped toward the ocean. Slumping of the bluff occurred progressively in a series of discrete landslide events. Most of the initial motion occurred between 1:15 AM and about 4:00 AM during a falling tide immediately preceding a new moon, but well before a heavy rain on the afternoon of April 16. Figure 1 is an aerial photo of the slide area taken in April of 1996.

Figure 1. Air photo of the Rockland landslide, April 1996.

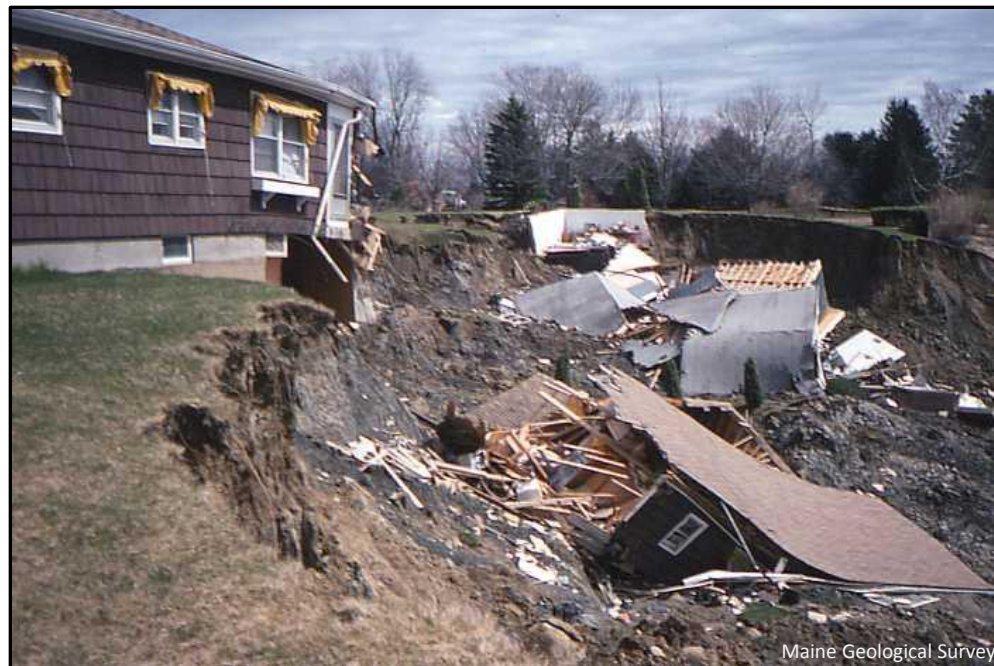
Before the landslide, the bluff top was about 50 feet above sea level and the base of the bluff ended at the high water mark. During the initial slumping events, portions of two houses collapsed into the main body of the landslide (Figure 2). These structures were about 75 feet landward of the top edge of the bluff prior to the landslide. A topographic survey by geologists from the MGS and the University of Maine determined that by the next week the slide displaced more than half an acre of the original bluff top. When it was over, the slide had moved horizontally over 400 feet onto the mudflats of the intertidal zone and had disturbed a total area of 3.5 acres.

Figure 2. Photo of the landslide showing collapsed building.

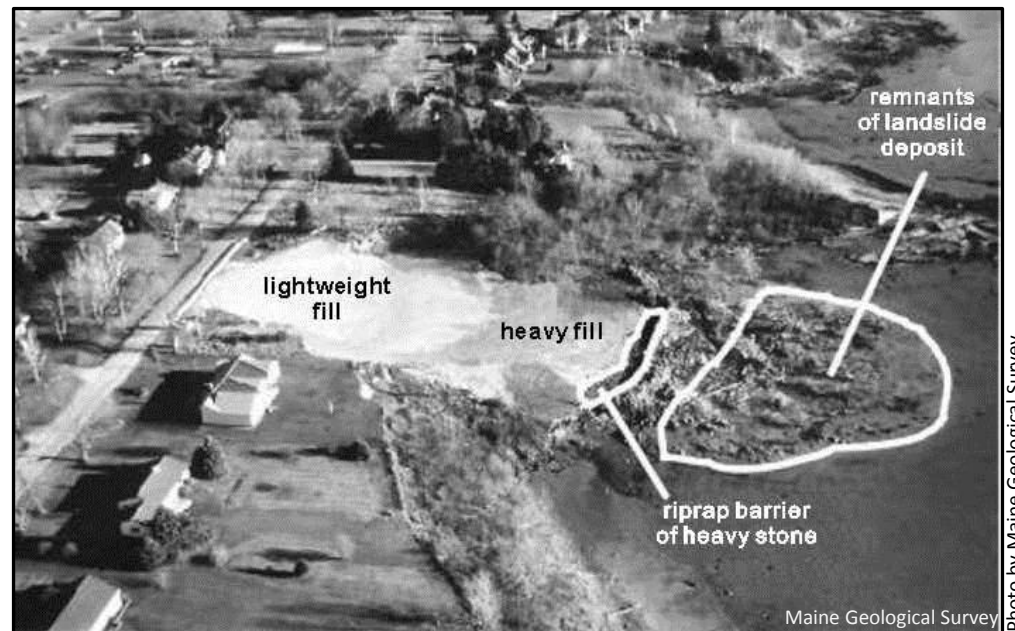
For a month following the initial slide, smaller blocks continued to fall from the steep landward slopes. These continued slope failures resulted in the enlargement of the affected area by landward progression of the vertical scarp. This progression moved the main scarp to within 15 feet of a sewer main on the seaward side of the road. Possible disruption of a city water main buried beneath the landward shoulder of the road was also of public concern. To protect the road and minimize further enlargement of the landslide area, the City of Rockland hired a private geotechnical engineering firm, R.G. Gerber-Jacques Whitford, Inc. of Freeport, ME, to undertake a stabilization project (Figure 3).

Figure 3. Photo of the Rockland landslide project showing locations of lightweight cement kiln dust, heavy rock fill, and the riprap barrier. The remnants of the slide on the tidal flat will be allowed to gradually erode.

The city received partial funding from the [Federal Emergency Management Agency \(FEMA\)](#). To buttress the road it was necessary to place fill on top of the clay that had failed during the landslide. The failed clay was very soft and unable to support heavy loads of buttressing fill, unless the fill was emplaced in a particular sequence. The toe or front of the slide had to be stabilized before the head of the slide could be filled. To begin, an access to the slide area was constructed across the remaining foundation of one of the destroyed homes. From here a road was built down to the toe of the slide. At the toe, an excavation was dug down to sea level and heavy stone riprap was emplaced to contain the buttressing fill. Heavy rock fill was placed behind the rip rap barrier on the lower part of the landslide area. On the upper part of the slope, lightweight cement kiln dust, available locally from the Dragon Cement Company, was used to cover the slide area progressively from the toe toward the headscarp. The combination of heavy fill at the bottom of the slide and lightweight fill at the top was a critical factor in the success of the stabilization process.

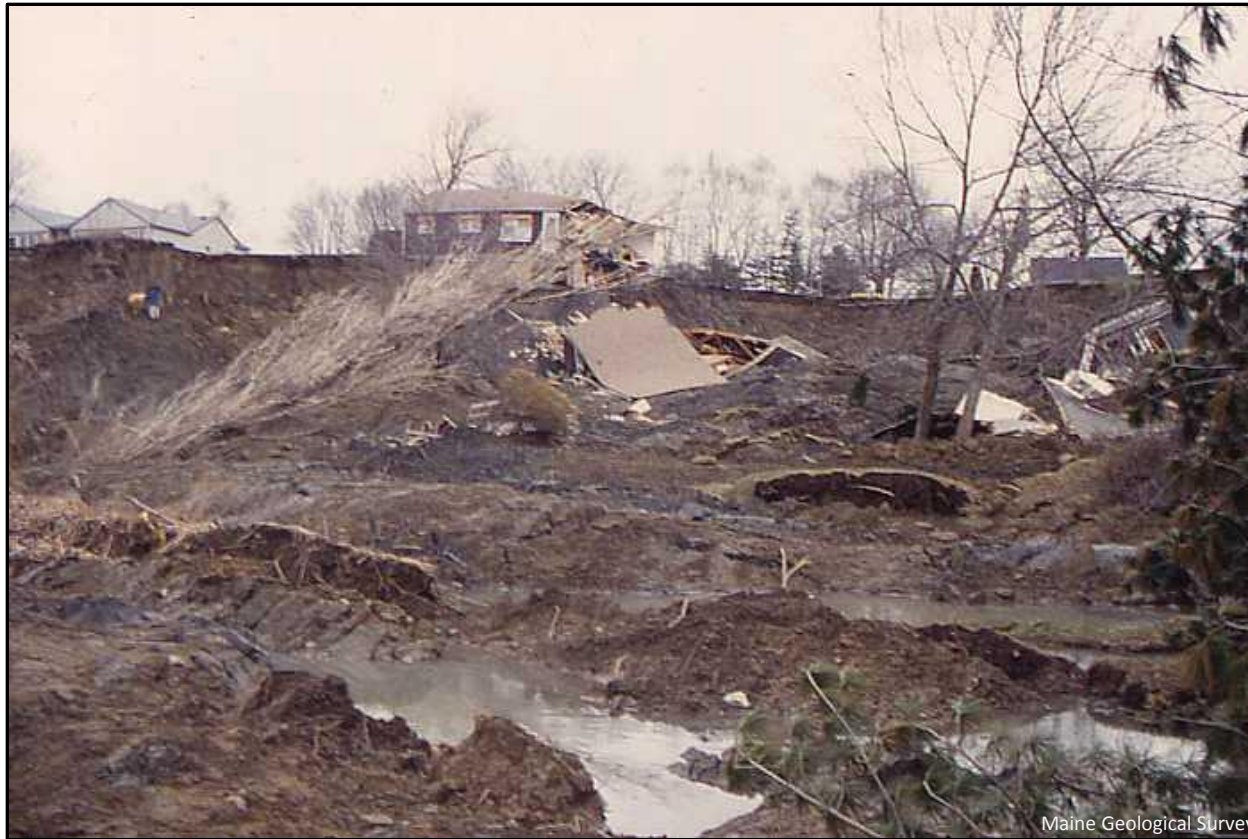
Figure 4. Photo of landslide area taken in April 1996.

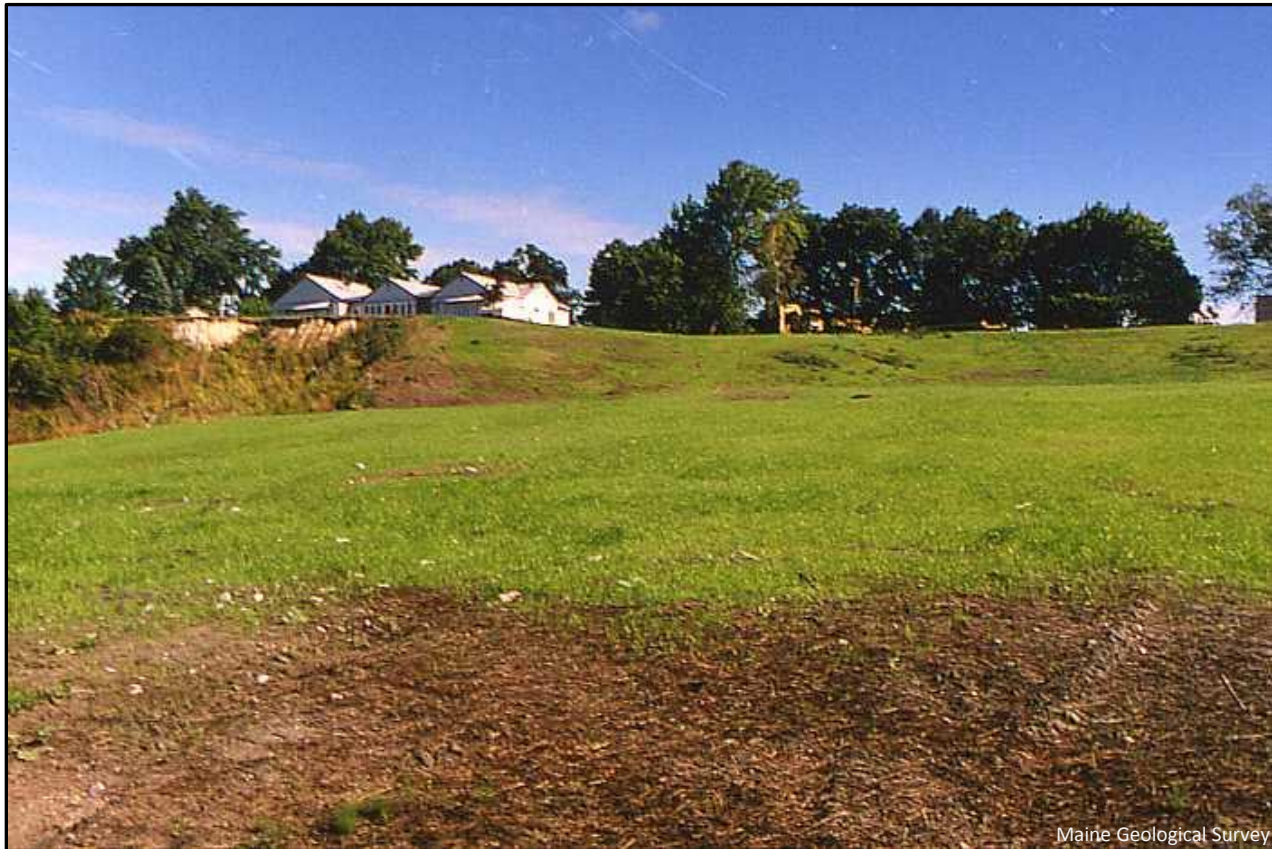
Following the spreading of topsoil the entire reclaimed area was seeded with grass and mulched. Figures 4 and 5 show the slide before and after the stabilization project. Figure 4 was taken in April, 1996; Figure 5, in September, 1997.

Figure 5. Landslide area after stabilization, photo taken in September 1997.

Once this fill was emplaced, topsoil from the slopes surrounding the landslide area was used to cover the fill. This topsoil excavation reduced the slope of the headscarp area to an angle that is normally stable over the long term.
