Maine Forestry Best Management Practices Use and Effectiveness 2008

Department of Conservation
Maine Forest Service
22 State House Station
Augusta, Maine 04333
Forest Policy and Management Division

August 2009

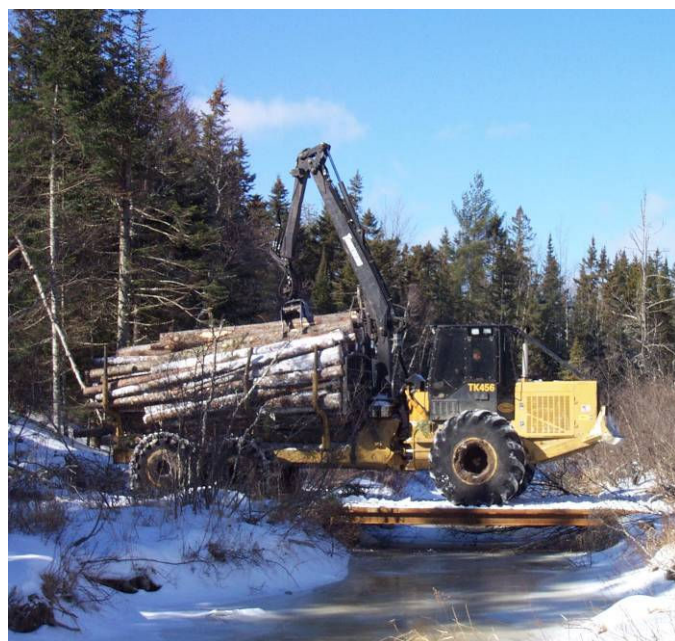
Then and now. As recently as the 1970’s little consideration was given to protecting water quality on timber harvests as the highly eroded banks in the log drive photo on the left illustrates. In contrast, today there is a general acceptance of BMPs by the forestry and logging professions. Sights like forwarders being used to minimize ground disturbance and temporary bridges to protect the integrity of stream channels indicate how far BMPs have come.

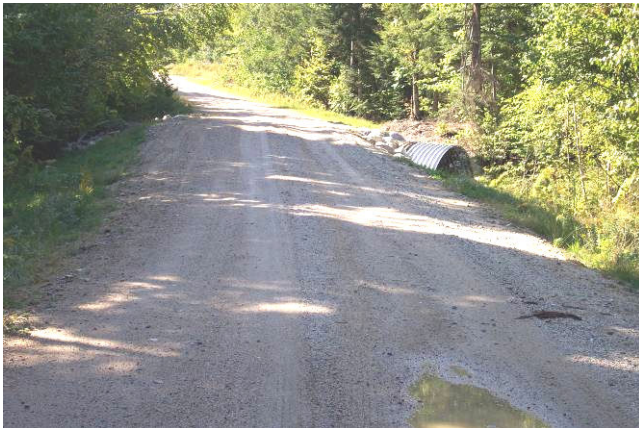
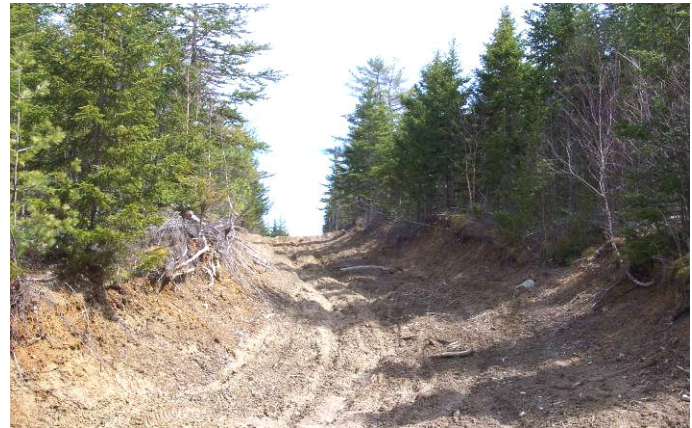
BMPs should extend uphill from the crossing to the point at which a break in the road grade directs water away from the crossing. The road on the left has well designed approaches that direct water into a vegetated filter strip before it reaches the stream. In contrast the road on the right has no place for the water to go before reaching the waterbody. Grading to maintain the road crown, ditch turnouts and vegetated filter strips are some of the BMPs used on approaches.

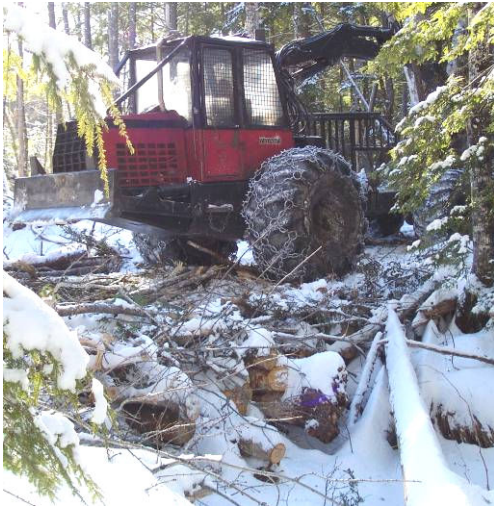
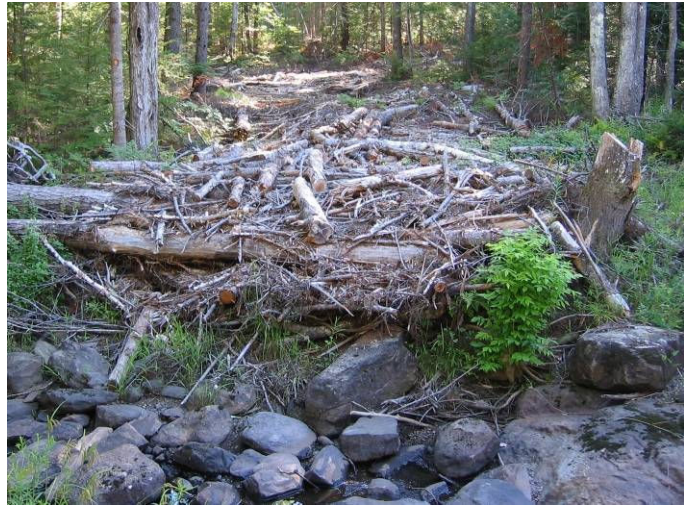
Well designed temporary crossings can be very cost effective and minimize disturbance to the waterbody. Pictured is the same crossing during use and after removal. Note that slash has been left on the approach to the crossing to stabilize any exposed soil. No sediment was deposited below the bankfull elevation of the channel.

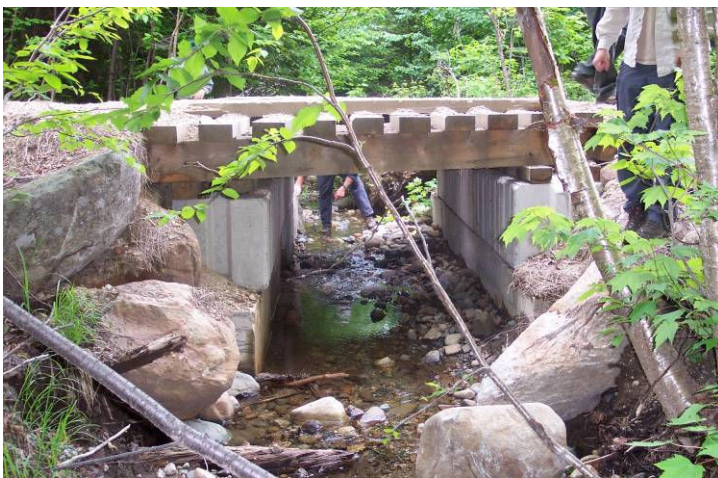
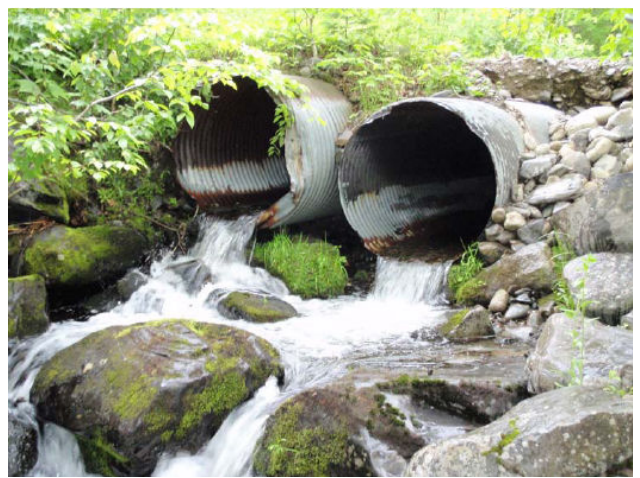
Crossing structures that are open to the natural stream bottom allow for fish passage. Closed bottom structures that do not span the stream channel or are improperly installed can become perched, making it difficult for fish to move upstream.
