Maine State Cultural Building Augusta, Maine : Exterior Building Facade Investigation

Harriman Architects & Engineers

Project No. 09594

October 16, 2009
Final

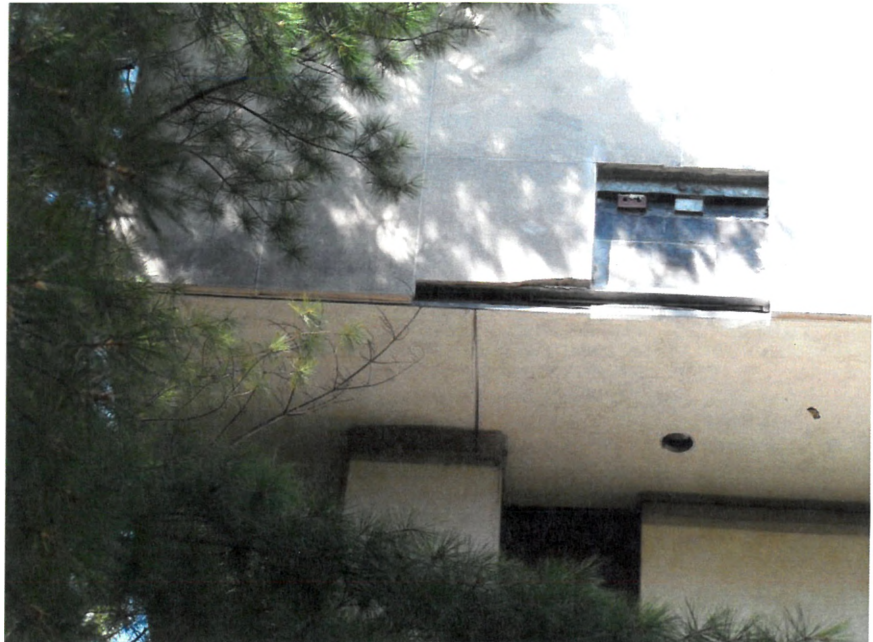
The location image EP1 on the east wall of the building is the location on the façade where the bottom section of panel broke off as reported by the Museum personnel. Image EP2 shows the bottom section of the panel that was reported to have broken off and the removed panel. This location was chosen for a panel removal for a series of reasons. The fact that the panel was already broken and the review of the construction documents showed flashing details at the bottom of the cavity that were suspect, it offered a location to inspect multiple rows of structural angle supports and hangers. The selection of the bottom row of the façade panels was due in large part to the physical size and weight of the panels and the ability to remove and replace them. A crane would have been required to remove the larger panels in the rows above. With our first walk-through, we noticed that there was extensive water damage to the cement plaster soffits on three sides of the building and this generated questions as to the water entry points.

EP1 - East wall - broken panel and removed panel

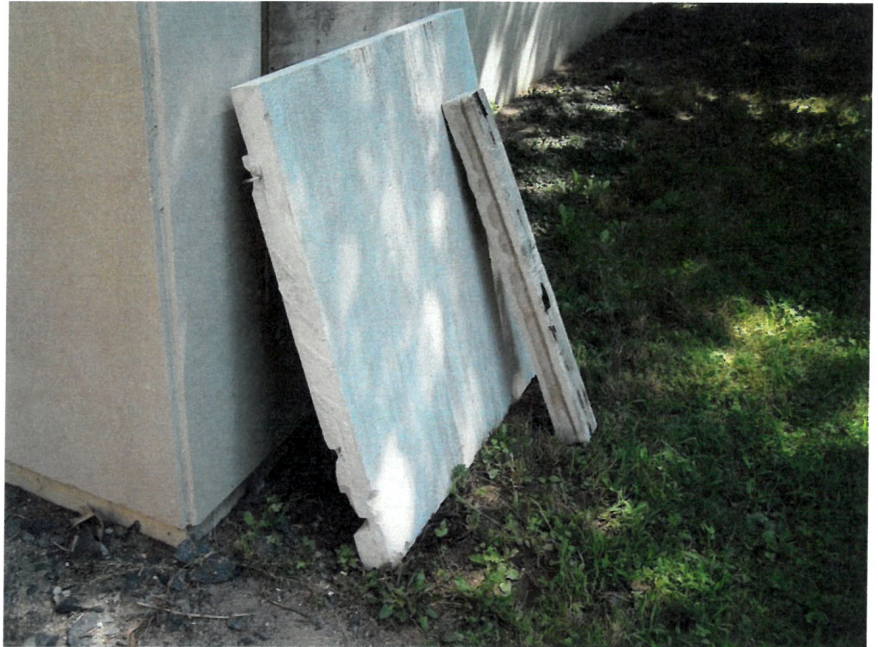
*EP2 -Removed panel and
broken section*

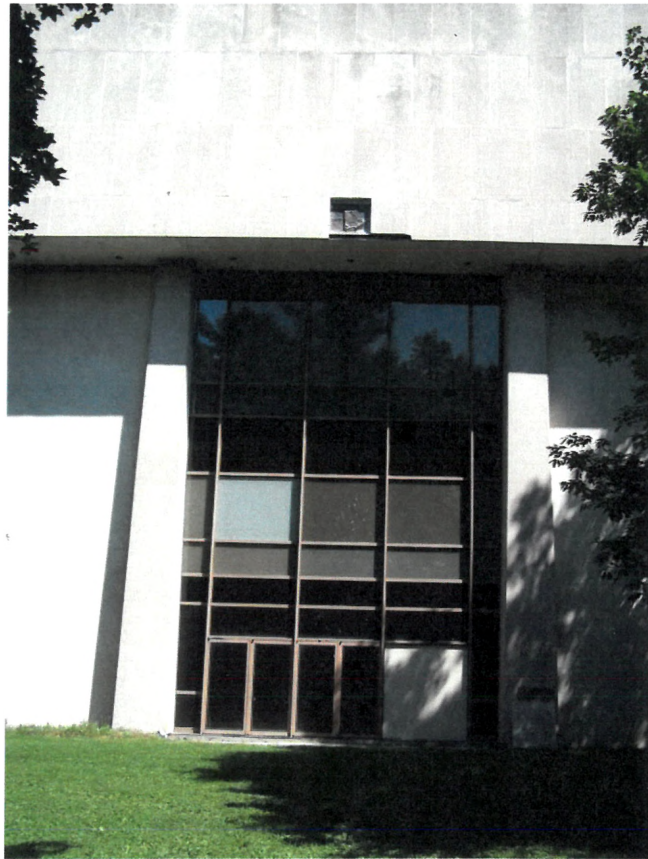
As outlined, we selected a location on three sides of the building for visual inspection to determine the condition of the wall system on three exposures. The lower panel on the south wall was removed for the reasons stated in EP1. In the panel removal process, the section at the adjoining panel broke off pointing to the current unstable condition of the lower section of the panels. The details of construction and condition of the wall will be outline further in this report.

*EP3 - South wall panel
removal location*

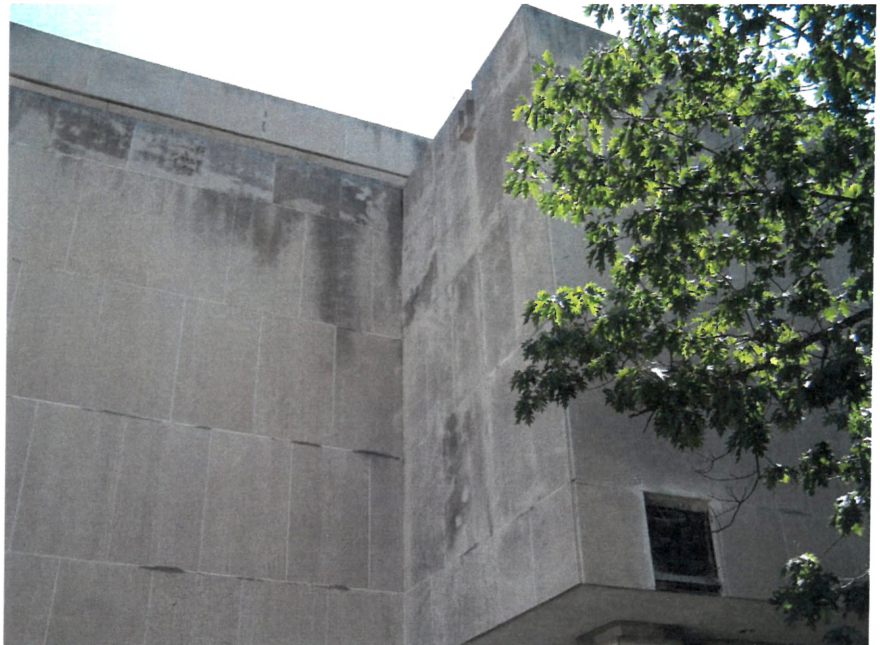
As outlined, we selected a location on three sides of the building for visual inspection to determine the condition of the wall system on three exposures. The lower panel was removed at the west wall for the reasons stated in EP1. The removal of the panel at this location was made easier by a full-height control joint in the façade panel system on the left side. Another reason for panel removal here was the large amount of staining on the face of the panels and the joints and a desire to discover if water penetration into the cavity is one of the contributors to the panel face effect. The details of construction and condition of the wall will be outlined further in this report.

*EP4- West wall panel
location*

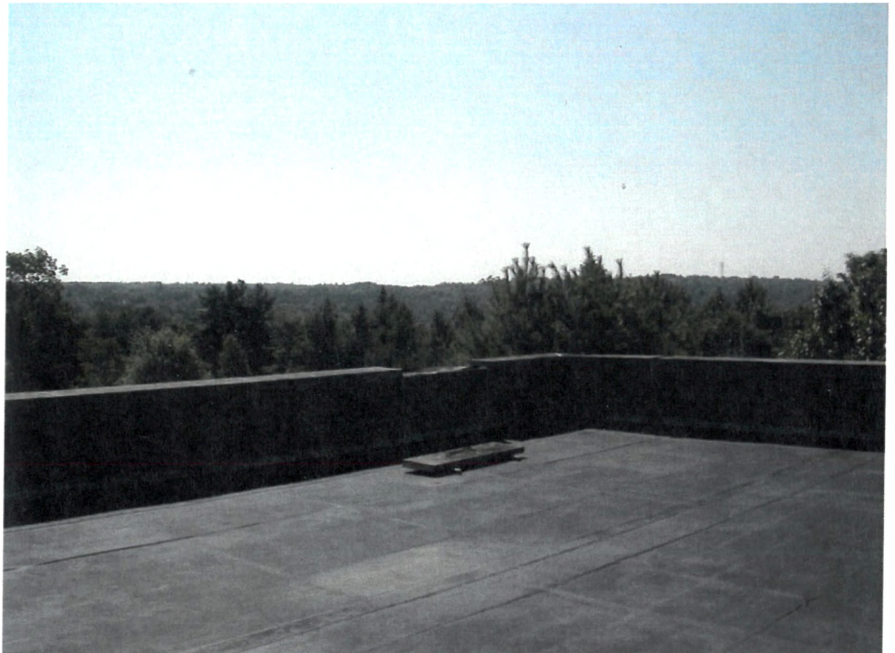
To determine the condition of the existing wall system, a location on three sides of the building was selected. The parapet cap on the southeast corner was removed to observe the anchorage details of the components and installation of the flashings and the condition of the cavity. The limestone cap was removed as part of the existing conditions field observation. Per Harriman's request, a second limestone cap on the north side of the building was removed by Consigli Construction. See Parapets southeast corner inside (tab 4) for more information.

*EP5 - Southeast corner
parapet cap removed*

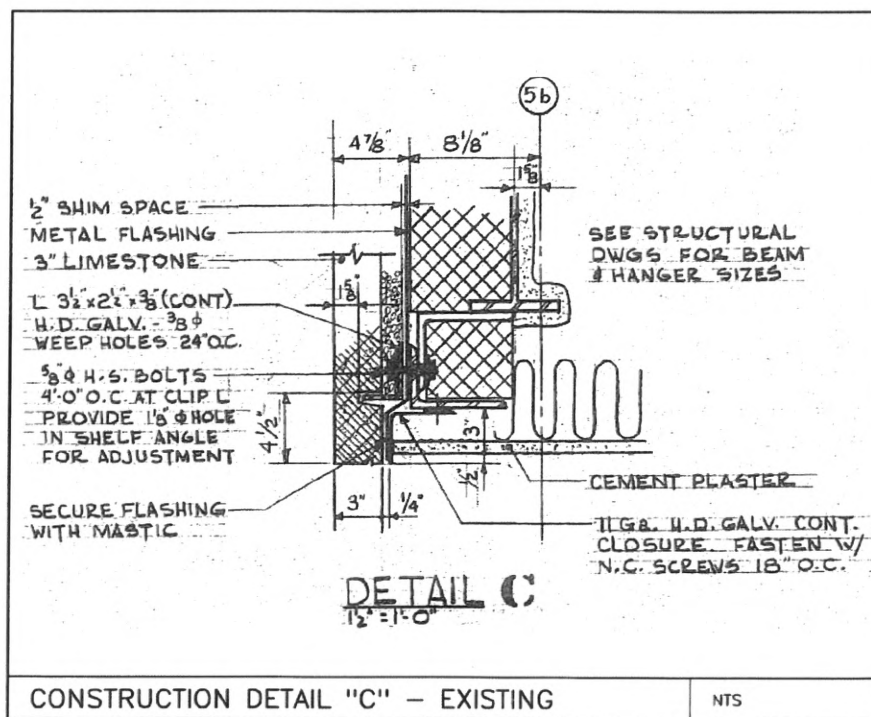
AB2 - Construction
detail C - existing

Image AB2 shows a large scale detail of the bottom wall detailing how the support angle is attached to the structure and the slot that was incorporated into the back of the limestone panel. It also shows the intent of how the wall cavity was to be drained and the connection of the suspended ceiling, flashing and panel system. Please note the location of the flashing at the ceiling and the intent to weep the cavity for moisture – we will delineate this further in the report.

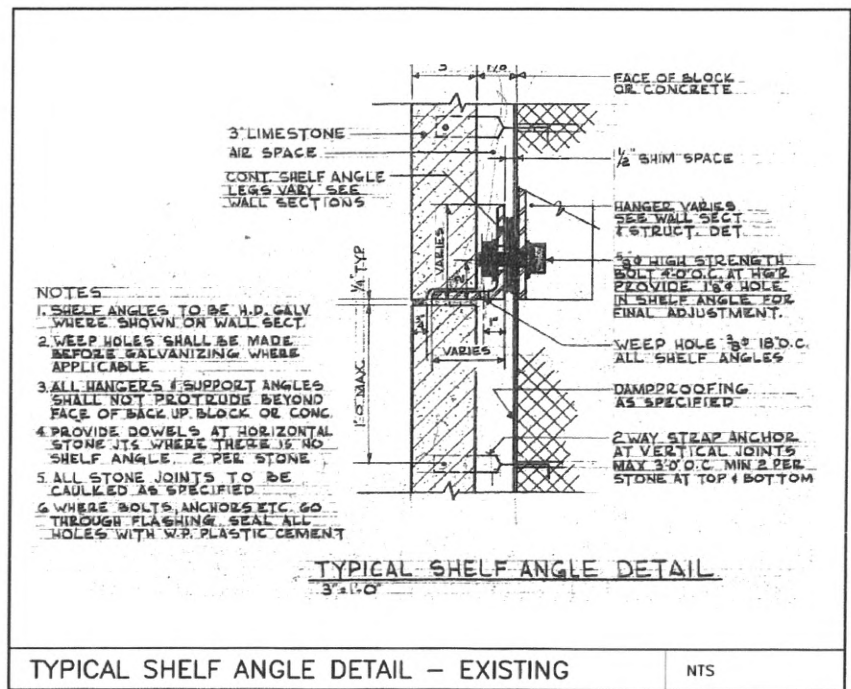
AB5 - Typical shelf angle detail - existing

On Image AB5, the items of importance for visual inspection were the strap anchors, the bolted connection and the weep hole that was drilled through the bottom leg of the support angle for moisture to drain through. All the support angles per this detail are noted as galvanized to resist rust due to exposure to moisture. Note #5 (below) states that all the joints shall be caulked.

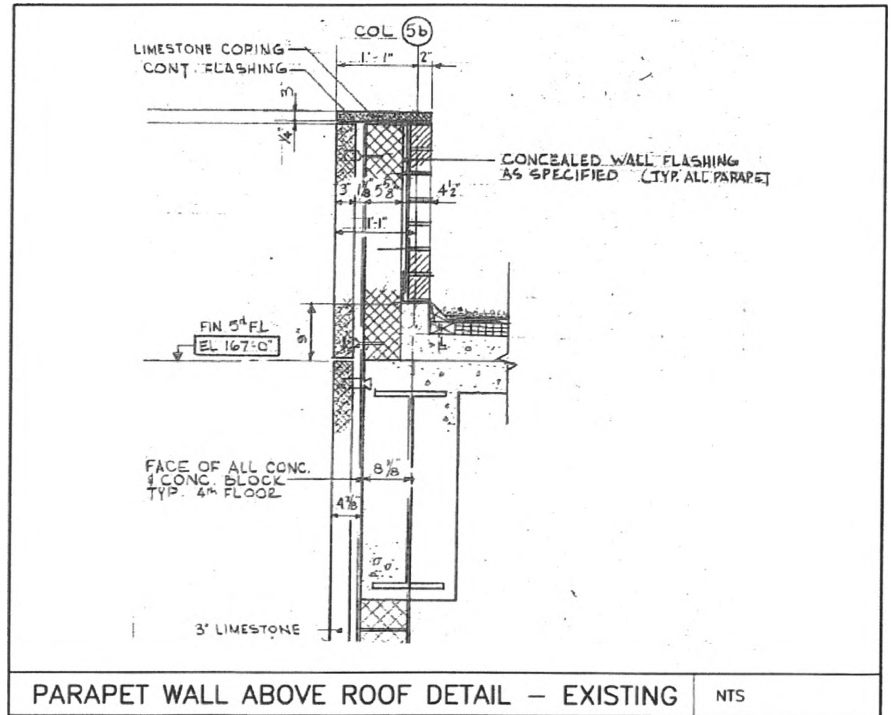
*AB6 - Parapet wall above
the roof detail - existing*

Image AB6 shows how the limestone panels were integrated with the back up system above the roof. Of note here is how the top row of limestone panels are anchored to the block backup system without any noted structural lateral support for this extension above the roof.

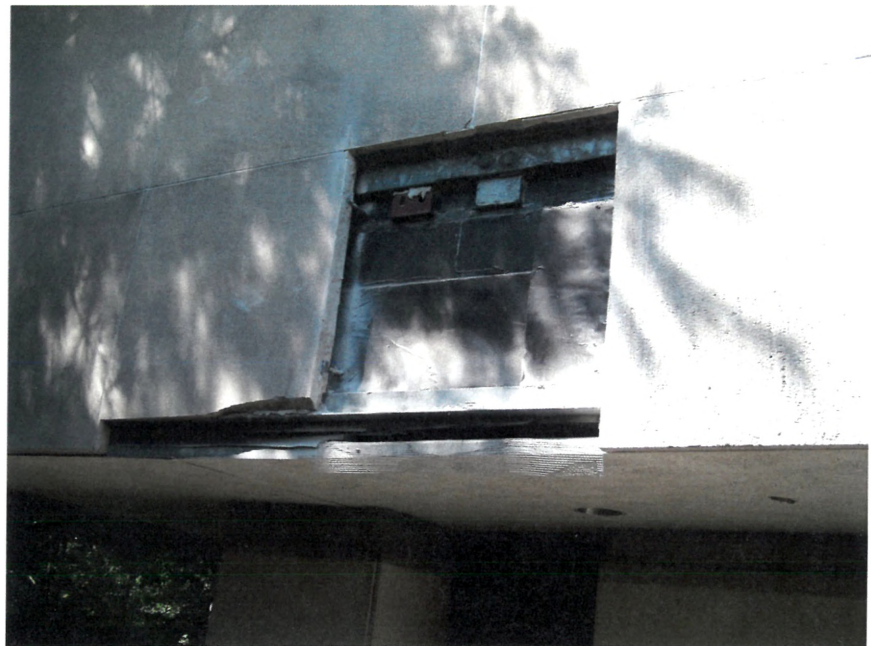
Image PR1-1 and PR1-2- This is the location on the building where the panel broke and fell to the ground as reported by Maine State Cultural Building facilities personnel. The picture shows that the panel broke along the line of the upper edge of the slot. The support angle and its condition is very evident. The support angle is galvanized as documented and the bolted connections are as detailed. The extra red support clip was initially installed as the connection to the horizontal support – the clip was not correctly sized and consequently was left in place and a new clip was installed to connect to the horizontal panel support angle. The cavity space is very dry and showed no signs of excessive moisture build-up due to inadequate weeping of the cavity. The fabric flashing to the right is inserted into a CMU joint and laid down over the angle hanger support system for the bottom panel support angle as protection from moisture in the cavity.

*PR1-1 - Panel removal
east side*

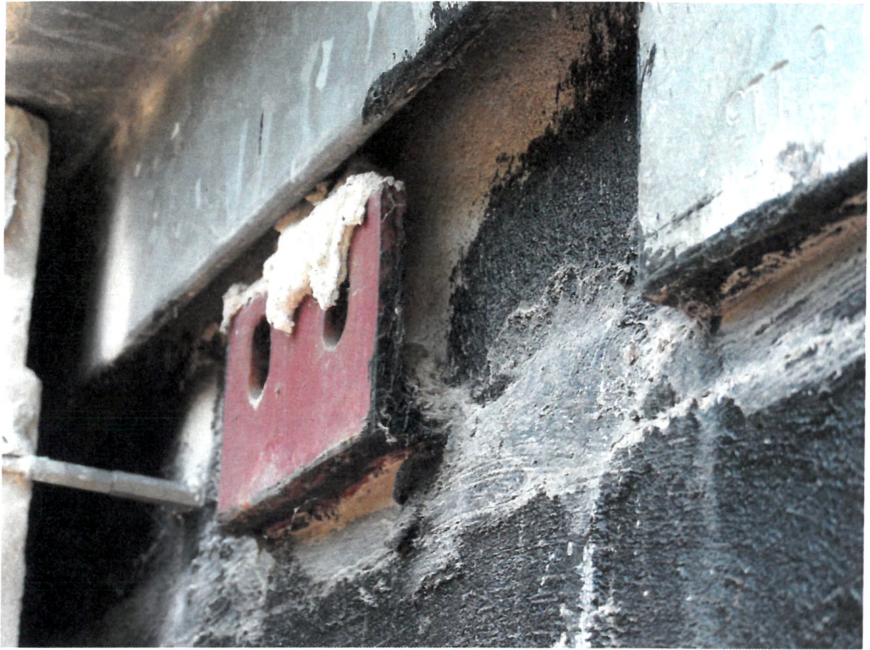
*PR1-2 - East side clip left
in place, anchor and
dampproofing.*

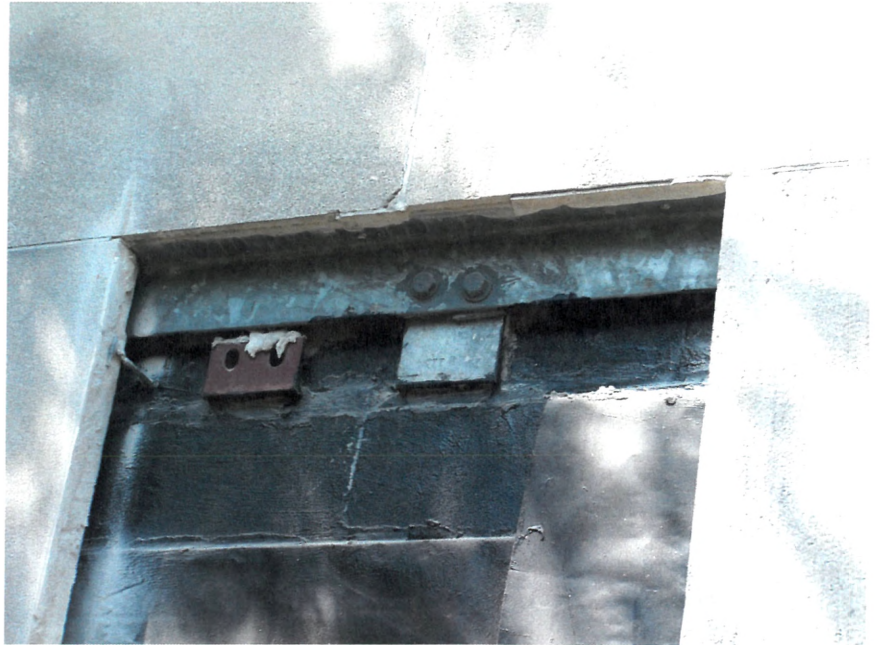
PR1-3 and PR1-4 - The pictures below show that the support angles are bolted as detailed and galvanized as documented. The bolted connections do not show signs of slippage even with the multiple shims that were installed behind the leg of the angle. The shims were installed for alignment reasons and we did verify the elongated erection hole on the clip angle as noted by typical detail "C". It also clearly shows that the damp proofing on the CMU backup does not extend up behind the angle.

*PR1-3 - East side
connection*

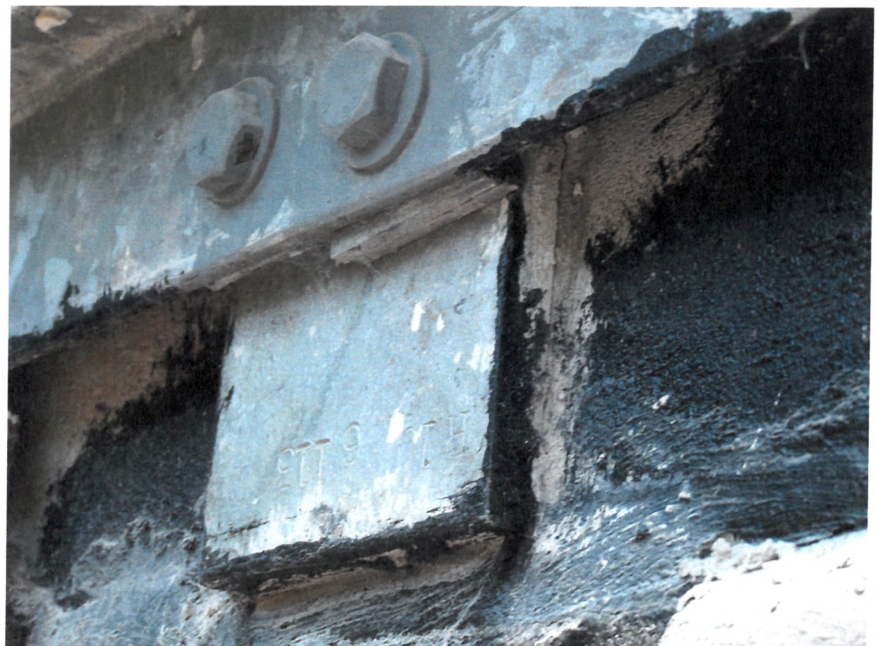
*PR1-4 - East side
horizontal support angle -
bolted connection*

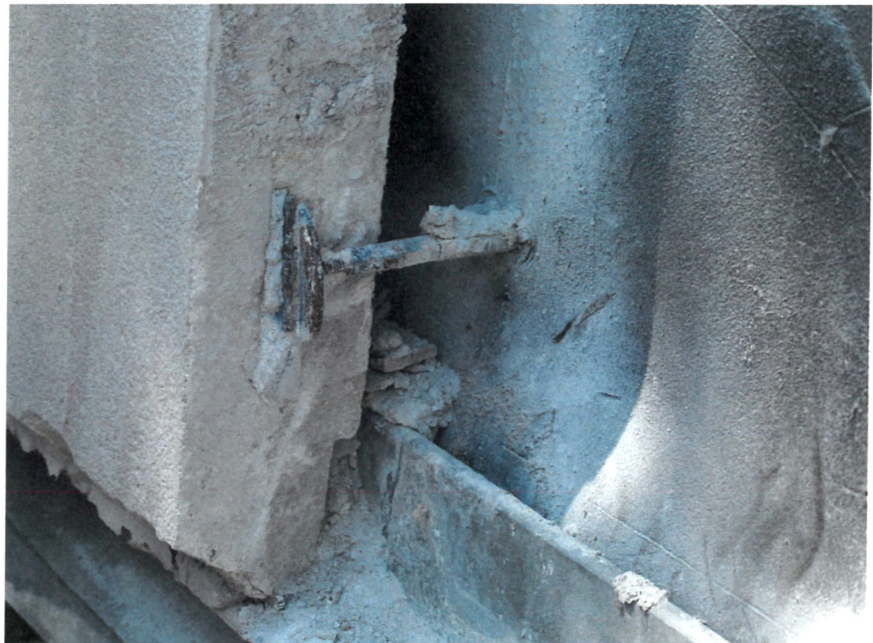
PR1-5 - The picture indicates that the panel anchors are not as specified on the contract documents. The contract documents indicated use of a flat strap anchor and this picture shows an adjustable anchor with threaded couplings for horizontal adjustment during erection. The back part of the anchor is a threaded coupling thru the flashing into the block cell and at some locations into a grout joint. This indicates that with this type of anchor, the panels were installed in a progressive manner using the bottom left corner of the façade and progressing both horizontally and vertically across the face of the building. The panel slot was set into a grout base on the angle and the biscuit end of the anchor was set into the slot on the edge of the panel and a full grout bed, then the next panel is set in place to form the panel layout. The detail called for pea stone fill to act as a grout catch during the panel installation but the distance from the back of the support angle and the flashing installation method will not allow the pea stone to remain in place.

*PR1-5 - East side angle
panel support*

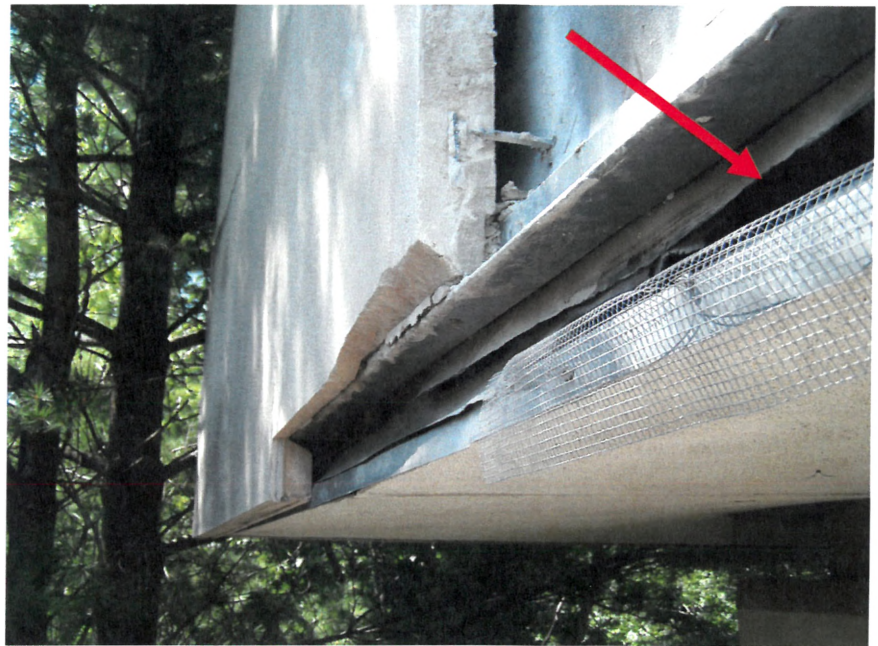
PR1-6 and PR1-7 - The failure of the panel occurred at the top of the slot above the angle – this is the weak point of the panel in regard to its thickness. It would be safe to assume that the slot was too deep for a limestone panel. This continuous slot out of the back of the panel is not recommended by Indiana Limestone Company, Inc. It also shows how the fabric flashing system was extended down behind the angle and laid over the galvanized metal edge at the end of the cement plaster soffit. This system was installed as detailed but is also the weak point for water weep from the cavity as evident in the image PR1-7. The figure also shows how the flashing was not extended down long enough to get out over the metal edge and allow water to migrate out of the cavity. The hole created by this poor installation is a major source of air infiltration into the building (see arrows on PR1-6 and PR1-7). The cold outside air penetrates over the soffit directly into the building's ceiling cavity.

*PR1-6 - East side angle
panel support*

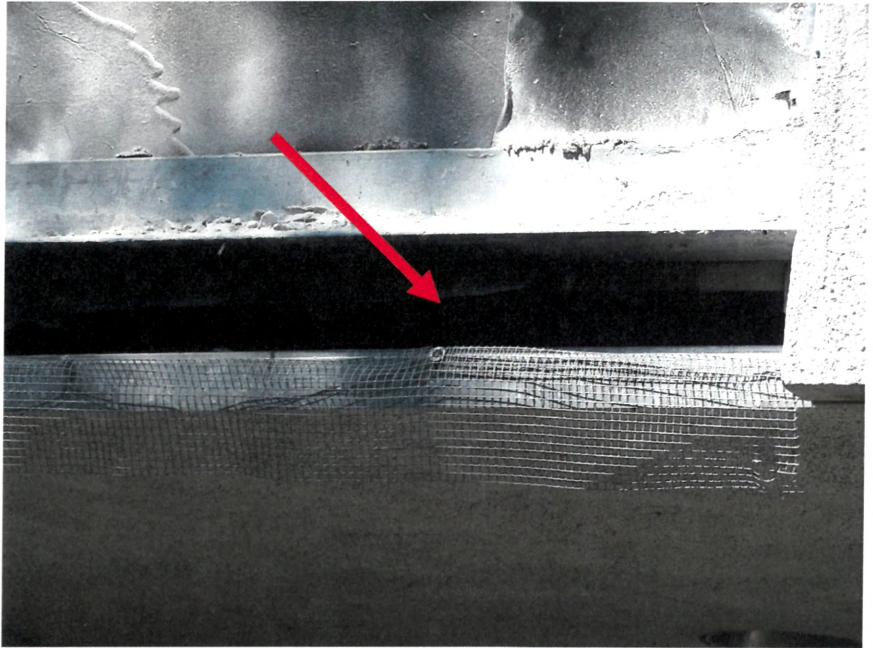
PR1-7 - Hole in flashing

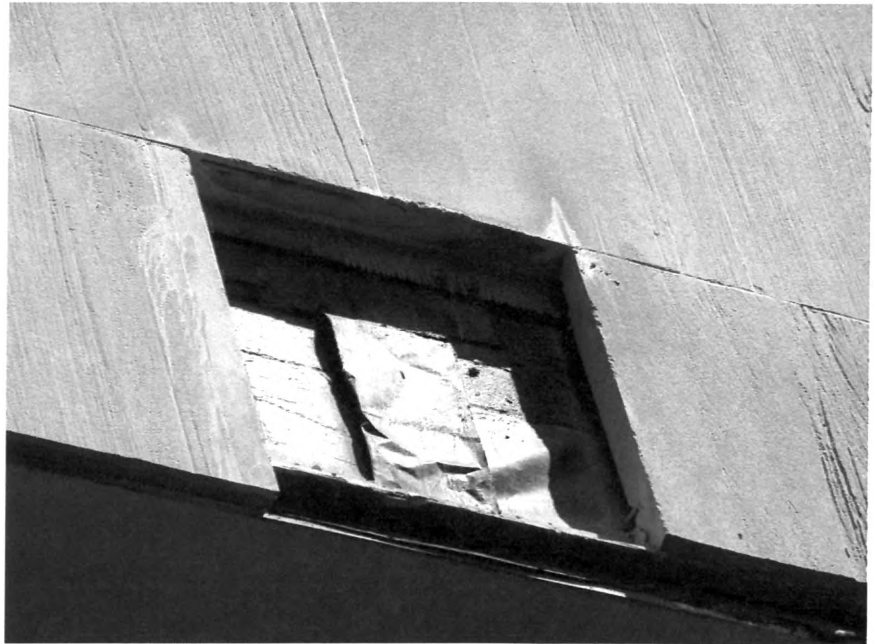
PR2-1 - The panel removal location on the south side revealed that the cavity and the backup system were in the same condition as location 1. No abnormal deterioration of the panel support system was evident and the panel and its associated flashings and backup system were constructed as detailed. The picture shows where the adjoining panel broke along the line of the upper edge of the notch during the removal process. The cavity space is very dry and shows no signs of excessive moisture build-up due to inadequate weeping of the cavity. The fabric flashing in the center was installed over the structural hanger system to protect it from moisture.

*PR2-1 - South wall
removal location*

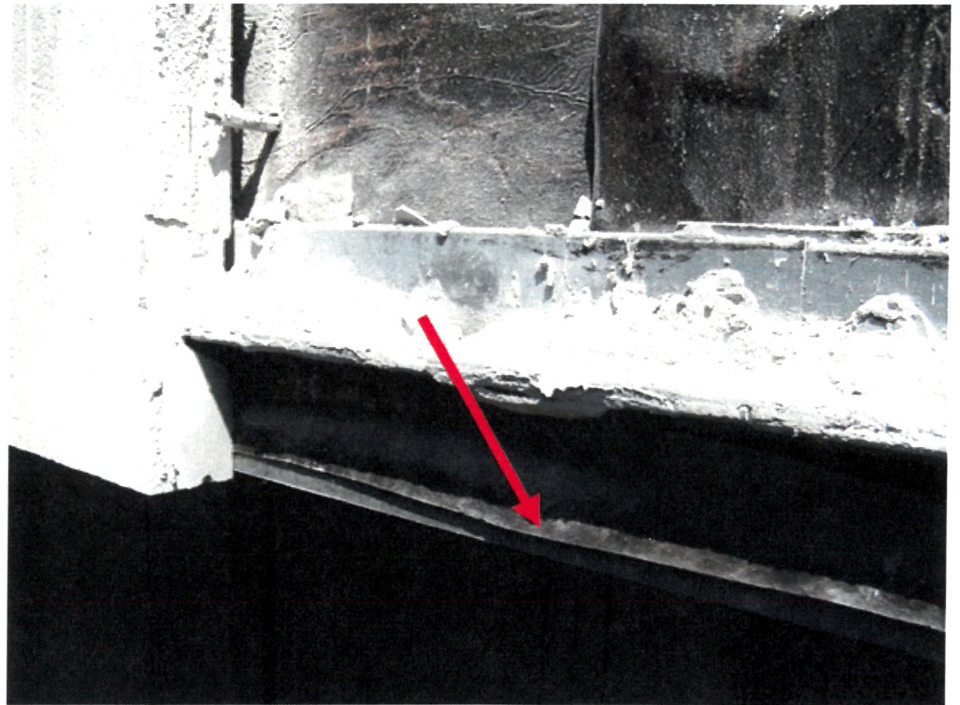
PR2-2 and PR2-3 - These images show that the limestone panel slot is supported on the angle and the system was set in a continuous bed of grout. The panel anchor is in a location consistent with the others observed. The anchor is the same type used in the other locations which is a different type than what was specified in the existing documents. Also note that the fabric flashing is tucked down behind the support angle and extended out of the metal edge at the soffit.

*PR2-2 - Flashing
extended down over metal
soffit edge*

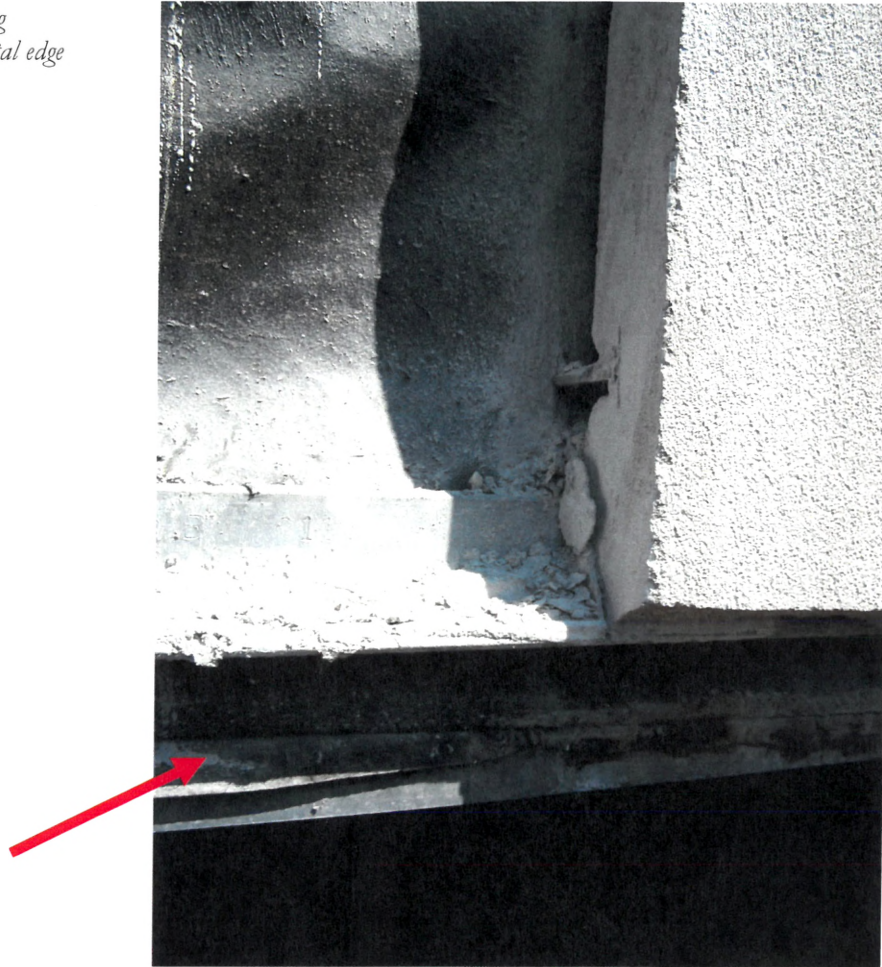
*PR2-3 - Flashing
extended over metal edge*

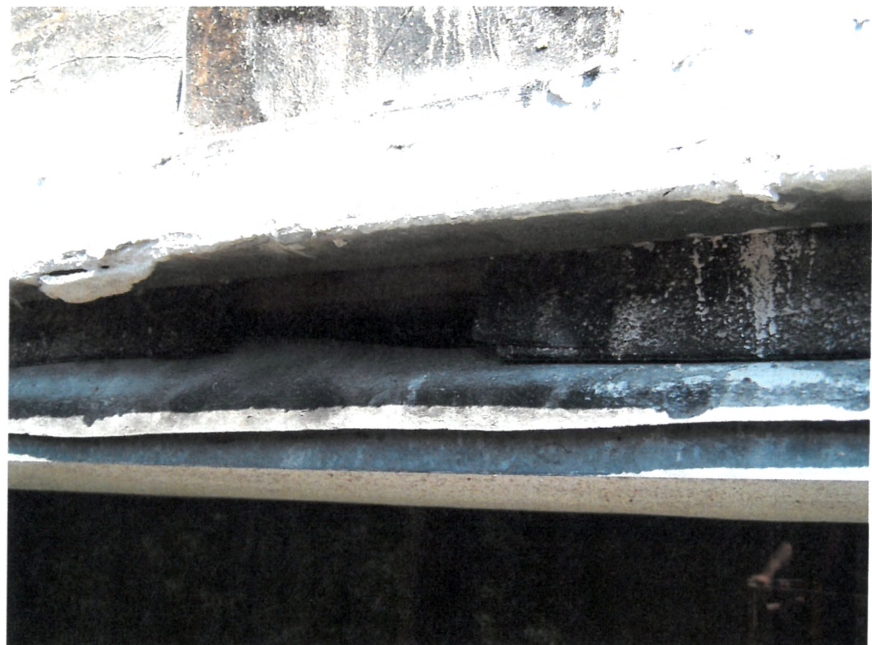
PR2-4 and PR2-5 - At this location, we discovered the fabric flashing did not extend down over the metal soffit edge leaving a large hole for water and air infiltration to the interior. This hole is the direct cause of all the water stains on the cement plaster soffit. The cement plaster soffit shows large stain areas near the outer edge of the soffit over many locations on all three building faces.

The soffits have large cracks and it is safe to assume that where these stains and cracks occur, water enters the hole in the flashing through the backside of the soffit. The hole also includes air infiltration which impacts the operating efficiency of the mechanical system for both the heating and cooling system.

Another item of concern is based upon the panel to soffit system detail outside air is infiltrating directly over the soffit direct to the internal ceiling cavity at that floor.

*PR2-4 - Flashing not
installed at hanger support*

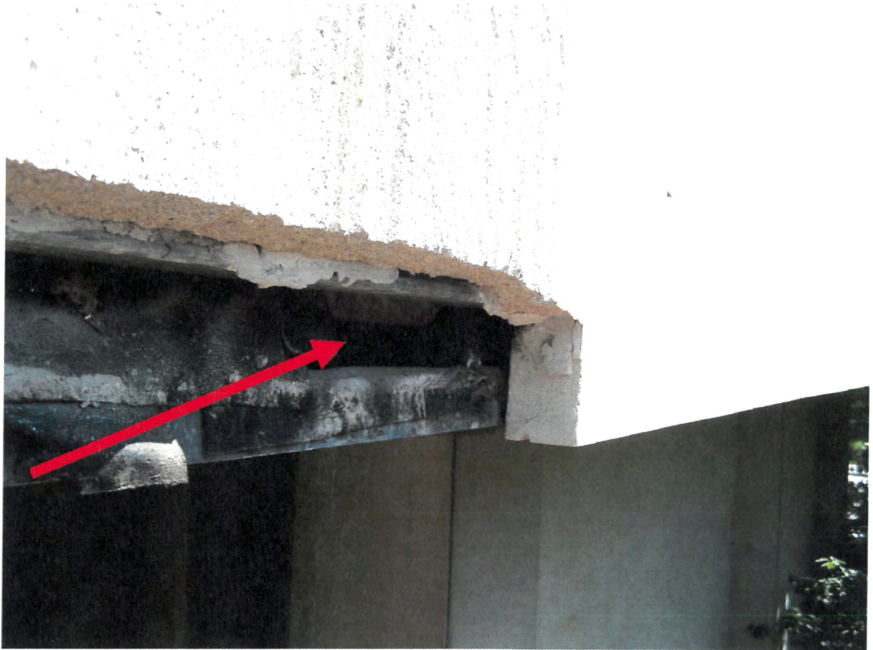
*PR2-5 - Flashing not
installed at hanger support
(arrow indicates hole)*

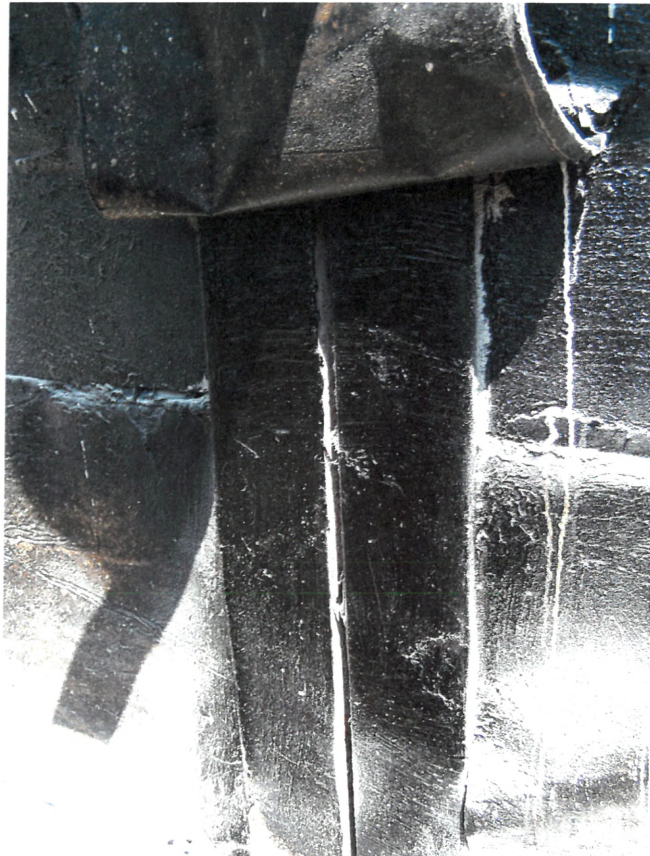
PR2-6 - Image PR2-1 indicates a large piece of fabric flashing extended vertically down through the picture. In lifting this piece of fabric flashing (*image PR2-6 below*), the angle hanger system for the lower panel support angle is revealed. The image indicates that the vertical hanger was not galvanized; the angles have been coated with a damp proofing product and the CMU backup has been installed behind the angles. The fabric flashing was not sealed to the angle hangers nor was it extended down far enough behind the support angle below creating the hole (as noted previously). These angles were not noted as galvanized in the existing construction documents. The vertical slot between the angles revealed some surface rust on the vertical leg of the angles which is considered detrimental to its support capacity. This slot is also a point of entry for air-infiltration into the ceiling cavity.

*PR2-6 - Flashing over
angle hanger*

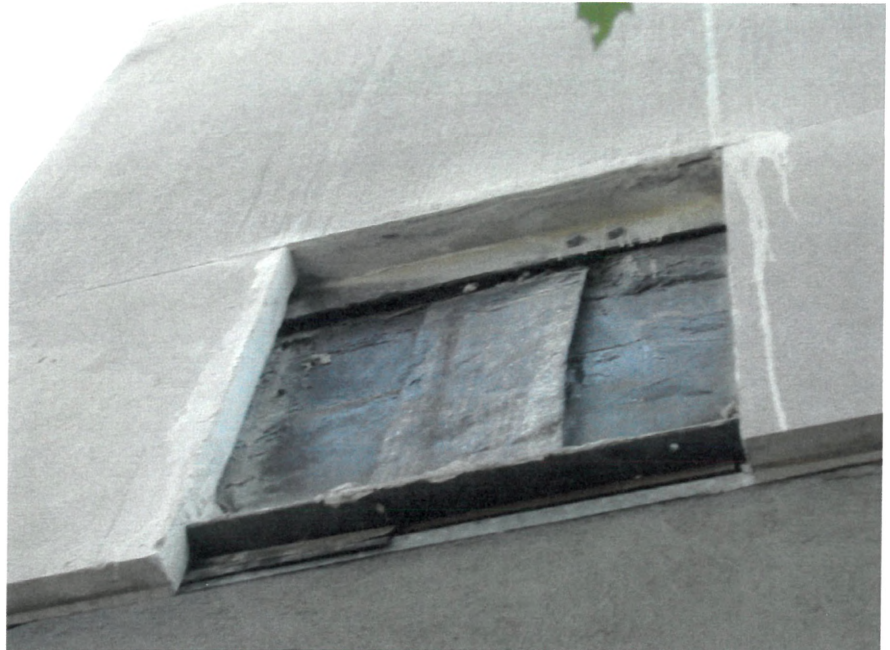
PR3-1 - The panel removal location on the west side revealed that the cavity and the backup system were in the same condition as location 1. No abnormal deterioration of the panel support system was evident and the panel and its associated flashings and backup system were constructed as detailed. The cavity space is very dry and shows no signs of excessive moisture build-up due to inadequate weeping of the cavity. The fabric flashing in the center was installed over the structural hanger system to protect it from moisture. The continuous joint on the right side is an expansion joint full height from the bottom edge of the panel to the underside of the limestone cap above. The sealant in the joint is deteriorating and there were holes opening up due to the sealant cracking and falling out.

*PR3-1 - West wall panel
removed*

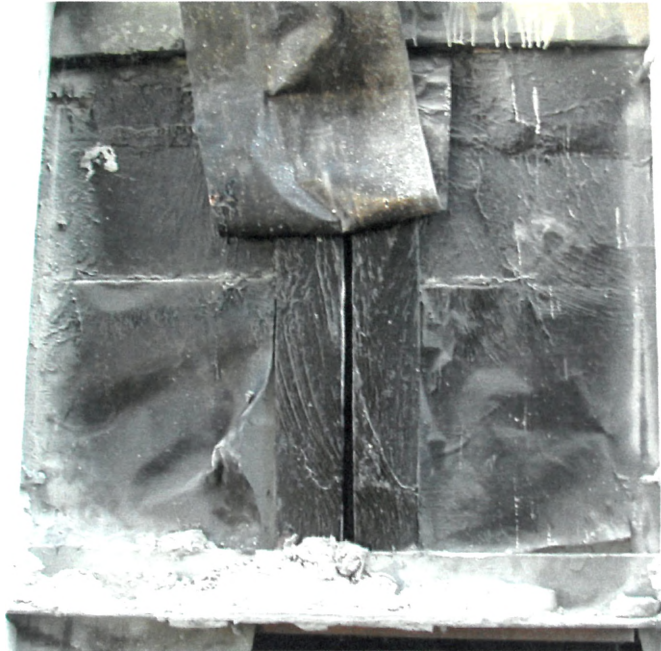
Image PR3-4 and PR3-5– At the structural hanger location, we lifted the fabric flashing and as observed in the other locations, the hangers were damp proofed and constructed as detailed. In lifting the side fabric flashing, it is noticeable that the CMU backup behind the fabric flashing was not damp proofed. In PR3-5 the hole in the flashing system below the angle support is clearly obvious and it is inline with the hanger system above. The connection of the hanger support system to the horizontal angle will not allow the fabric flashing to extend down over the metal soffit edge below and allow the weeping of the cavity as intended by the existing detail. The support hanger system on the existing drawings is denoted to be spaced at 4'-0" on center – it is safe to assume that this hole in the flashing occurs at this location around the entire lower perimeter of the building.

*PR3-4 - Flashing at angle
hanger*

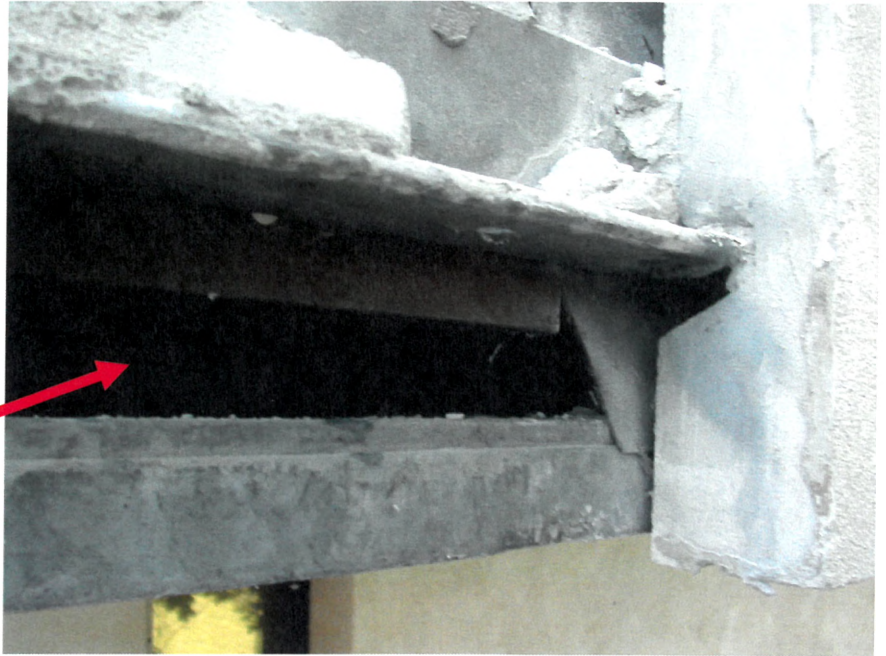
*PR3-5 - Hole in flashing
system at hanger (arrow
indicates hole)*

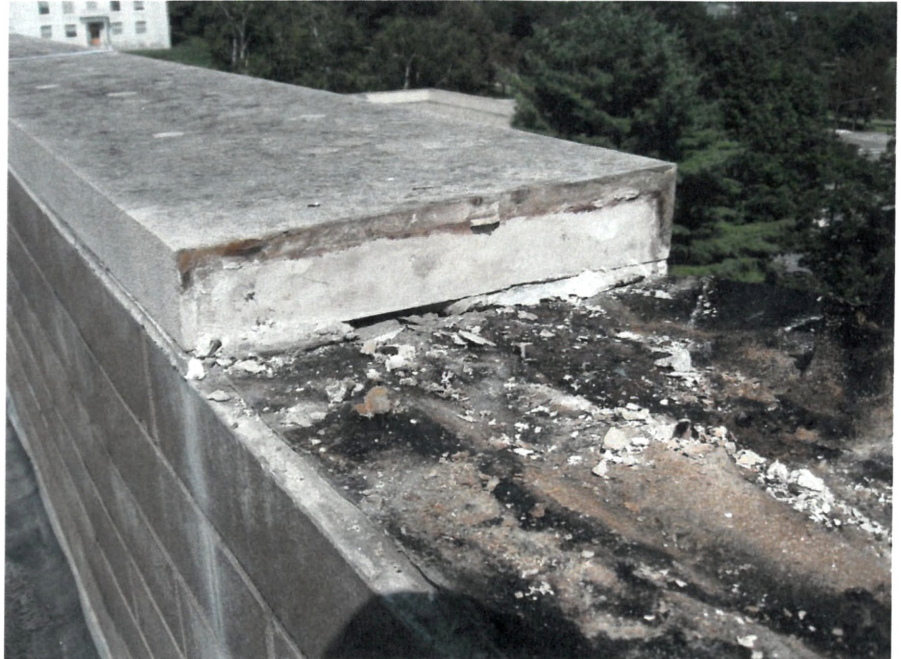
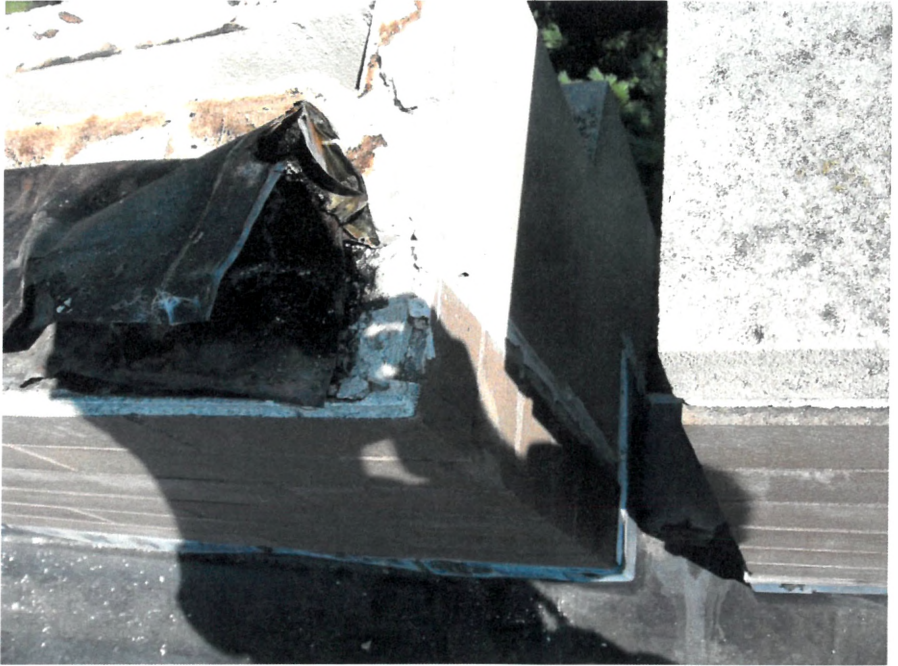
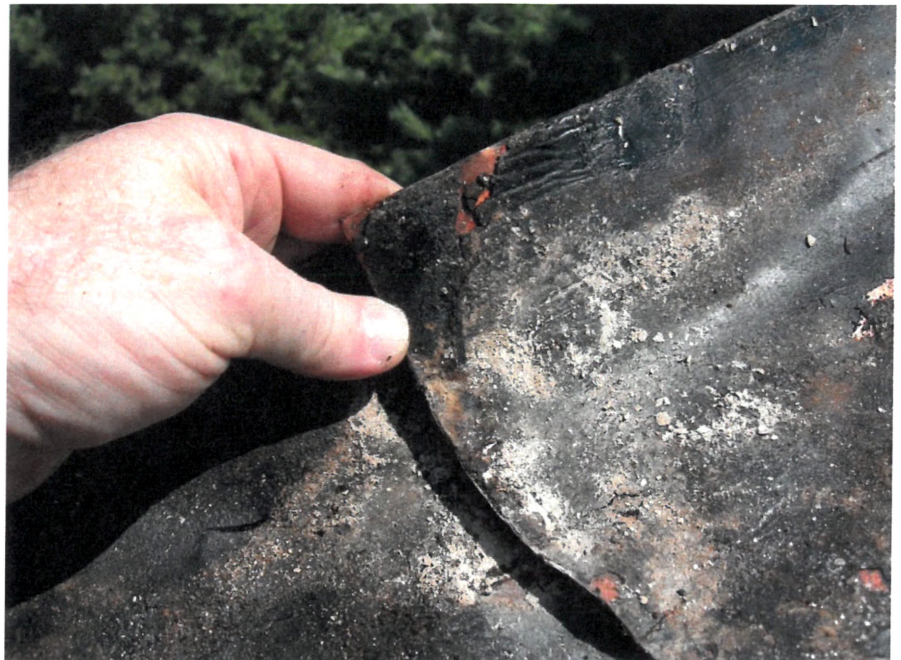
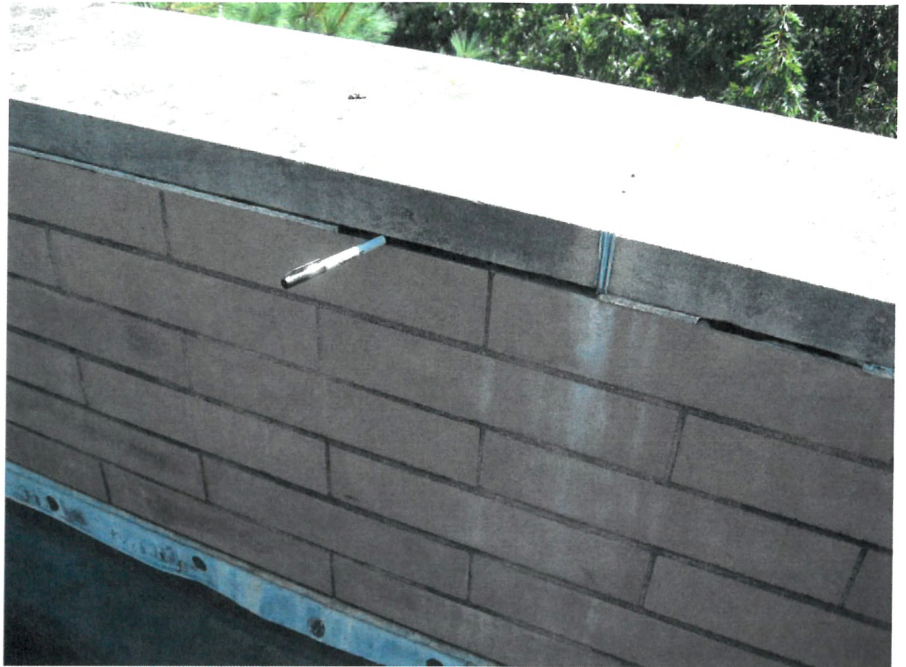
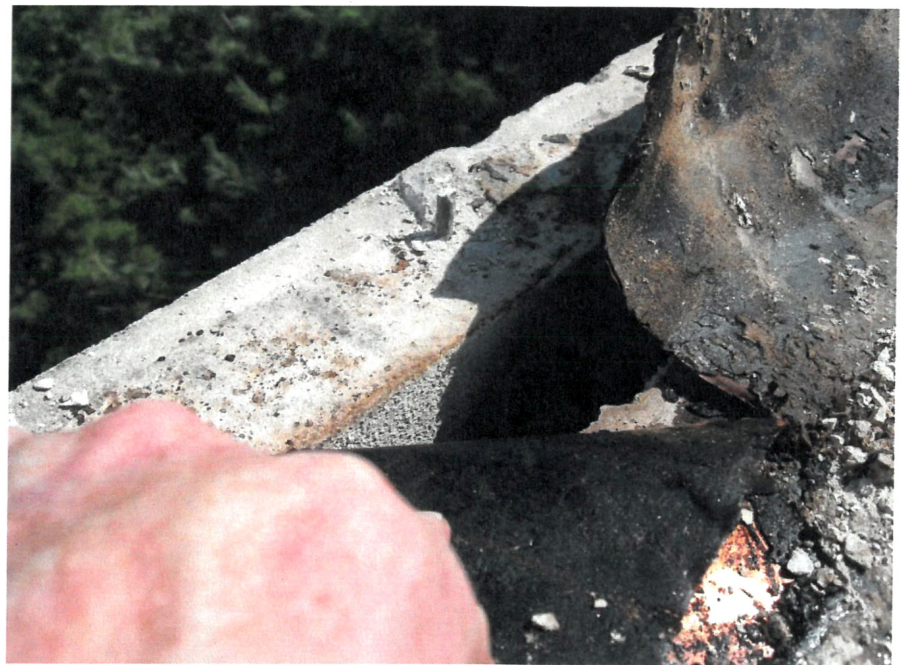
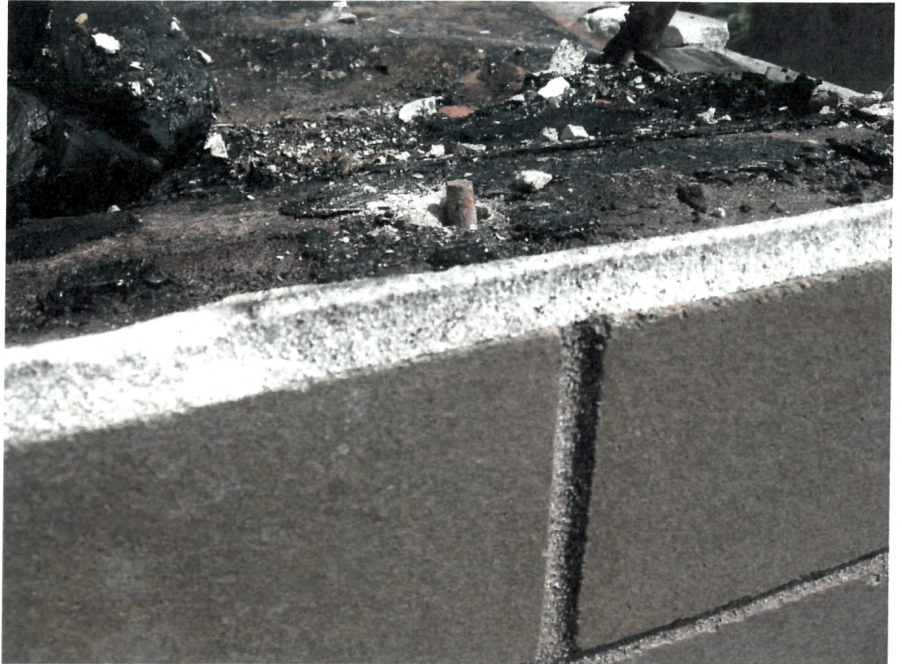
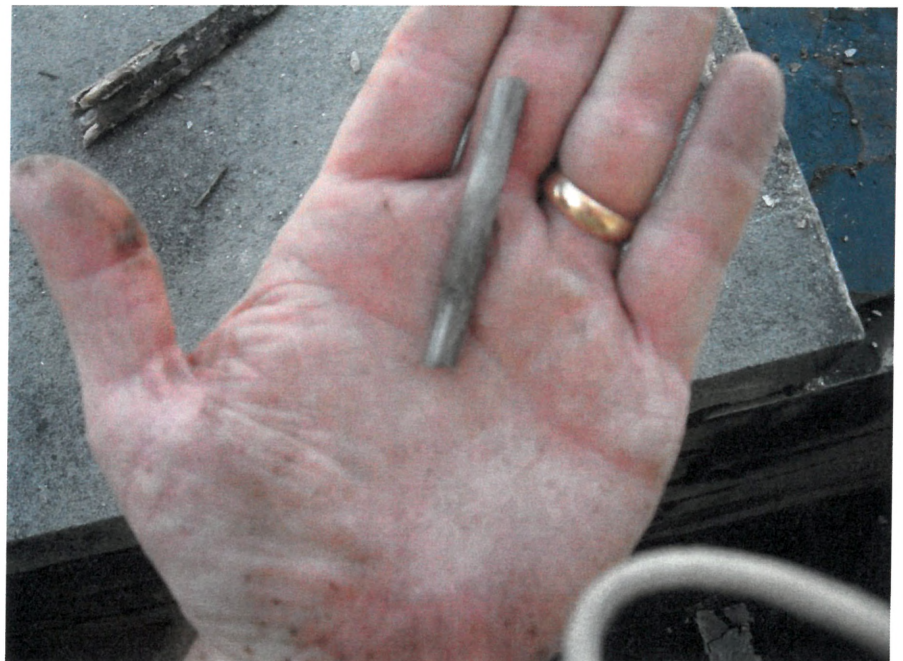
Image PR4-5, PR4-6, PR4-7, PR4-8, PR4-9, PR4-10, PR4-11 – In removing the limestone caps, it was observed that the fabric-faced copper flashing has not deteriorated due to age. The insertion of flashing at this horizontal location in the backup wall has created a bond break between the cap and the brick backup as well as the limestone face panel – PR4-5. The joints on both sides have broken away from the flashing and have deteriorated to a point where portions have fallen out PR4-8. The flashing was not sealed at the laps and not sealed at the top of the brick or the face panel, thus allowing water entry points into the parapet system PR4-7. The limestone cap is held in place with a series of pins set into the panels and the brick backup and is held down by use of a grout pocket in the base of the limestone cap. In images PR4-9, PR4-10, PR4-11, these pins are shown in place, but are considerably shorter in height than what should have been used to properly hold down the cap. Since the grout joint under the cap has no bond left, and the pins are not secure into the cap, we can assume that the dead load of the cap itself is what is holding the system down.

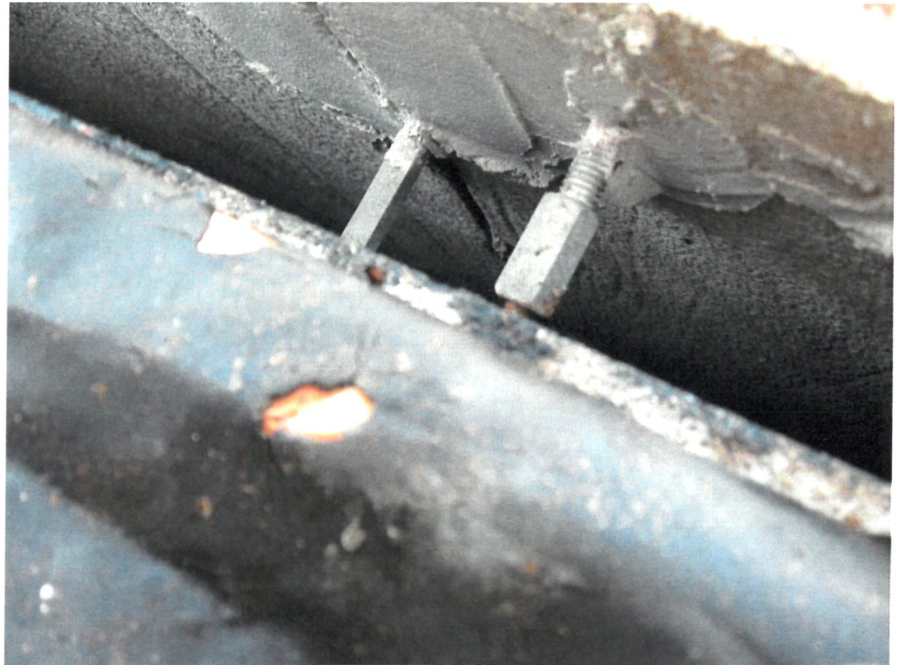
PR4-12 - Cavity looking down

PR4-12 and PR4-13 – In viewing down the cavity from above the panel anchors showed no visible signs of rusting to the 3/16” diameter threaded rod. There was some surface rust to the anchors at the top of the wall but looking down the cavity most the anchors appeared to be in good shape.
