Maine State Cultural Building Augusta, Maine : Exterior Building Facade Investigation

Harriman Architects & Engineers

Project No. 09594

October 16, 2009
Final

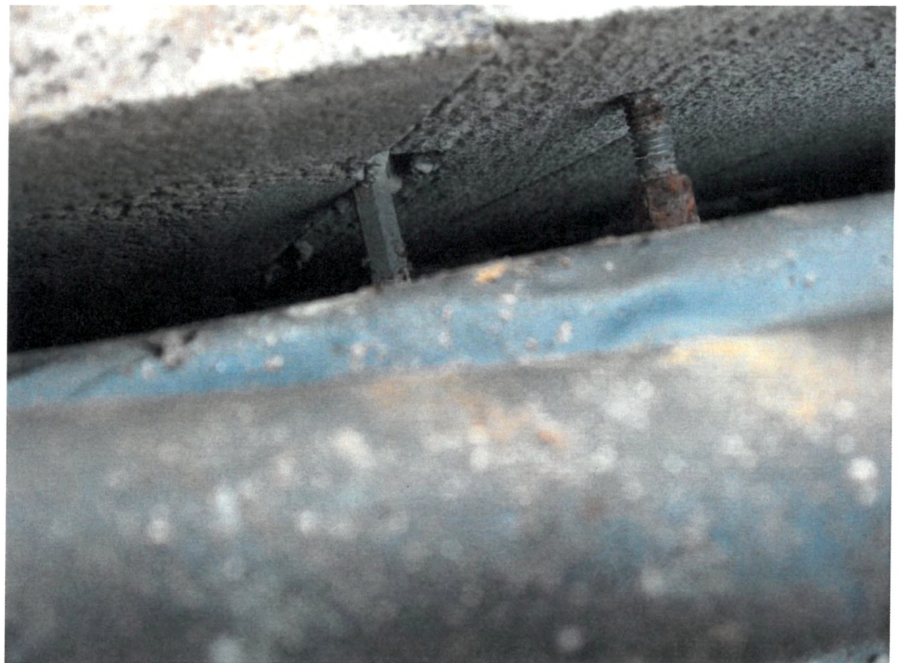
PR4-12 and PR4-13 – In viewing down the cavity from above the panel anchors showed no visible signs of rusting to the 3/16” diameter threaded rod. There was some surface rust to the anchors at the top of the wall but looking down the cavity most the anchors appeared to be in good shape.

PR4-13 - Cavity looking down - minimal rust on anchors

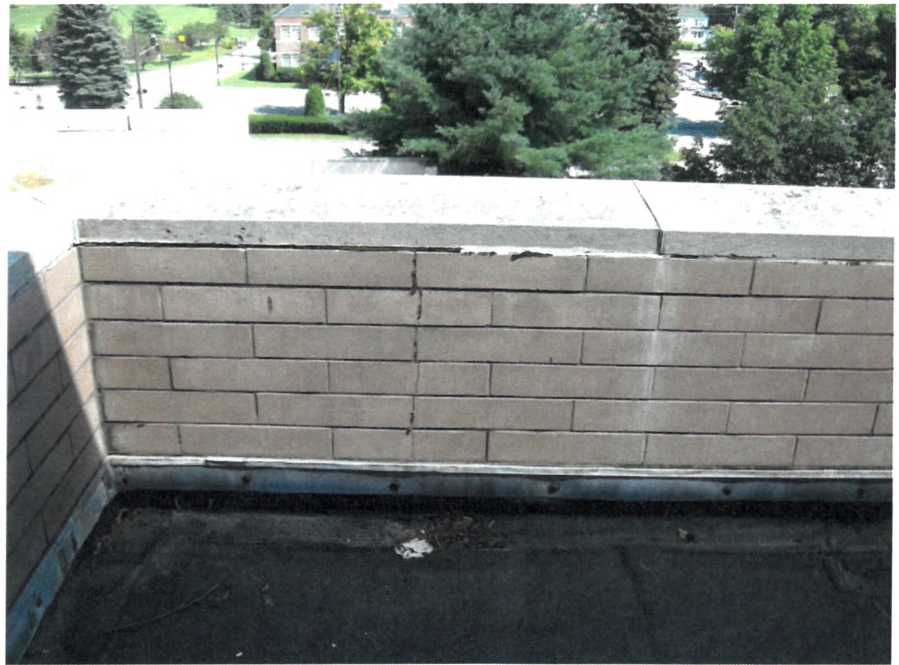
PR4-14 - The inside face of the parapet walls have vertical cracks on all sides of the building. The grout joints are totally broken at the cap and the backup system has vertical cracks from the caps to the base. This has presented a real structural concern to the top panel and parapet of the system. The existing construction documents show the top row of limestone panels anchored to the backup system in the same manner as noted previously. In the removal process of the limestone cap, we were able to physically move the backup system with little pressure. With no lateral structural element in the backup system shown on the construction documents, and the field forensics indicating the system was constructed as detailed, the vertical cracks in the backup system indicates movement in the system. We would consider this whole parapet system to be structurally unstable and should be addressed as soon as possible.

*PR4-14 - Parapet backup
cracked*

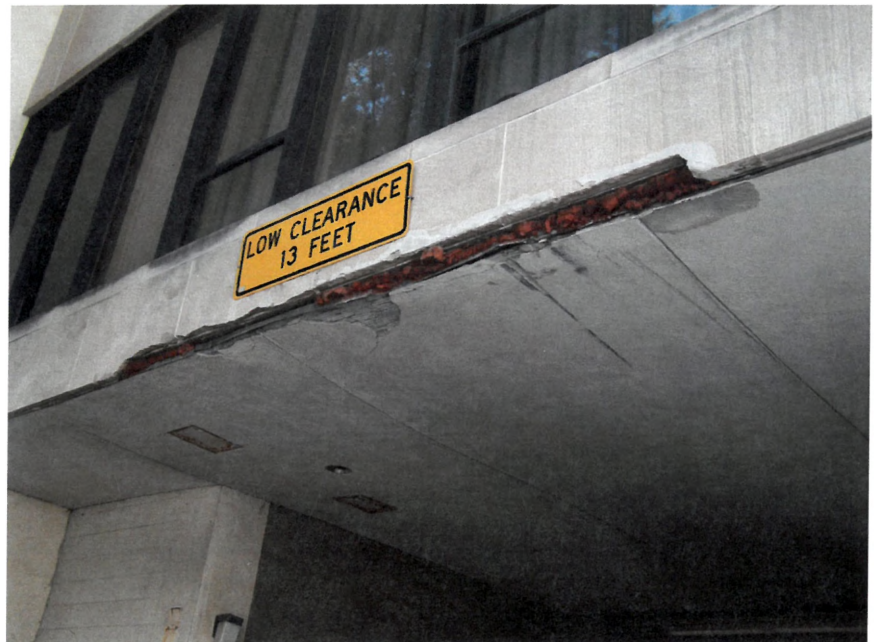
The damage to the limestone panels – LD1 – is a result of tractor trailer deliveries to the receiving door. The damage was caused from the impact from trailer box hitting and breaking off the bottom section of the limestone panel. Image LD2 shows the construction document detail of a similar connection at the limestone panel with a slot and seat on a support angle. The structural support frame at this opening does not appear to have been compromised by these incidents. The cement plaster soffit has been damaged beyond repair due to the impact of the trailer box. Our observation has shown that the soffit is bulging out and we can safely assume that the hung metal support system for the ceiling has been bent out of plumb and cannot be corrected to its original position without complete removal and replacement.

LD2 - Damage at panels over loading dock door

The recommendation for this loading dock area is to construct a new loading dock with the face of the extension out beyond the plane of the current limestone panel. With this new extension and opening, we would recommend a new dock pad and weather shield canopy to protect the loading and unloading operations during inclement weather. These new pads can also seal the loading dock area from the exterior temperatures during heating season.

Another important recommendation for this opening would be the installation of a dock leveler/dock lift to accommodate various truck heights and boxed displays during loading and unloading operations. The loading dock entry drive, drainage and grading should also be redesigned to allow for easier truck access.

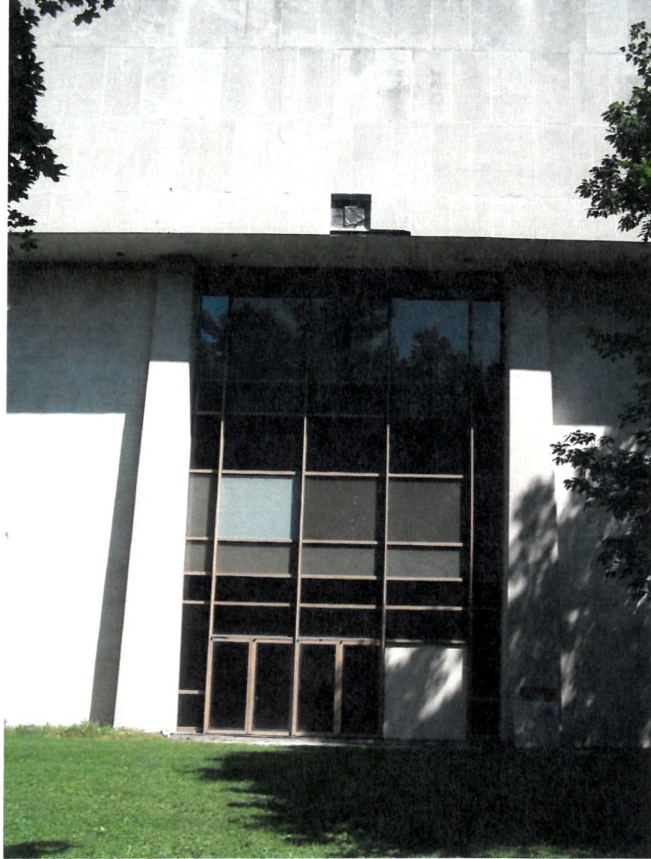
The existing exterior steel framed/aluminum doors are single-pane glazed openings in a steel framed curtainwall system. The opening on the south side has four single doors and the west side has three single doors. There is an additional single door opening on the south and west side of the building. All of these door openings are currently being utilized as emergency means of egress. At all these door openings the current hardware is beyond the point of repair and needs replacement. The weather stripping is also in poor condition. These openings have water and air leakage problems around the openings.

*ED1 - South wall
emergency egress doors*

The replacement system for these openings will have to be paired unequal leafs as stated by the life safety code for an existing condition and fully active and accessible at all time.

The single door openings on the west and south sides are also being utilized as emergency exit doors. These existing door openings are sized so that a new replacement door and frame will meet the minimum door width parameters as required by the current Life Safety Code.

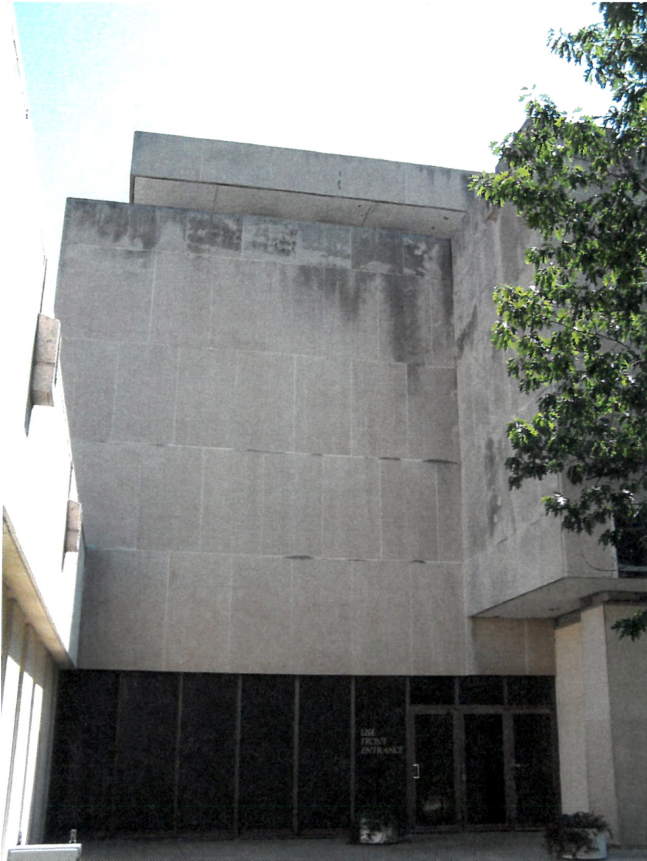
*ED2 - West wall
emergency egress doors*
