Naples - Bridge Replacement and Highway Reconstruction, US Route 302, Project No. BH-A106(000), July 17, 2013

Naples – Bridge Replacement and Highway Reconstruction, US Route 302, Project No. BH-A106(000)

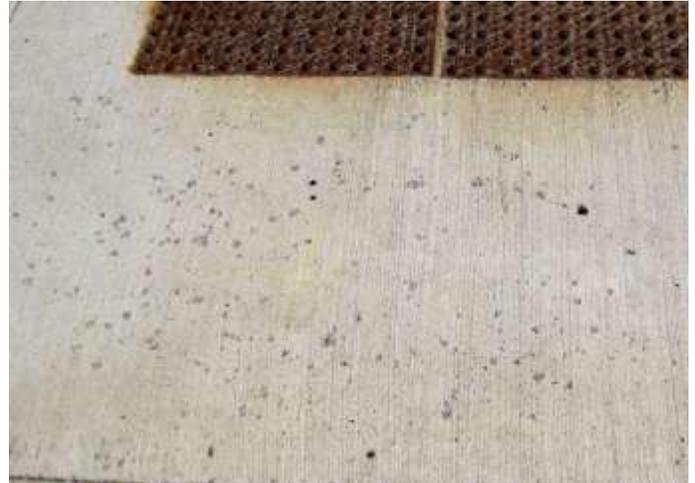
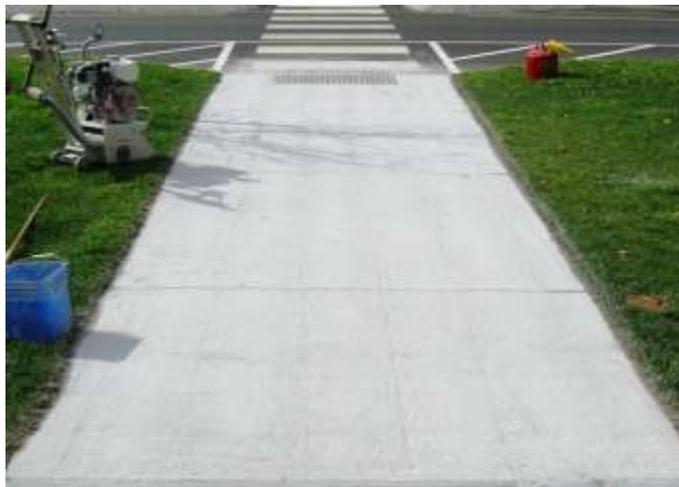
The concrete sidewalks on this project were constructed in 2011. After one winter, “blotchy” pitted areas began showing up on the surface. They did not appear everywhere, but in enough places to raise concern about future durability plus they were unsightly.

After a review of the sidewalks, it was determined that the surface contained a lot of fine material including cement paste, which de-bonded under freeze-thaw conditions.

It was recommended to scarify the surface with a “walk behind scarifier”, followed by thorough cleaning and an application of a silane sealer.

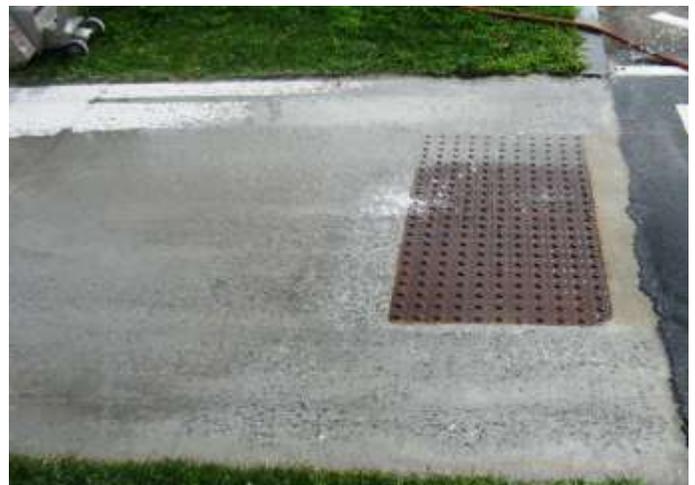
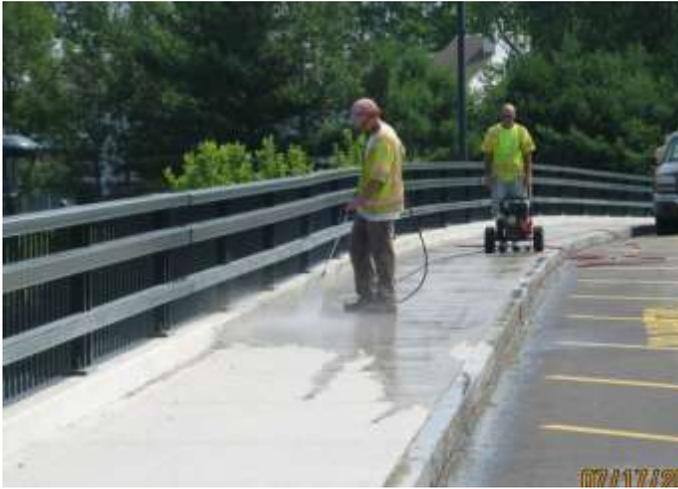
The scarifying process was a slow and tedious one due to the high strength of the “LP Concrete.”

After scarifying, the loose dust was swept up, followed by a rinsing of the surface with low-pressure water.

Originally, the sidewalks had a light-broomed finish. The appearance now is more of an exposed aggregate look.

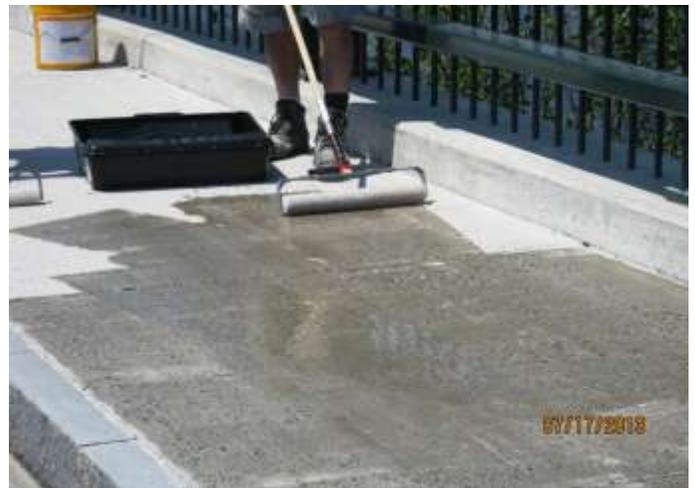
The crew used rollers for the primary application, with brushes used for hard-to-reach areas.

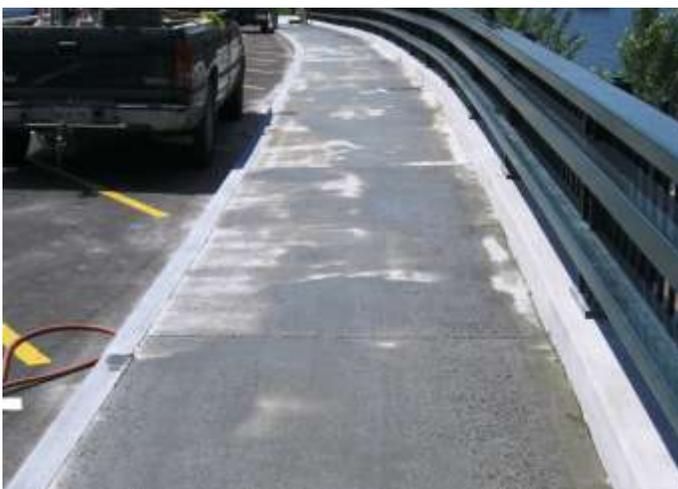
An hour after application, the silane still had a somewhat wet appearance. The manufacturer recommends a minimum of 3 hours drying time (at 68 degrees) before being exposed to rain.
