Maine Geologic Facts and Localities
November, 2007

Brunswick, Maine Patriots' Day 2007 Landslide

Text by
Michael E. Foley

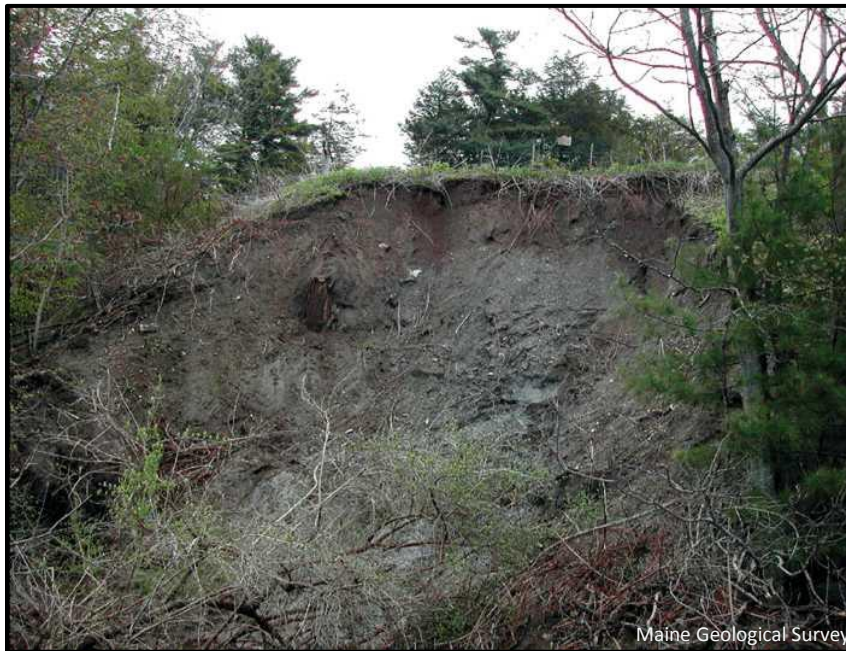
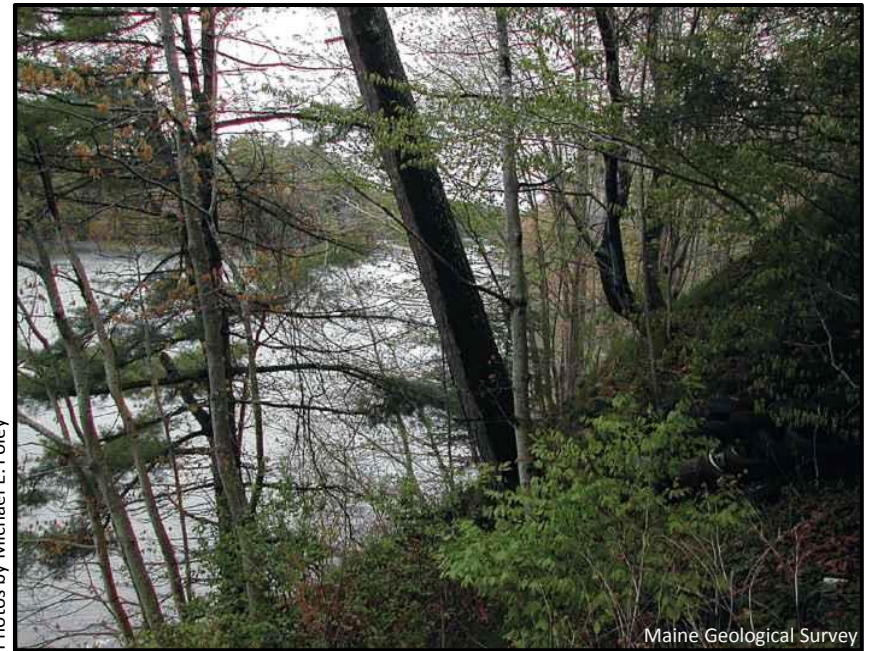
On Monday, April 16, 2007, a landslide (Figure 1) and adjacent slope subsidence (Figure 2) occurred along the east shore of Buttermilk Cove in Brunswick, Maine.

Figure 1. (Left) View of the rotational landslide looking northeast from Buttermilk Cove toward Route 24 (Gurnet Road). (Right) Bluff slope and leaning trees. Buttermilk Cove is in the background.

The slide occurred along a steep bluff (Bryant and others, 2002) adjacent to Route 24 (Gurnet Road) (Figure 3). The bluff top was about 30 feet above sea level (Figure 1, Right).

1. **Unstable soils** - leaning trees exhibiting prior slope creep and movement. The presence of large leaning trees demonstrates that earth movement has been continual over time.

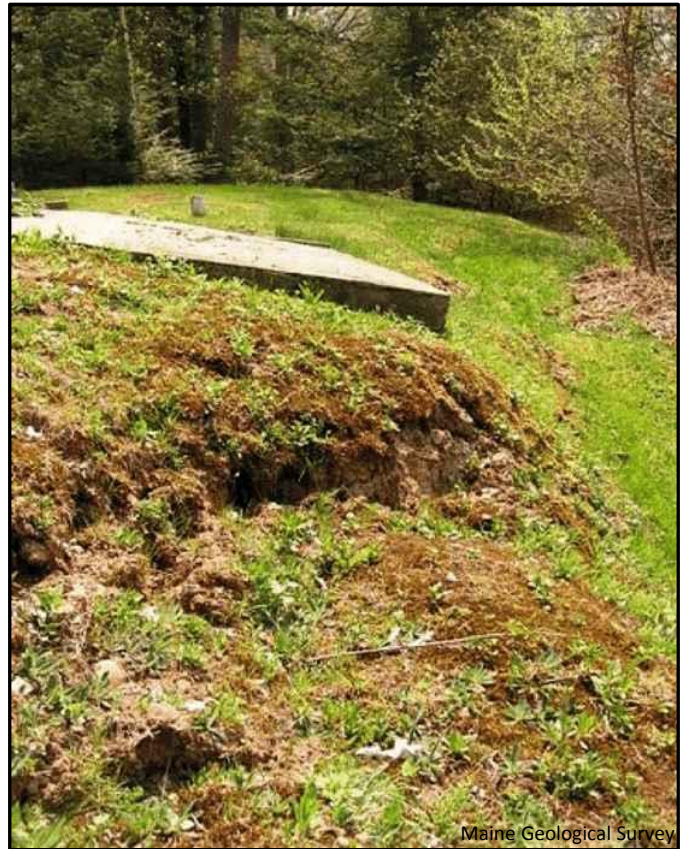
Figure 2. Backyard slumping and scarps show down-dropped sections of earth. The top of the bluff and shoreline are to the right and the house to the left.

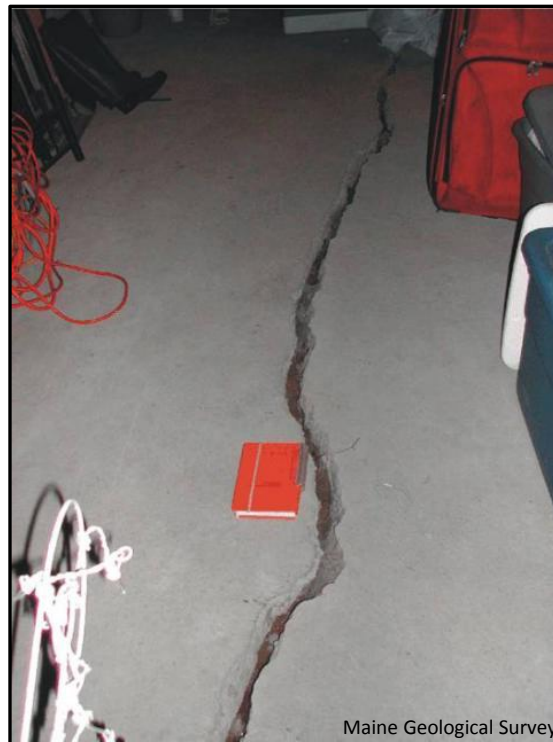
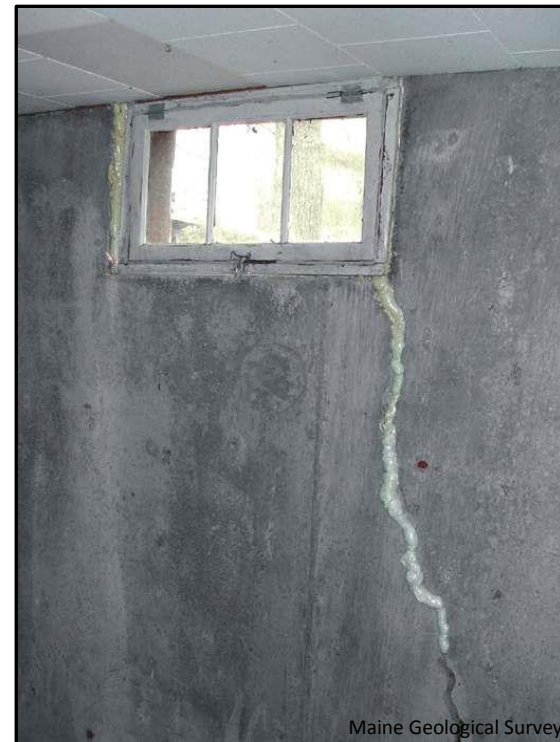
This site location has evidence of prior slope failure and subsidence. The basement and foundation walls show previous cracking due to ground subsidence (Figures 5). The most prominent crack runs along the entire length of the basement floor and resulted in a slight separation in the cement. The floor section on the west side of the basement towards the water shows subsidence and also drastic sloping down toward the shoreline.

Figure 5. (Left) Basement floor of the residence with a large crack parallel to the bluff face. (Right) Relic basement wall cracks from previous subsidence. The bluff is to the right.

2. **Foundation cracks** - extensive wall and floor foundation cracks show both prior and recent subsidence since the building was constructed.
3. **Tension cracks** - landslide scarps begin as tension cracks. Field evidence exists of prior and new tension cracks and scarps extending for 90 feet across the back yard.

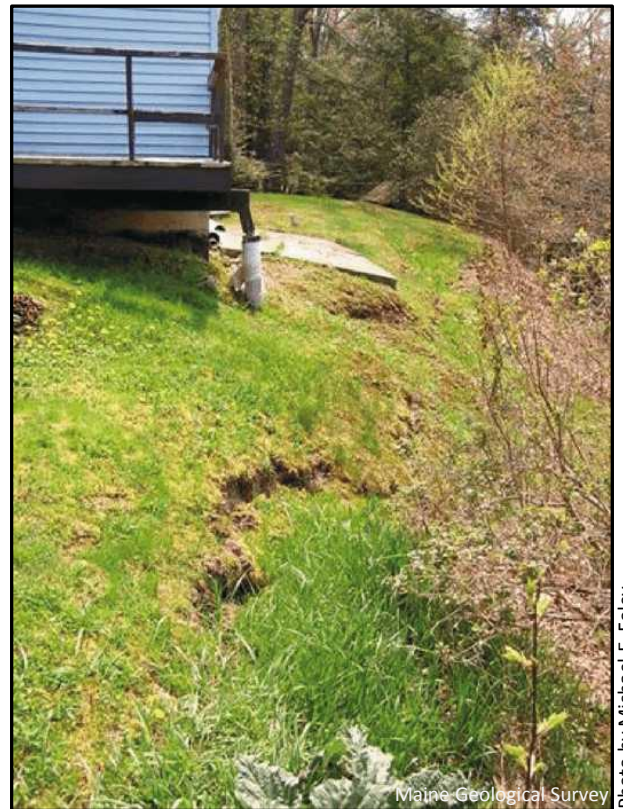
The back yard, which is located west of the house towards the water, exhibits extensive subsidence and sloping from prior slope failure events (Figure 6). There is evidence of 2 to 3 old landslide scarps in this same area between the building and the bluff face.

Figure 6. Back yard showing subsidence, tension cracks and small landslide scarps. The shoreline is to the right and the major landslide site is behind the photographer.

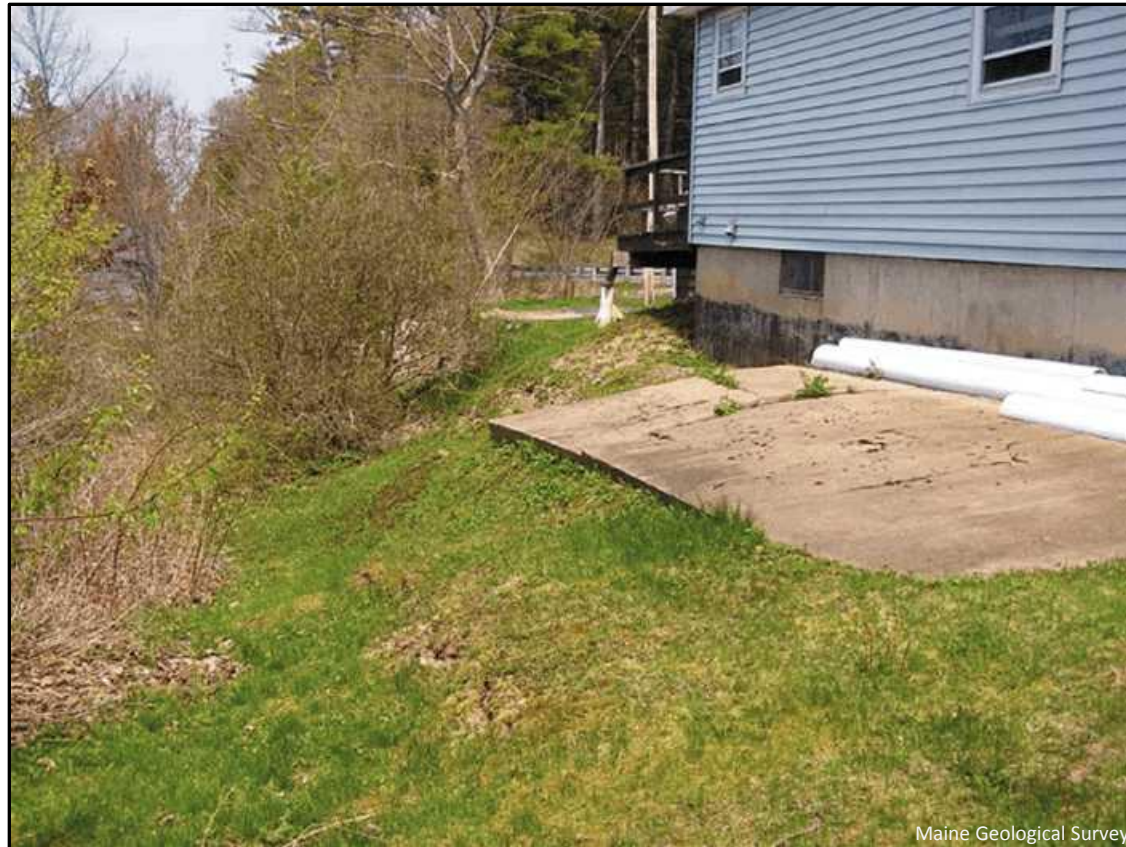
A cement patio, built in the early 1970's level to the ground, now exhibits a 20-degree slant towards the water (Figure 7). The patio slab is now completely broken up and cracked by previous ground movements.

Figure 7. Patio slab showing slumping, multiple cracks and uneven vertical offset. Buttermilk Cove is to the left.

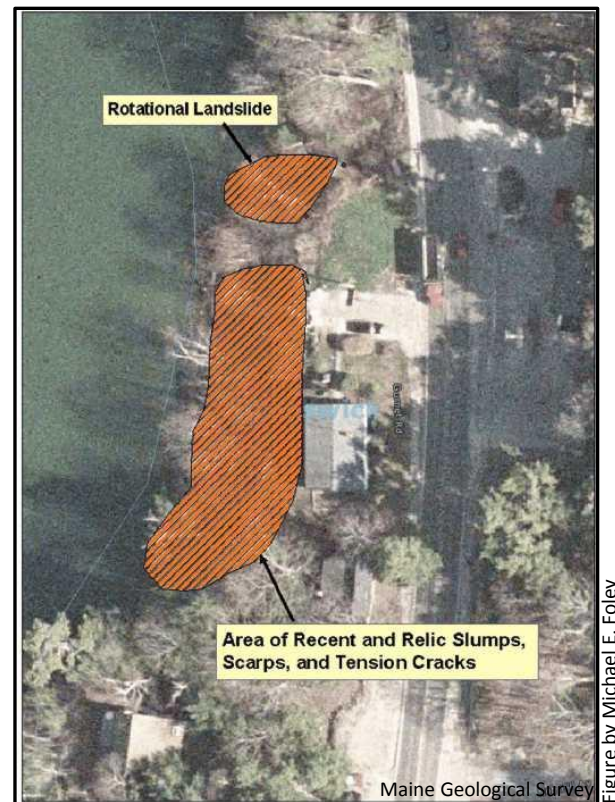
During a site visit by Maine Geological Survey geologists, two distinct areas of slope failures were observed (Figure 8). One, a large rotational landslide, occurred 90 feet north of the house in an area where runoff from both a cross-road culvert and the leach field drainage were focused. This rotational slide produced a distinct 30-foot long concave scarp with a tree-covered toe at the base.

Figure 8. Aerial photograph showing areas of rotational slides and slumping.

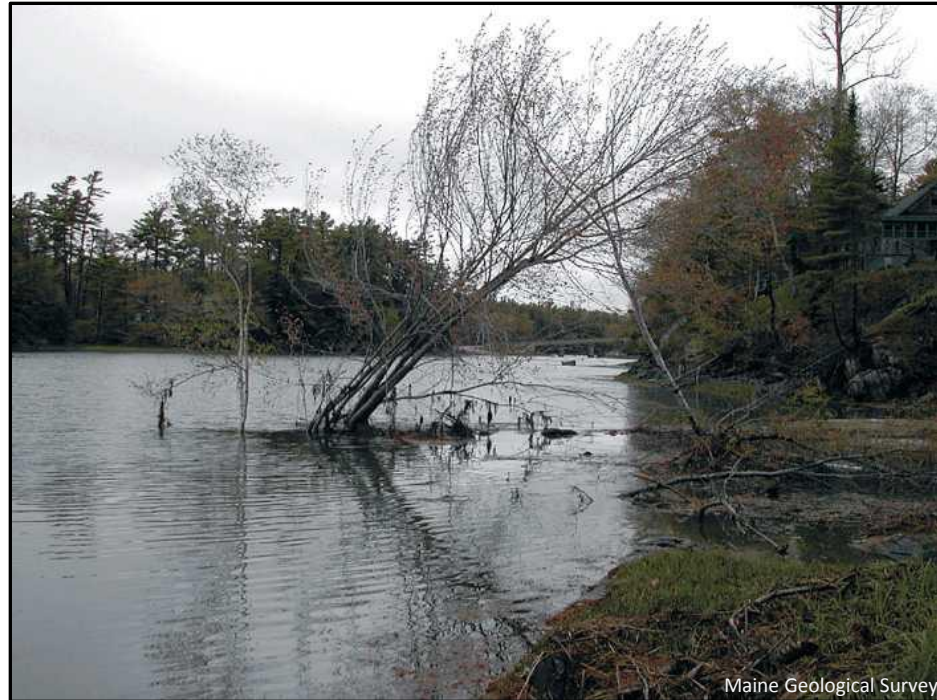
The landslide toe extended into the intertidal zone of Buttermilk Cove (Figure 9). The second area of slope movement extended from the southern edge of the main scarp, southward for approximately 90 feet. This is in the same area as the previous subsidence and slope failure on the west side of the house described above. This slope movement and subsidence consisted of fresh tension cracks and minor parallel scarps in the lawn. This movement caused the ground behind the house to slope more steeply toward the top of the bluff and water.

Figure 9. The toe of the rotational landslide moved out into the intertidal zone in Buttermilk Cove.

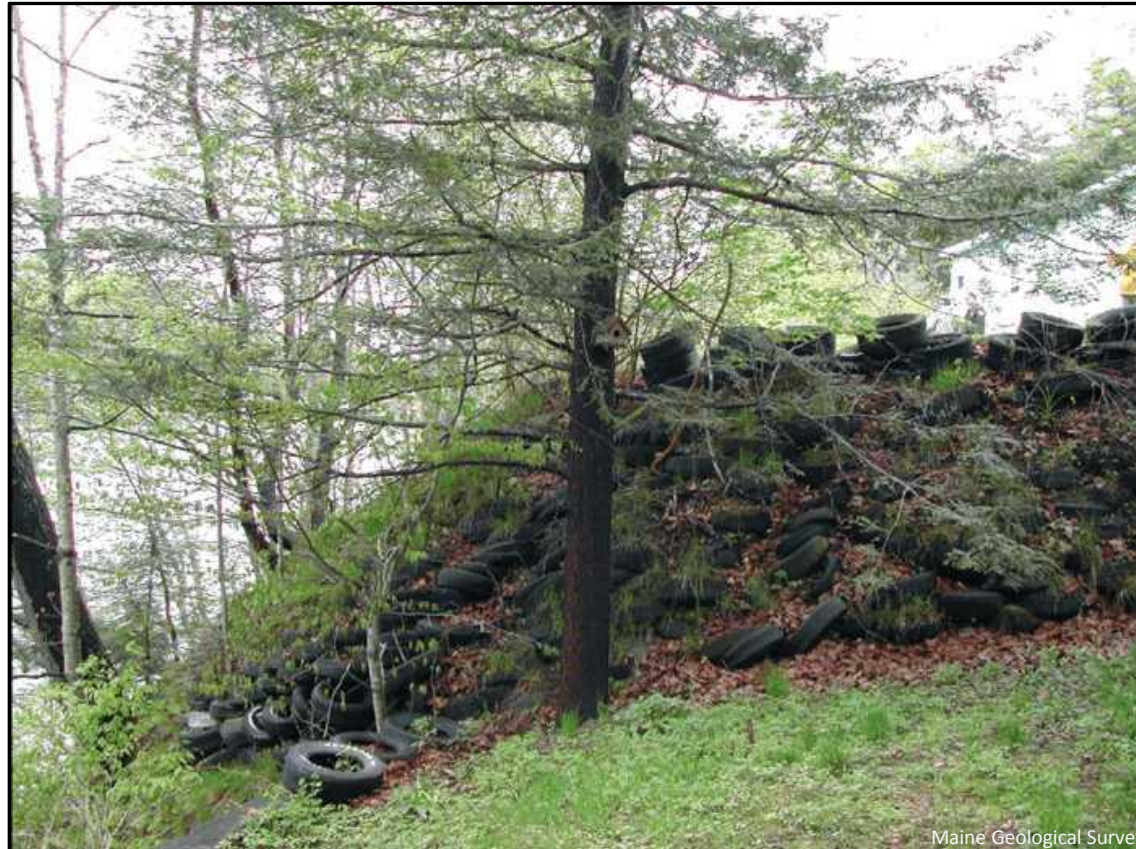
The site has been built up and out towards the water with artificial fill (Figure 10). The north end of the site appears to be filled with a medium to coarse-grained sand which the owner thought came from a local construction site. This area is also the location of a leach field for the home's septic system. The remainder of the site is filled with a mixture of material, the majority of which consists of old tires.

These tires are loosely placed and prevalent on and within the oversteepened slope (bluff face) and appear to have been placed haphazardly and not in an engineered form. Other slope materials include metal, cement, bricks, shrubs, and trees.

Figure 10. Tire fill used to level the back yard of the property. Buttermilk Cove is in the background.

4. **Slope oversteepening** - slope behind house is extremely oversteepened- a primary cause/precursor for a landslide.
5. **Overburden loading** - the area has had extensive artificial fill brought in, which can only lead to an increase in overburden stress on the underlying marine clay, increasing the risk of slope failure.

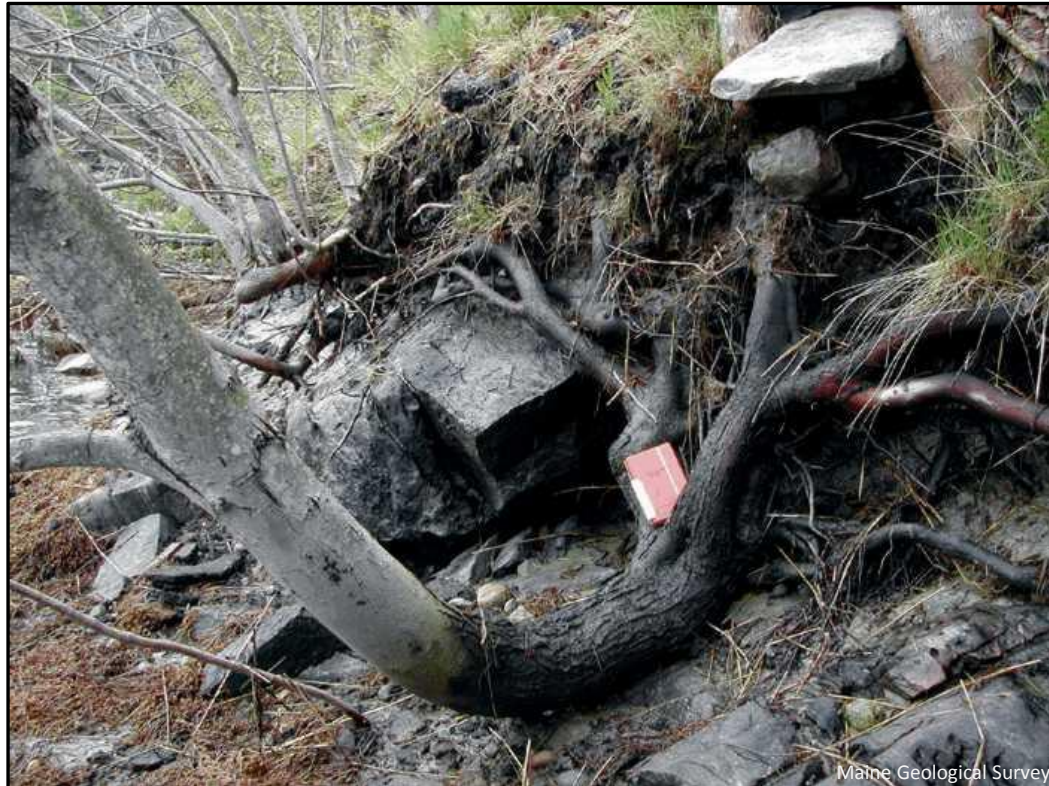
Observation of the bluff toe suggests very little or no till present and Presumpscot Formation clay overlies bedrock at this site. Bedrock underlying the sediment is metamorphic rock of the Sebascodegan and Cape Elizabeth Formations (ancient rocks of Ordovician to Early Silurian age). These rocks crop out along the edge of Buttermilk Cove near the elevation of mean high tide (Figure 11). Outcrops are also located directly across Route 24 to the east of the slide area.

Figure 11. Bedrock outcrop along the high tide line at the base of the coastal bluff in Buttermilk Cove. Note the bent tree trunk caused by previous landslide movements or gradual creep due to toe erosion.

7. **Bluff-toe erosion** - tidal currents and waves erode sediments at the base of the slope. Active toe erosion is present across the entire base of slope at this site. This condition leads to slope oversteepening and less support for land at the top of the bluff.
