Maine Geologic Facts and Localities

April, 2013

Sandy River Bank Erosion, Avon, Maine – 2nd Update

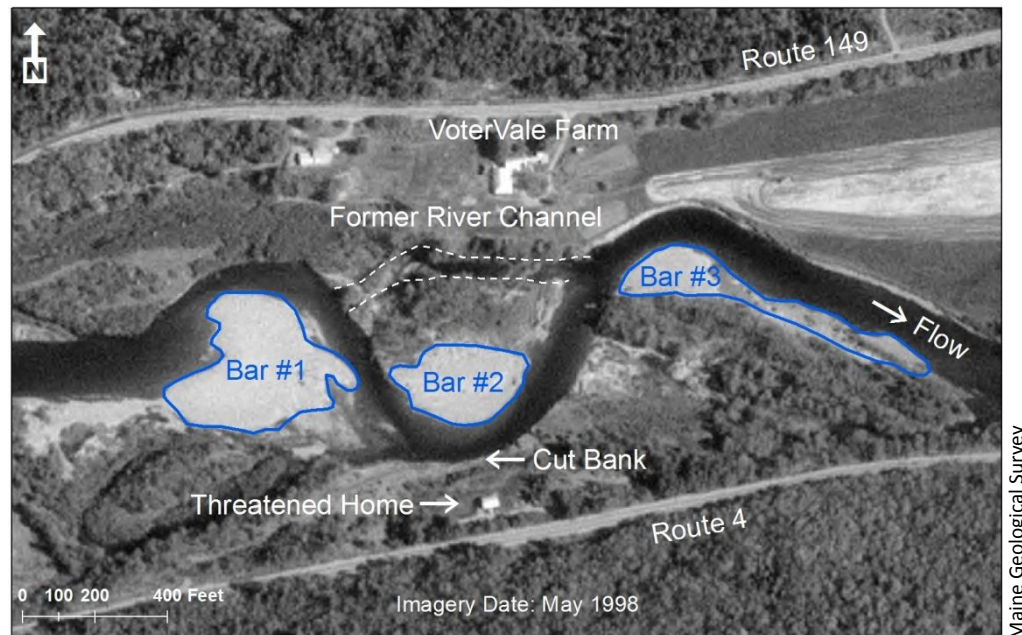
The Sandy River adjacent to the VoterVale Farm has seen significant changes over time. Back in 1998, the Maine Geological Survey was asked to comment on a proposal to remove sand and gravel from three point bars in an attempt to alleviate erosion on a cut bank which was threatening the property south of the VoterVale Farm (north of Route 4). Rather than remove material from these bars, a more direct and effective approach would have been to excavate a former channel which would cut off the meander and thus render this section of the river an eventual oxbow or at least a backwater channel in the short term. This appeared to be an environmentally prudent act since the river would eventually choose this course of action anyway.

Figure 2. Image of site depicting point bars, cut bank, and potentially threatened home in 1998. Also shown is a former river channel where dredging was proposed to cut off the meander.

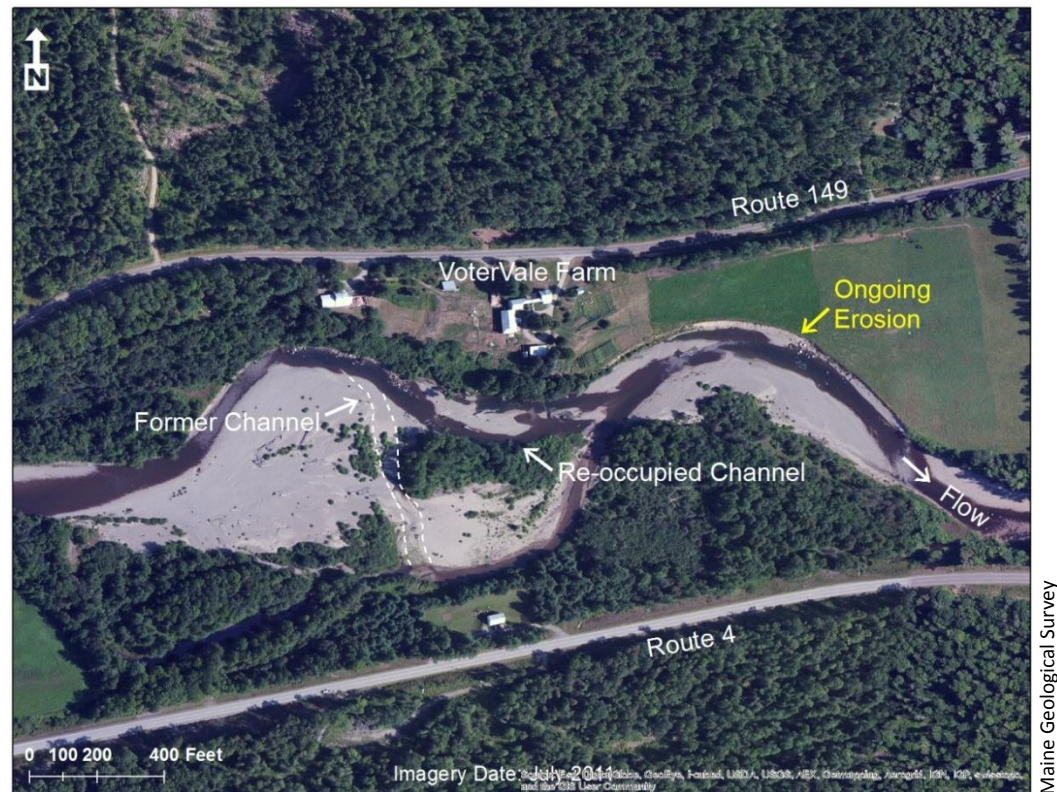
In the spring of 2005, the Sandy River changed course and re-occupied the former channel which cut across the meander. Clearly, this change of events significantly reduced the erosion on the cut-bank which was threatening the residence. However, erosion downstream of fields owned by the VoterVale Farm continues. An interesting outcome of abandoned channels is that they make excellent habitat for many types of wildlife.

Figure 3. Image depicting re-occupation of former channel and the abandonment of the meander to the south.

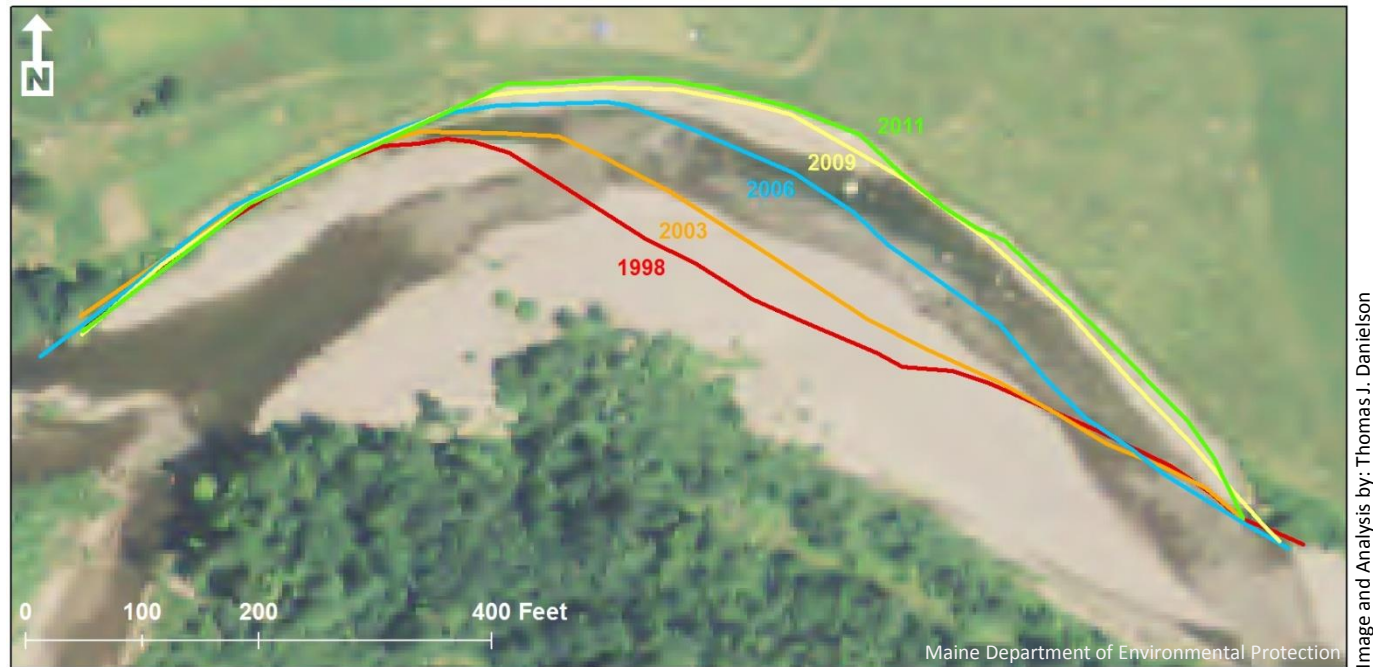
As a consequence of the natural change in river course across the meander, there continues to be significant erosion occurring over time that is well documented by studying aerial photographs from 1998 through 2011 (Refer to area noted in yellow on Figure 3 for location). In this analysis, a series of five aerial photographs were examined and the edge of the stream bank was delineated. The progression of these stream bank edge delineations from 1998 to 2011 can be clearly seen as a northeasterly encroachment of the Sandy River onto the VoterVale Farm field; a distance of approximately 175 feet. This resulted in a loss of approximately 1.9 acres of land.

Figure 4. This image depicts a detailed analysis of five delineated stream bank edges from aerial photographs dated 5/12/1998, 5/19/2003, 8/9/2006, 8/14/2009, and 7/16/2011.
