Maine Cultural Building Atrium Envelope: Invasive Investigation Report

Atrium Envelope: Invasive Investigation Report

Building	PROJECT:	Maine State Museum & Archives Building
Performance	CITY, STATE:	Augusta, ME
Advisors LLC	OBSERVER:	Matt Losquadro, PE
	OTHER	Ben Cawley, G. Drake Masonry
104 Prospect Street • Portland ME 04103	ATTENDEES:	Clayton Langley, G. Drake Masonry
207-536-4500 www.buildingperformanceadvisors.com	DATE:	24 May 2019

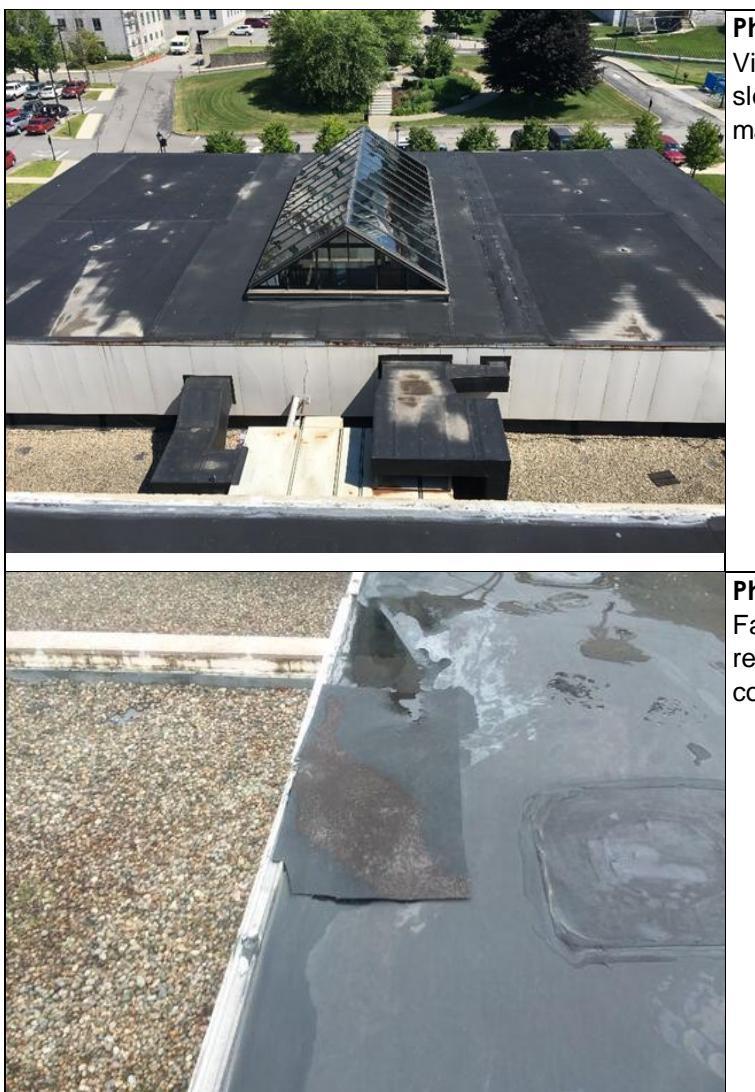
Photograph 1.

The adhered EPDM roof of the atrium appears weathered and in poor overall condition. Several areas of ponding water and billowed membrane suggest the underlayment has been physically distorted due to chronic saturation, and is no longer flat and secure to the roof structure beneath. Drawings dated 11/13/1987 indicate the roof membrane is applied directly to tapered rigid insulation, which is installed over a layer of 4" rigid insulation and the concrete roof deck.

View of exposed adhered EPDM and sloped roof glazing system over atrium at main building entrance.

The adhered EPDM roof of the atrium is approximately 32 years old and is beyond the limit of its expected useful service life. It should be replaced before existing deficiencies worsen over time and further deteriorate the atrium structure and interior finishes. An alternative termination detail of the new single-ply membrane roof along the north, east and west walls should be utilized to improve the protection of the roof edge from future water intrusion. Installation of metal flashing with a vertical leg overlapping the top of the granite is suggested, as a cost-effective way to protect the roof edge against water entry.

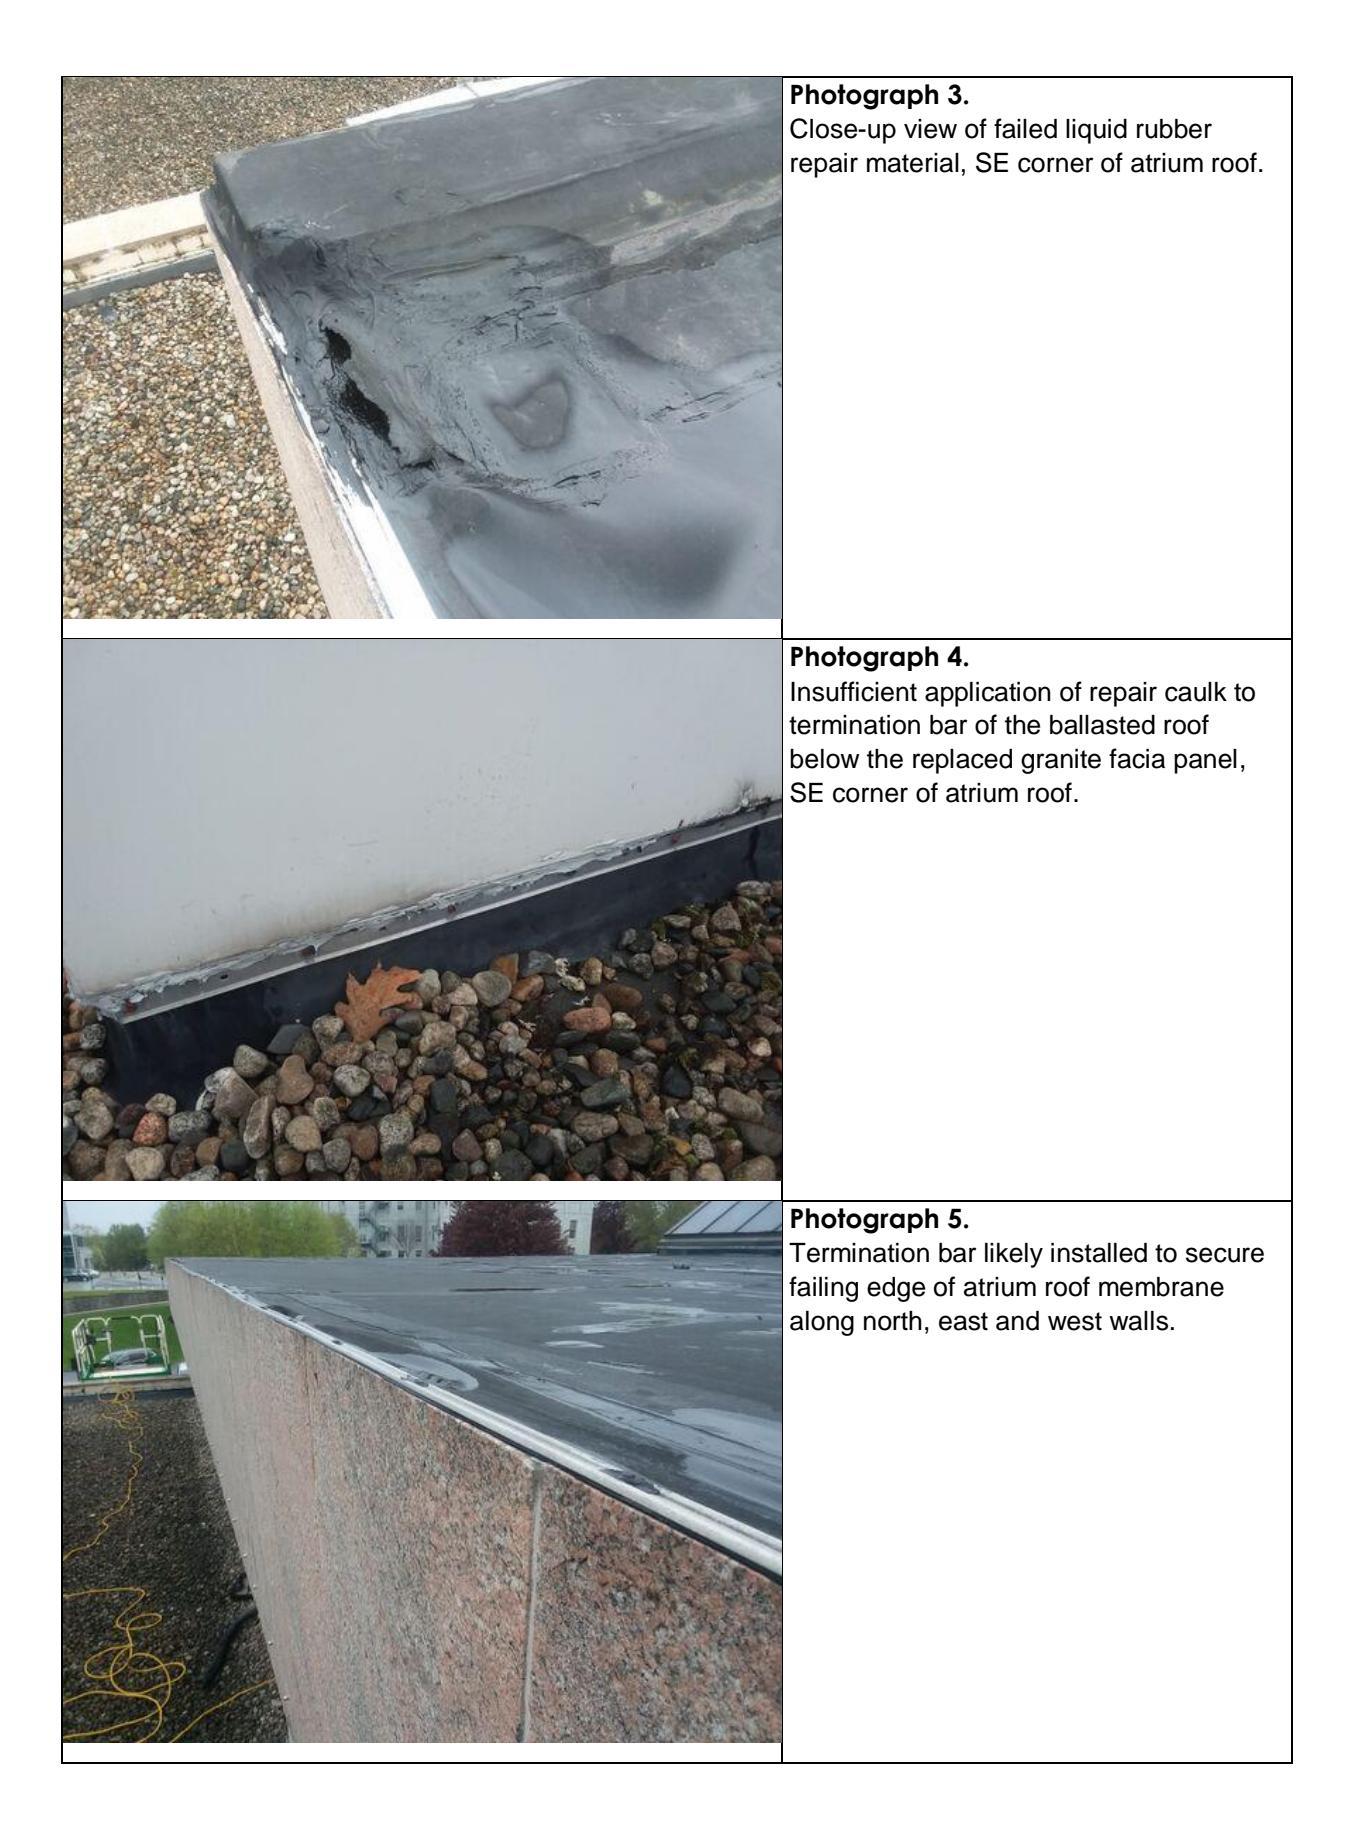
Photograph 2.

According to the museum staff, recurring leaks have been observed at the southeast corner of the atrium. Repairs performed in 2005, which included the removal and reinstallation of the third granite panel north of the southeast corner, have failed and are allowing water to enter the interior space of the atrium attic. The patch along the termination of the rubber roof over this third panel has failed and is likely permitting water to intrude behind the reinstalled panel (Photo 2). The liquid rubber applied near the southeast corner of the roof has also failed (Photo 3), as have the sealant joints between panels. The termination bar of the ballasted roof below this panel shows evidence of a previous repair, although less than half of this termination bar was recaulked. The unrepaired section of the termination bar is another likely source of water intrusion in this corner of the atrium (Photo 4).

Failed patch over granite facia panel removed and reinstalled in 2005, SE corner of atrium roof.

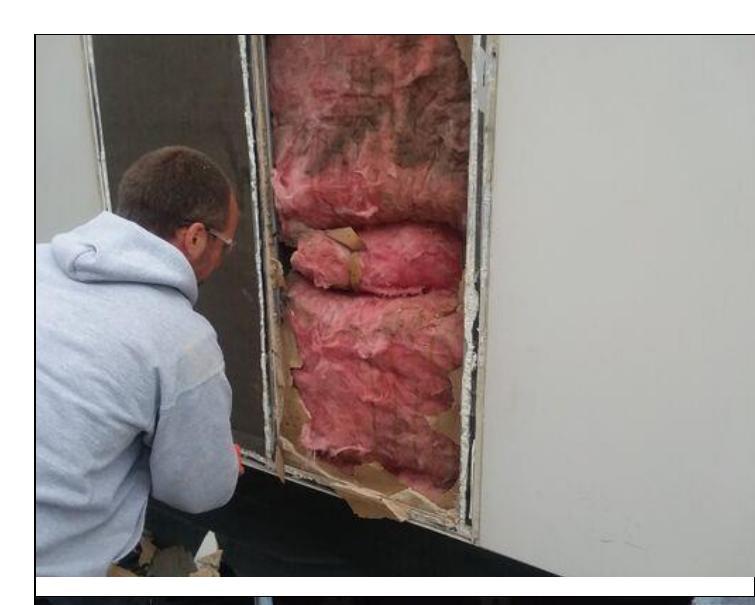
Photograph 12.

The fiberglass batts installed in the steel stud-frame backup wall have sagged or completely fallen out of the wall in the areas accessible to view. The paper-faced batts most likely fell out of the spaces between studs due to the weight added when the fiberglass became saturated with water from leakage through the wall cladding and/or the roof. Photo 9 shows evidence of the chronic accumulation of moisture in the concealed space above the atrium soffits.

Contractor removing gypsum sheathing from east panel location. Stained and sagging fiberglass batt insulation show signs of water intrusion.

Thermal insulation should be installed at all exterior wall surfaces, and the exterior wall insulation should be installed so that it abuts the roof insulation tightly to eliminate any gaps in the thermal barrier. New mineral fiber insulation can be installed in the stud framing and/or on the face of the backup wall behind the new cladding system.

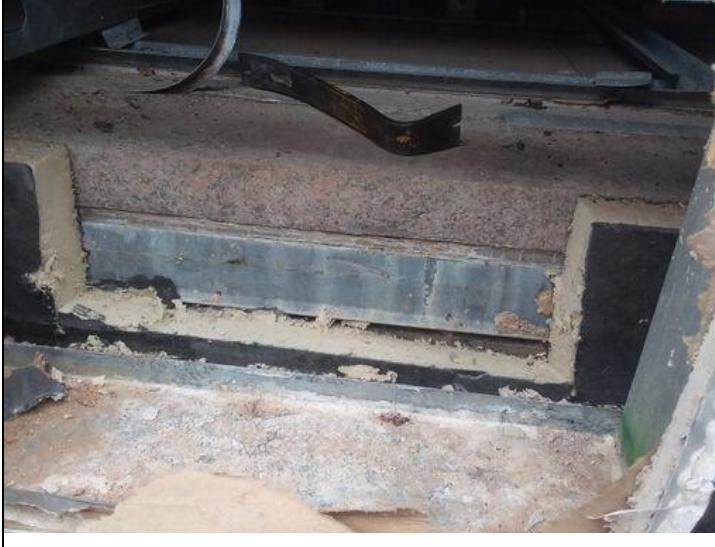
Photograph 13.

Removal of fiberglass insulation and small section of rigid insulation at east panel reveals lead-coated copper flashing over original masonry parapet wall, granite coping stone, lead Tflashing and top edge of original 3" thick granite panel in atrium over entrance doors to museum lobby.

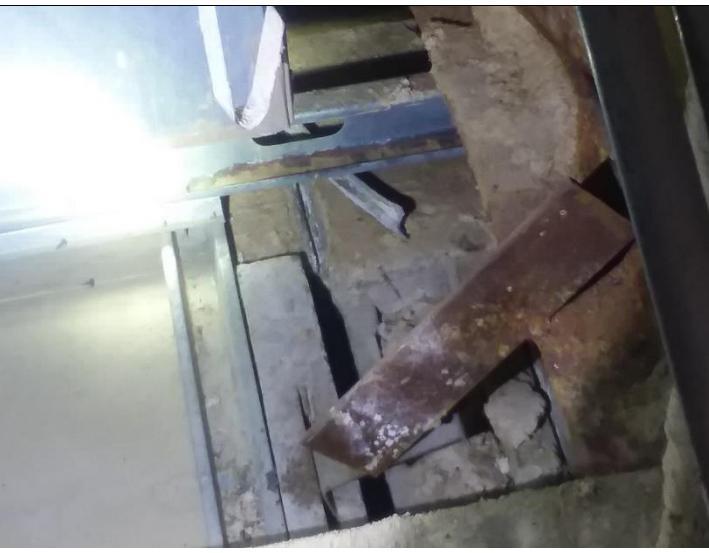
Photograph 14.

Drawings indicate 5" x 3-1/2" x 1/2" angles secured to the inside face at the bottom and midpoint of the new granite panels. The lower angle is supported by an existing 3-1/2" x 3-1/2" x 3/8" continuous steel bracket attached to the building structure. The midpoint angle rests on a 1/2" plate with an adjusting slot and anchor bolt to position the panel flush with the adjacent panels. These structural supports could not be visually confirmed during this inspection, and it is unclear if the original panels are supported in the same manner.

Top edge of stone panel above archives entrance door was exposed to view during the investigation. A steel angle inserted into the top of the panel provides lateral bracing of the panel, which was installed when the atrium was constructed. The structure providing vertical support of the stone could not be seen from within the concealed space behind the south atrium wall.

Confirmation of the panels' structural support could most likely be accomplished by removing one or more of the recessed lights in the soffit above the museum lobby to allow inspection at close range using a fiber-optic video inspection camera.

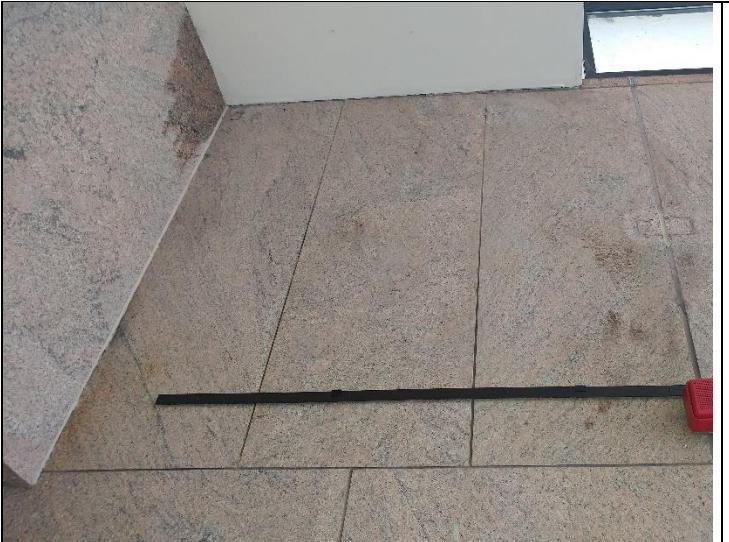
Photograph 15.

Water stains were observed on the exterior surface of the gypsum sheathing behind the east panel where the fiber-cement panel was removed (Photo 11). Staining was also found on the inside face of the exterior wall sheathing (Photo 10). Photos 15 & 16, provided by BREM in an email to BPA dated Dec 17, 2018, show the result of this moisture accumulation in the concealed space above the southwest corner of the atrium lobby. The areas of saturation and water damage in the atrium space are directly below the areas shown in BPA photos 9 through 11. Moisture from above the atrium soffits has migrated behind the interior granite panels and manifested on the interior surface of the porous stone.

This photograph provided by BREM shows water intrusion at the top edge of the stone panel in the preceding photo. The staining is located directly below the area exposed to inspection and shown in photo 9 above.

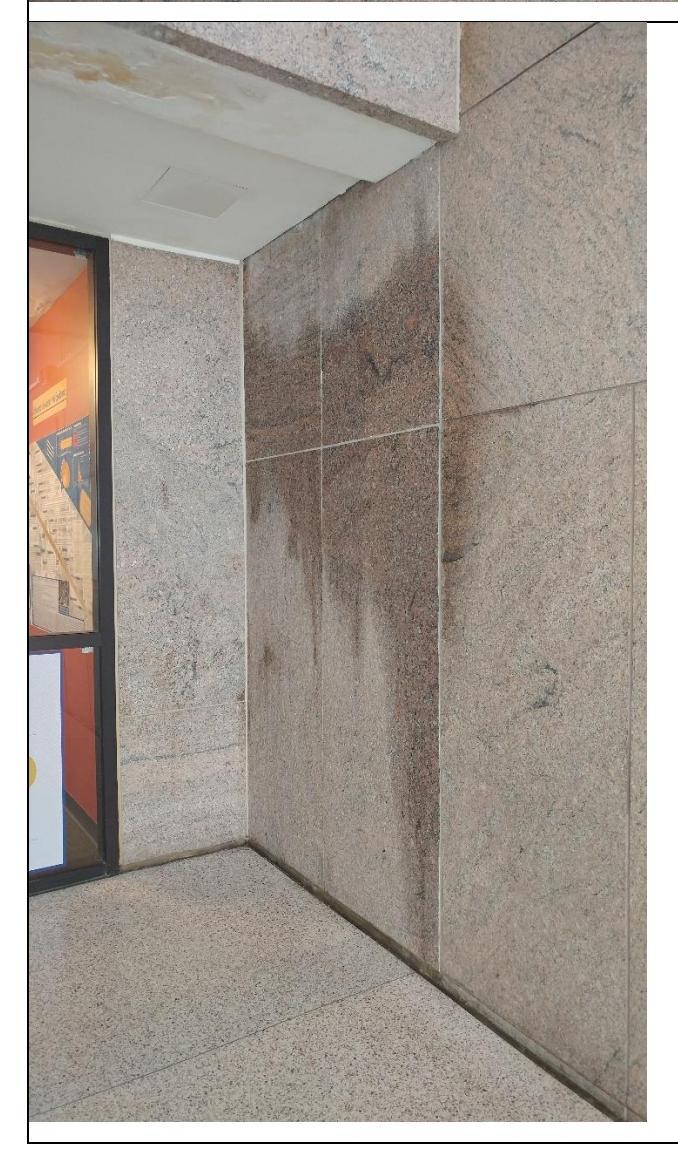
Photograph 16.

This photograph provided by BREM documents water damage at the gypsum soffit above the archives entrance, and saturation of the stone cladding on the west wall. These areas are directly below the space shown in photo 9 above.
