Maine Geologic Facts and Localities March, 2009

Coastal Erosion at Crescent Beach State Park Cape Elizabeth, Maine

Text by Peter A. Slovinsky

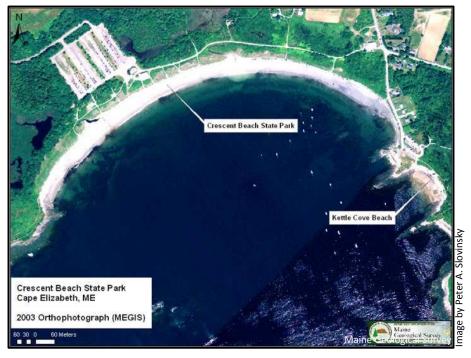
Figure 1. Crescent Beach State Park is an arcuate-shaped pocket beach that is bound by headlands. Kettle Cove is a small pocket beach located southeast of Crescent Beach. Base imagery from MEGIS (2003).

<u>Crescent Beach State Park</u>, located off of Route 77 in Cape Elizabeth, Maine, is a popular State beach, offering superb recreational beach opportunities with easy access from Portland (Figure 1). The approximate 1.4 km length pocket beach, and the adjoining smaller beach at Kettle Cove, has undergone episodic erosion, some of the most severe occurring during the May 2005 series of northeasters, and the 2007 Patriots' Day Storm.

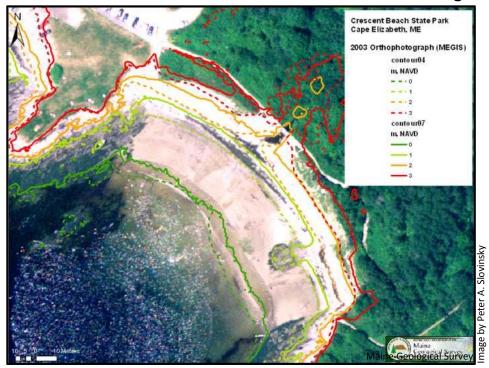
Figure 4. Comparison of 2004 (dashed) and 2007 (solid) contours, derived from LIDAR data, along Kettle Cove. It is clear that each contour has moved landward, indicating both beach and dune erosion. Base imagery from MEGIS (2003).

By comparing the horizontal (i.e., landward or seaward) positions of specific elevation contours on the beach and near the dune, one can determine whether or not a beach or dune is accreting or eroding. Typically, if a beach is accreting, contours will move in a seaward direction from Time 1 to Time 2. Conversely, if a beach is eroding, contours will move in a landward direction from Time 1 to Time 2. We extrapolated 0.5 meter contours from the 2004 (NOAA CSC) and 2007 (USACE) LIDAR data and compared the positions of the contours. Results for Kettle Cove are shown in Figure 4.

Comparison of individual contours along Kettle Cove (Figure 4) shows that the beach and dune system is moving in a landward direction (eroding). The 0-3 m contour lines have all migrated landward between 2004 and 2007. The largest changes occurred at the 1, 2, and 3 m contour lines along the beach berm and frontal dune.

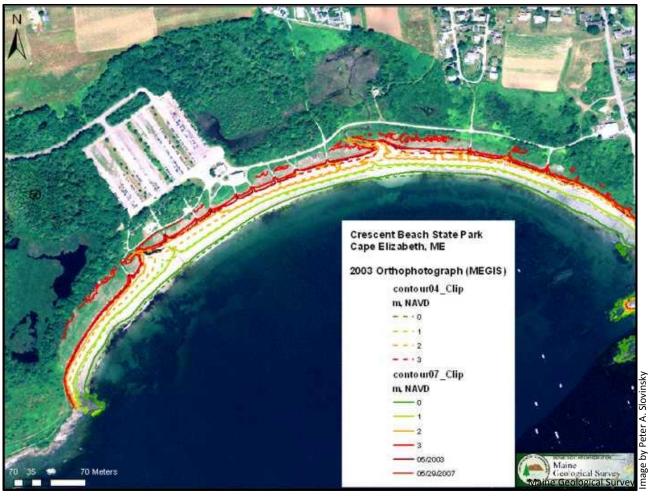
Figure 5. Comparison of 2004 (dashed) and 2007 (solid) contours, derived from LIDAR data, along Crescent Beach. Generally, contours have migrated in a landward direction, indicating net erosion. Base imagery from MEGIS (2003).

Contour comparison results for Crescent Beach are shown in Figure 5

LIDAR contour data comparisons for Crescent Beach are shown in Figure 5. Contour transgression (landward movement) generally occurred along the entire beach. The 0 m contour moved landward consistently along the beach. Inspection of the 1 and 2 m contours shows little change along the central portion (in front of the parking lot) of the beach, and movement of the easternmost inlet in a westerly direction. The 3 m contour, which roughly denotes the edge of the frontal dune in 2004, receded dramatically along this same central portion, and along the eastern portion of Crescent Beach.
