Maine Geologic Facts and Localities

Surveying Beach and Bathymetry Changes near the Scarborough River, Scarborough, Maine

Text by
Peter A. Slovinsky

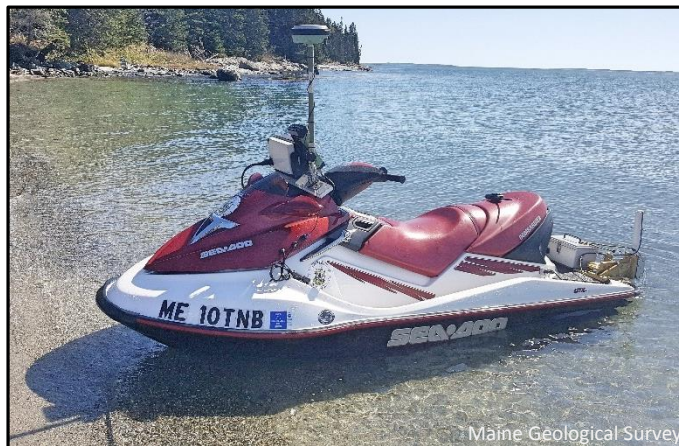
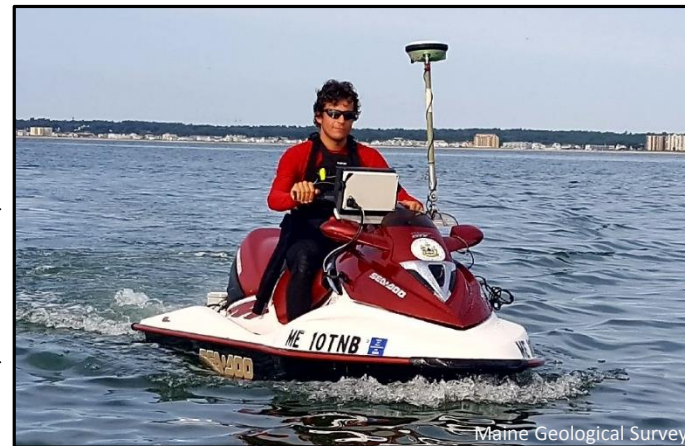
Figures 2a & b. MGS personal watercraft-based bathymetric survey system.

Later, during higher tides, the MGS Nearshore Survey System (NSS), a personal watercraft-based survey platform outfitted with RTK-GPS and a precise single-beam echo-sounder (Figure 1), was used to collect bathymetry along the same shore perpendicular transects so that points could be overlapped (Figure 2). Additionally, survey transects were completed parallel to the beach. Points were collected at a rate of every 2 seconds, resulting in a point cloud of over 30,000 bathymetric points for the study area.

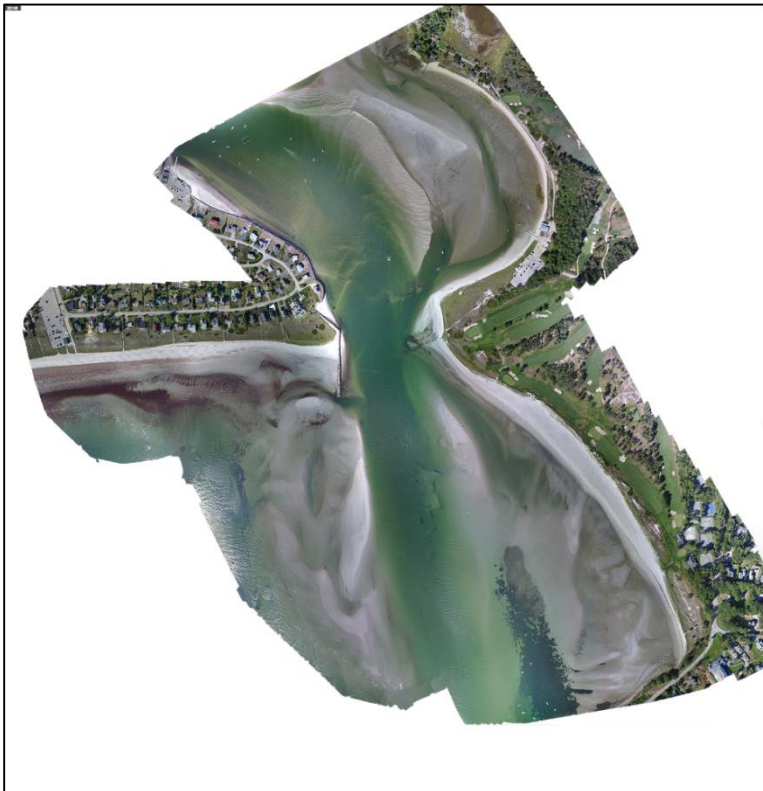
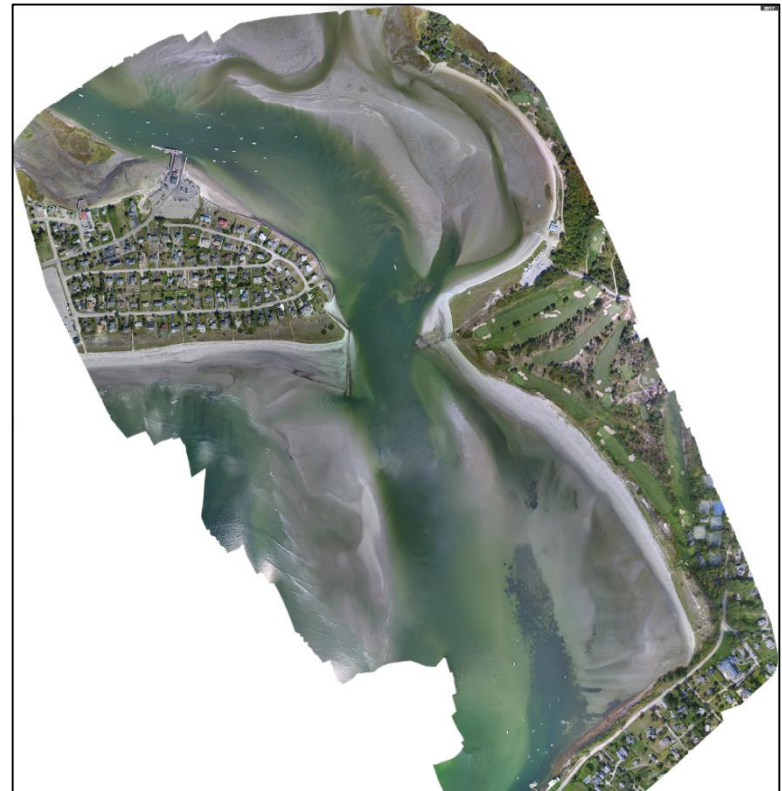
Figure 8. Screen capture of the GPCOG imagery comparison tool – 2016 (left) and 2017 (right).

During both years, the Greater Portland Council of Governments (GPCOG) was contracted to fly a unmanned aerial vehicle, or drone, to capture high-resolution ortho-imagery of the study area, thereby supplementing the elevation data with imagery. Subsequent drone flights by GPCOG allowed for further [visual comparison](#) of the morphologic changes between 2016 and 2017 in the vicinity of the Scarborough River. The differences in the imagery clearly show the areas of gain and loss from analysis of the elevation changes.
