U.S. Naval Radio Station - Apartment Building (Bldg 1) : Historic Structure Report; Acadia National Park

U.S. NAVAL RADIO STATION— APARTMENT BUILDING (Bldg 1)

HISTORIC STRUCTURE REPORT

**Acadia National Park
Bar Harbor, Maine**

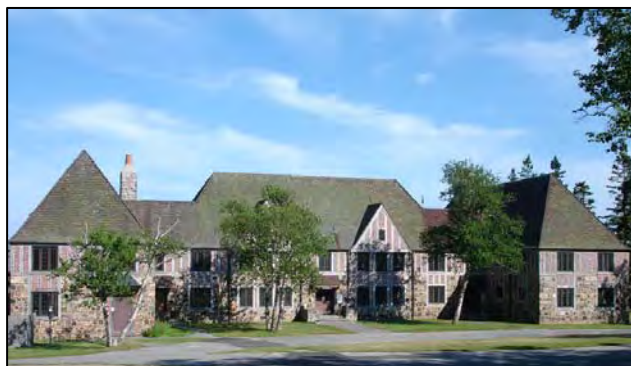
Figure 2. Apartment Building, northwest (NW) elevation, 2008.

The current views of the Apartment Building depict the physical appearance of the two primary elevations of the building (figs. 2 and 3). The following is selected from the current List of Classified Structures (LCS) information for the Apartment Building:⁶

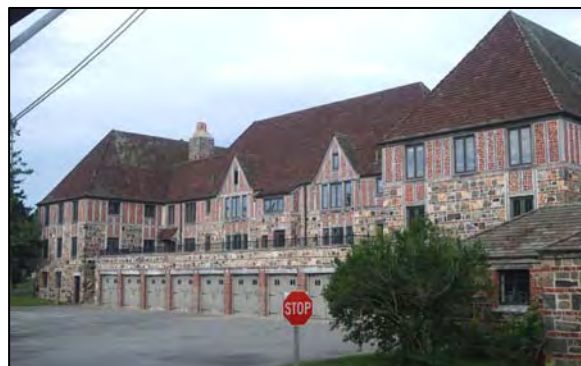
Figure 3. Apartment Building, southeast (SE) elevation, 2008.

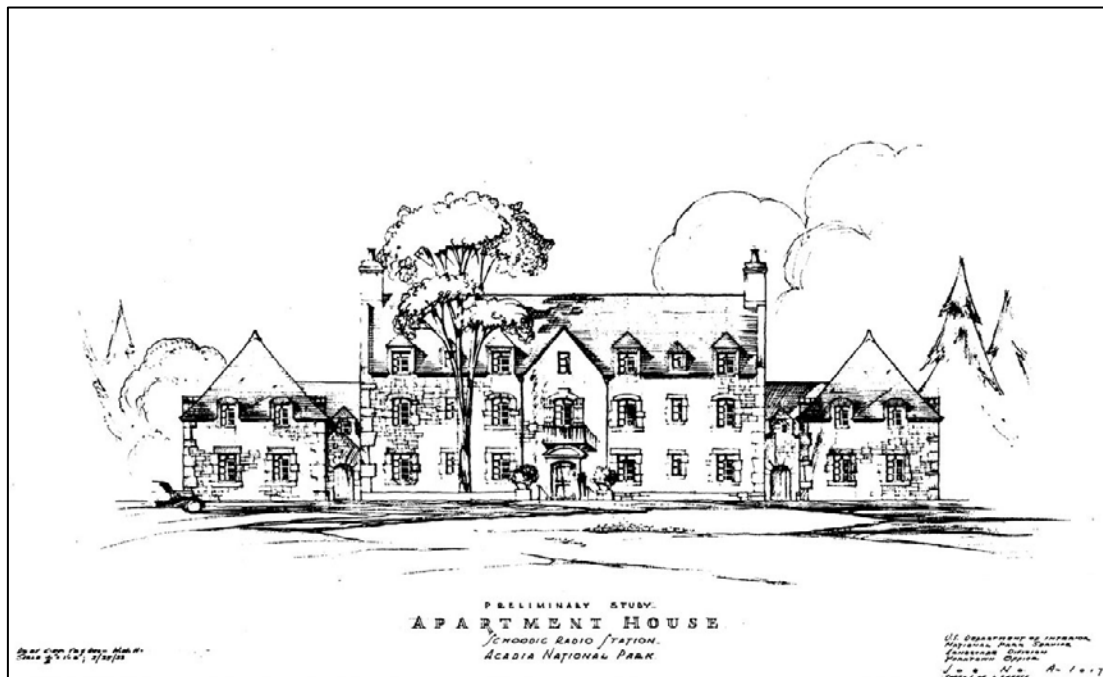
Figure 9. Preliminary Study, Apartment House, Schoodic Radio Station, Big Moose Island, Acadia National Park, February 25, 1933.

Preliminary designs for the radio station Apartment Building were dated February 25, 1933. These plans were drawn by NPS architects to meet the requirements of the Navy, as well as address aesthetic issues of the NPS: the eleven-unit Apartment Building was a large masonry structure that was designed in the Georgian Revival style. It had a main block that was three stories high topped with a dormered gable roof, flanked by two one-and-a-half-story pavilions with hipped roofs, and connected by one-and-a-half-story hyphens (fig. 9).¹⁰⁴ These preliminary plans were probably the plans sent by NPS Director Albright to JDR Jr. for review and were also presented by NPS architects to Grosvenor Atterbury for his consultation in March 1933.

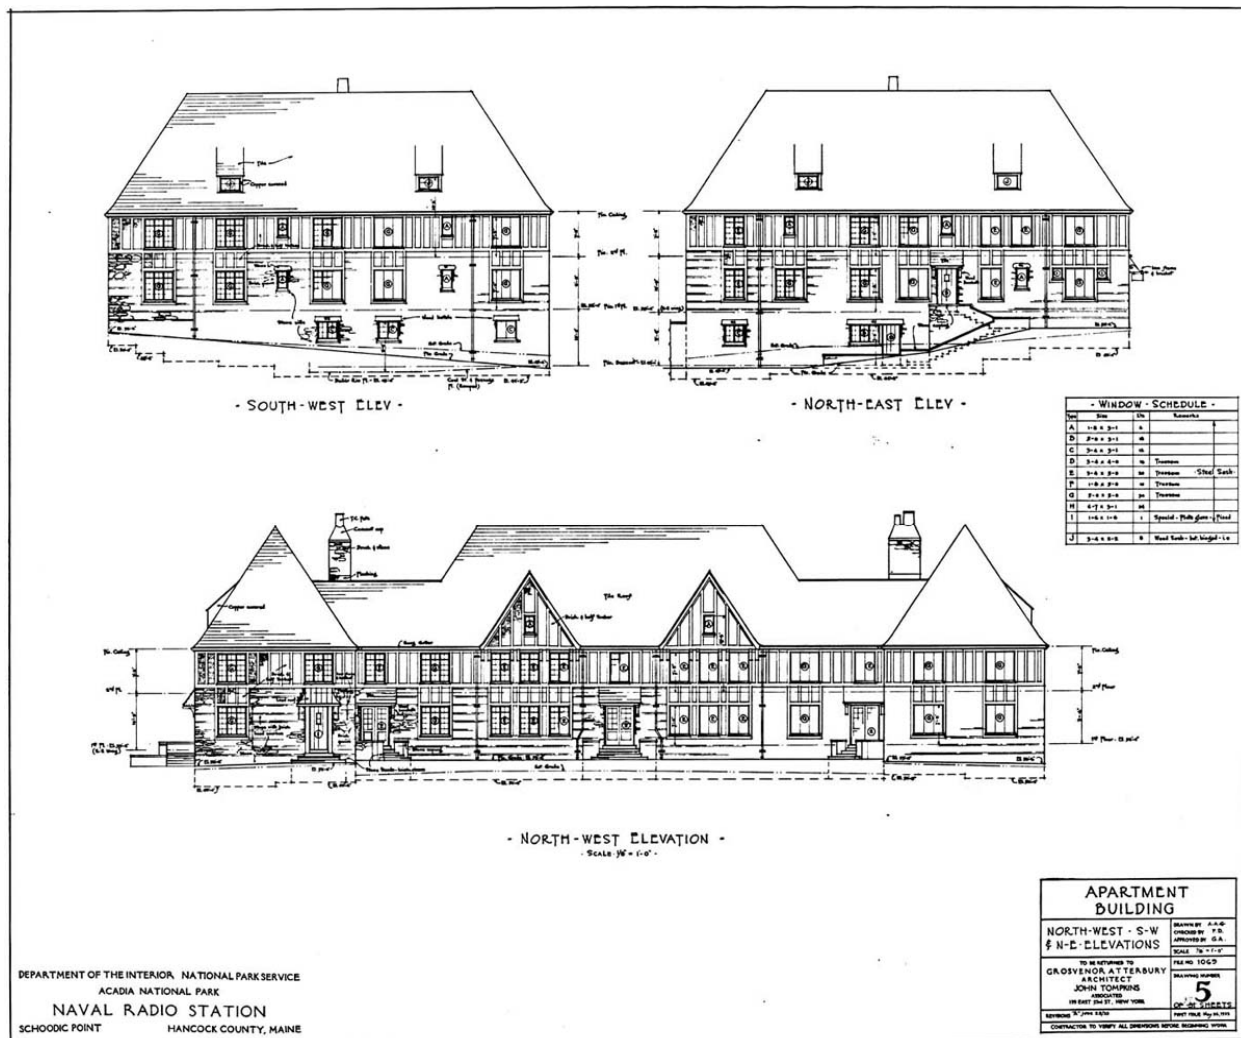
Figure 10. Sheet 5 of 37, Apartment Building, Acadia National Park, Naval Radio Station, Schoodic Point, Hancock County, Maine.

Grosvenor Atterbury's redesign of the Apartment Building lowered the height of the preliminary design by removing the third story; it retained the flanking pavilions and masonry exterior walls and steep roofs while introducing a distinctly French Eclectic style to the exterior (fig. 10). Atterbury's plans sited the building on a gently sloping site with the façade of the building oriented to the northwest and the flanking wings on the northeast and southwest sides (fig. 10). The drawings were revised in June 1933, presumably adding details to the working plans and including the Navy Department, Bureau of Yards and Docks drawings for the contractor. Albright informed JDR Jr. on June 20th that bids for the buildings at the new radio station complex had been received,¹¹⁰ and on August 3, 1933 *The Bangor Daily News* reported that the contract for the construction of the buildings at the U.S. Naval Radio Station at Schoodic Point had been awarded.¹¹¹

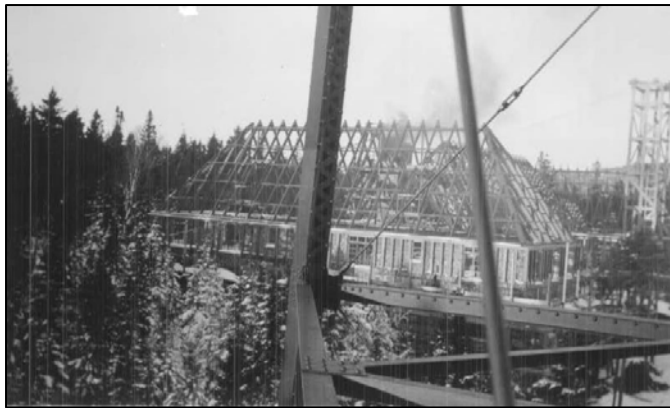
Figure 11. View of the SW elevation and roof framing from SW radio tower, December 9, 1933.

Construction of the eleven-unit Apartment Building and the other structures at the radio station complex by Central Engineering and Construction Company, Pawtucket, Rhode Island, began in the fall of 1933 soon after the contract was signed. A collection of historic photographs taken during various phases of the project documented the construction of the Apartment Building and other structures on the site (Appendix B). Photographs taken of the Apartment Building on November 13 and 16, 1933 showed that the masonry foundation and first-story masonry exterior walls had been completed. The photographs also illustrated that some of the steel framing for the second-story ceiling had been installed, including a central I-beam and some of the steel ceiling joists. The building was at least partially staged at that time. Photographs dated November 22 and 23, 1933, depicted the progress of the steel roof framing of the Southwest Pavilion and the second-story concrete slab floor. The staging of the Apartment Building appeared to be complete in those photographs and included a staging tower on the southeast elevation for conveying materials to the upper stories.

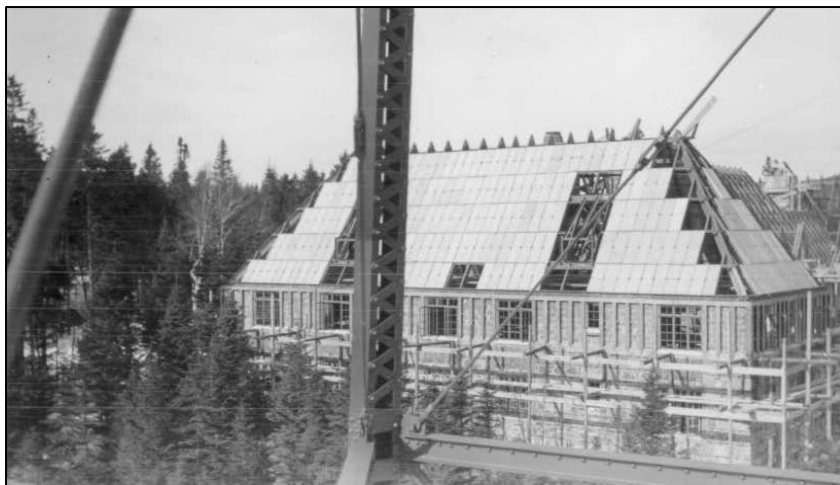
Figure 12. Apartment Building, SW elevation, March 8, 1934.

One of the March 8, 1934 photographs depicted the "nailcrete" panels being installed on the roof of the Apartment Building (fig. 12). The photograph also showed that work was being done on the north chimney. It is possible that the south chimney was complete by that time since it would have been needed for the heating system Taylor indicated was installed in December and operating in January. In addition, the Intercept Building had been framed by March 8th.

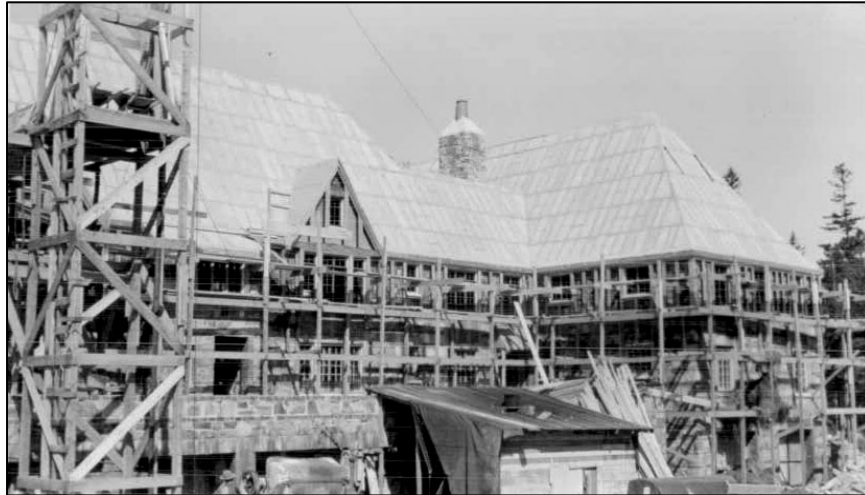
Figure 13. Apartment Building, SE elevation,
April 14, 1934.

The subsequent set of progress photographs was dated April 14, 1934 and entitled “Nailcrete Roof Slab Construction Nearing Completion.” On that page four photographs documented the installation of the panels and included a view from the attic of the steel roof framing and the wire ties, which secured the panels to the steel purlins. The north chimney was also depicted in those photographs and was complete (fig. 13).

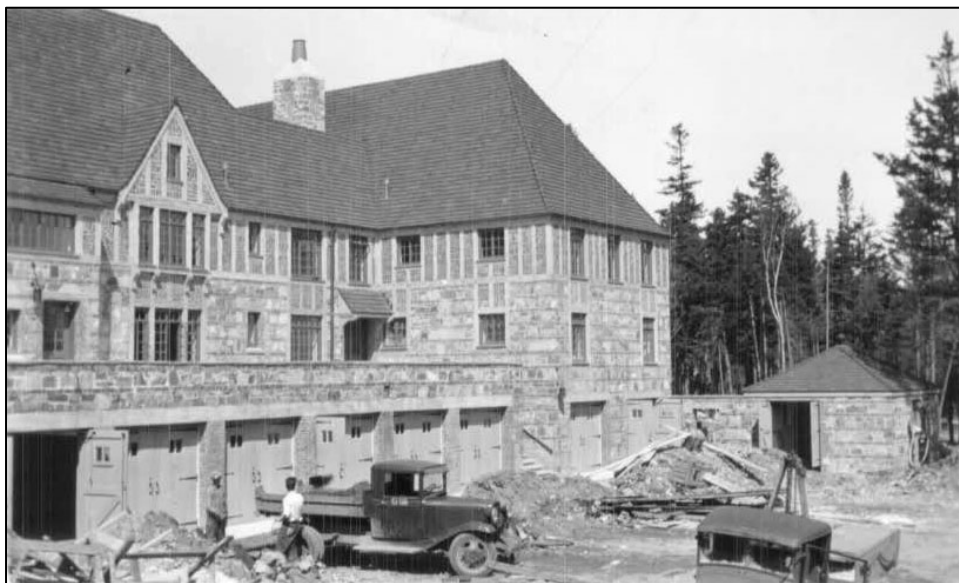
Figure 14. Apartment Building, SE elevation depicting completed exterior of building and debris removal, September 15, 1934.

The next set of photographs was dated September 15, 1934 and depicted the exterior of the Apartment Building as complete. Views of the SE elevation showed the garage doors installed, gutters hung, exterior electrical fixtures in place, and exterior doors installed with automatic closers (fig. 14). The debris on the southeast side of the building was being removed in preparation for landscaping around the building. Photographs of the Intercept Building and the Radio Compass Station from the same date illustrated that the exteriors of those buildings were complete as well.

The original multi-light steel sashes of the Apartment Building had a clearly defined grid of glazed lights that was part of the exterior pattern of materials and contributed to the overall appearance of the Apartment Building. The original appearance of the window openings was captured in the historic photographs of the building, which aptly illustrated the effect of the multi-light sashes (figs. 14, 18, 20, 21, and 26).

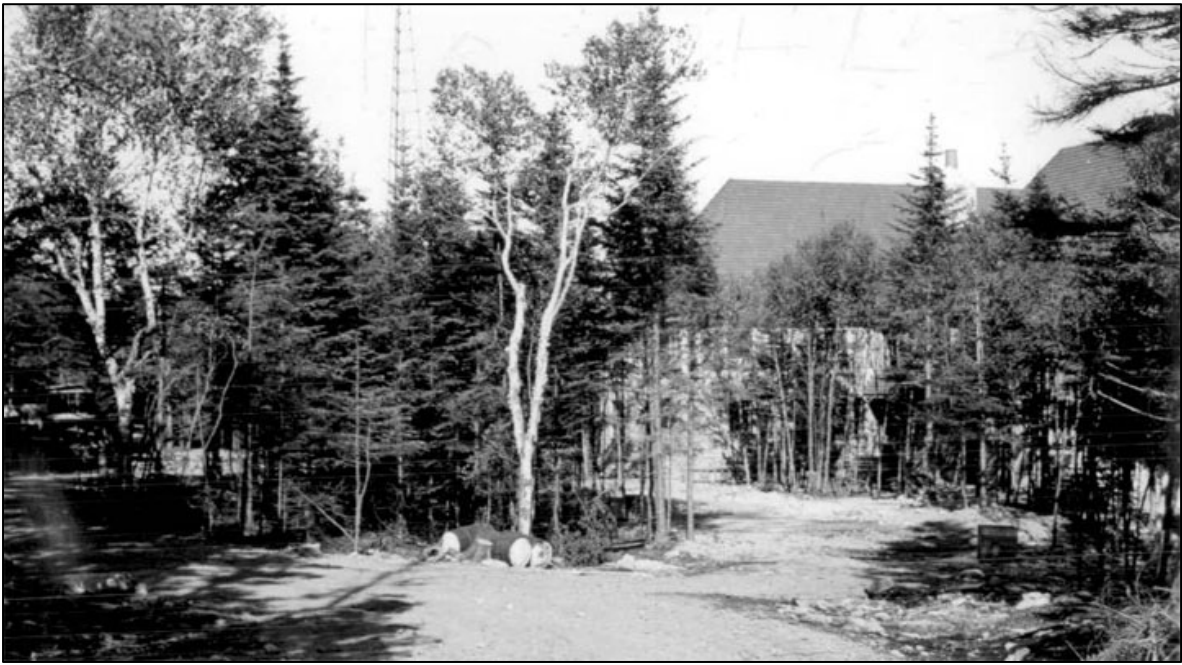
Figure 15. Apartment Building, NW elevation and courtyard, looking NE, before selective tree cutting and landscaping, October 1934.

Subsequent photographs taken in October and November 1934 recorded the site prior to landscaping (fig. 15) and the initial efforts of the landscaping around the Apartment Building in the fall of 1934 (see subsequent section “Landscaping”). A sequence of two photographs depicted a panoramic view of the northwest elevation of the Apartment Building (fig. 20). The panorama showed the completed building exterior, the sublevel of the driveway and pathways, and some preliminary landscaping.

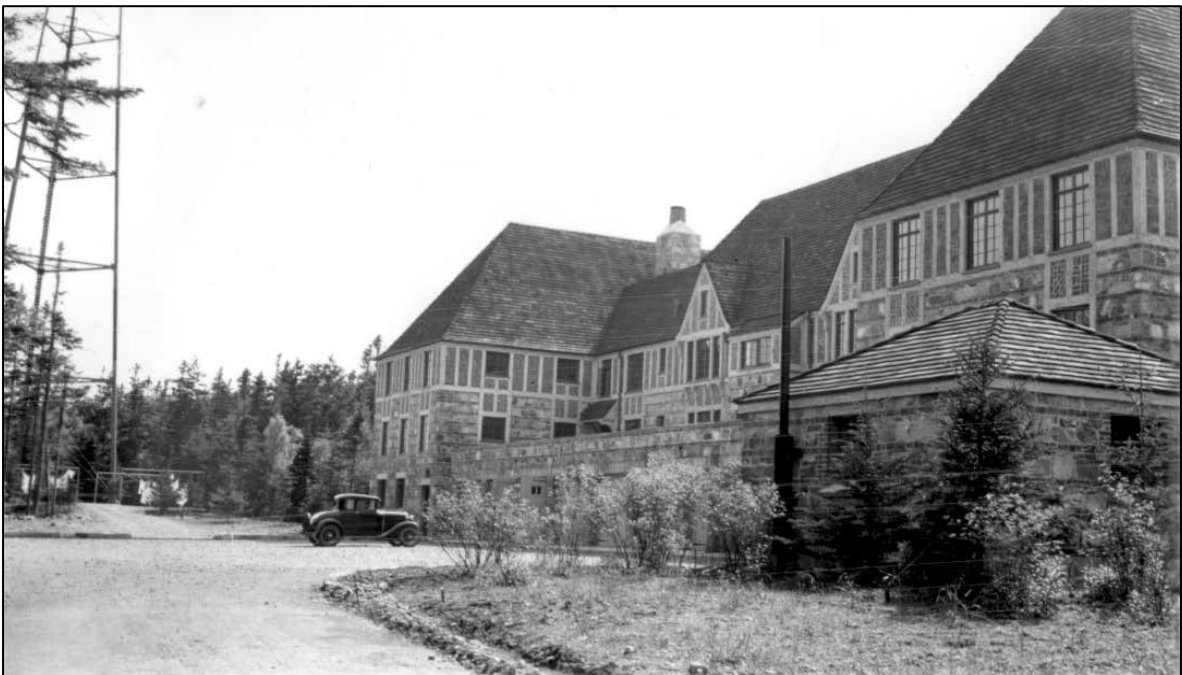
Figure 16. Apartment Building, SE elevation, looking SW. Power House in the right hand foreground, June 1935.

The radio station equipment and personnel were presumably moved to the new Radio Station between January and February. Though no documentation of the exact dates was found, the sequence of events suggested that most, if not all, of the move occurred prior to May 1935 when legislation to transfer the Otter Cliffs Radio Station to the NPS was introduced. Photographs of the exterior of the Apartment Building from June 1935 depicted the completed building and improved grounds (fig. 16).

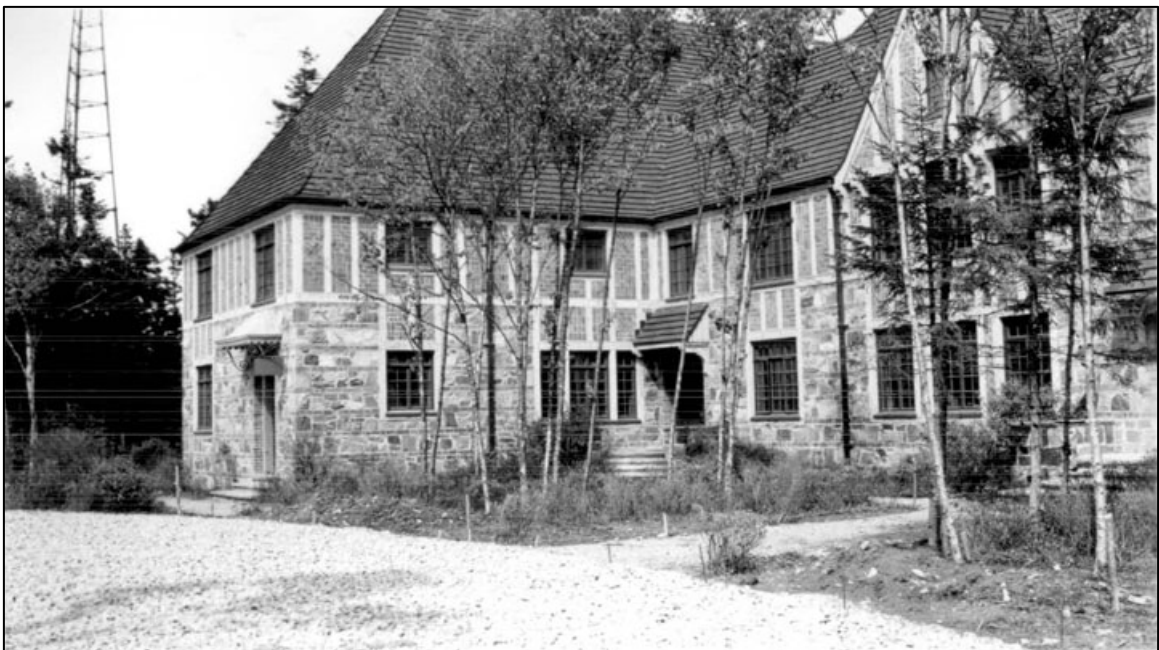
Figure 18. Apartment Building, NW elevation courtyard depicting some scrub cleared, shrub planting completed, driveway and paths graded, and graveled, seeding and cleanup still required, June 1935.

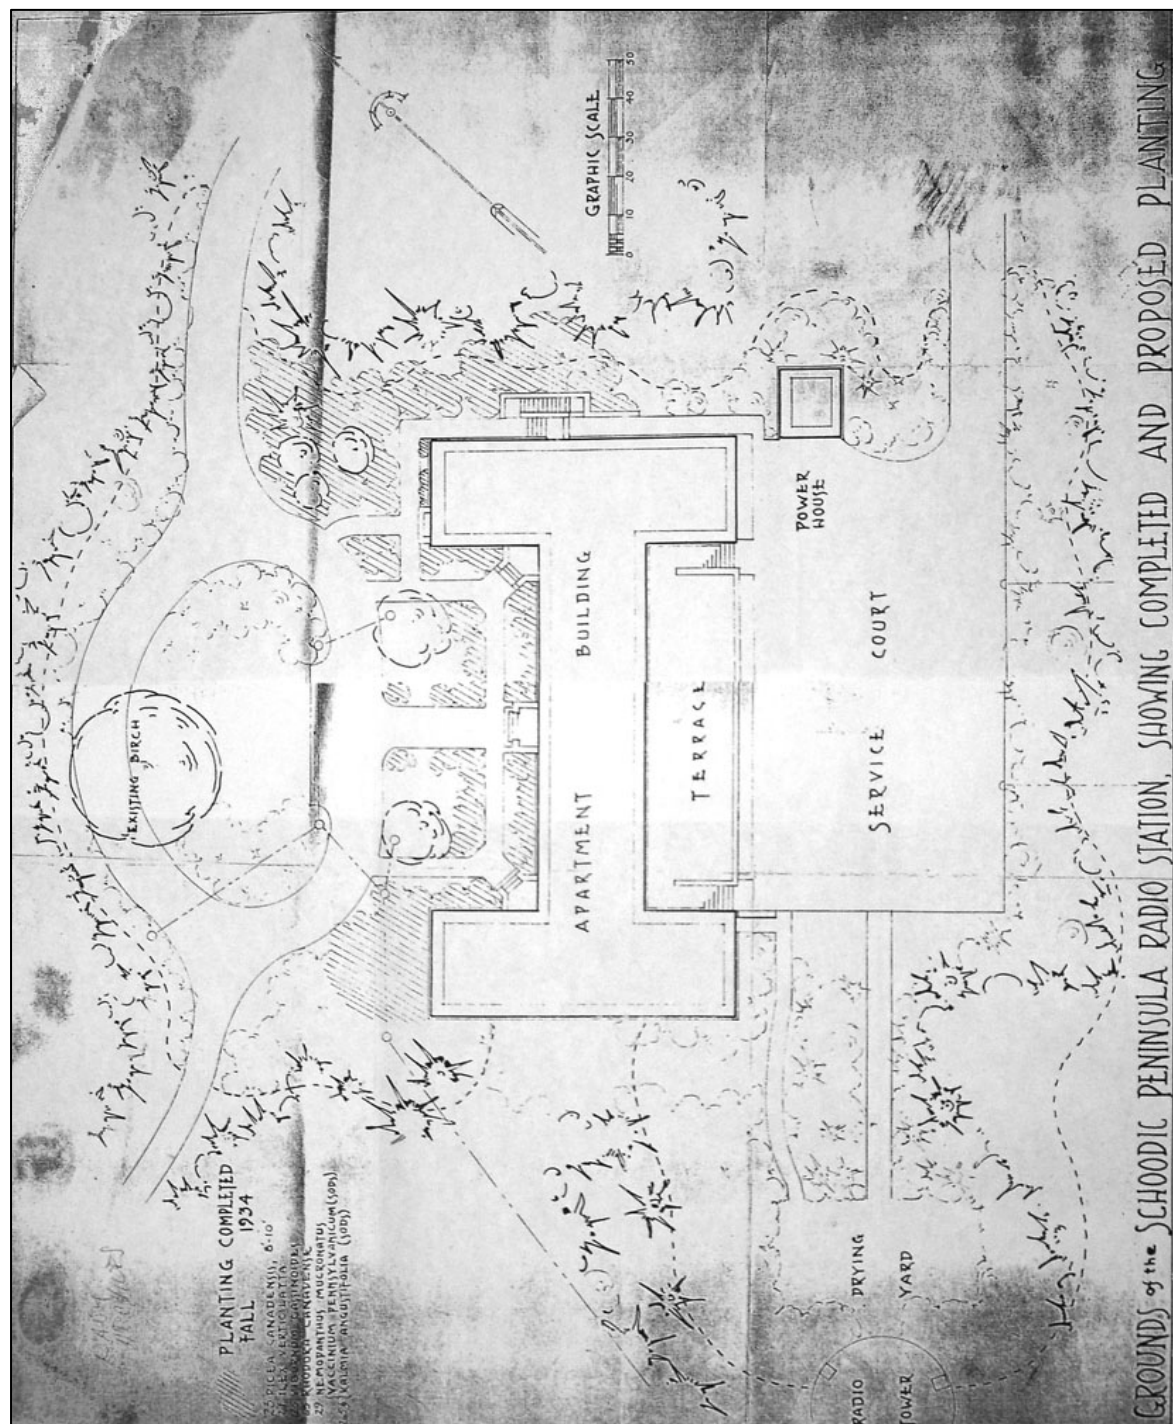
Figure 19. Apartment Building, Landscape Plan depicting planting completed in fall 1934 and proposed planting for spring 1935.

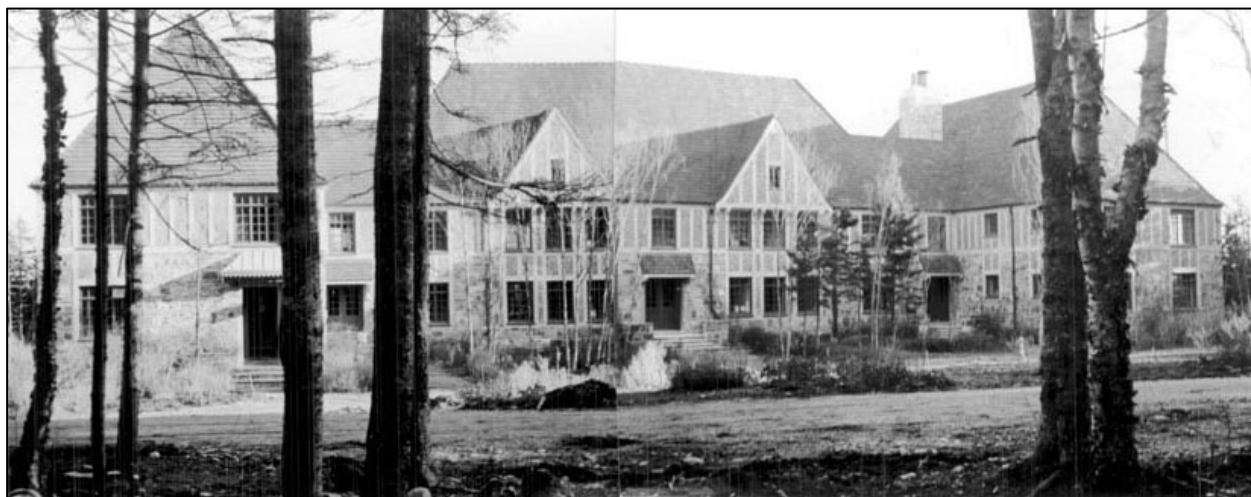
Figure 20. Panoramic view of Apartment Building, NW elevation, November 1934 after some landscaping had been completed.

The NW façade of the Apartment Building was two stories high with two cross-gable bays that flanked the center entrance doorway (fig. 20). Each cross-gable bay had three window openings on the first and second stories and a single window opening in the gable. The gable projected approximately six-inches beyond the plane of the façade. At either end of the Main Block were two additional bays:¹³¹ on the first story those bays had a window opening and a doorway, and on the second story there were window openings.

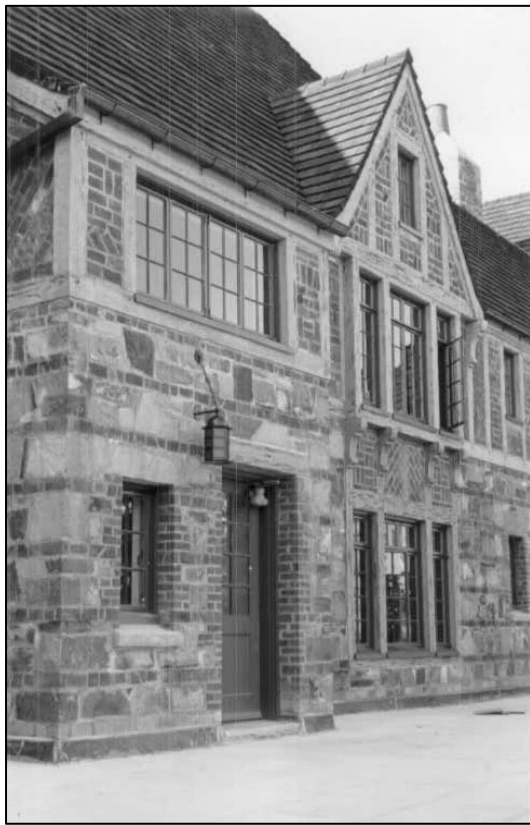
Figure 21. Apartment Building, SE elevation, center bay and cross-gable bay, September 1934.

The SE elevation of the Main Block had three doorways on the first story leading to the Terrace. The projecting center bay had a doorway that was framed with brick and had a pecky cypress lintel (D106, fig. 21). The doorway threshold was bluestone, and inside the brick reveal was a plain wooden door jamb and head. A wooden door with twelve glass lights over one wood panel was hung from the right door jamb. Evidence of extant doors of the same design suggested that the door handle was a brass Suffolk-style handle and latch with a separate deadbolt lock above that had a heart-shaped escutcheon. The door had an automatic closer and was hung with butt hinges. That doorway led to the back vestibule of the Center Hallway.

There was only one type-H window opening used in the Apartment Building, and that was located in the second story of the SE elevation projecting bay. The window opening had two sets of steel casement sashes, which totaled four sashes, each with six glazed lights (fig. 21). The window opening was framed with pecky cypress and flanked by brick panels framed with cypress. The four casements formed a band of windows on the second story of the projecting bay. That window opened onto the Center Hallway staircase.

Two of the original exterior light fixtures have been retained. These are located on the SE elevation at the basement level: one by D001 on the Southwest Pavilion and one by D010 on the Northeast Pavilion (fig. 56). Both fixtures retain the brass brackets and lanterns depicted in the historic photographs (fig. 21). The fixture by D106 originally had the same type of lamp, but it has been changed to a six-sided brass lamp. The does not replicate the historic lamp, but it is compatible and the original bracket was retained.

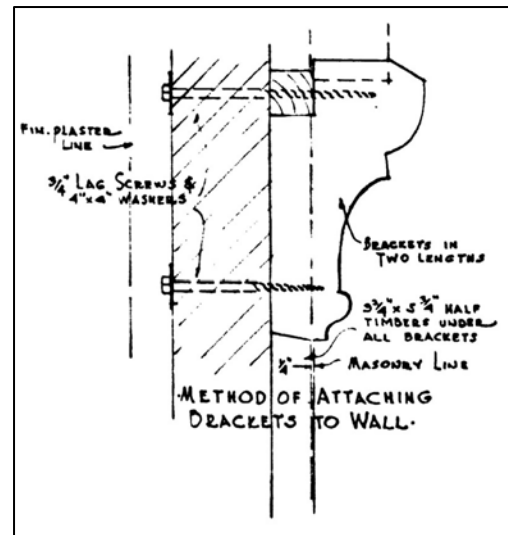
Figure 22. Apartment Building, bracket detail, Grosvenor Atterbury, drawing number 8 of 37 sheets.

described for the foundation. The masonry walls on the first story were 1 foot 4 inches thick. On the first story, half-timbering was used to frame the window openings. Half-timbering was infilled with brick panels, also installed above all first-story window openings except those with single sashes (see subsequent section “Window Openings”). At the second story half-timbering continued at the windowsill level and was carried around the building. The masonry walls on the second story, including the brick and the interior cinder block, were 1 foot thick. The exterior cross gables on both the NW and SE elevations were also constructed with half timbers and brick panels. The half-timber sections of the exterior walls were constructed with pecky cypress timbers.¹³⁵ Pecky cypress was also used at the Brown Mountain Gate Lodge, and in that case Atterbury called for the wood to be “hand hewn and all exterior trim shall be burnt with a torch on all exposed faces and edges and thoroughly brushed with a steel wire brush to remove all charred wood.”¹³⁶ This was apparently done to give the pecky cypress an aged look and may have also been done at the Apartment Building. The more detailed drawings of the exterior walls illustrated that the half timbers were chamfered along the exposed edges and had decorative pegs at both ends of the timber. They also detailed the pecky cypress wooden brackets that supported the projecting cross gables and window openings on the NW and SE elevations (fig. 22).¹³⁷ The brackets were approximately 1 foot 5 inches long and were composed of a beveled ovolo, fillet, covetto, and cyma reversa profile. They were fastened to the wall framing with lag screws. The architectural drawings also indicated that some of the timbers were fastened to the steel frame of the building with lag screws. This was depicted for the horizontal timbers used to frame the window opening and the horizontal timber at the base of the cross gable.¹³⁸ Other half-timbering was probably lagged to interior framing, and the vertical timbers framing the window openings were fastened to the masonry.¹³⁹

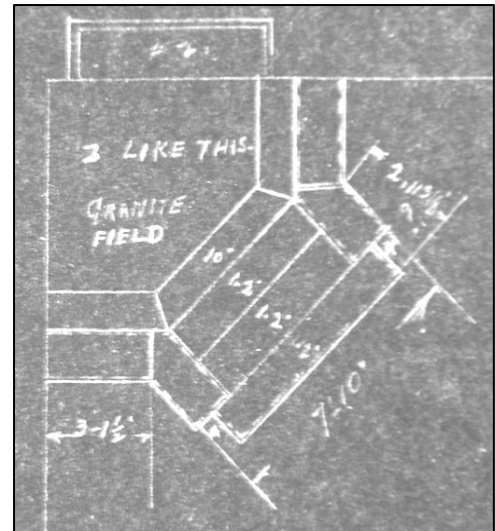
Figure 23. Apartment Building, NW elevation, entrance stoop and steps, August 1933.

The entrance stoops at either end of the NW elevation of the Main Block accessed the side hallways of the Apartment Building. These were both constructed with similar materials to the center entrance including concrete foundations, above-grade granite knee walls, bluestone coping, and bluestone steps with brick risers. The entrances were built at opposite inside corners of the façade where the Main Block was connected to the pavilions, and mirrored each other. The granite walls of the stoops extended at right angles from the adjacent walls of the building and were angled at the entrance steps. The steps of the side entrance stoops came out from the corner of the building at 45-degree angles as depicted by the construction blueprint (fig. 23). The bottom step was longer than the others and extended beyond the inside edges of the stoop sidewalls. Thick bluestone thresholds were installed at the entrance doorway as depicted in the blueprint (see subsequent section “Doorways”).

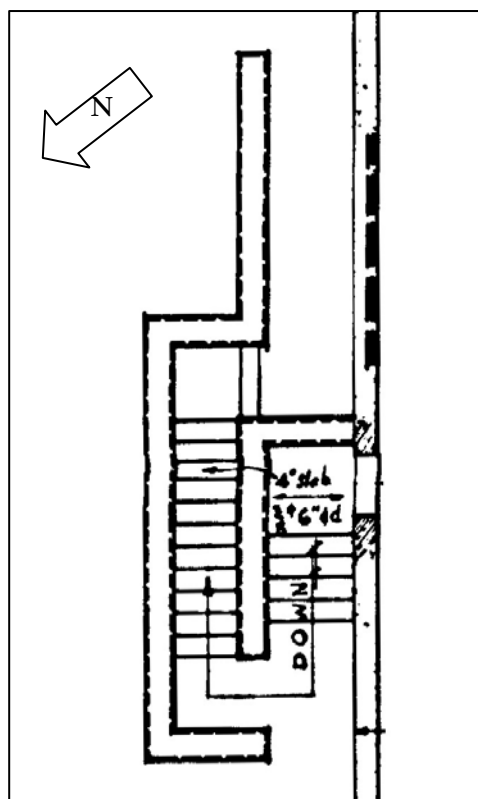
Figure 24. Apartment Building, NE elevation of Northeast Pavilion, steps to NE entrance and staircase to the back of the building. Sheet 21 of 37, Drawing No. 116387, Navy Dept. Bureau of Yards & Docks, June 1933.

A staircase leading from the first-story level down to the basement story was constructed on the NE side of the Northeast Pavilion adjacent to the entrance steps (fig. 24). The staircase was constructed with a granite retaining wall with bluestone coping and had ten bluestone steps with brick risers leading down to a lower granite landing. At the lower landing the staircase turned SW and continued down one step to the basement-story grade. From there a pathway continued along the NE elevation toward the back of the building. The granite retaining wall with bluestone coping was continued along NE side of the pathway for approximately 14 feet where it was terminated.

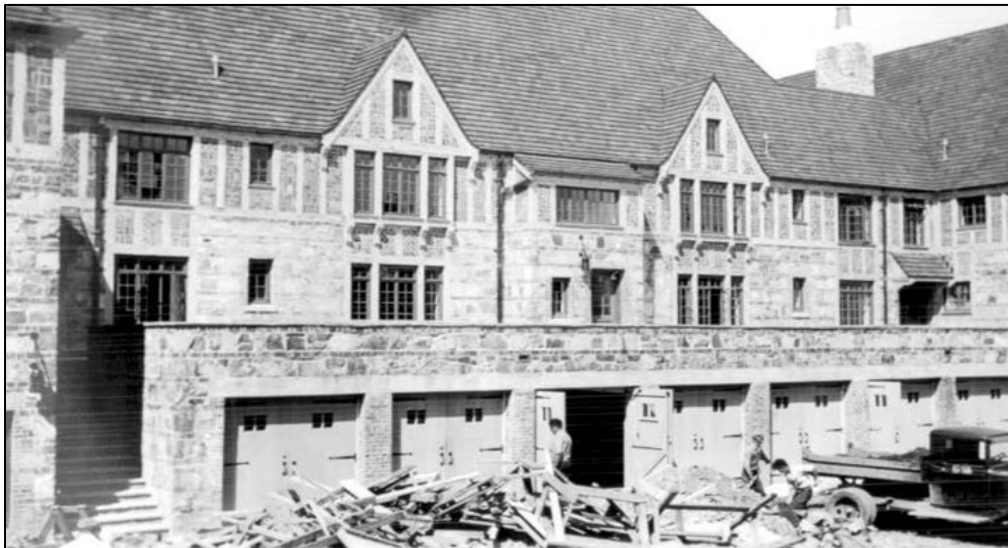
Figure 26. Apartment Building, SE elevation depicting window openings with original multi-light steel sashes, September 1934.

Eight garage doorways for the Apartment Building (D002 through D009) were constructed under the SE Terrace (fig. 26). The garage doorways were framed with brick and had pecky cypress lintels. The wooden lintels were constructed with 8-inch-by-10-inch timbers that spanned each doorway and were supported on brick piers that separated the doorways. The construction drawings indicated that the lintels were fastened to a steel L-bracket that was in turn anchored to an interior reinforced-concrete lintel that spanned the entire length of the eight-bay garage. Each doorway had a concrete ramp and an angled steel edge at the lip of the garage floor. The inner frame of each doorway was constructed with a plain wooden jamb and head that were attached to wood framing that was anchored to the masonry walls. Each doorway had a set of wooden double doors that were constructed with vertical-splined

The exterior fenestration, including doorways and window openings, of the Apartment Building was part of the overall symmetry of the building and was best depicted in the original architectural drawings and the historic photographs (fig. 26). With few exceptions, the window openings were symmetrically placed, and the corresponding sashes in the first- and second-story bays were the same type. The notable exceptions were the projecting bay on the SE elevation, and the Northeast Pavilion. As previously described, the projecting bay had a doorway and single window opening on the first story below a wide window opening with four sashes on the second story. Overall the exterior symmetry was maintained on the Northeast Pavilion, but, due to the different functions of the interior rooms, some of the window openings varied from the first story to the second story (see subsequent section “Interior Elements”). The following section on window openings will provide a general description of the types of historic window openings and the associated elements. The

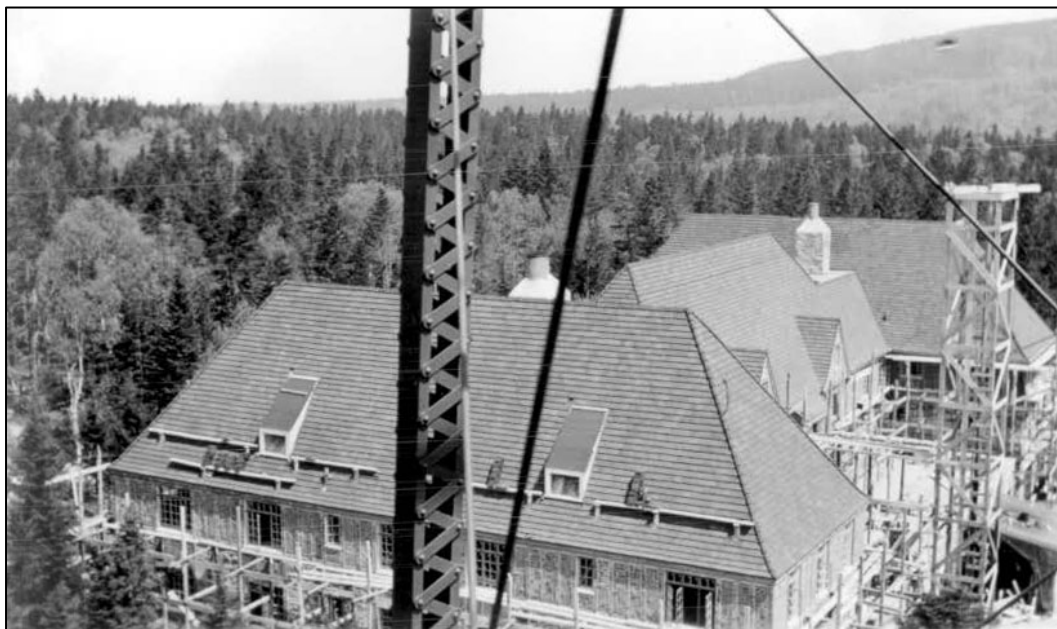
Figure 27. Apartment Building roofs, looking north with Southwest Pavilion in foreground, photograph taken from south radio tower, June 2, 1934.

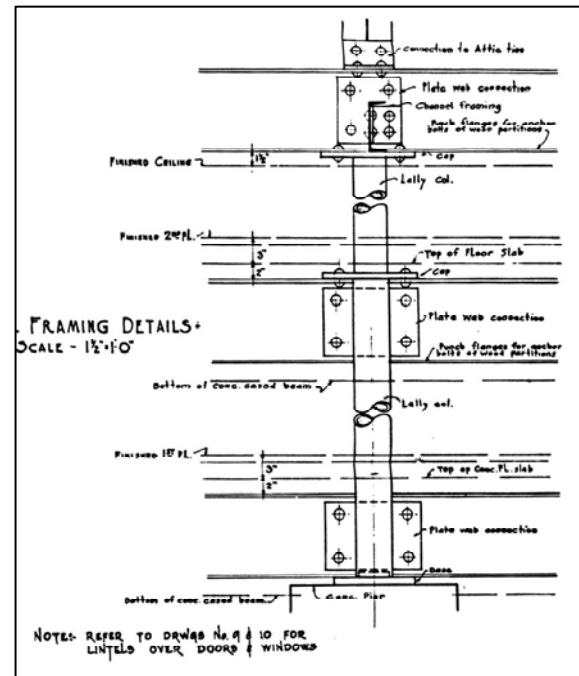
Figure 28. Steel framing details depicting steel Lally columns and beams, drawing number 21 of 37 sheets.

In the basement of the Main Block and the two flanking pavilions, reinforced concrete piers were constructed to support the interior structure of the upper stories. The piers were aligned along the center axis of each section of the building and were generally spaced between 10 and 14 feet apart (Appendix A, drawing number 21 of 37 sheets). The piers in the Main Block and the Southwest Pavilion were 12 inches by 20 inches, and the piers in the Northeast Pavilion were 16 inches by 16 inches. The architectural drawings of the framing plans indicated that the piers should be either carried down to bedrock or be constructed with spread footings.¹⁵⁹ Each pier supported a steel Lally column on the first story, which in turn supported another steel Lally column on the second story that supported the steel framing for the roofs. For the most part the rest of the steel and masonry structural system was tied into the column system. Thus the concrete piers were essentially the building blocks for the structural system of the upper stories of the Apartment Building.

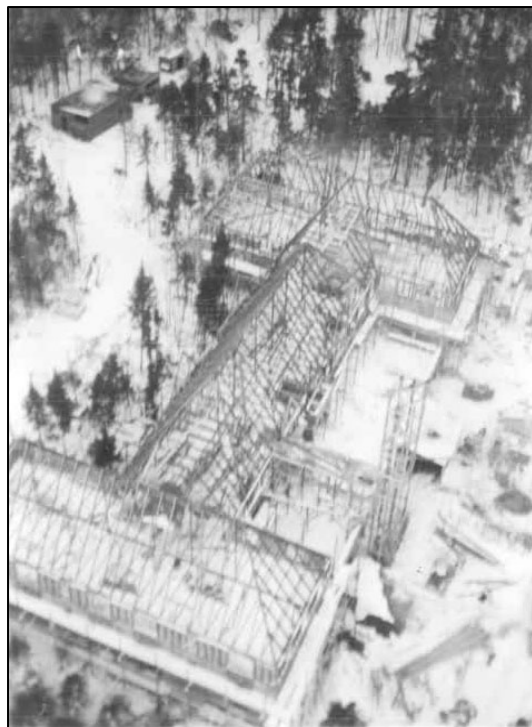
Figure 29. Apartment Building roof framing, view from SW tower.

The roofs of the Apartment Building were framed with steel beams, rafters, and purlins (fig. 29). The roof framing was supported by the column system at the lower stories, which supported T-shaped columns in the attic. The attic columns carried the ridge for each section of the building to which the rafters were attached. The ridges were constructed with 10-inch I-beams, and the rafters were constructed with 8-inch channel beams, which were also used to frame the roofs of the cross gables. The plans indicated that the steel rafters were installed approximately 3 feet on center. Corresponding rafters on opposite slopes of the roof were connected at the peak of the roof with metal plates that were apparently fastened to the ridge beam. The framing plans indicated that the hip and valley rafters were 12-inch I-beams. L-shaped collar ties were bolted to the attic columns and to the rafters. The flat roofs at both ends of the Main Block were framed with 12-inch channel beams around the perimeter of the roof deck and channel beam rafters. The openings for the chimneys were also framed with channel beams. The inverted T-shaped purlins were bolted to the

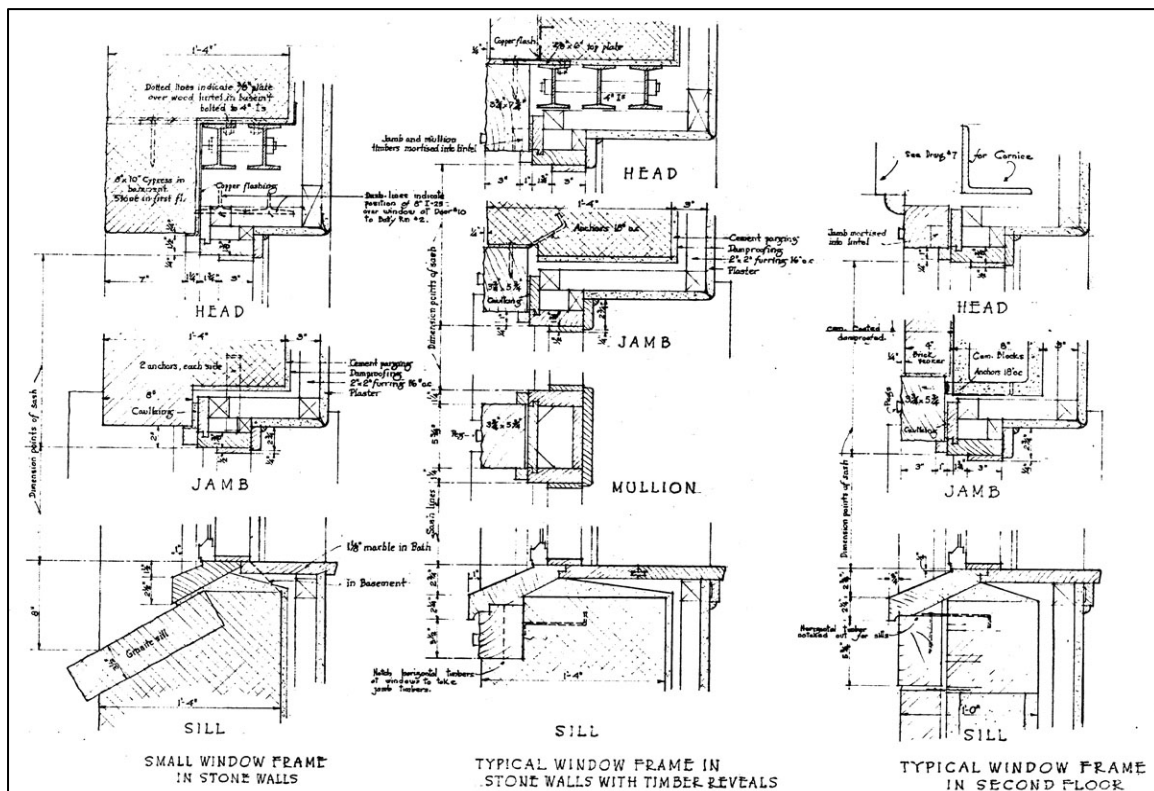
Figure 30. Apartment Building drawings depicting typical window opening elements, drawing number 9 of 37 sheets.

The window openings at the Apartment Building were constructed with steel casement sashes and although there were several different configurations of the sashes, the interior elements on the first and second stories were very similar. Due to the thickness of the exterior walls, the interiors of the window openings were deep: on the first story the window openings were approximately 11 inches deep from the jamb to the plane of the interior plaster wall; on the second story the window openings were approximately 8 inches deep. At approximately 6 inches deep, the type-A single-sash window openings were shallower, because the exterior was framed with masonry elements and the sash was set deeper in the masonry wall. The construction of the window openings was best illustrated by the architectural drawings by Grosvenor Atterbury's firm (Appendix A and fig. 30).

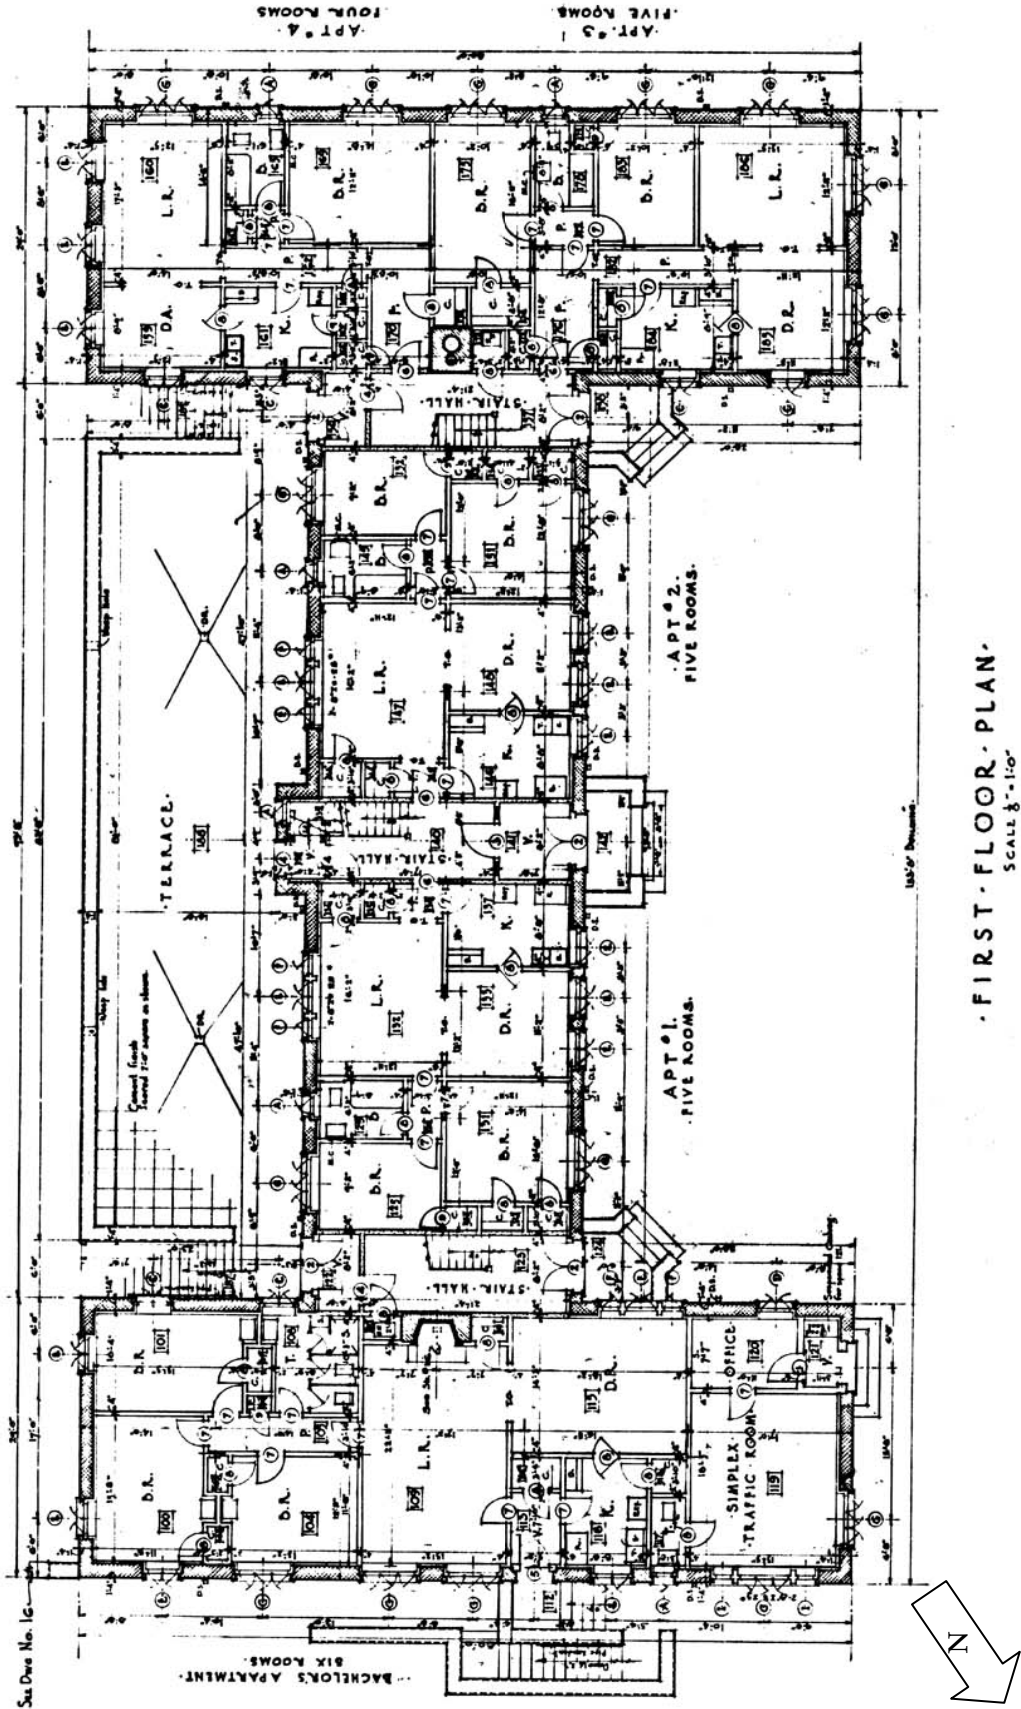
Figure 32. Apartment Building, Grosvenor Atterbury Architect, John Tompkins, First Floor Plan, May 26, 1933;
 (drawing number 2 of 37 sheets, this figure represents a portion of the original drawing reproduced at half-size, not to scale).

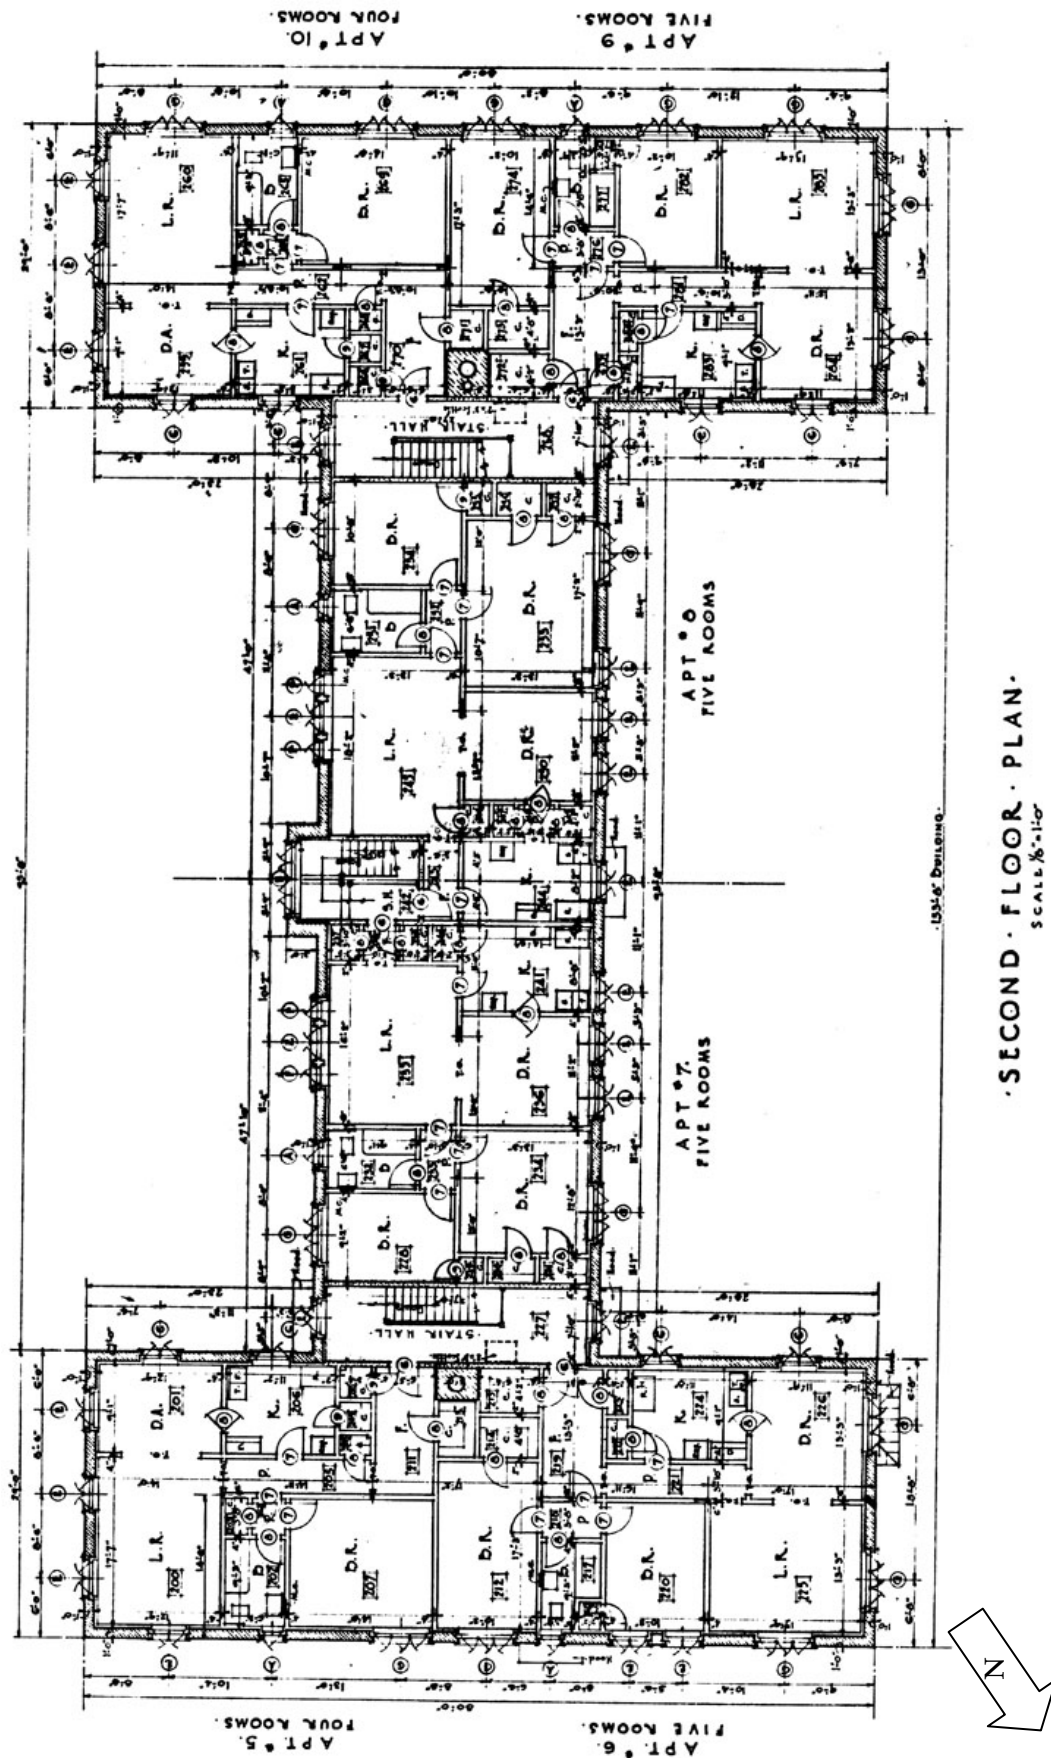
Figure 33. Apartment Building, Grosvenor Atterbury Architect, John Tompkins, Second Floor Plan, May 26, 1933; (this figure represents a portion of the original drawing reproduced at half-size, not to scale).
