U.S. Naval Radio Station - Apartment Building (Bldg 1) : Historic Structure Report; Acadia National Park

U.S. NAVAL RADIO STATION— APARTMENT BUILDING (Bldg 1)

HISTORIC STRUCTURE REPORT

**Acadia National Park
Bar Harbor, Maine**

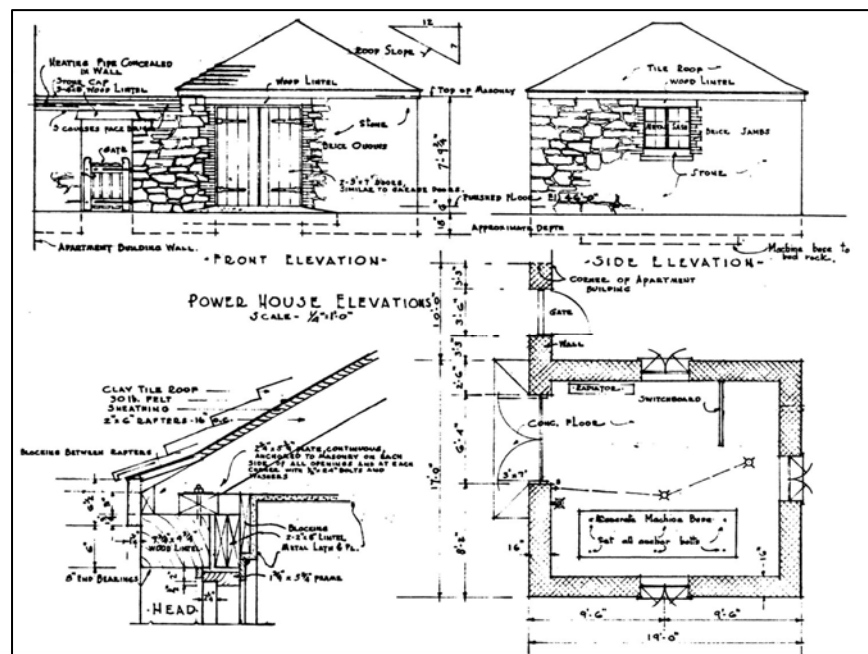
Figure 34. Power House, Naval Radio Station, Winter Harbor, ME. (drawing number 17 of 37 sheets, this figure represents a portion of the original drawing reproduced at half-size, not to scale).

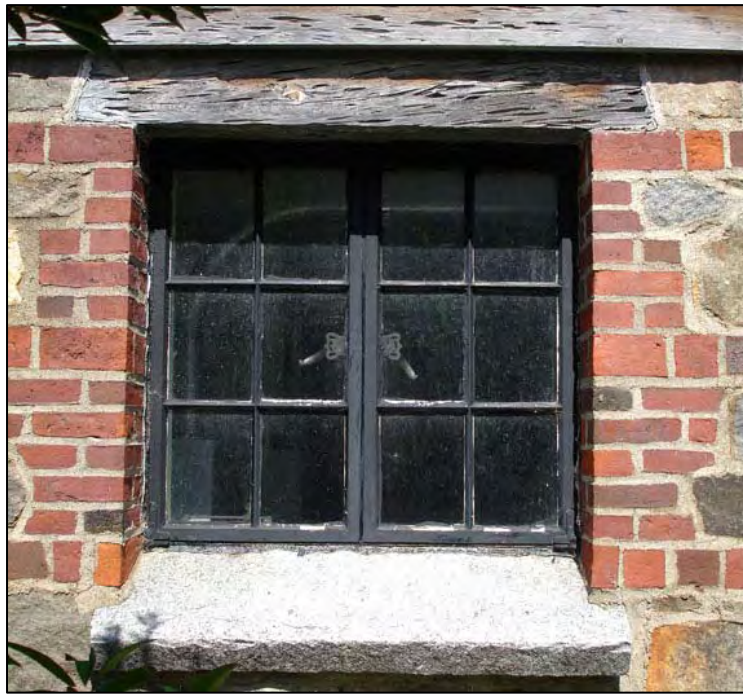
Figure 35. Power House, SE elevation, window opening with brick jamb, granite sill, pecky cypress lintel, and steel casement sashes, 2008.

One extant example of the type-C window exists on the SE elevation of the Power House (figs. 35 and 36). Based on that example, the steel casement sashes were hinged at the top and bottom with steel L-hinges and the sashes were separated by a steel mullion in the center of the window opening. Each sash had a curved locking interior handle that was surface mounted on the inside stile and a casement adjuster attached to the bottom rail that would keep the sash in an open position. Though this was the only extant example of the type-C sash, it is likely that the other specified steel casement sashes, type C, in the Apartment Building were of a similar basic design and used similar hardware.

The Power House measured 17 feet wide by 19 feet long. The exterior walls of the masonry building were constructed with granite and brick laid in the same manner as the Apartment Building. The SW elevation or front of the building had a large doorway that was framed with brick and had a pecky cypress lintel. A concrete ramp with a shallow incline was installed in front of the doorway. The doorway had a set of double doors that were constructed with splined vertical planks on a Z-braced frame. Like the garage doors, each of the Power House door leaves had three strap hinges and a Suffolk-type handle. The other three elevations were constructed with a single window opening centered on the respective elevation. The window openings were framed with brick jambs, pecky cypress lintels, and granite sills. All three of those window openings had two steel casement sashes with six lights each. The sashes were similar to the type-C windows in the Apartment Building, and as previously described, one original casement is extant on the SE elevation of the Power House (fig. 35).

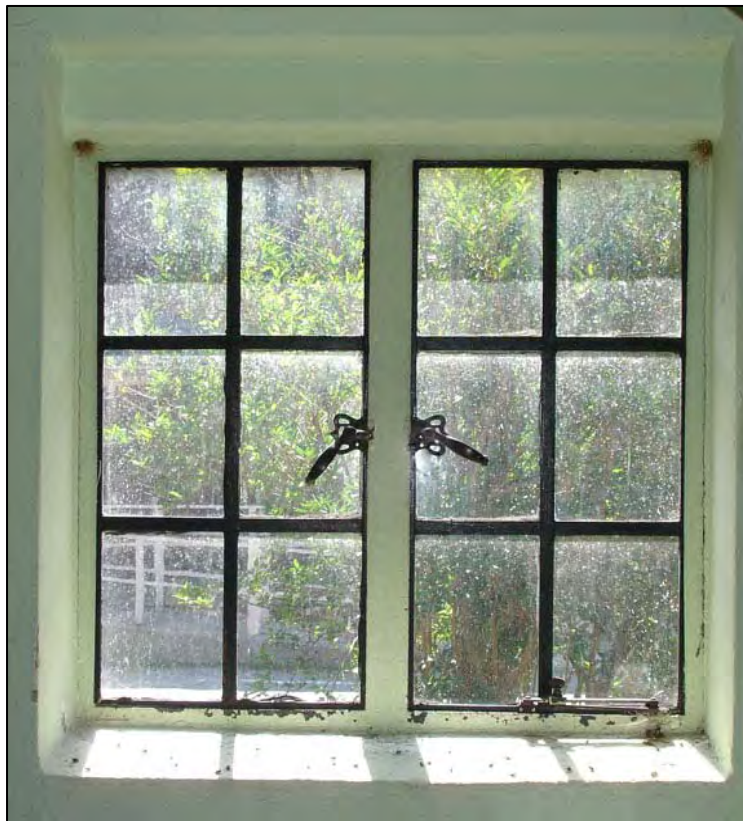
Figure 36. Power House, SE elevation, interior elements of window opening, 2008.

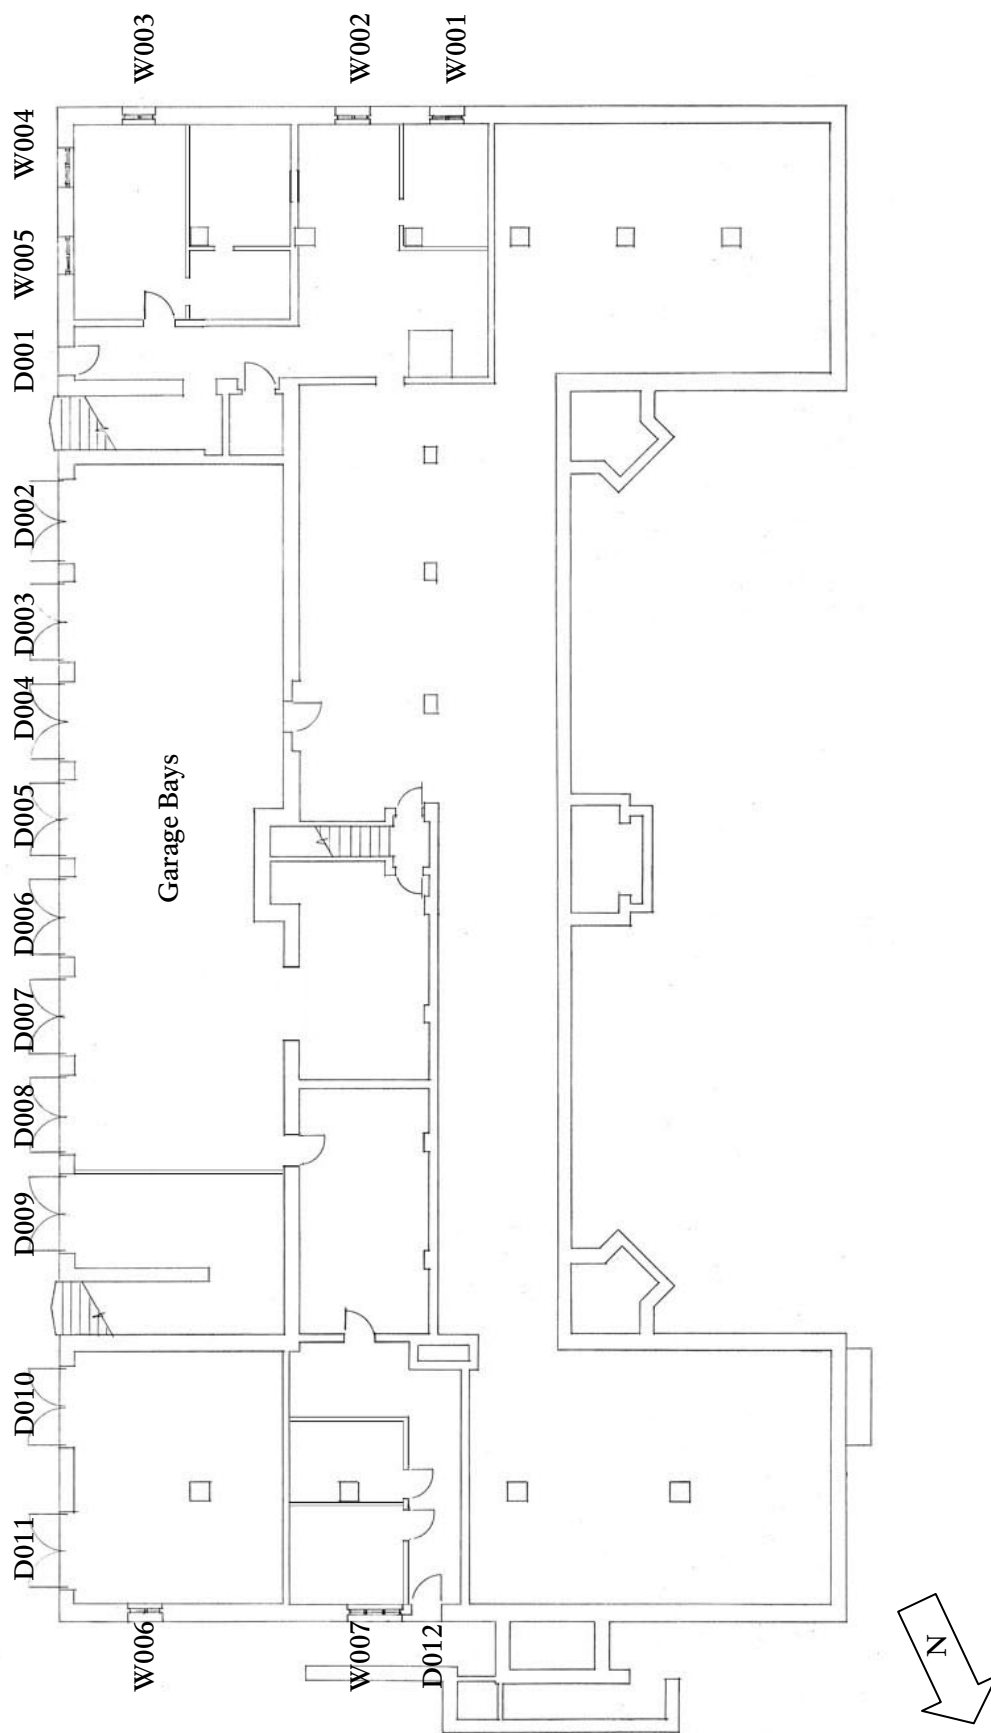
Figure 40. Apartment Building, basement-story floor plan with window opening and doorway numbers assigned during the current project (not to scale).

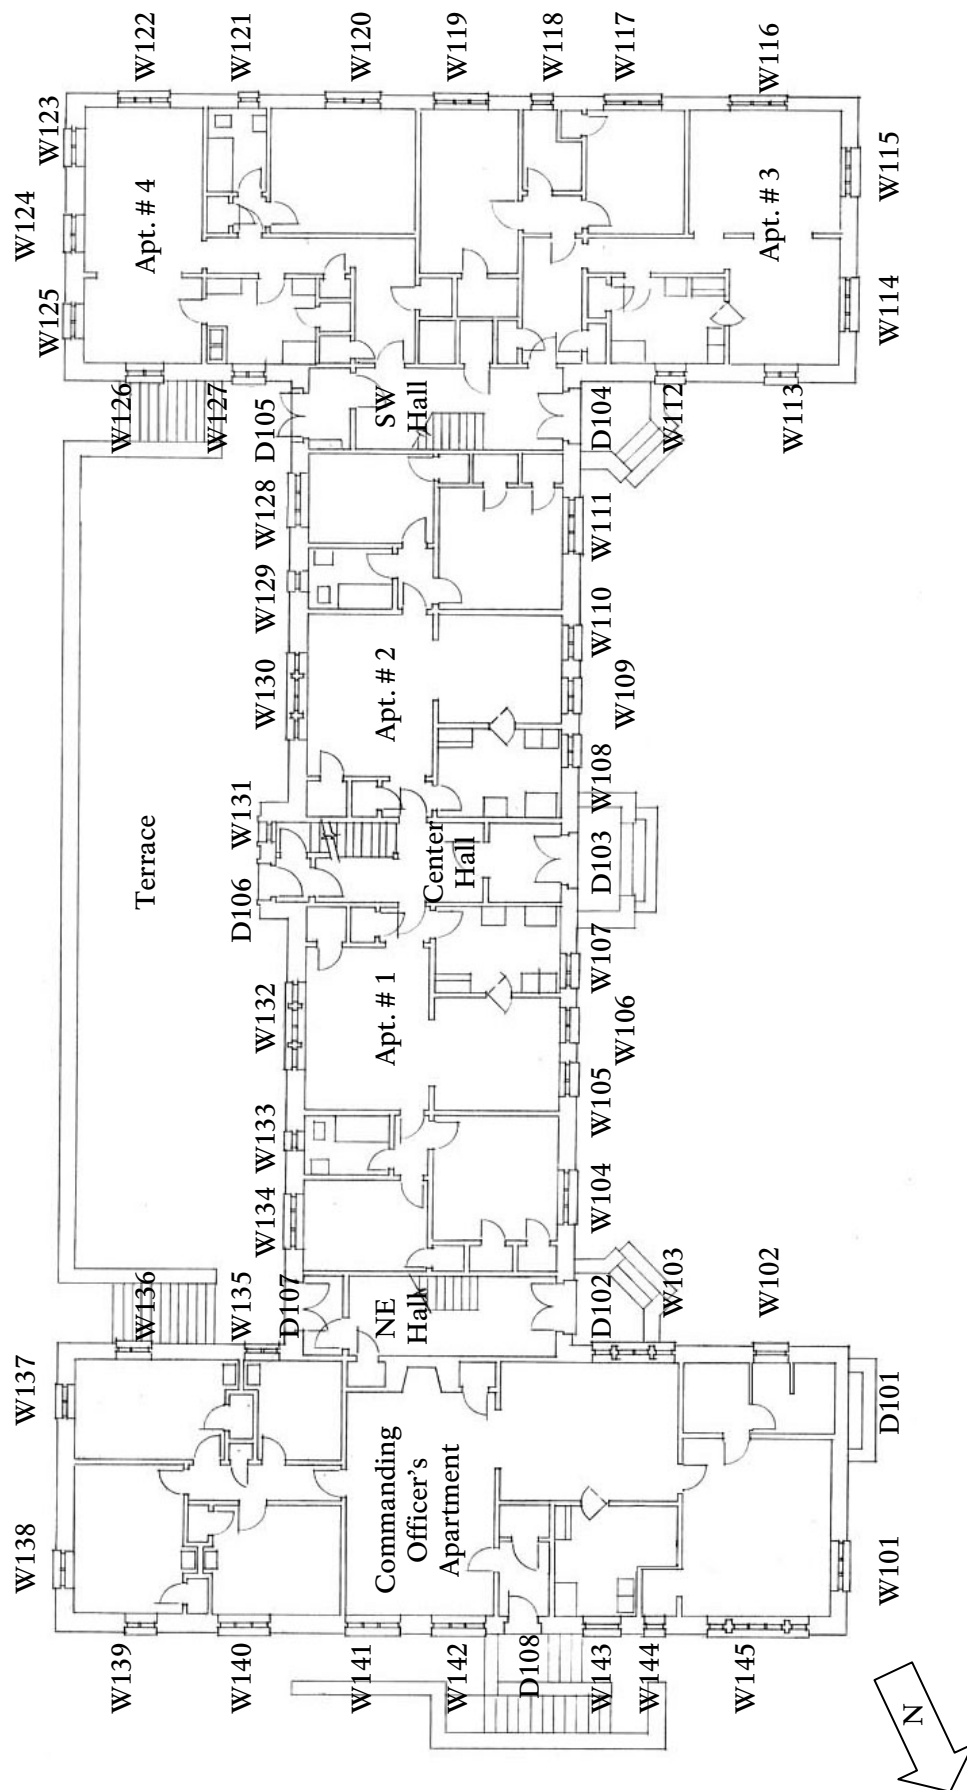
Figure 41. Apartment Building, first-story floor plan with exterior window opening and doorway numbers assigned during the current project (not to scale).

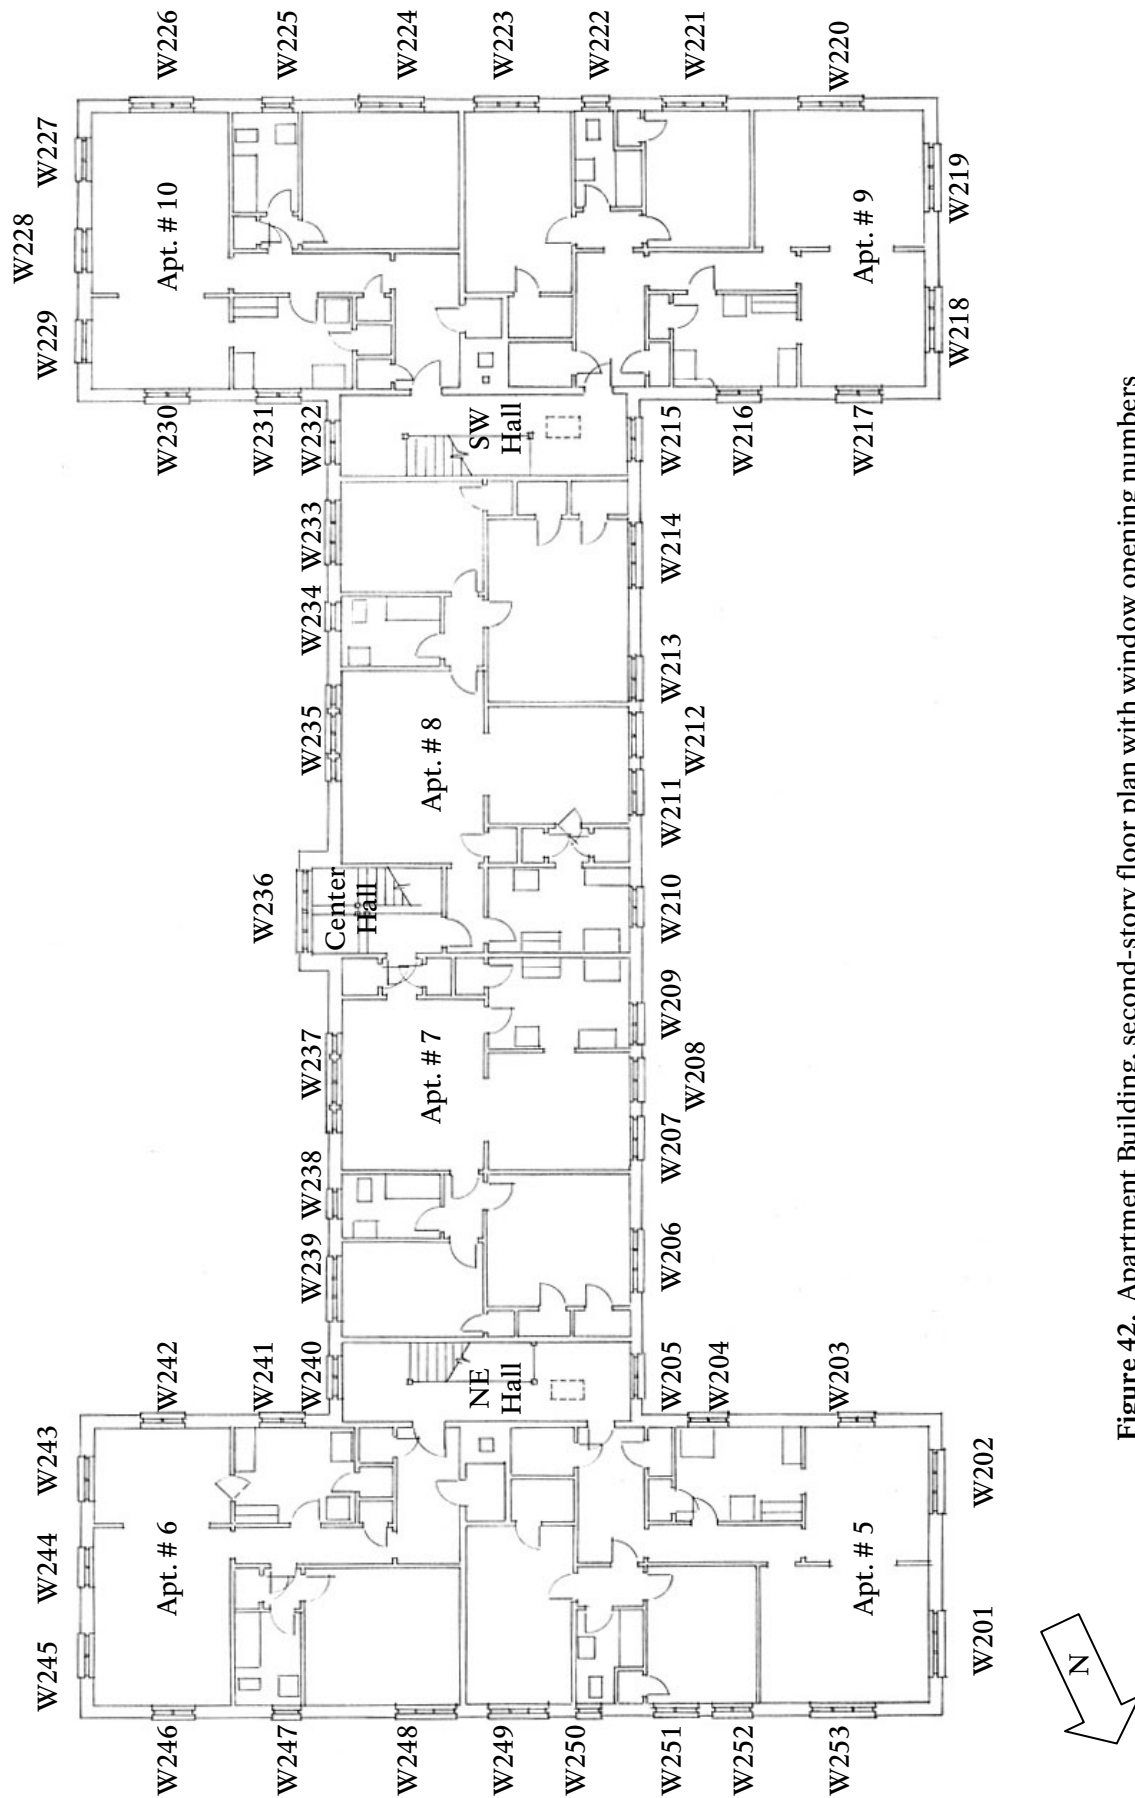
Figure 42. Apartment Building, second-story floor plan with window opening numbers assigned during the current project (not to scale).

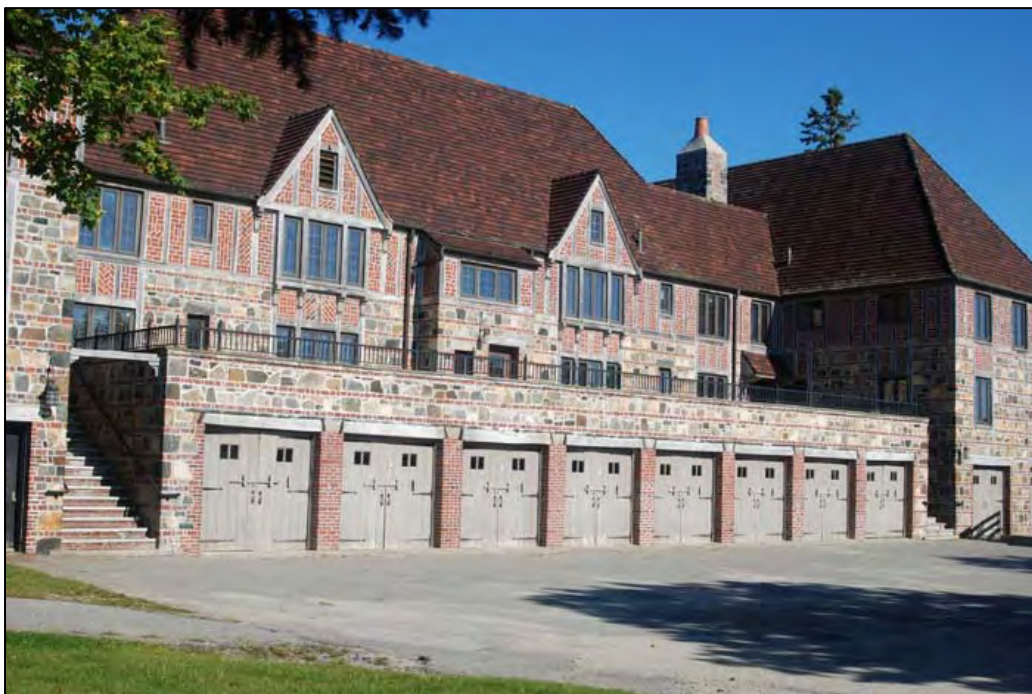
Figure 44. Apartment Building, SE elevation depicting garage bay doorways at basement story, 2008.

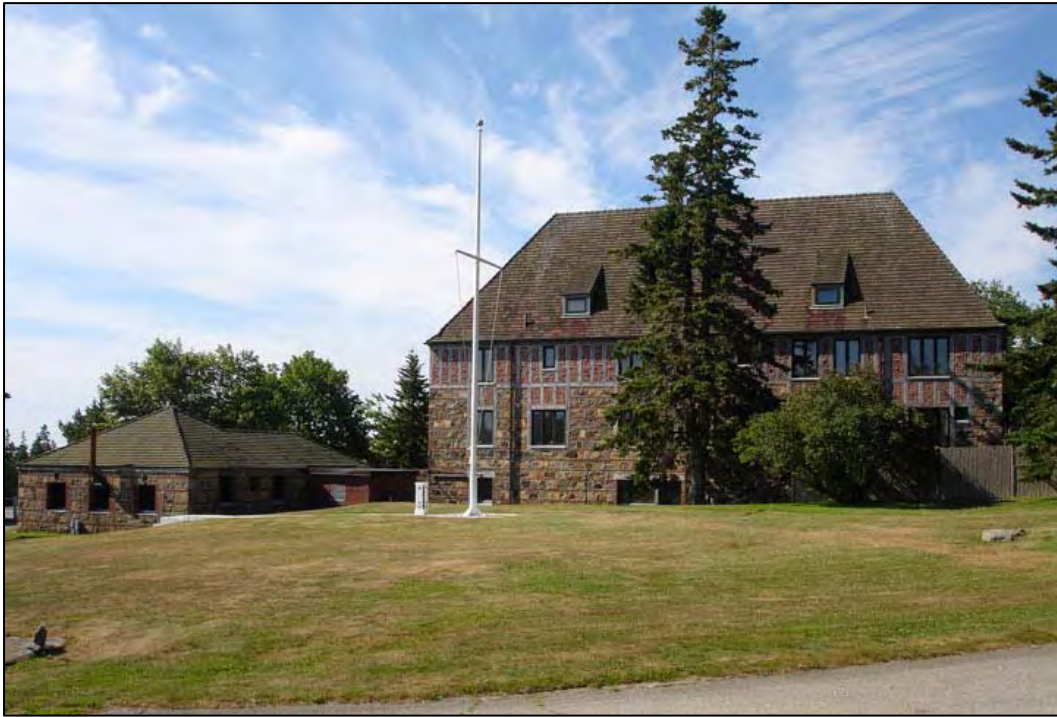
Figure 45. Apartment Building, NE elevation with Power House on the left, 2008.

Additional existing landscape features include the stockade fence that was erected at the north corner of the Northeast Pavilion, enclosing a small yard. The fence was not evident in circa-1970 photographs, but a portion of the fence was built by circa 1990. The fence has been extended along the NW side of the pavilion since the circa-1990 photograph (fig. 38) was taken. There is currently a lamp post near the north corner of the Northeast Pavilion and a lamp post next to the NE elevation walkway at the basement ground level. A flagpole with the cement walkway and the memorial anchors are presently situated on the lawn NE of the building (fig. 45).

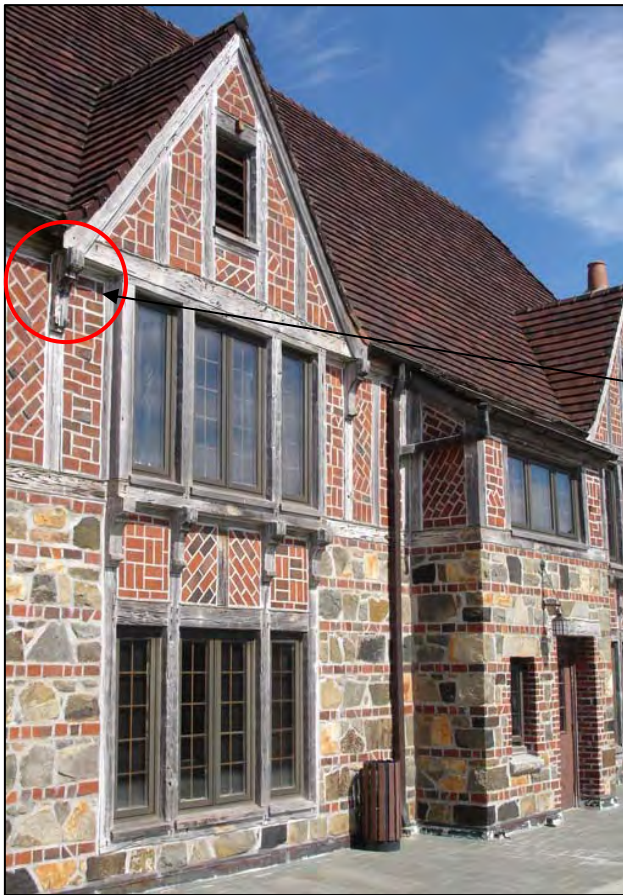
Figure 47. Apartment Building, SE elevation, cross gable and projecting center bay, 2008.

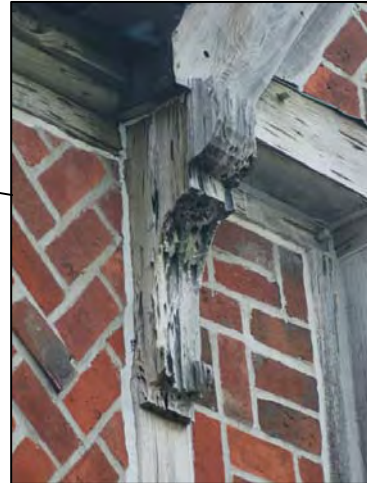
Figure 47a. Apartment Building, SE elevation, deteriorated cross-gable bracket, 2008.

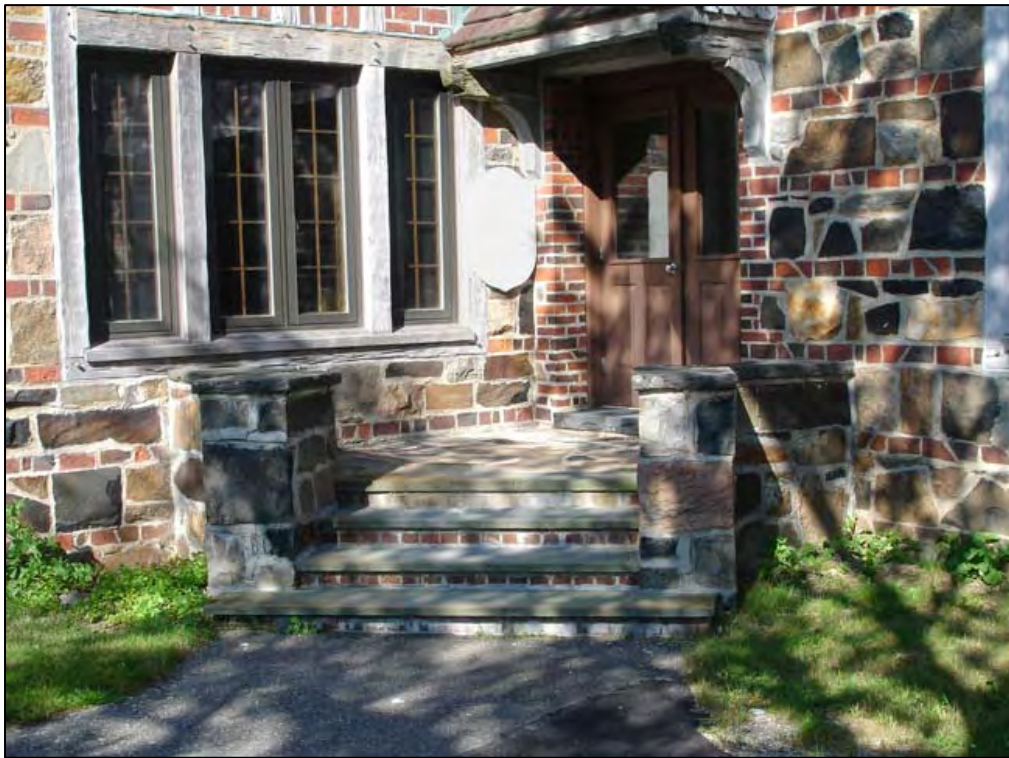
Figure 49. Apartment Building, NW elevation entry stoop to D102, 2008.

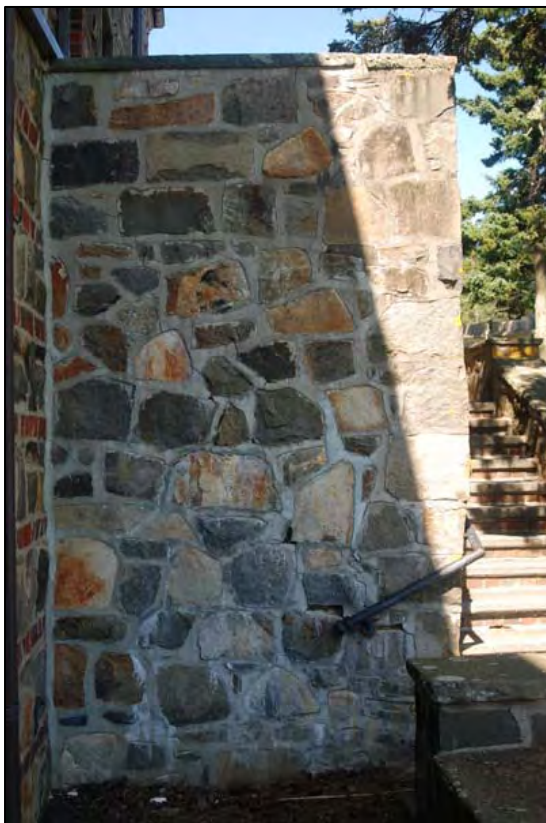
Figure 50. Apartment Building, Northeast Pavilion, SE wall of NE entrance stoop to D108, 2008.

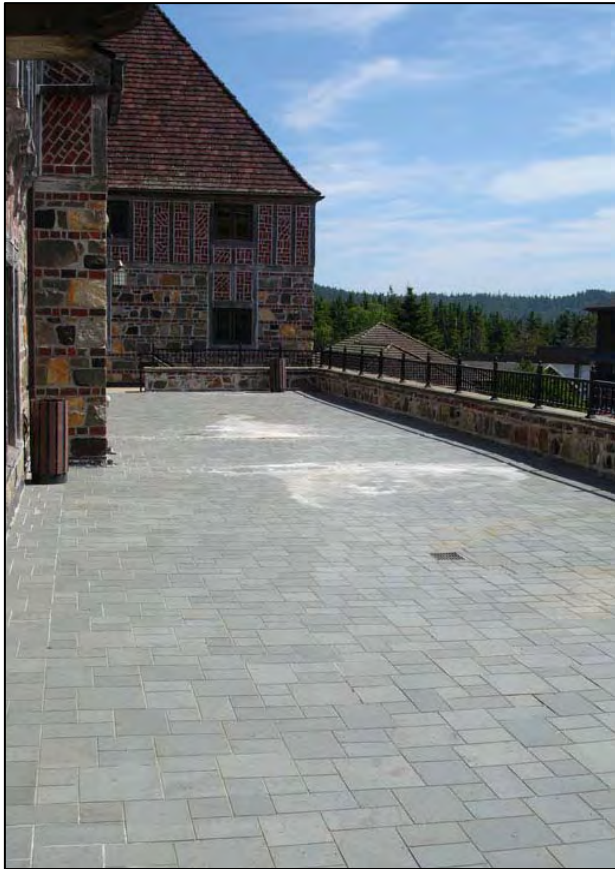
Figure 51. Apartment Building, SE elevation, terrace, 2008.

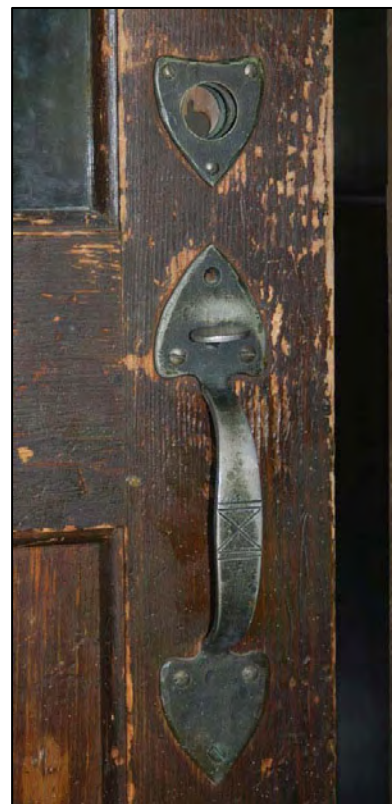
Figure 53a. Extant Suffolk-style latch and escutcheon on interior door to NE Hallway vestibule. Note the similarities to the hardware in the catalog illustration.

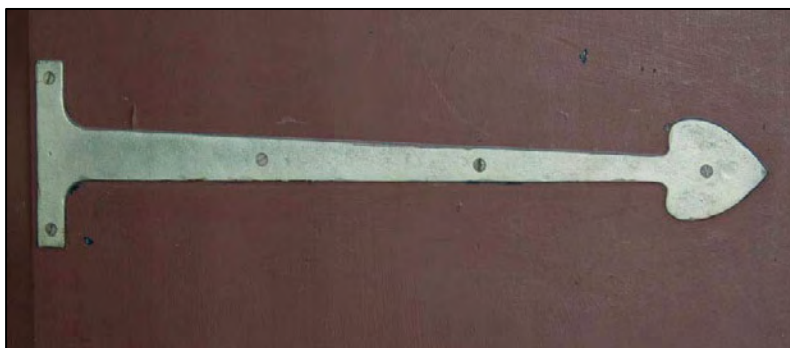
Figure 53b. Extant reproduction strap hinge on Northeast Pavilion entrance door, D108. Note the similarities to the hardware in the catalog illustration.

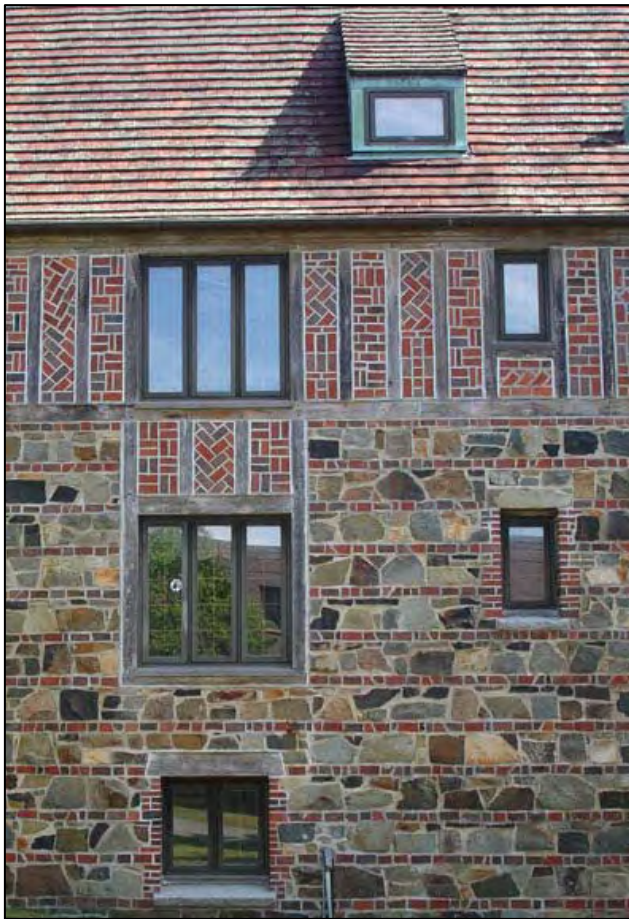
Figure 54. Apartment Building, SW elevation, window openings depicting exterior elements of different window types including:
 Basement, W002 (type C);
 First Story, W120 (type G),
 W121 (type A, masonry surround);
 Second Story, W224 (type G), W225 (type A, wood surround);
 Attic, W304 (type J in dormer), 2008.

The original locations of the window openings and the original window opening surrounds were retained when the window sashes were replaced in 1981. The rough openings were not altered and the schedule for the new window sashes followed the same type designations that were assigned in the 1933 plans (see previous section “Original Appearance; Window Openings”). The exterior elements of all the replacement sashes are aluminum clad with a dark brown finish (fig. 54). The exterior jamb and head elements between the sashes and the window surrounds are aluminum clad. The mullions separating the sashes in the double and triple sash window openings are also aluminum clad. The following window schedule describes the various window types. The subsequent tables record the window openings by numbers assigned during the current project (figs. 40, 41, and 42) and document the current configuration.

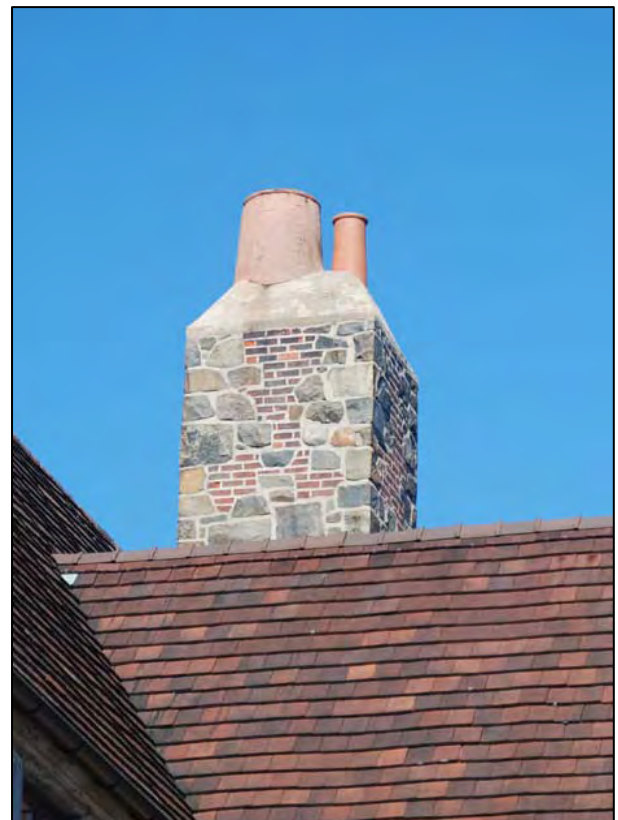
Figure 55. Apartment Building, SW chimney, 2008.

The two masonry chimneys do not appear to have been significantly altered (fig. 55). Both chimneys retain the original masonry materials of granite stone and brick, and the terra-cotta chimney pots are intact. The exterior masonry repointing projects most likely included some work on the chimney stacks. Currently the mortar and masonry appear to be in good condition.

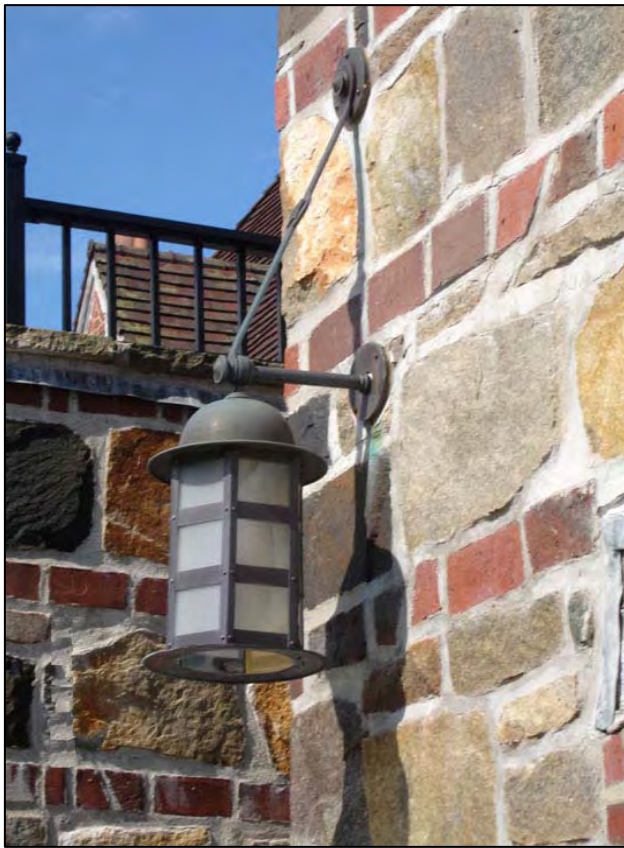
Figure 56. Apartment Building, SE elevation, exterior light fixture on Northeast Pavilion, 2008.

Two of the original exterior light fixtures have been retained. These are located on the SE elevation at the basement level: one by D001 on the Southwest Pavilion and one by D010 on the Northeast Pavilion (fig. 56). Both fixtures retain the brass brackets and lanterns depicted in the historic photographs (fig. 21). The fixture by D106 originally had the same type of lamp, but it has been changed to a six-sided brass lamp. The does not replicate the historic lamp, but it is compatible and the original bracket was retained.

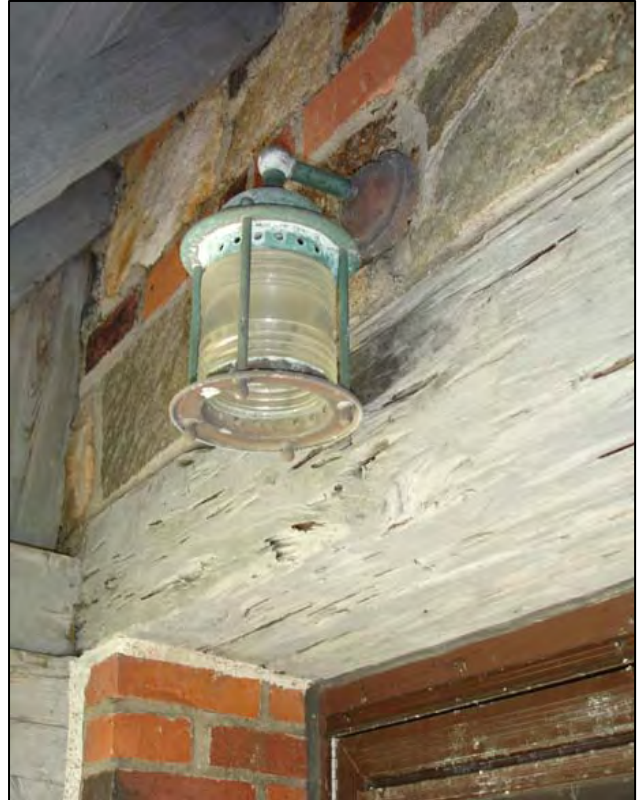
Figure 57. Apartment Building, NE elevation, exterior light fixture above D108, 2008.

The overhead light fixtures above the façade doorways (D102, D103, and D104) are currently brass lanterns with six rounded panels, a domed top with brass finial, and a brass backplate. Though there was no documentation for the original lanterns, these fixtures appear to be replacements. Similar light fixtures are installed over the SE first-story doorways that have the same type of doorway hood (D105 and D107). The fixture over D108 is different from the others (fig. 57). It is a copper lantern with a dome-shaped copper top and a ring at the base. Four posts attach to the top and bottom and enclose a cylindrical glass globe. The fixture hangs from a copper-pipe bracket that extends from the exterior wall and has a backplate. The fixture appears to be older than the other doorway lanterns and could possibly be original to the building. The recessed fixture set in the soffit of the metal hood over D101 is in an original location and may retain original elements.

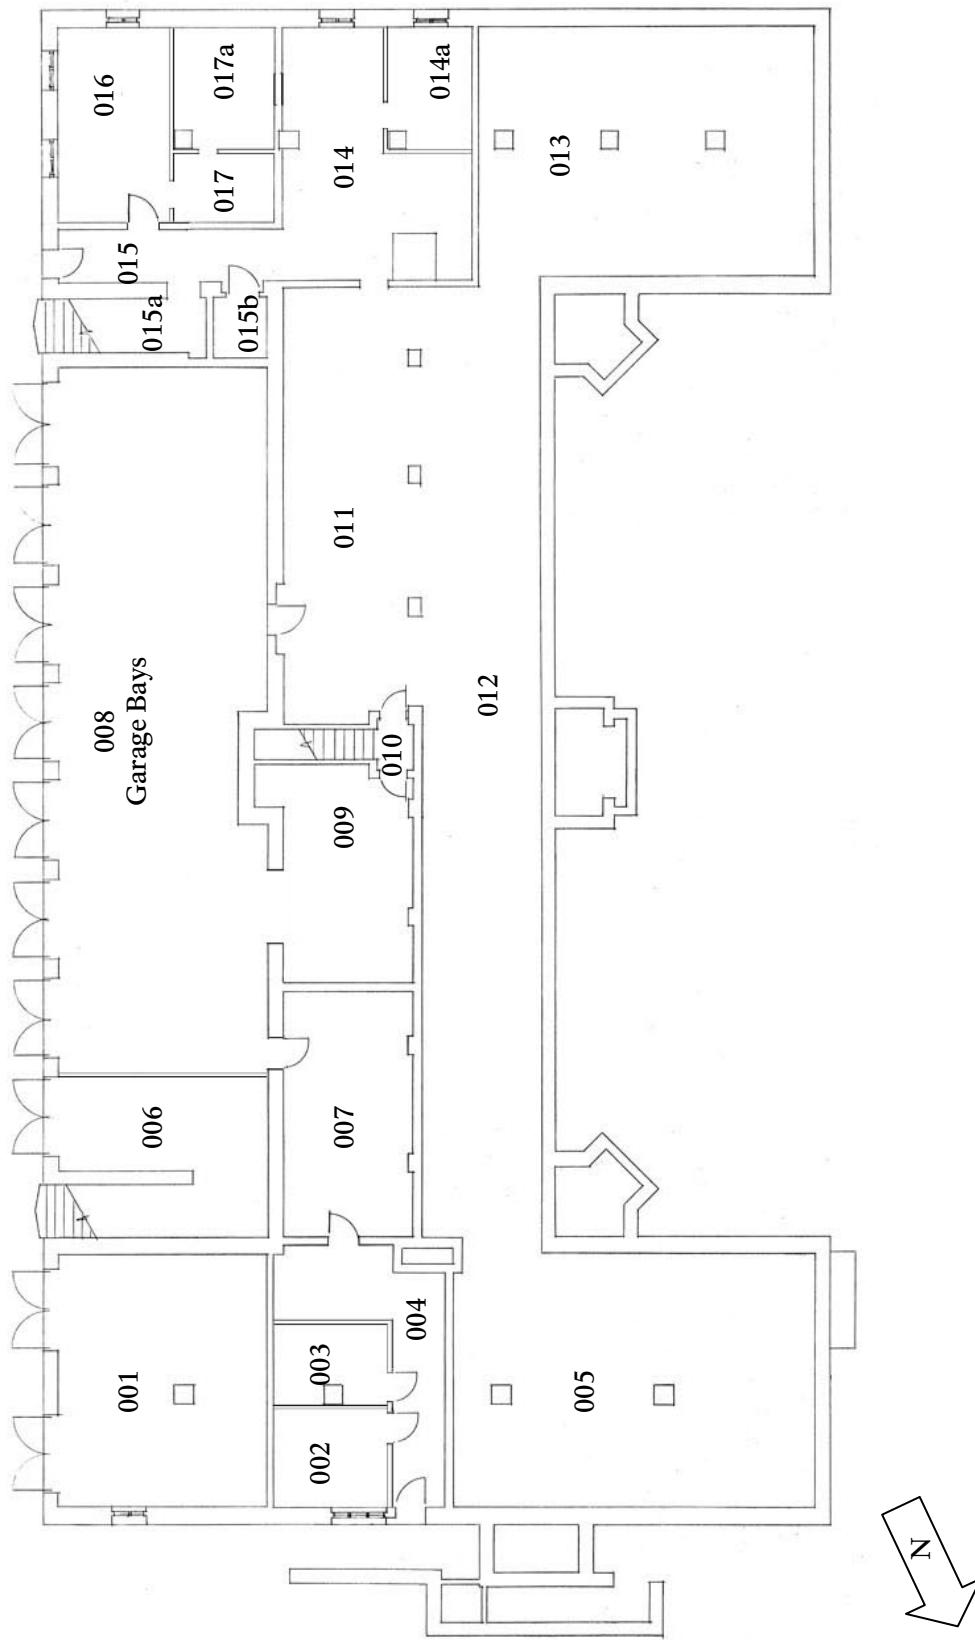
Figure 58. Apartment Building, basement-story floor plan with room numbers assigned during the current project, (not to scale).

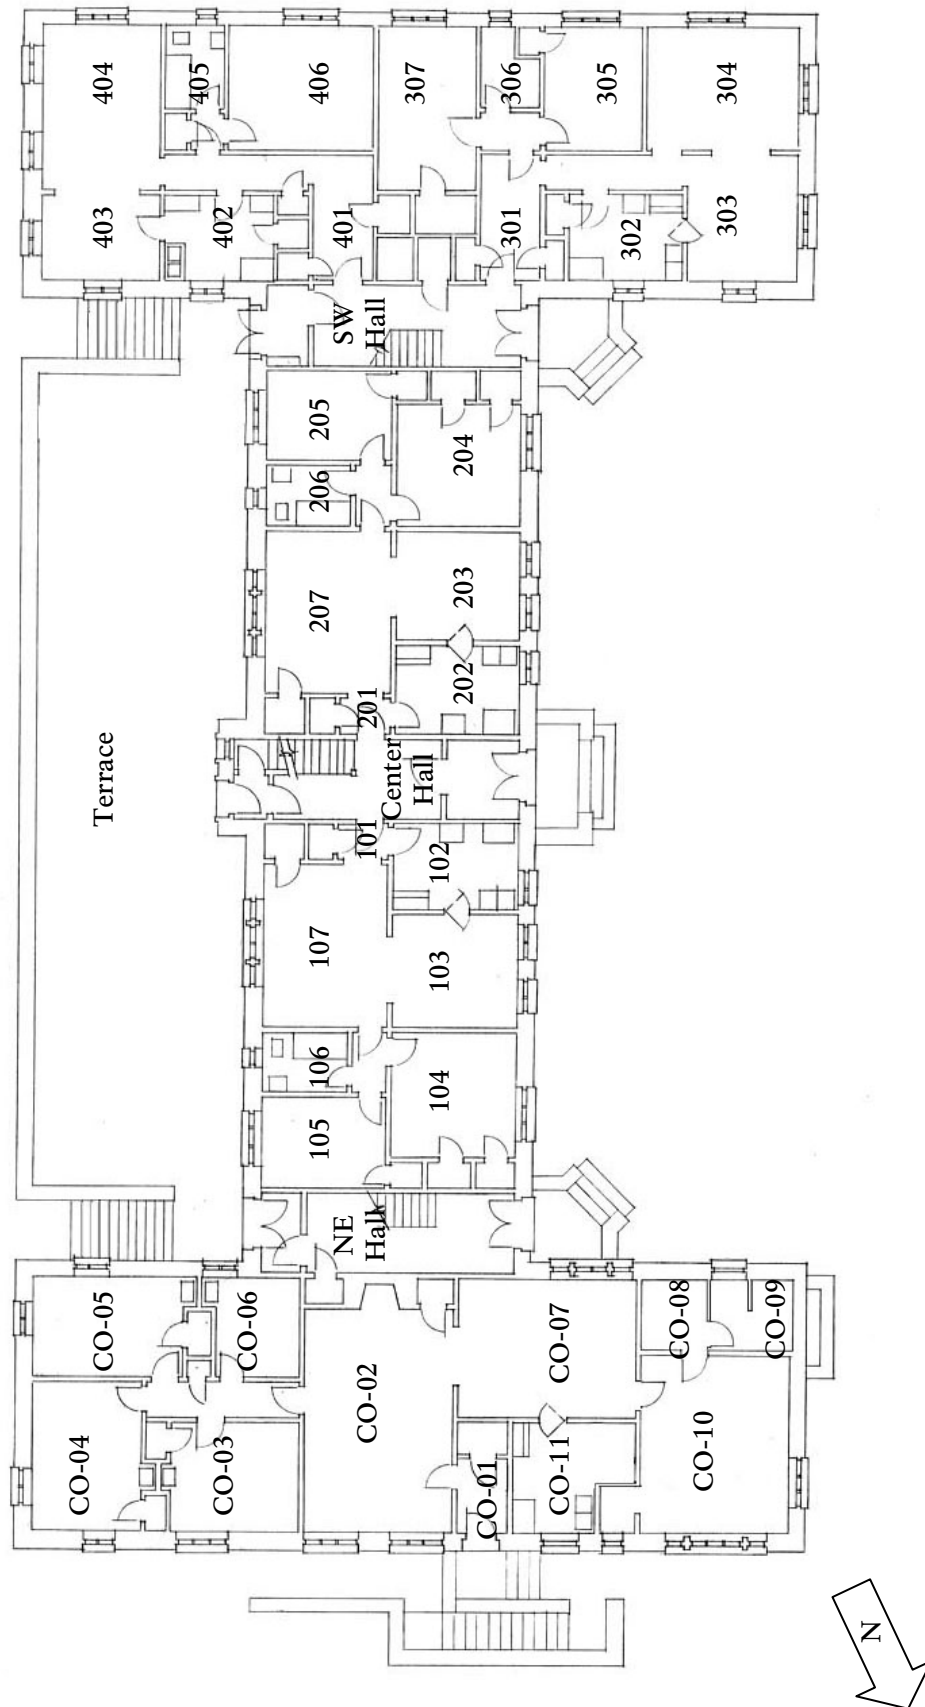
Figure 59. Apartment Building, first-story floor plan with room numbers assigned by apartment number during the current project (not to scale).

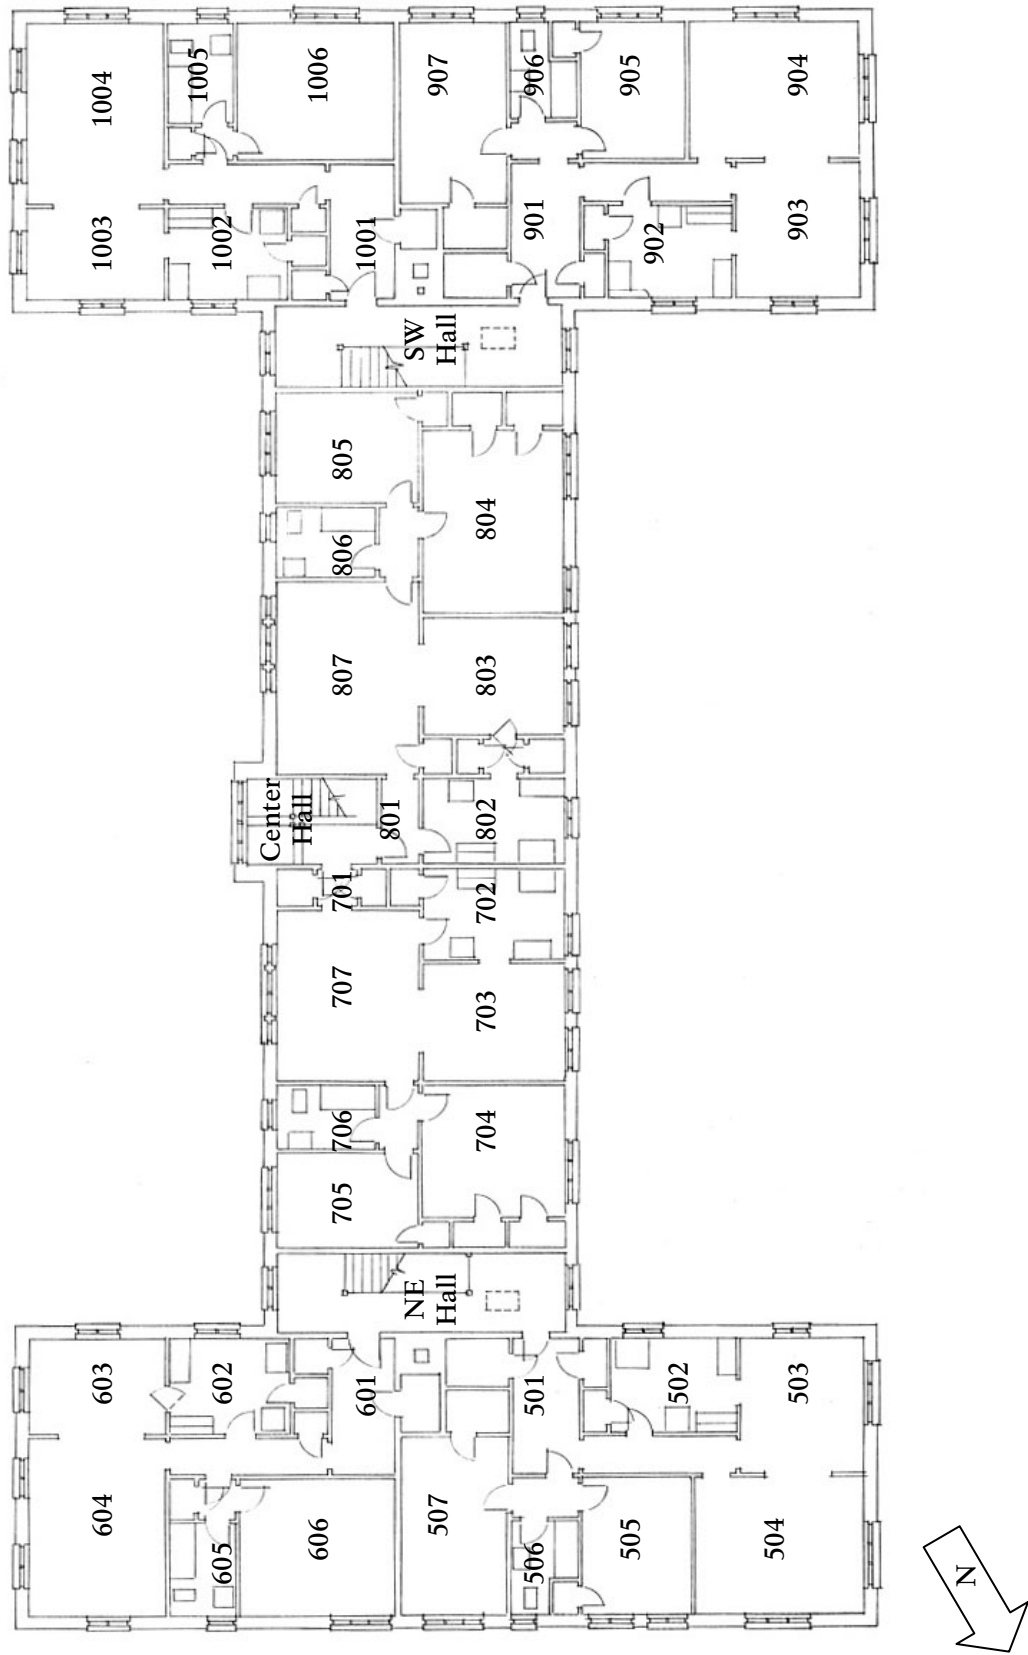
Figure 60. Apartment Building, second-story floor plan with room numbers assigned by apartment number during current project (not to scale).

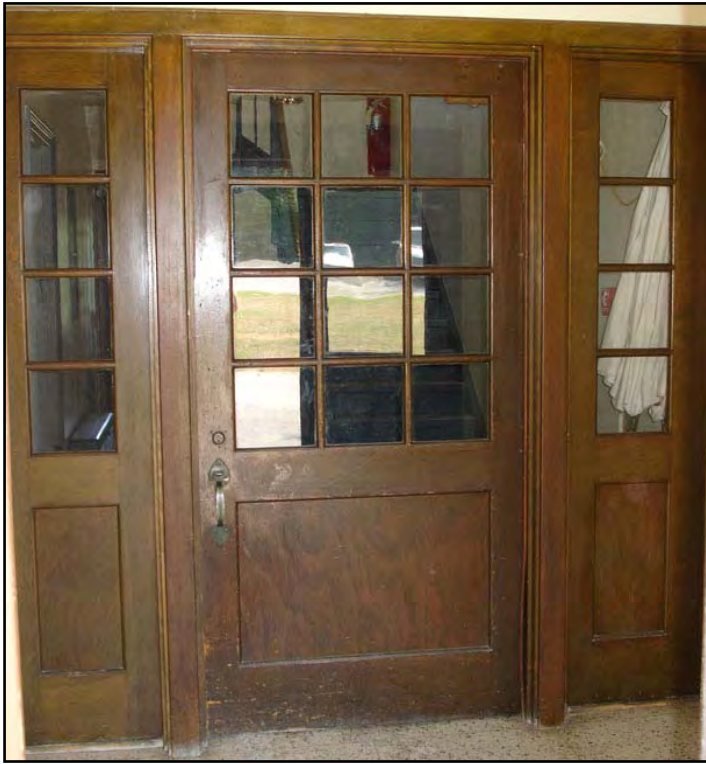
Figure 61. Apartment Building, Center Hallway NW vestibule interior doorway, 2008.

The interior trim of D103 retains the plain surround with quarter-round molding. The same trim is retained around the doorway from the vestibule to the main hallway and around the doorway to the SE vestibule. The doorway separating the NW vestibule from the staircase hallway preserves the original elements that were illustrated in the 1933 architectural drawings (Appendix A, drawing number 13 of 37 sheets, fig. 61). Likewise, the doorway from the staircase hallway to the SE vestibule retains the original elements. The doorways to Apartment No. 1 and Apartment No. 2 retain the molded-steel surround and the two-panel doors that are typical of the apartment entry doorways. The doorknob on the apartment entry doors were replaced with the current brass locking knobs with a brass backplate. A steel surround is also installed in the doorway leading from the SE vestibule to the basement staircase. The SE exterior doorway (D106) is trimmed with plain boards.

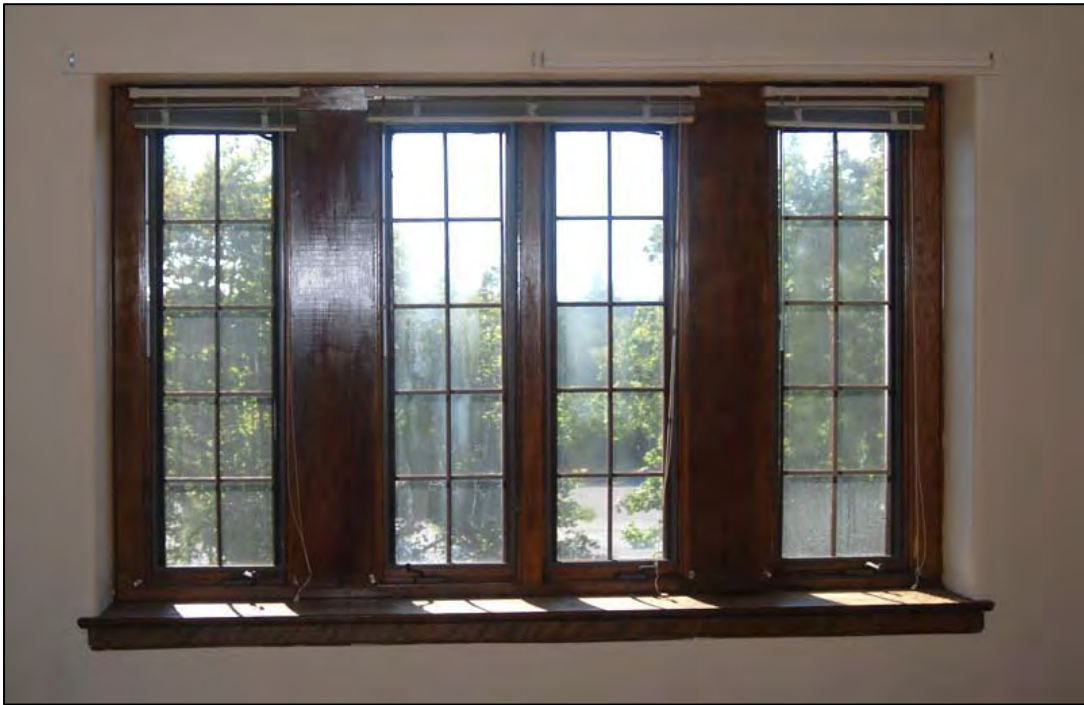
Figure 63. Apartment Building typical interior of window opening with four sashes (W237), 2008.
