U.S. Naval Radio Station - Apartment Building (Bldg 1) : Historic Structure Report; Acadia National Park

U.S. NAVAL RADIO STATION— APARTMENT BUILDING (Bldg 1)

HISTORIC STRUCTURE REPORT

**Acadia National Park
Bar Harbor, Maine**

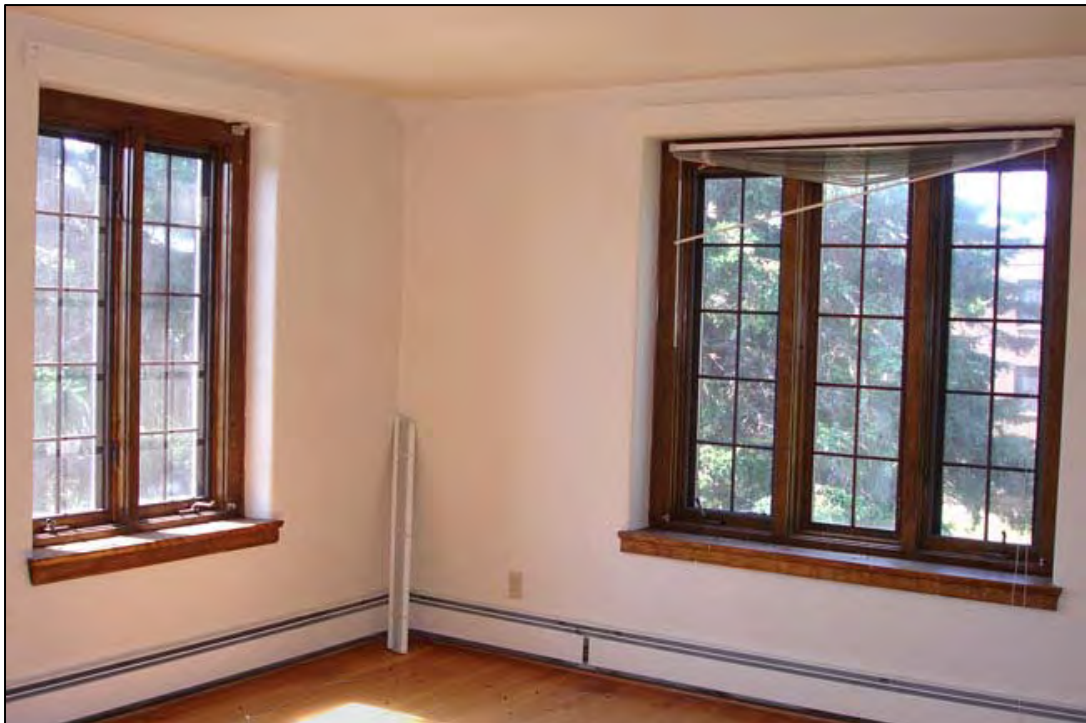
Figure 64. Apartment Building typical interior of window openings with two sashes (W227) and three sashes (W226), 2008.

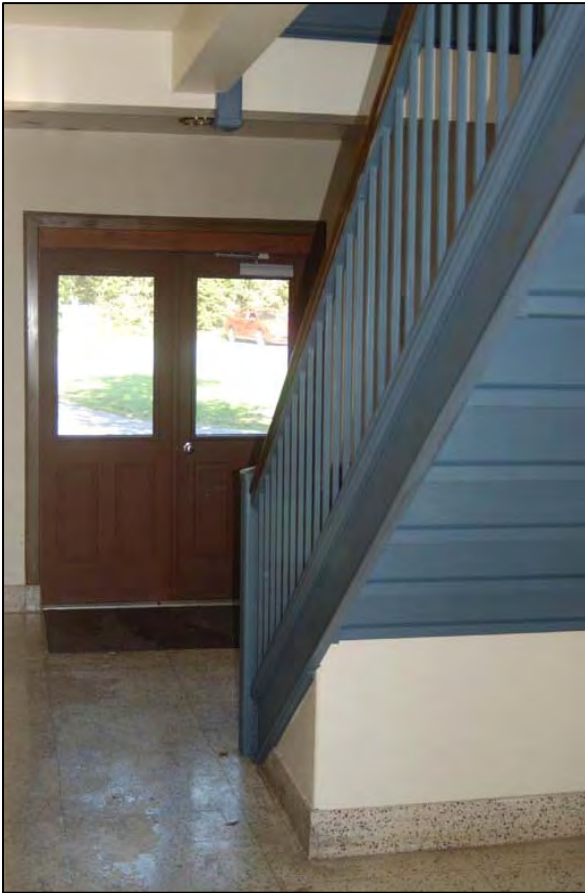
Figure 65. Apartment Building, SW Hallway looking NW at staircase and interior of D104, 2008.

Like the other hallways in the Main Block, the SW Hallway was not significantly altered (figs. 65 and 66). The plan follows the original layout consisting of a main hallway with a staircase on the NE wall and access to the first-story apartments in the Southwest Pavilion, and the back vestibule with an exterior doorway to the Terrace. The hallway floors, walls, ceiling, and staircase appear to retain original elements and are generally in good condition. A new brass lantern light fixture is installed in the ceiling near D104.

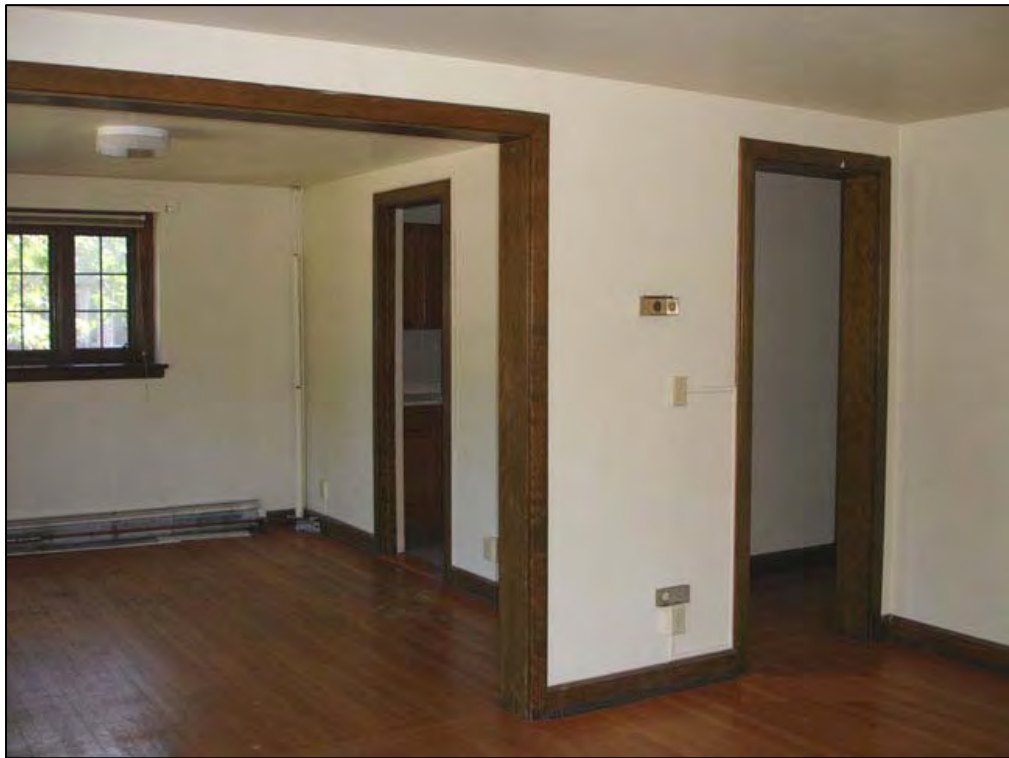
Figure 67. Apartment Building typical apartment interior elements, Apartment No. 9 looking NE from Living Room to Dining Room, 2008.

The plan of Apartment No. 9 has not been altered. It generally follows the two-bedroom apartment plan of Apartment No. 3 on the first story with the previously noted difference in the Foyer (Room 901) closet. With the exception of the Kitchen and bathroom, the rooms in the apartment appear to have original elements with few alterations (fig. 67). As with the other apartments, the electrical service was upgraded with surface-mounted conduit, switches, and sockets, as well as new ceiling light fixtures. The heating was changed to baseboard radiators. The Kitchen (Room 902) has been renovated with replacement wood cabinets, Formica countertops, ceramic backsplashes, vinyl tile floors, and new appliances (fig. 68). The doorway to the Kitchen closet has a bi-fold door and retains the historic surround. The bathroom (Room 906) has been renovated with a new toilet, sink and vanity, shower fixtures and liner, and medicine cabinet with light. However, it retains the original ceramic tile floor, porcelain tub, plaster walls with faux tile, and plaster ceiling with ceiling vent.

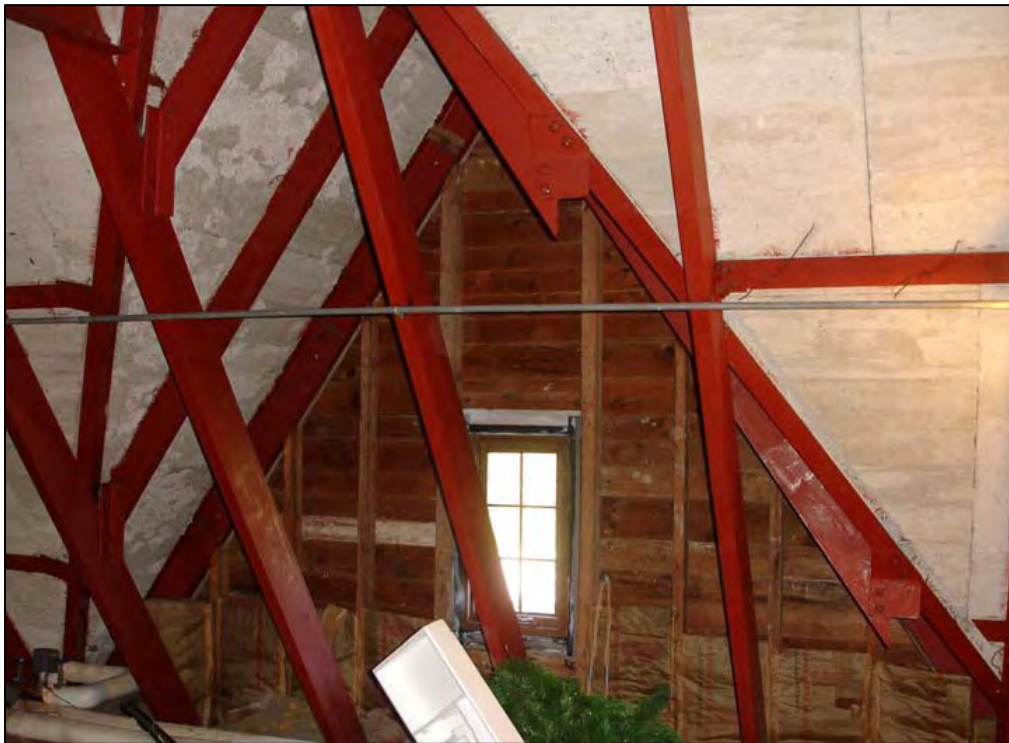
Figure 69. Apartment Building, attic story, typical framing of roof and cross gable, 2008.

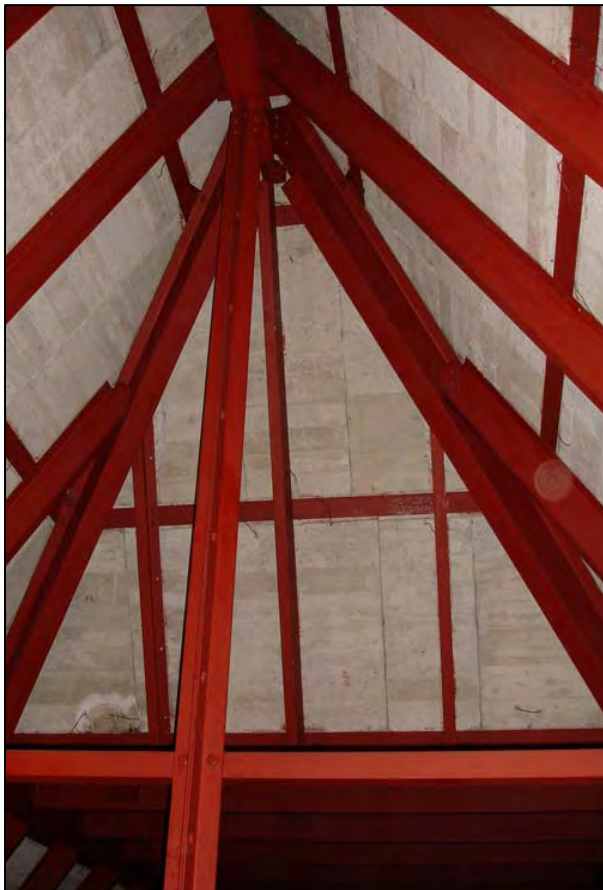
Figure 70. Apartment Building typical steel framing of hipped roof and "nailcrete" sheathing panels, 2008.

The window openings in the cross gables have replacement aluminum-clad casement sashes with wooden interior finish and wooden snap-in grills. The SE elevation SW gable window opening has metal louvers for the current ventilation system in place of the sash. There is no interior trim on the cross-gable window openings (fig. 69). The dormer window openings were also rehabilitated with replacement sashes but are otherwise unchanged. The attic story preserves some important original elements, especially the steel framing members and the “nailcrete” roof sheathing (fig. 70), and has a high degree of historic integrity.

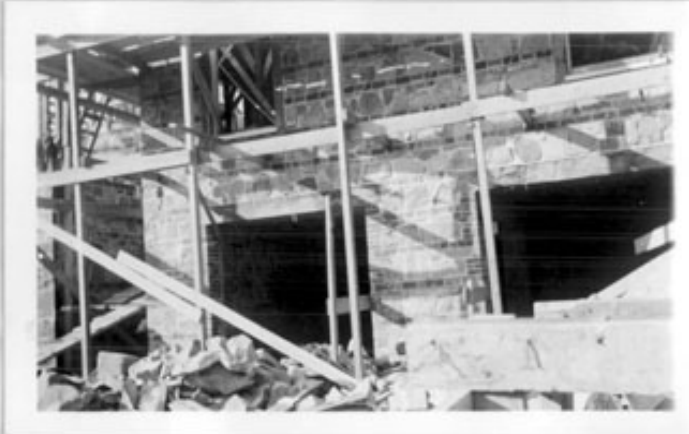
Apartment Building:
Nov. 13, 1933.

View from the East;
Garages under N.E. wing.

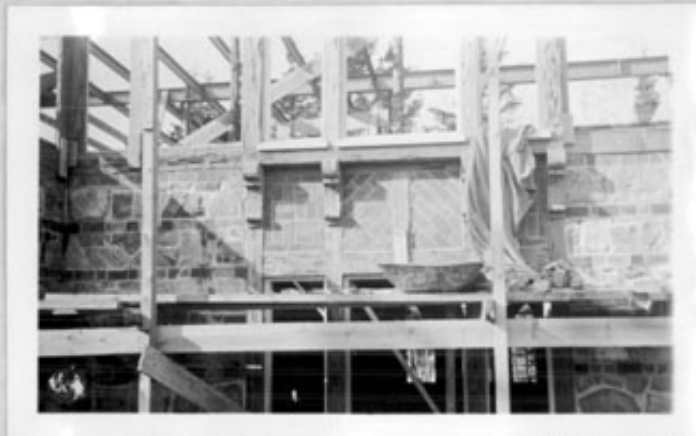
Apartment Building:
Nov. 16, 1933.

View from Terrace;
Brick panel detail under
Southerly Cable

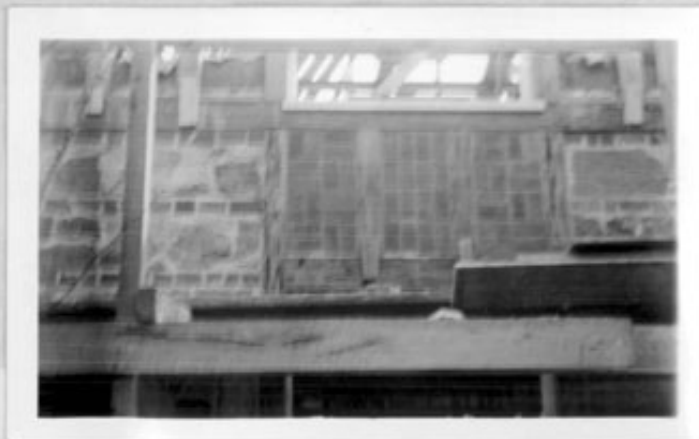
P67 39 of 73

Apartment Building:
Nov. 16, 1933.

View from the West;
Brick panel detail above
first floor window on
S.W. wing.

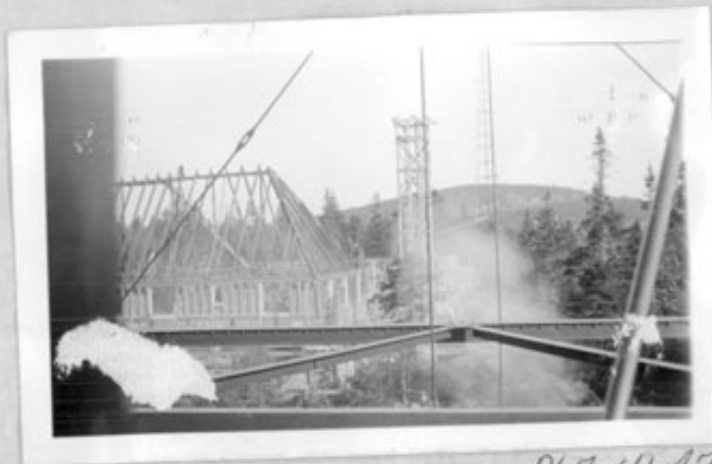
P67 41 of 73

Apartment Building:
Nov. 22, 1933.

View from South Radio Tower;
S.W. wing of Apartment with steel roof framing in progress.
All of roof framing supported on shores, the masonry walls being
built under afterwards. This allowed all steel to be bolted with-
out stresses in anchor bolts or masonry.

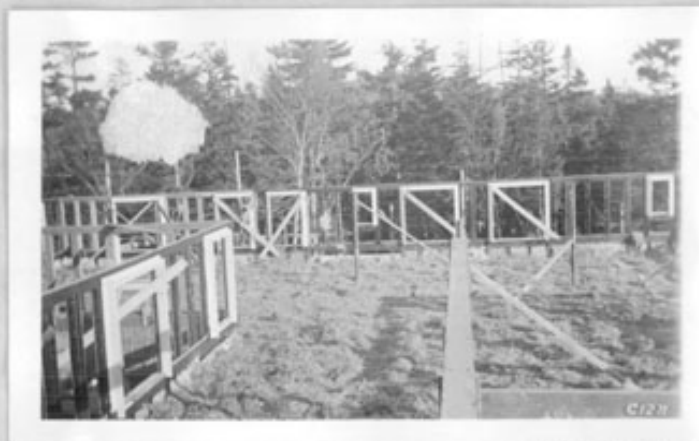
P67 42 of 73

Apartment Building:
Nov. 23, 1933.

View of Second floor of N.E. wing, soon after Second floor
slab was poured. Under the thick bed of straw a waterproof
tarpaulin was laid. Salamanders were used beneath this floor,
the openings below being boarded up. These precautions were
taken for below freezing temperatures.

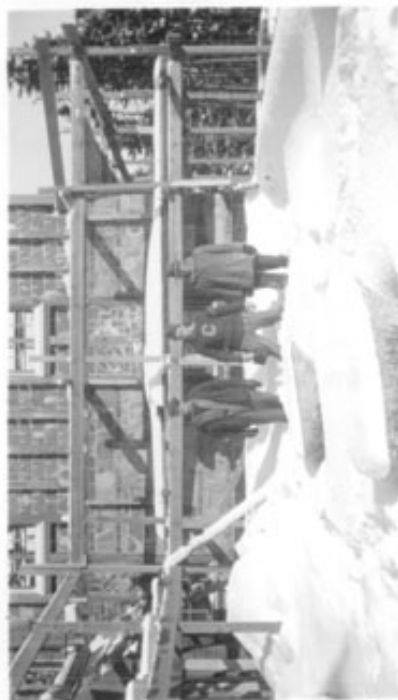
Apartment. East Wall of Corridor.
on 2nd floor. January 15, 1934. P67 64 of 73

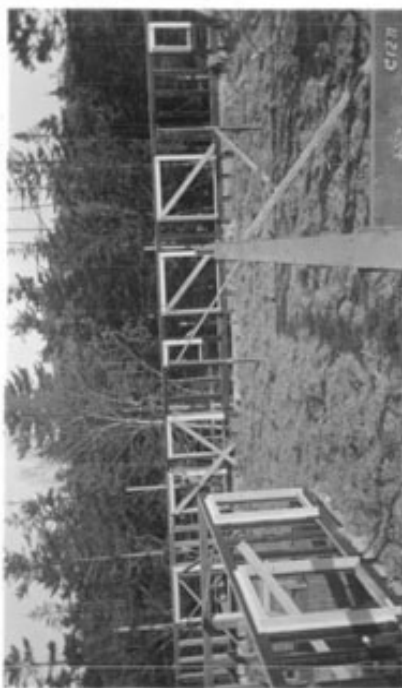
P67 69 of 73

Apartment 2nd Floor Concrete Slab with Protection
from Freezing. November 23, 1933.

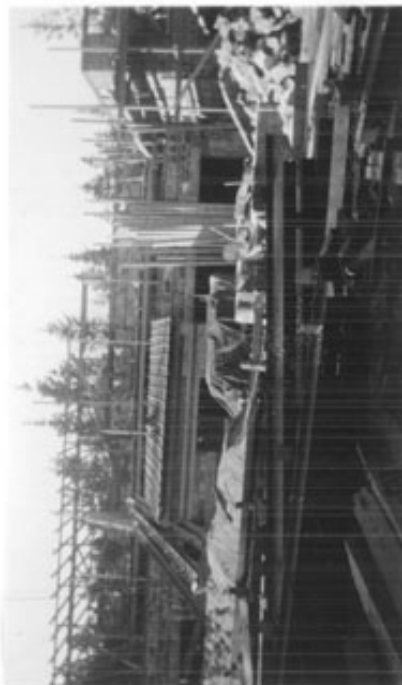
P67 68 of 73

Apartment, Steel Framing for 2nd Floor Ceiling
From S.E. December 10, 1933.
