# Katahdin Iron Works and its Effect On the Water Quality of the West Branch of the Pleasant River

**Katahdin Iron Works Township  
(T6 R9 NWP)  
Piscataquis County, Maine, USA**

By Mark Whiting  
Maine Department of Environmental Protection  
Bangor Regional Office  
106 Hogan Road, Suite 6  
Bangor, Maine 04401

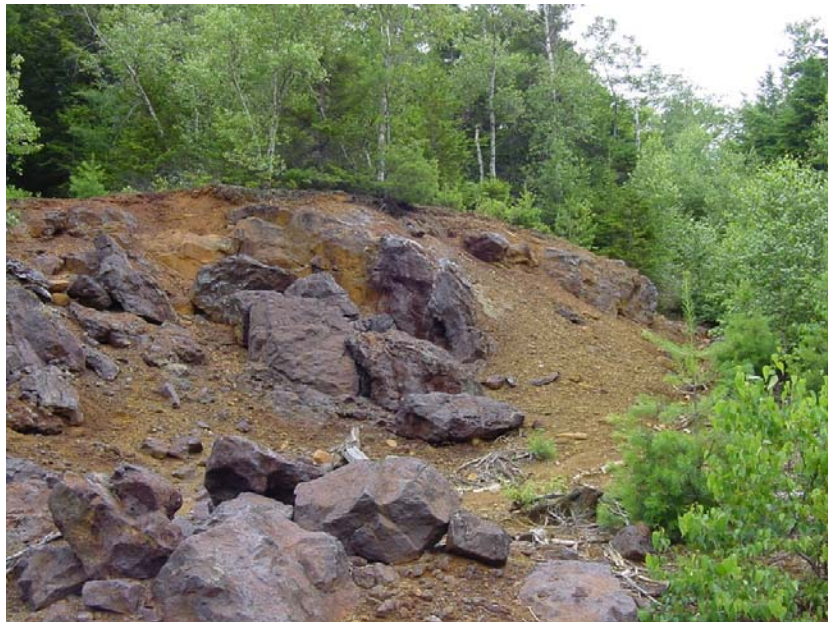
Ore Excavation Pit, Ore Mountain, Photo by Mark Whiting  
June 14, 2010

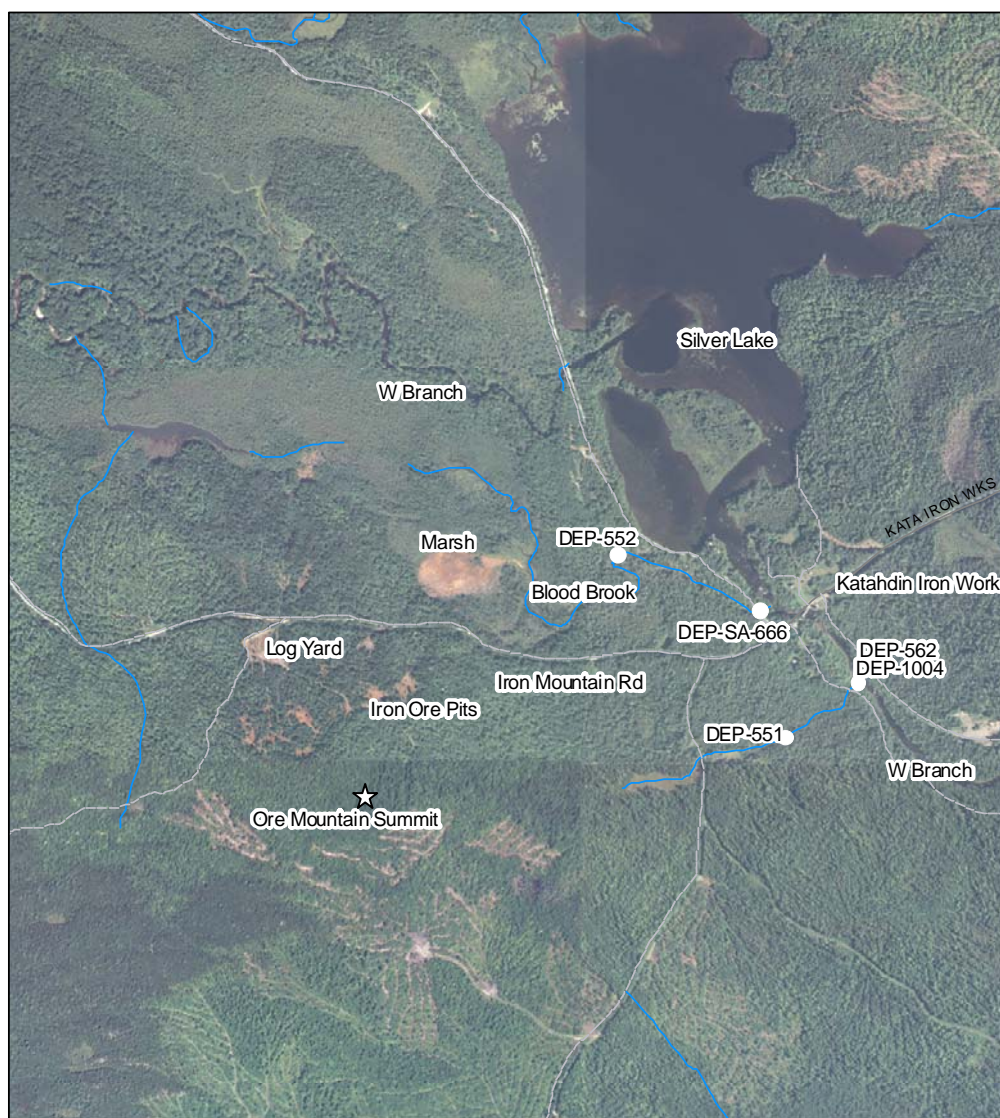
## DEP Biomonitoring Sites in the Katahdin Iron Works Area

Figure 1. Aerial photograph of the Katahdin Iron Works area showing the DEP Biomonitoring Program study sites. The Ore Mountain summit is indicated with a star. Blood Brook enters the West Branch of the Pleasant River just below Silver Lake. Blood Brook was sampled in 1996 for macroinvertebrates (at the upstream site) and was sampled again in 2003 (at the lower site) for algal communities. Samples were taken

from the West Branch in 1996 and 2001. No-name Brook enters the West Branch just below the KIW site and was sampled in 1996.

Blood Brook is located on the far side of the West Branch (southwest) from the Iron Works, but on the same side as Ore Mountain as the mine excavation sites (Figure 1). Blood Brook is so named because of the red staining on rocks from iron deposits. The stream and the immediately downstream reach of the West Branch are listed as impaired due to "legacy pollutants" due to iron mine contamination (DEP 2008). The macroinvertebrate collections at Blood Brook are very poor (just four individuals were recovered, including a midge, one beetle larva, a mayfly and a water mite from three rock baskets). The sample not only did not meet Class A criteria, but did not even meet the Class C criteria (the lowest water quality class) (Table 2). This acidic and iron-stained stream has no fish, and has very little evidence of any animal life. In fact, the problem

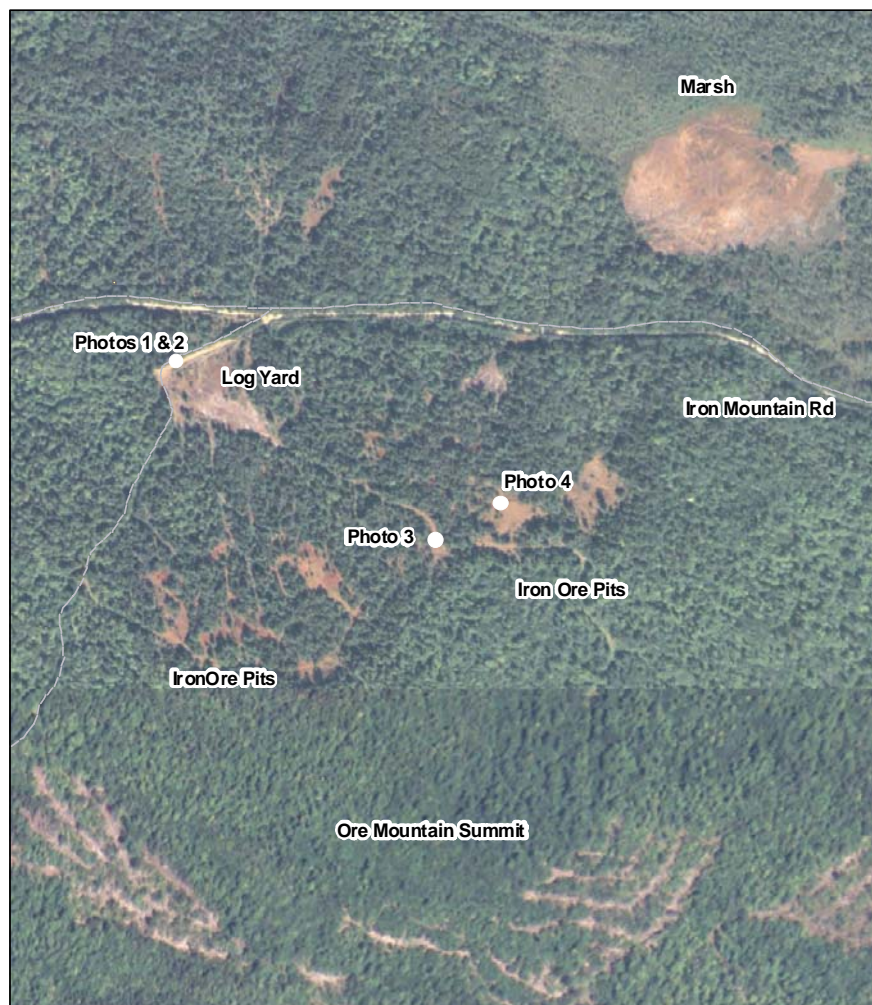
Ore Mountain Iron Ore Pits and Photo Locations

Figure 5. Locations of ore pits and of photos taken on Ore Mountain on October 8, 2009. The parallel roads on the bottom of the figure are modern logging roads and skidder trails.

In order to evaluate the metals and low pH sources, aerial photos (such as Figure 1) were used to locate potential ore pits. The pits were investigated on foot from the Iron Mountain Road. Three pits were found and photographed (Figure 5). The log yard appeared to have been excavated long before it became a storage area for modern logging crews (Figures 6 & 7). This pit was shallow, only a few feet of overburden had been removed, exposing bedrock immediately below. Due to the general lack of soils and recent disturbance due to log storage, this pit had very little plant cover. The second pit was very small (Figure 8). It was dug into the mountain side leaving large stones behind. The third pit (Figure 9) was the second largest and the deepest. This pit was internally draining and had some sparse grass cover. Only the first pit had any evidence of surface water drainage, and this was extremely small given that there had been 1.02 inches of rain the previous day (October 7, 2009 as recorded in Millinocket). A field pH meter recorded a pH of 2.2 in the runoff. Surface runoff from this site crossed under the Iron Mountain Road and flowed down the mountain side toward Blood Brook.

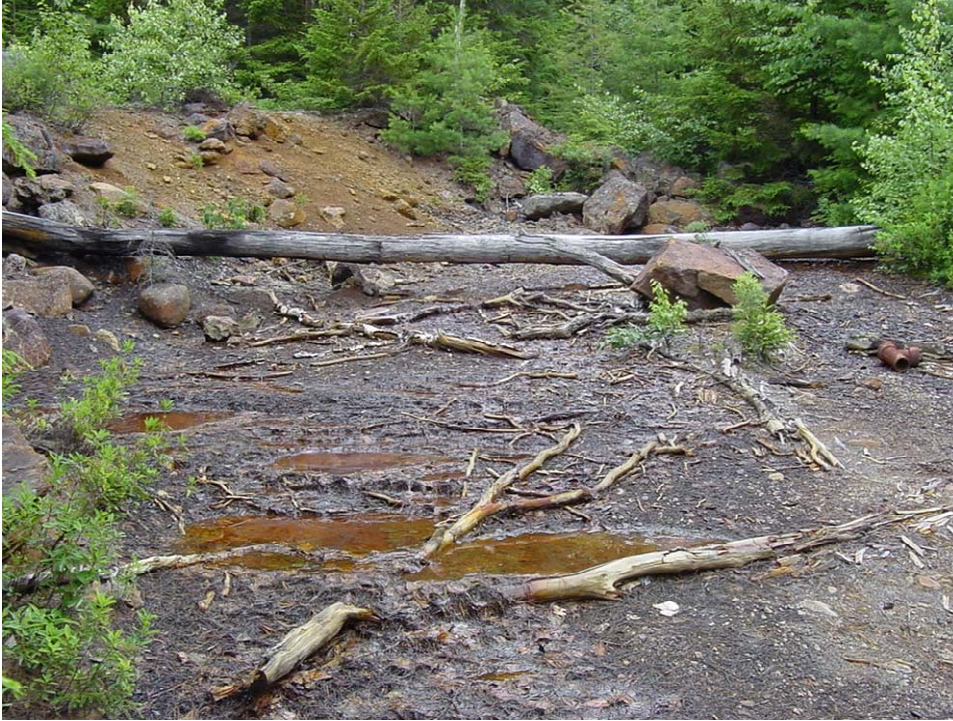
Figure 6. Photo 1 was taken from the bottom of the log yard/lower pit (along the Ore Mountain Road) after a rainstorm of 1.02 inches the previous day. The photo is looking west. This pit had a lot of exposed bedrock and a few small springs. Woody debris was common and there was very little plant cover.

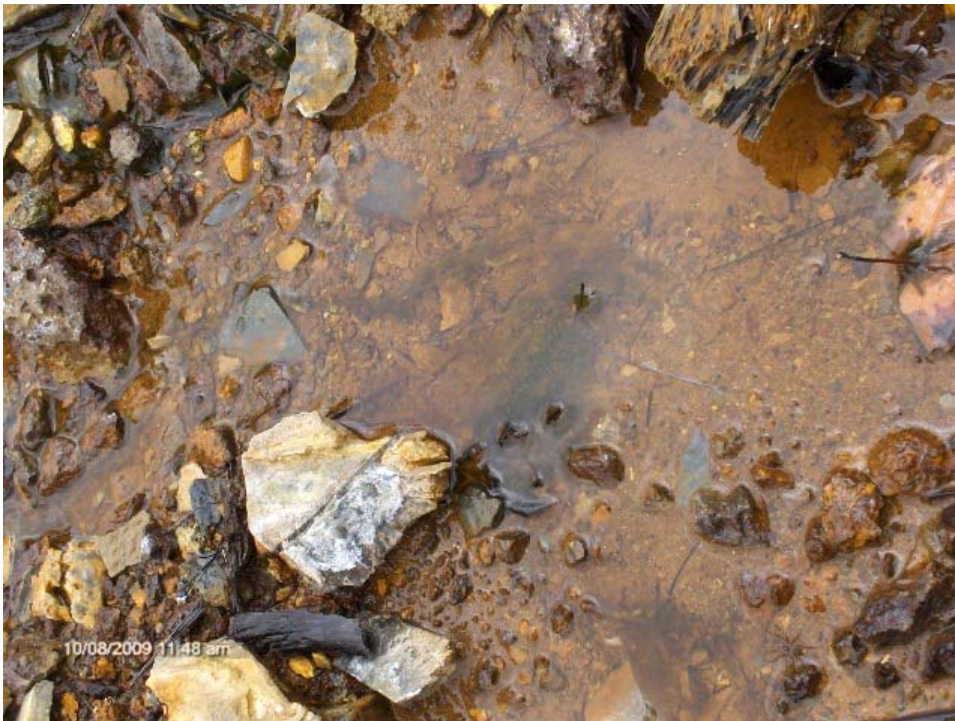
Figure 7. Photo 2 was taken in the bottom of the first pit, showing a small amount of surface water drainage after over an inch of rain the previous day. The pH of this runoff water was 2.2.

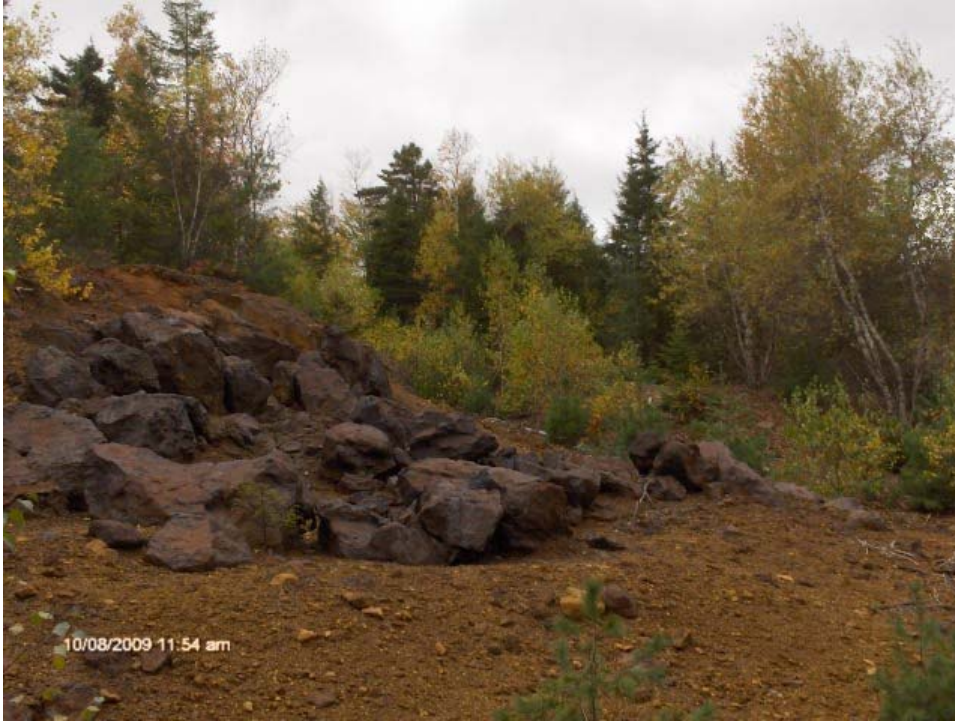
Figure 8. Photo 3 showing the second pit, looking northwest.

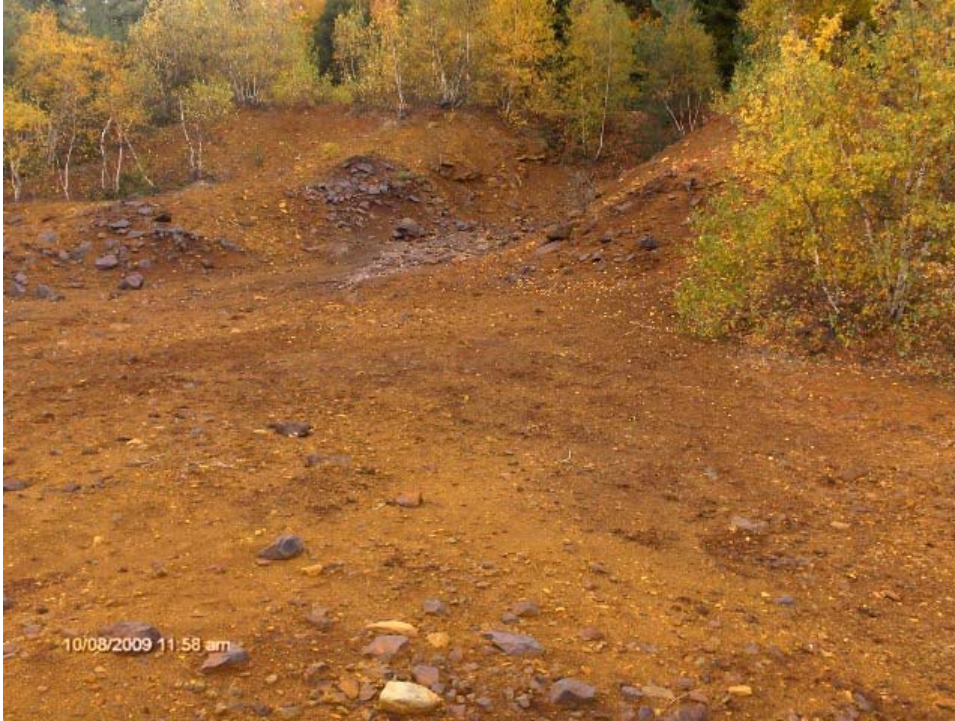
Figure 9. Photo 4 was taken from the bottom of the third pit while looking south.
