Maine Geologic Facts and Localities

Ogunquit Beach and Dunes Over Time

Text by
Stephen M. Dickson

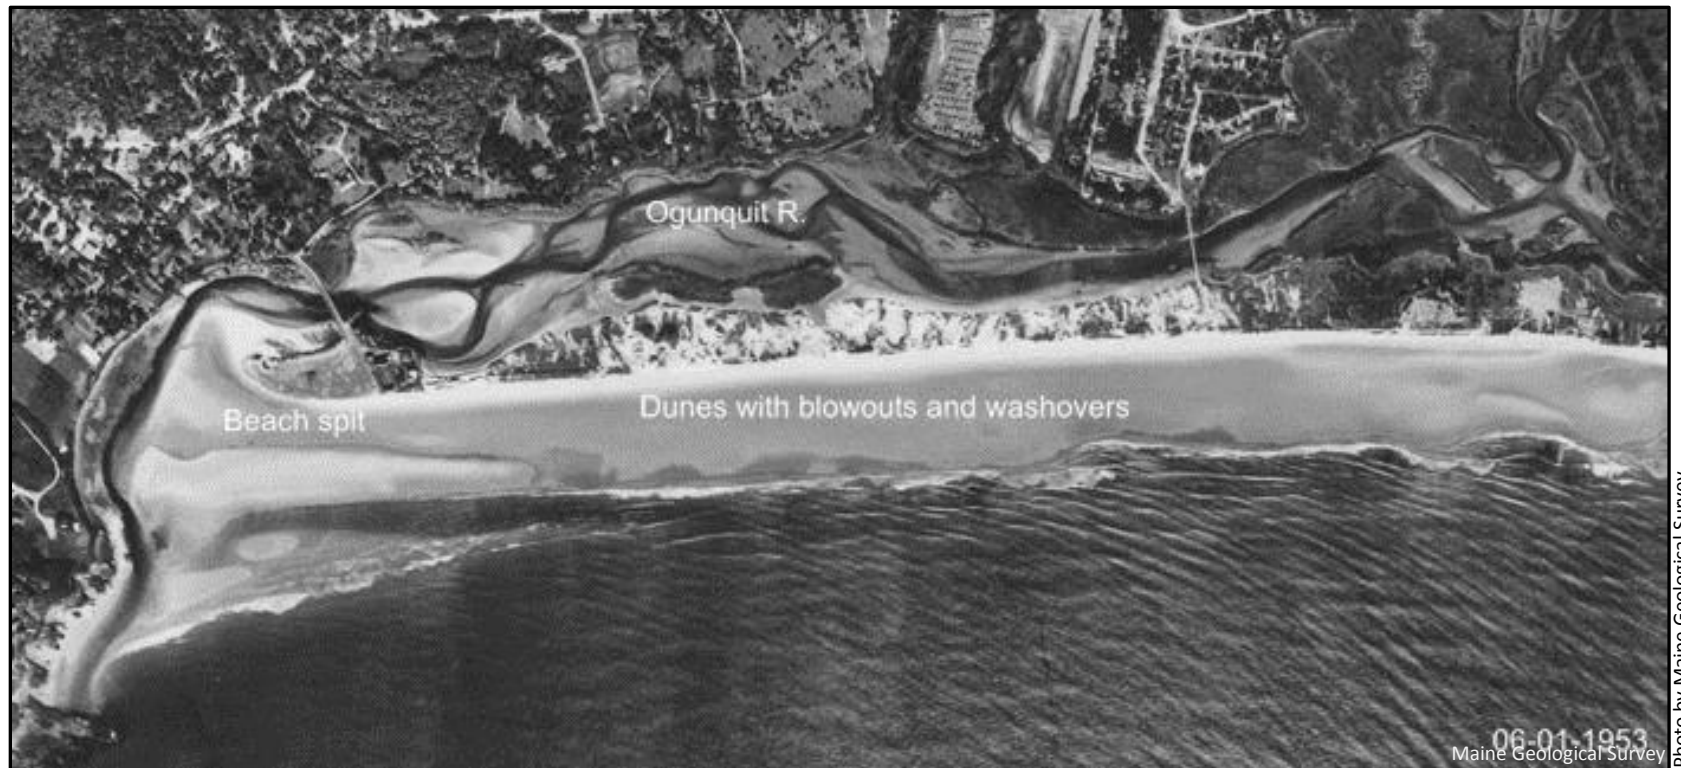
Figure 1. Aerial photograph of the dunes in 1953

In 1953 the central portion of the Ogunquit dune field was an equal mix of vegetated dunes and open sand surfaces (Figure 1). The open areas appear to be a combination of blowouts created by wind and washouts where surf and coastal flooding washed sand into the dune field. The entire beach and dune system was very dynamic and responsive to the forces of nature.

The northern segment of Ogunquit Beach (Figure 4) is the location of the Ogunquit Sewer District treatment plant. This facility was built in the back dunes. Close examination of the 1953 air photo (Figure 1) shows the alteration of the dunes in preparation for plant construction. The treatment facility once discharged into the Ogunquit River. Since 1993, the discharge has been through a pipe that is buried under the frontal dune and beach and extends offshore to an ocean outfall. Over time the plant's capacity has been expanded within the existing footprint in the dunes to accommodate a growing coastal population. The natural beach and dunes end at the Wells town line at Moody Beach.

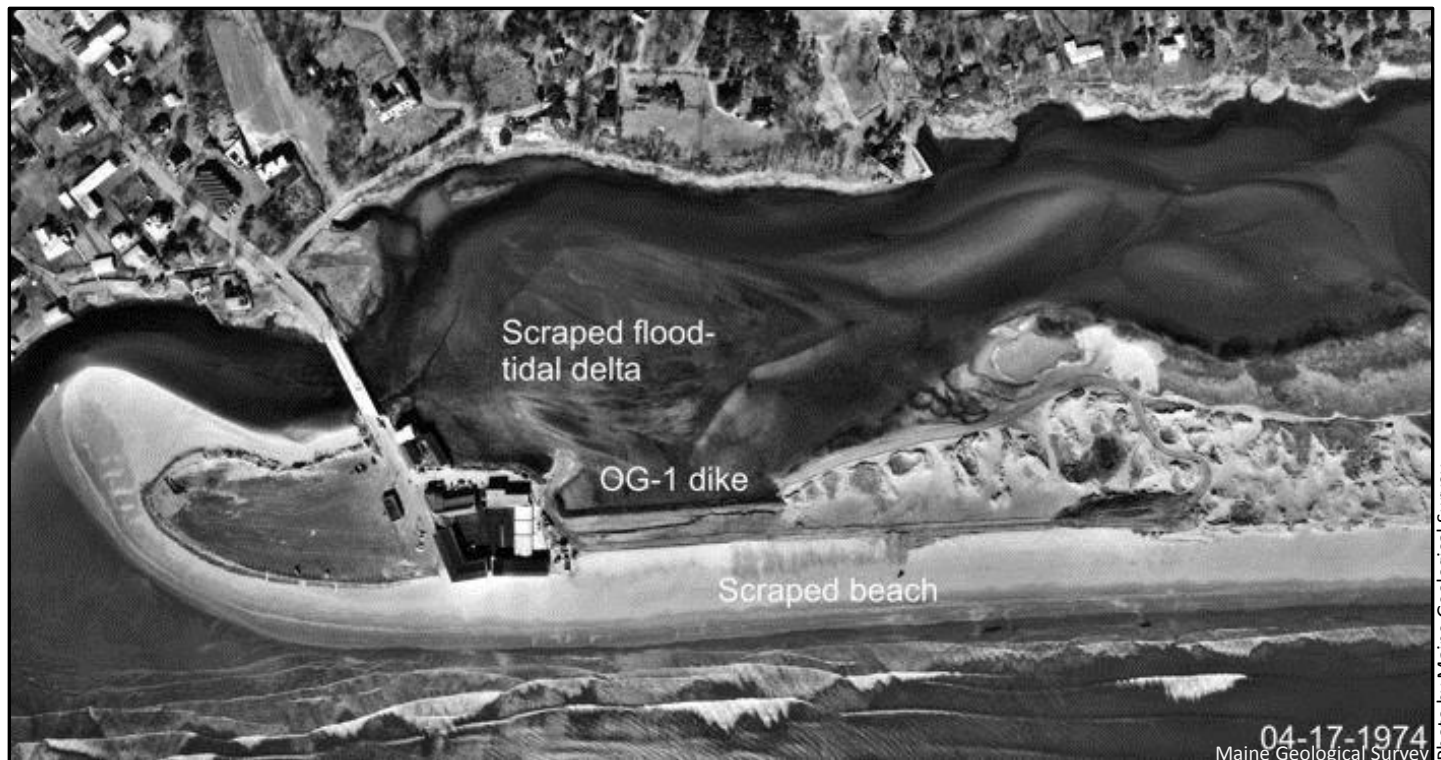
Figure 2. Aerial photograph of the dunes in 1974

In the 1970s the U.S. Department of Agriculture, Soil Conservation Service led an effort to stabilize the dunes at Ogunquit. In 1974 construction of the OG-1 dike replaced the natural dunes with a linear ridge built of sand scraped from the flood-tidal delta in the Ogunquit River and sand from the beach profile. Close examination of Figure 2 shows a bulldozer at work on the beach. A network of roads to move sand appears in the back dunes along the river. By the summer of 1974 work on OG-1 was complete.

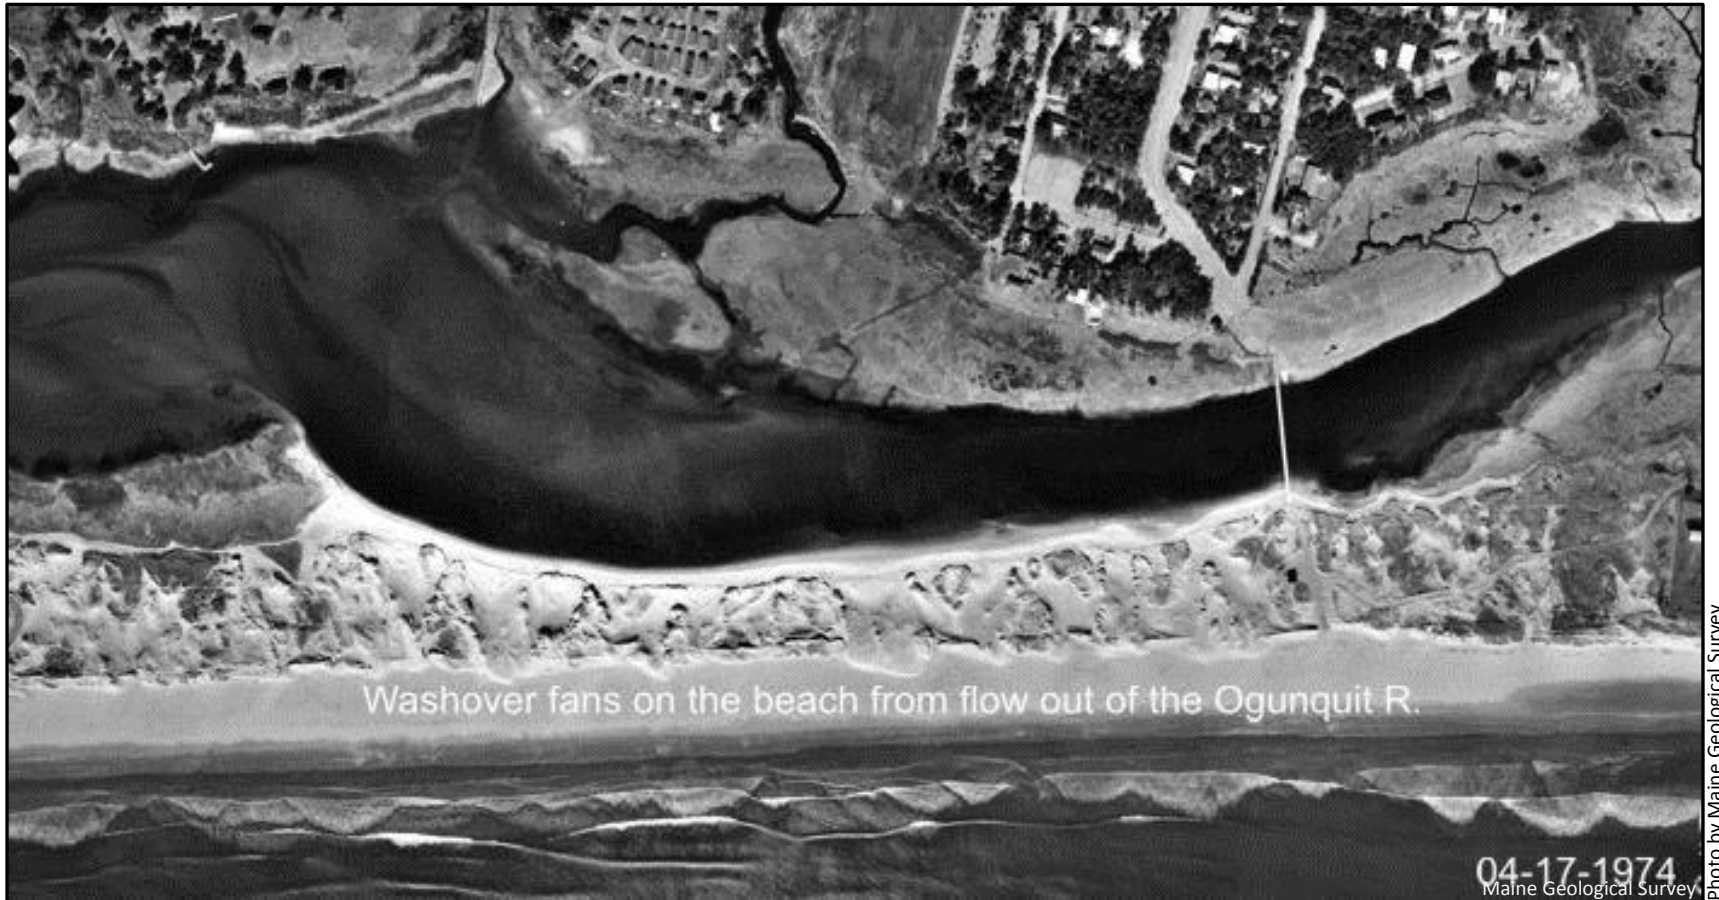
Figure 3. Aerial photograph of the dunes in 1974 showing washover fans.

The central Ogunquit dune field shows signs of sand washing onto the beach from the dunes (Figure 3).

High water levels in the Ogunquit River during a storm can cause flooding in the dunes and, as shown here, sand can be transported seaward and back to the beach. The washover fans form small delta-like aprons on the upper beach profile just seaward of the dune vegetation line. If a breach of the dunes is extensive, a new tidal inlet can form. Such occurrences are rare since waves and tides tend to seal the opening with sand from the beach soon after a storm has passed. There are historical accounts of the Ogunquit River having its tidal inlet at the northern end of the beach in 1760. By 1879 the inlet was charted to the south in the vicinity of where it is today.

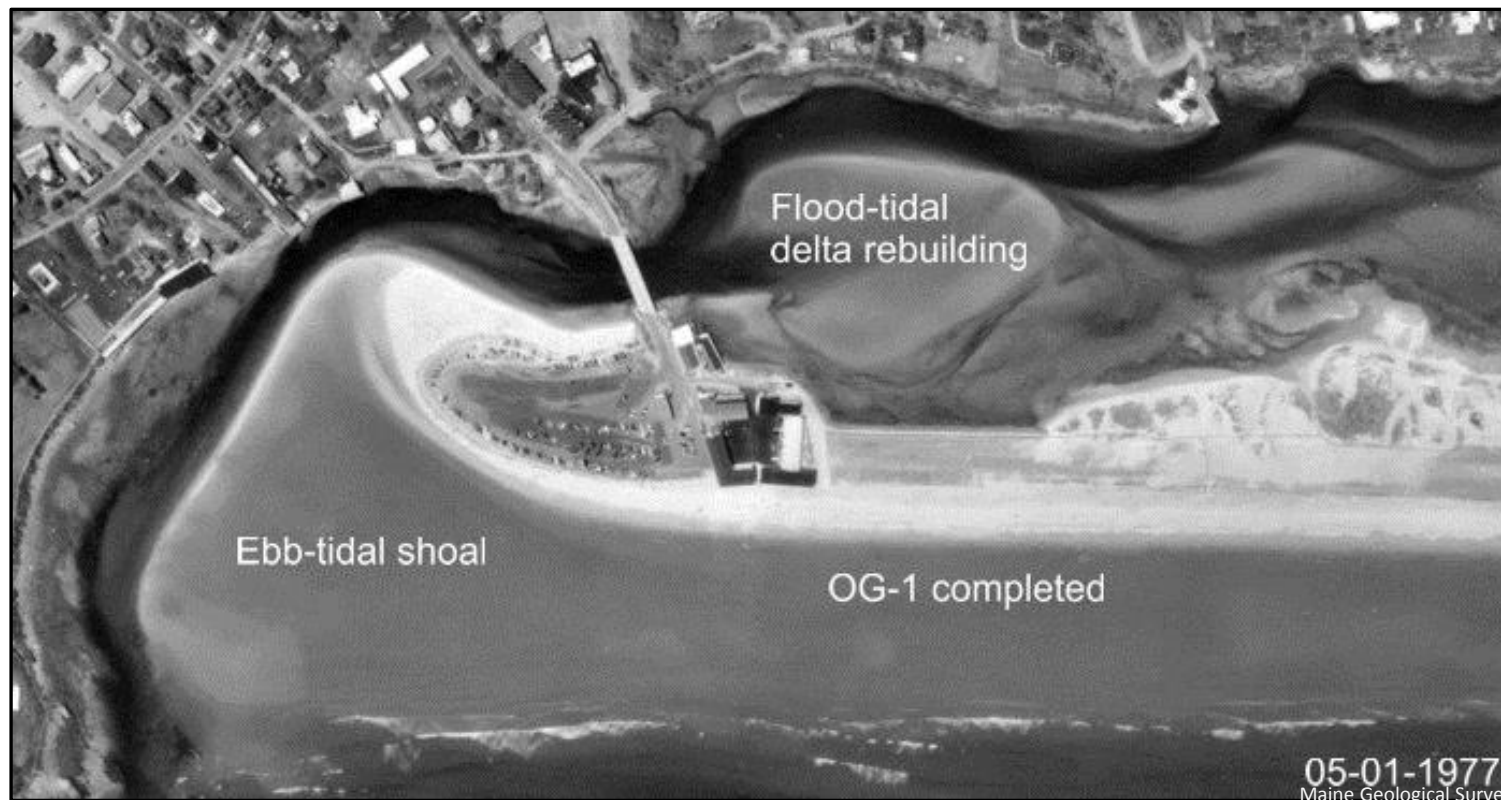
Figure 5. Aerial photograph of the dunes in 1977.

In a 1977 photo (Figure 5) the completed OG-1 dike is visible. It is a uniformly linear ridge covered with vegetation. A footpath on the Ogunquit River side of the dike can be seen. The flood-tidal delta in the river has grown in height since 1974 with sand most likely transported into the inlet from the beach and ebb-tidal delta (shoal) at the river mouth.

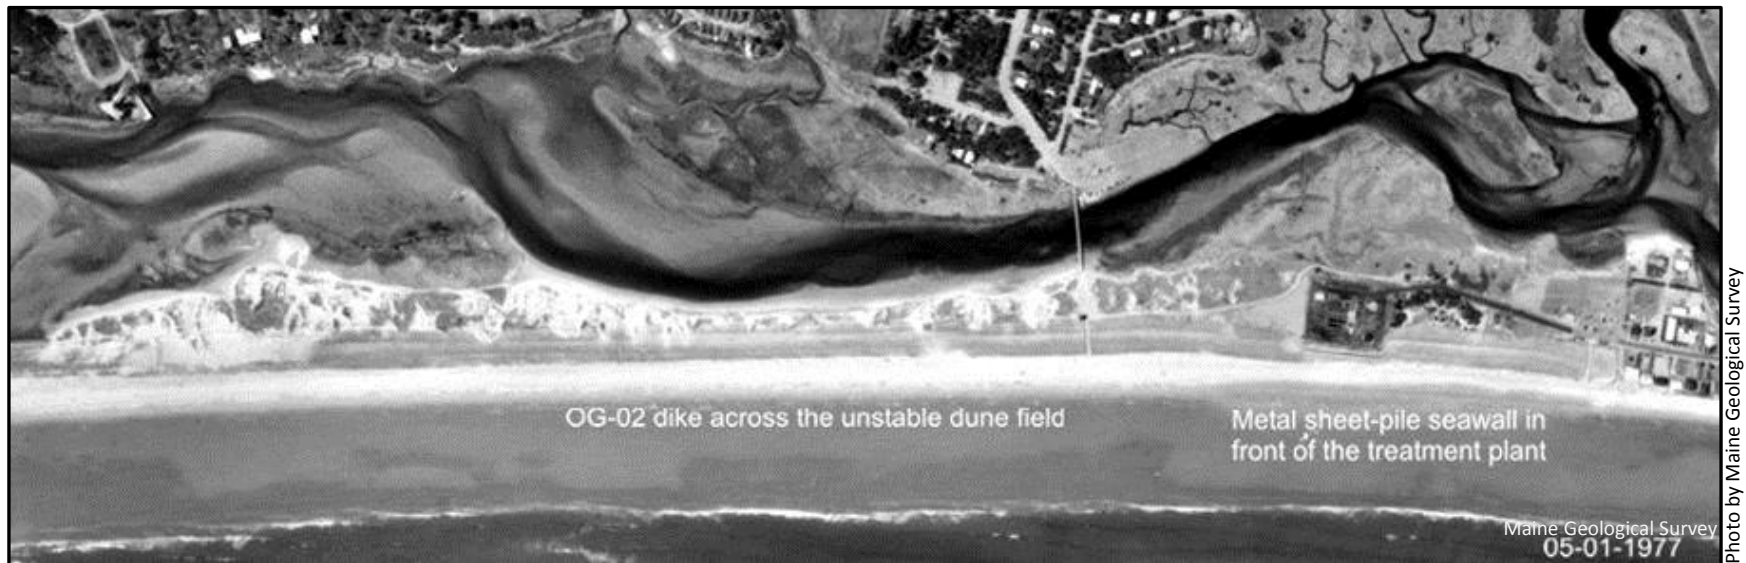
Figure 6. Aerial photograph of the dunes in 1977 showing the OG-2 dike.

The second phase of construction in the dunes at Ogunquit was the much longer OG-2 dike. This linear ridge was built with a core of glacial gravel brought in from an upland gravel pit between December 1974 and March 1975 (Figure 6). The ridge is also higher than the previous frontal dune ridge crest and higher than waves can run up in a 100-year storm. The ridge is a strong and rigid barrier to breaching in storms from both the ocean and river, but it also impedes the natural movement of sand that once existed between the frontal dune and back dunes. To protect the Ogunquit sewer treatment plant from extreme erosion events, a metal sheet-pile wall was driven into the frontal dune seaward of the plant. This engineering structure has remained buried in the frontal dune over the years because the beach has not been eroding significantly.

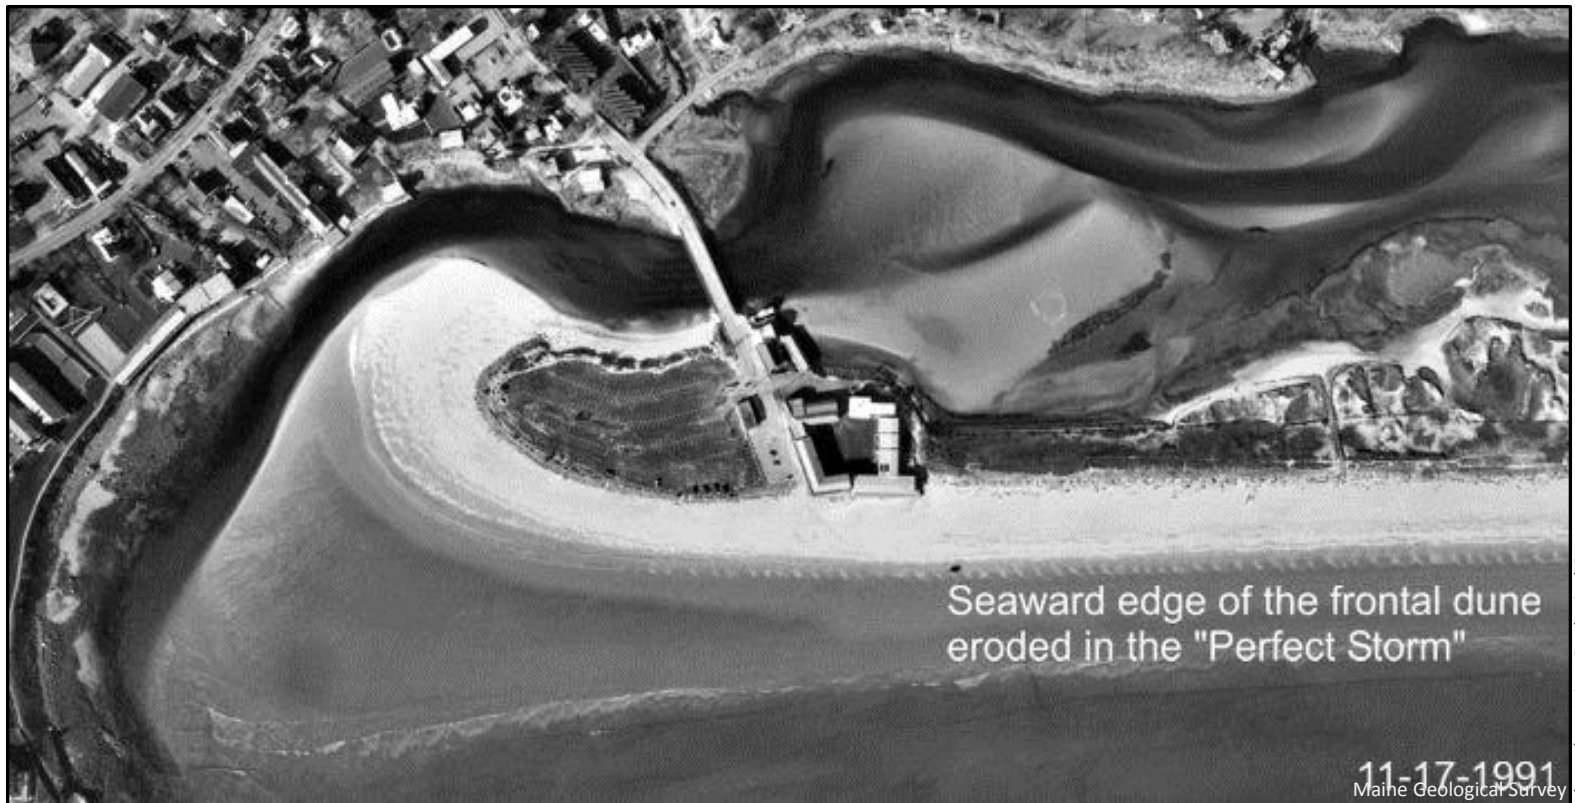
Figure 7. Aerial photograph of the dunes in 1991 after the Perfect Storm.

In Figure 7 and Figure 8 the ragged edge of the frontal dune can be seen 18 days after the Perfect Storm. It appears that there was very little overwash or flooding over the top of the OG-1 or OG-2 dikes. Large blocks of dune vegetation are visible on the beach profile. Erosion did not reach the seawall at the sewer treatment plant (Figure 8).

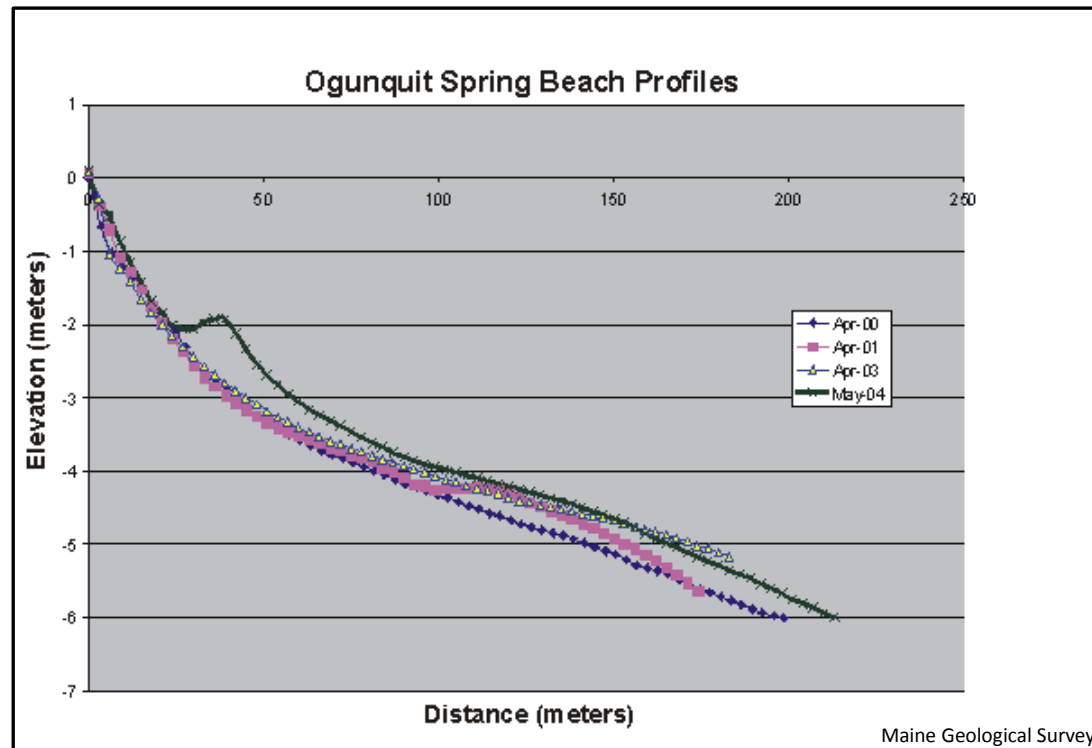
Figure 10. Comparison of spring beach profiles at the Ogunquit 2 station from April 2000 to May 2004.

The graph in Figure 10 illustrates how stable the Ogunquit Beach profile has been between 2000 and 2004. This graph shows the profile at the end of each winter storm season and before much of the summer sand has moved ashore from deeper water. The exception to this is in the May 2004 profile which already shows the additional vertical accumulation of sand in the form of a berm or relatively flat and dry part of the beach that is ideal for sunbathing.

The results shown here are good news. The beach and dune do not show signs of eroding over this four-year period of time. Perhaps of more importance to most people, sand comes back ashore in time for summer recreation.
