Maine Geologic Facts and Localities

August, 2009

Dune Recovery at Ferry Beach, Saco: A Helping Hand

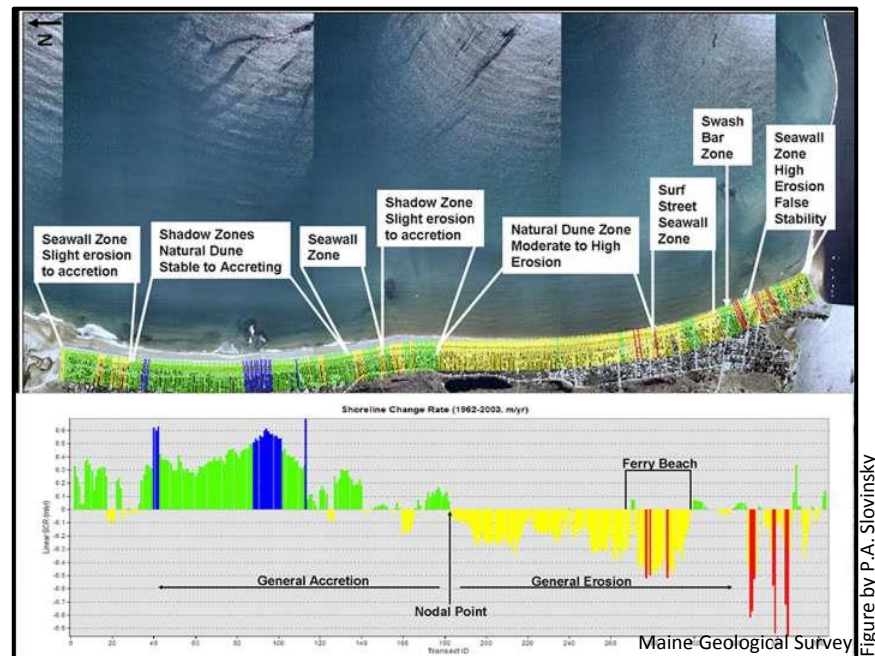
Figure 1. Historic shoreline changes along Saco beaches. Note the nodal point where the pattern changes from erosion to accretion. Ferry Beach is located between transects 275-300.

The Maine Geological Survey has documented historic shoreline changes along the Saco shoreline using historical aerial photographs from the late 1970s through 2003 (Figure 1). Based on this data, the shoreline changes along the Saco Beaches reflect a general lack (and loss) of sand at the southern end of the beach, with a point where patterns of erosion turn to accretion (i.e., nodal point) occurring approximately 6,000 feet north of the jetty where the shoreline movement reflects a more stable to growing shoreline at the northern end of the beach.

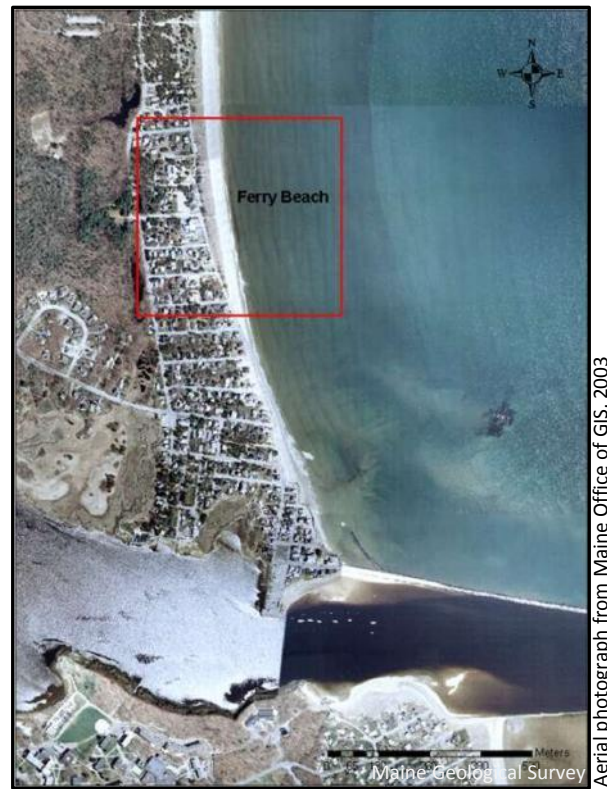
Figure 2. Location of Ferry Beach just north of the northern end of the seawalls that front Surf Street.

Over the past few years, we have specifically been concerned about erosion of the natural dune system located just north of the northern end of the seawalls that front Surf Street in the vicinity of Ferry Beach (Figure 2). This area of Saco has seen continual damage to Surf Street, especially during winter months, and subsequent dune erosion. A large section of Surf Street was damaged in the Patriots' Day Storm of 2007, and several homes were destroyed.

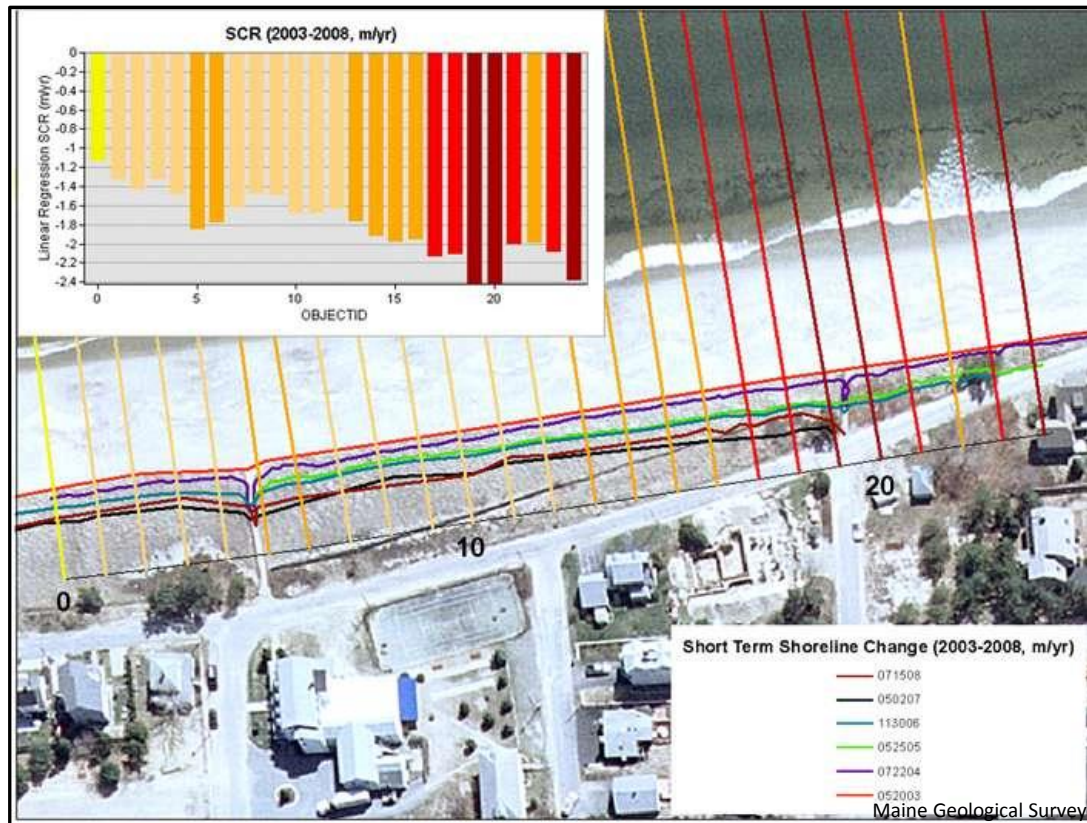
Figure 3. Short-term shoreline change rate (SCR) calculated using GPS measurements of the seaward edge of dune vegetation along Ferry Beach from May of 2003 through July of 2008.

Since 2003, we have conducted GPS surveys of the natural shoreline within a portion of this area. From 2003-2008, the seaward edge of the natural dunes has retreated dramatically (Figure 3), between 1 and 2 m/yr of dune loss - which represents up to almost 40 feet of dune loss over the 5 year period!

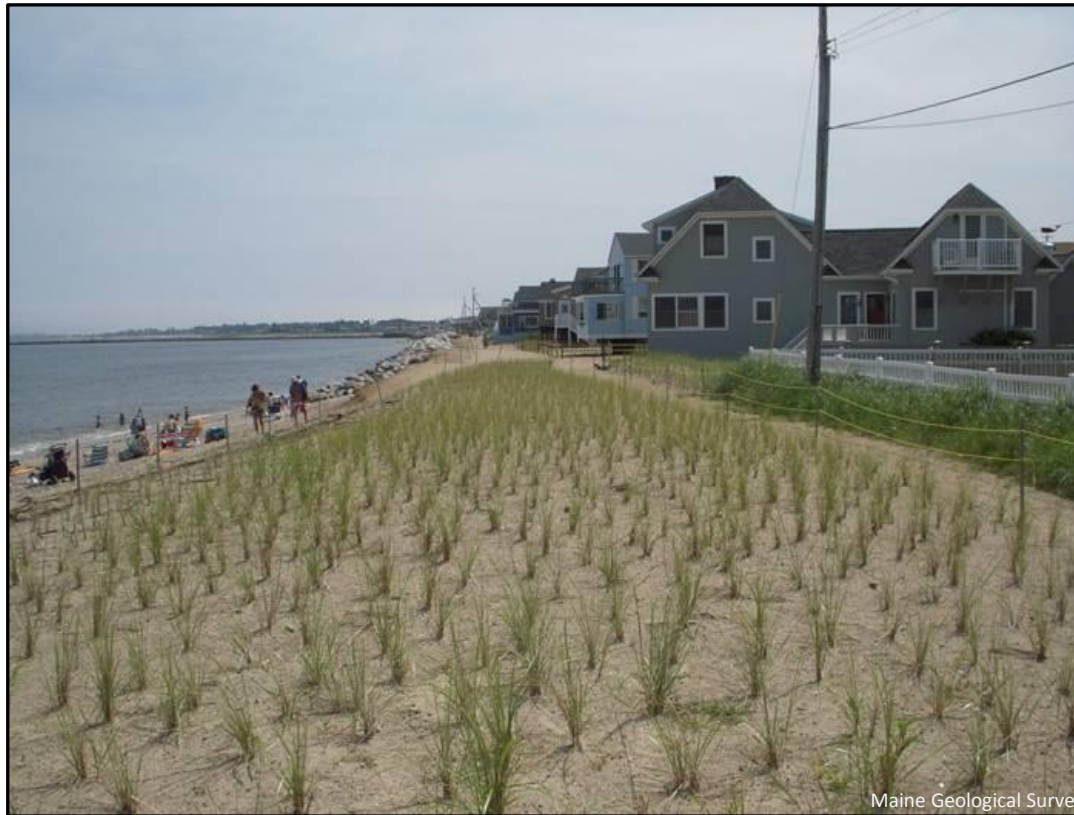
Figure 4. View south of geotube within Surf Street planted with dune grass.

In response to the significant damage to Surf Street during the Patriots' Day Storm of 2007, the City of Saco received a permit to bury a ProTec Tube (sand-filled geotextile tube) in the sand within the existing footprint of Surf Street and reestablish dune grass along a portion of the beach in front of Surf Street to aid in protection of landward property during future storms.

Photographs taken in July, 2009 show how the tube has been successfully planted with dune grass (Figure 4 and Figure 5).

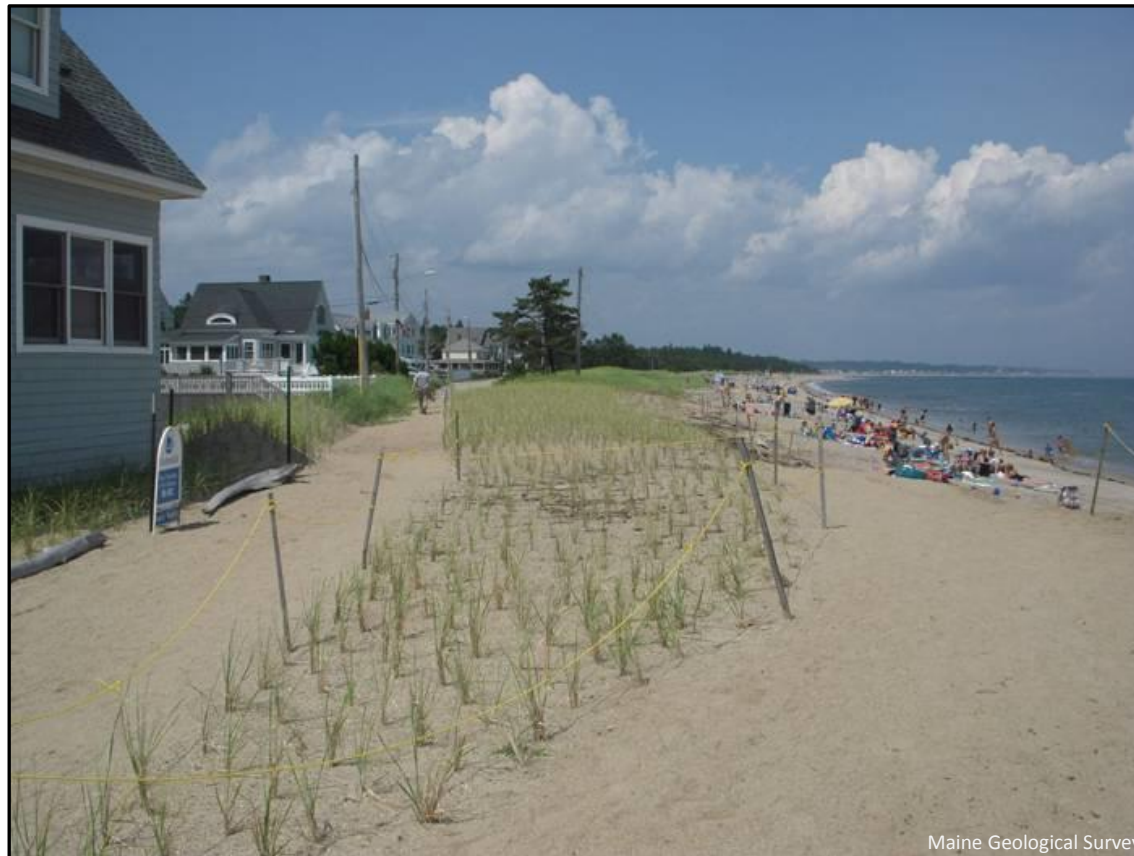
Figure 5. View north of geotube and dune grass plantings. The Ferry Beach Park Association's artificial dune construction begins at the tree and extends northwards (Figure 7).

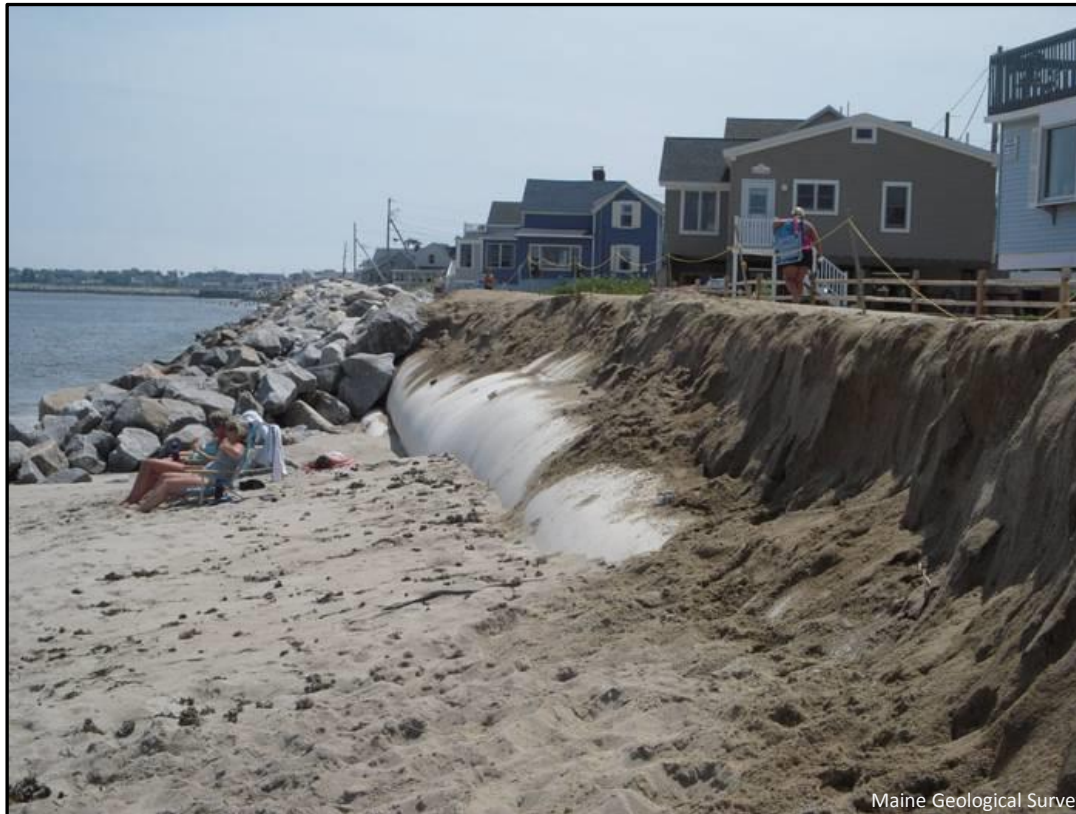
Figure 6. Undermining of the geotube remains a problem due to the combined effects of storm events and increased ("end effect") erosion at the northern end of the seawall.

As a condition of the issued permit, the geotube must be covered with sediment at all times; however, undermining of the tube remains a problem due to the combined effects of storm events and accelerated erosion at the northern end of the seawall (Figure 6).

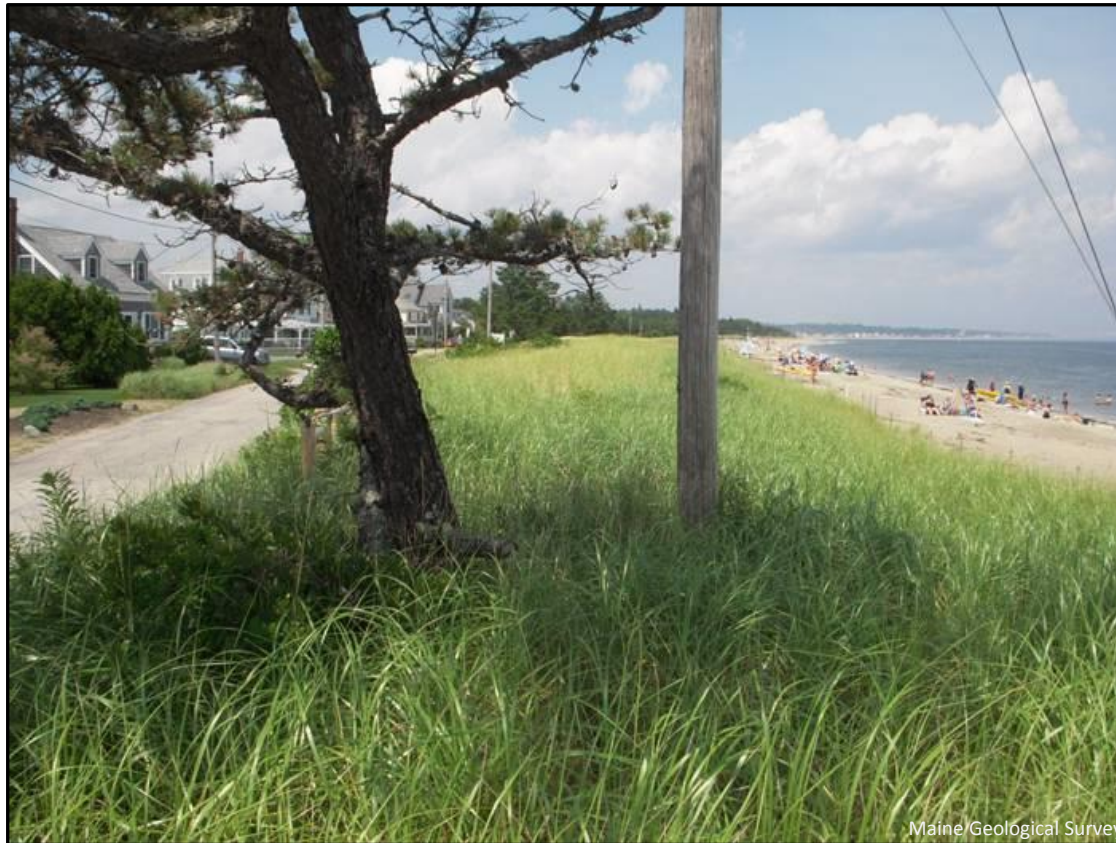
Figure 7. View north of secondary dune ridge constructed just north of the geotube project.

In addition, the Ferry Beach Park Association received a permit to enhance the existing contiguous dune north of the geotube project by constructing a secondary artificial dune ridge and planting it with native dune species (i.e., American beach grass) (Figure 7).

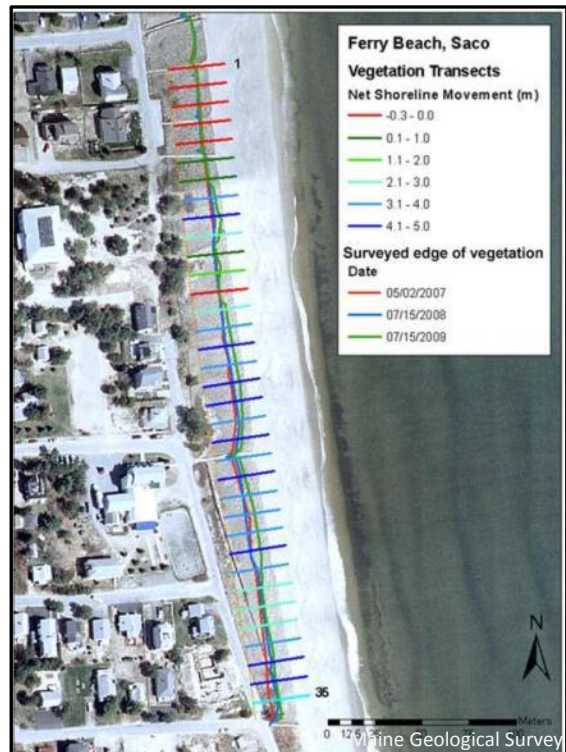
Figure 8. Net shoreline movement, in meters, for transects 1-35 (north to south) calculated from measurements of the edge of dune vegetation along Ferry Beach since the Patriots' Day Storm position in 2007 through July of 2009. See Figure 9 for a graph showing net shoreline movement at each transect.

Largely as a result of these dune management practices, the seaward edge of the dune along Ferry Beach has extended seaward since the post-Patriots' Day Storm position in 2007 through July of 2009. MGS compared the position of the seaward edge of the dune in 2007, 2008, and 2009, and determined that the net shoreline movement was up to almost 5 meters (Figure 8 and Figure 9).

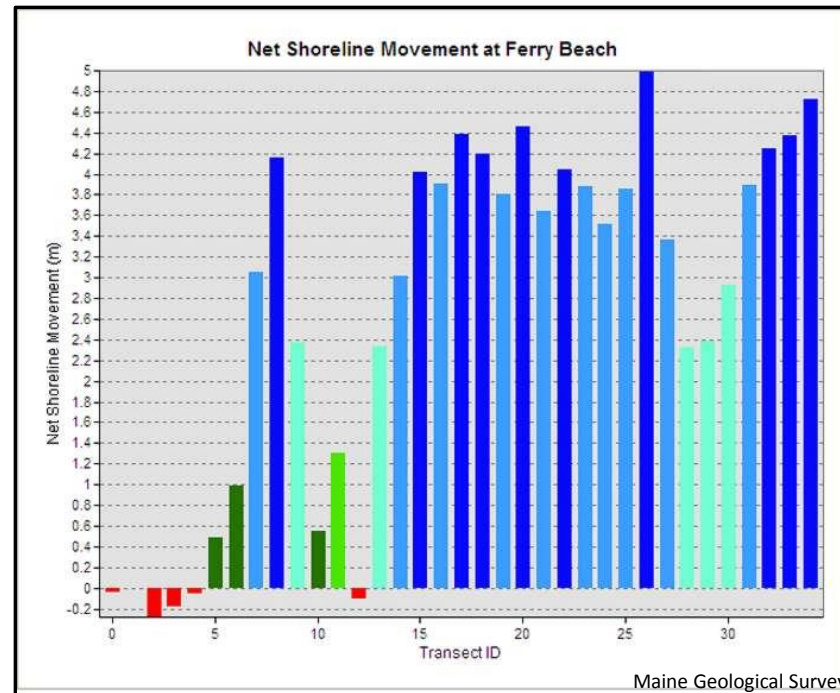
Figure 9. Graph showing net shoreline movement (of edge of dune vegetation) at each transect shown in Figure 8 along Ferry Beach since the Patriots' Day Storm in 2007 through July of 2009. This positive trend reflects dune management - including restoration and plantings - by the Ferry Beach Park Association.

North of these dune management projects, the shoreline has not extended seaward, but has remained in the same location with no further erosion. This data suggests a successful dune management strategy thus far. The artificially constructed dune north of the geotube has performed admirably, and represents a dramatic shift in the overall shoreline changes observed since 2003. We will be closely monitoring the fate of the dune over the coming winter months.
