Maine Geologic Facts and Localities

Coastal Storm Impacts – Winter 2018 at Pine Point, Saco and Western Beaches in Southern Maine

Text by

Peter A. Slovinsky

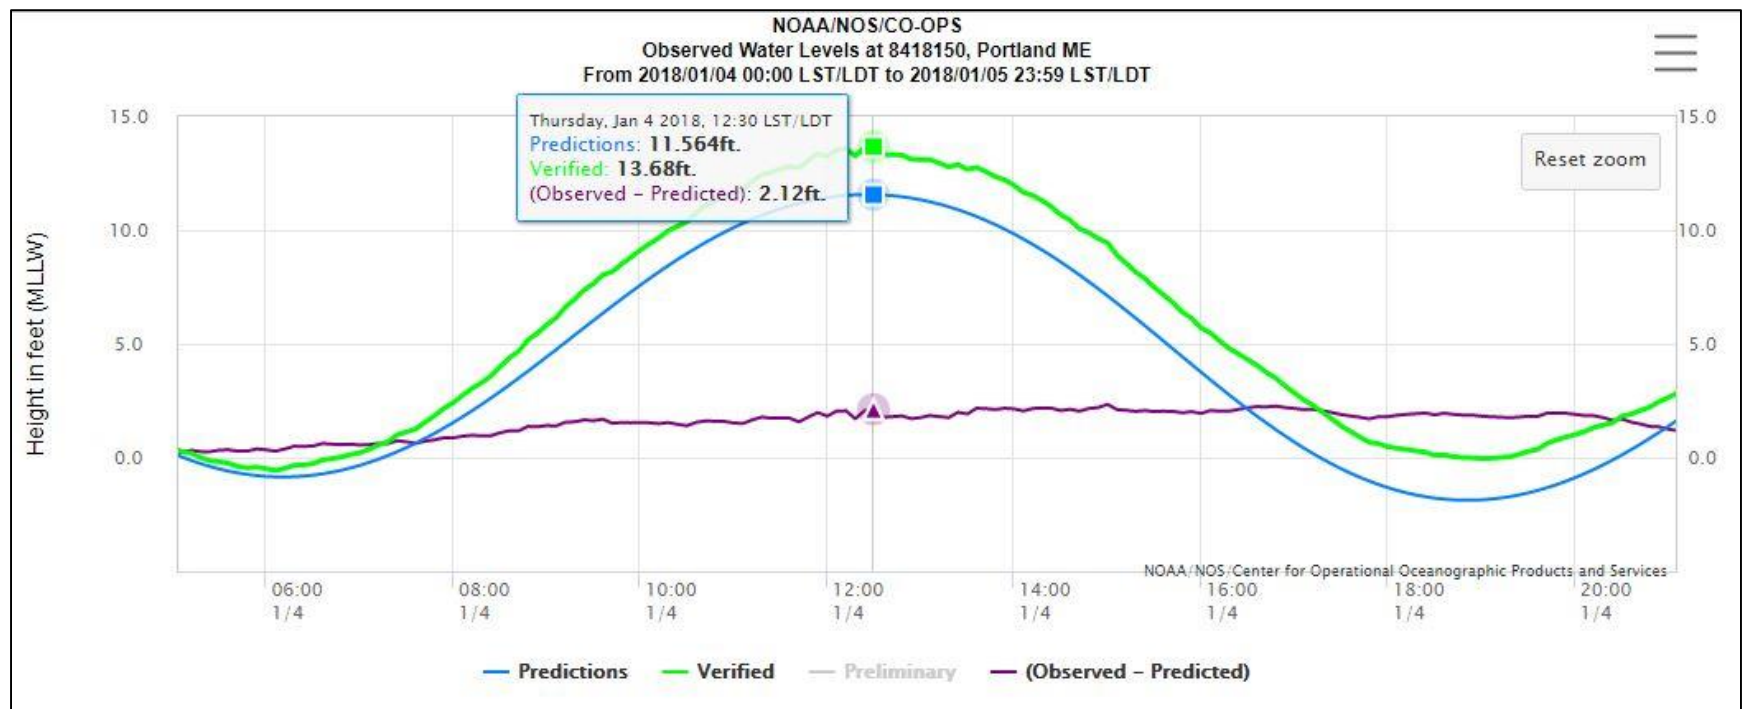
Figure 1. Verified water level at Portland, ME on 1/4/2018. Data courtesy of NOAA CO-OPs.

The winter of 2018 featured numerous storms which resulted in inundation and erosion of the Maine coastline, especially along its sandy beaches. 2018 began with a very strong ocean storm, Winter Storm Grayson, which coincided with high tides on 1/4/2018. At the peak water level, predicted tides were 11.56 feet, with 2.12 feet of surge. Verified water levels from the Portland, ME tide gauge showed that this event resulted in the third highest water level (13.68 feet MLLW) recorded in Portland, Maine since 1912 (Figure 1).

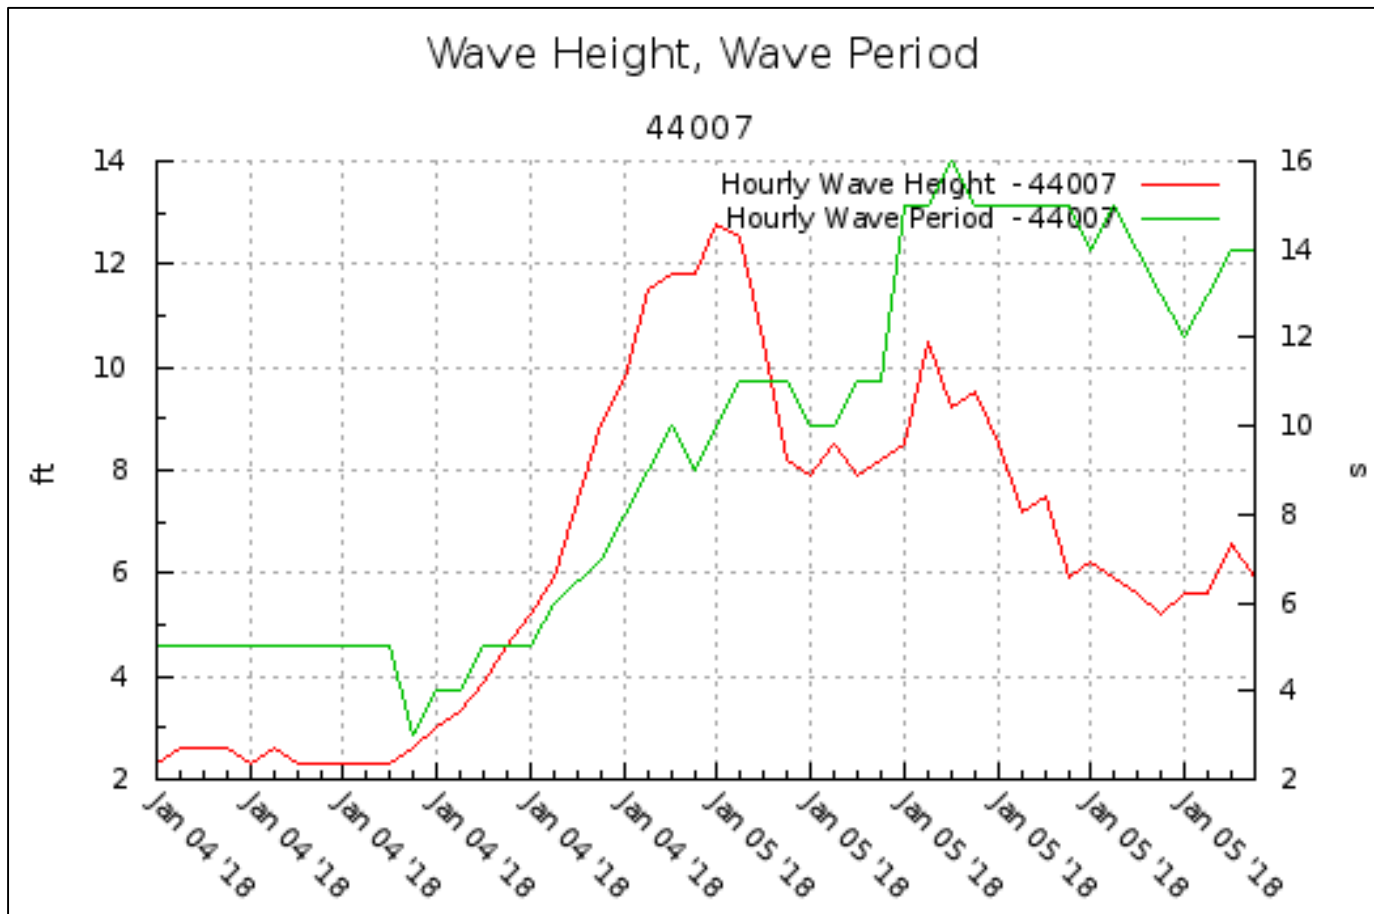
Figure 2. Significant wave height in feet (red line) and average hourly wave period in seconds (green line) at NOAA Buoy 44007 from January 4-5, 2018. Data courtesy of NERACOOS.

This extremely high water, coupled with waves that exceeded 10 feet with periods of 14 seconds (Figure 2), resulted in **extensive coastal erosion and flooding along many coastal Maine communities.**

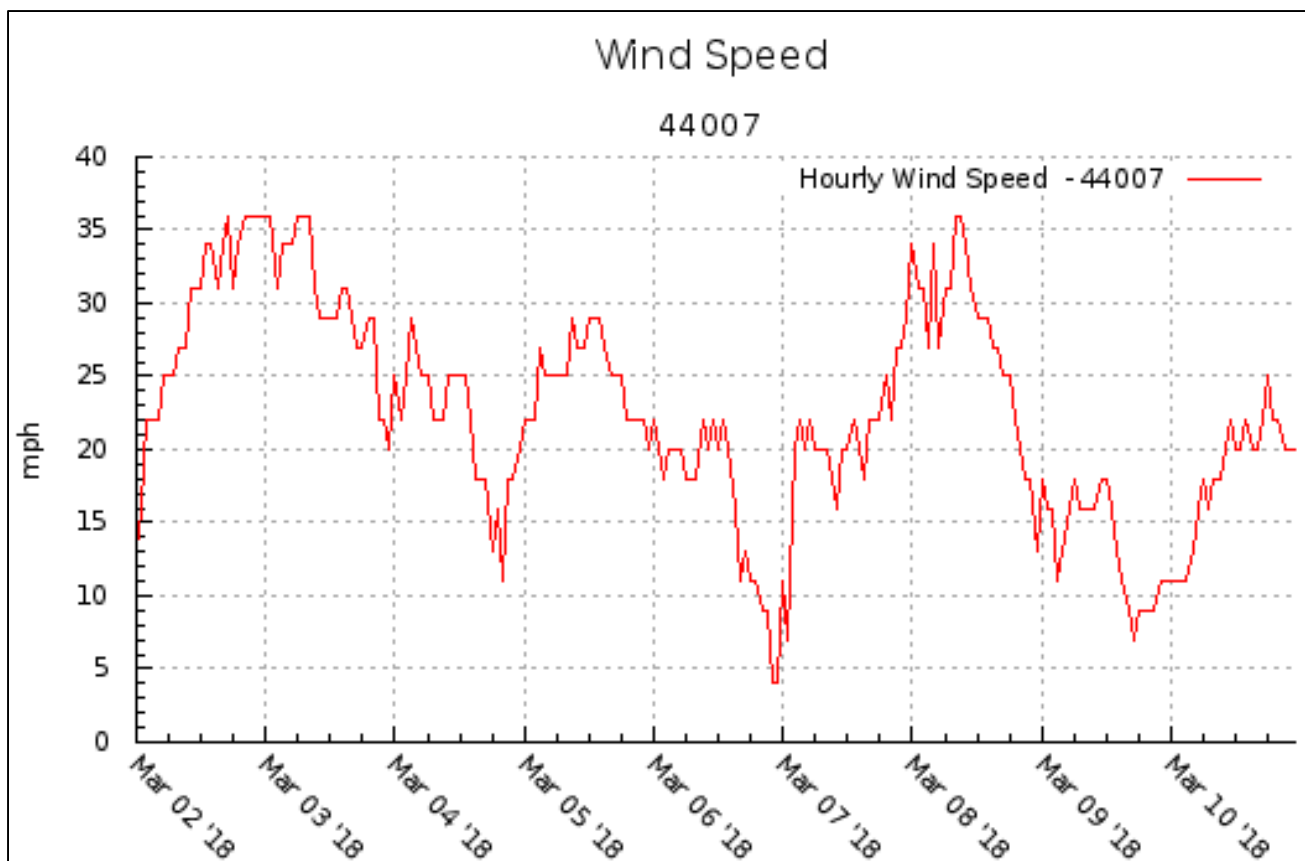
Figure 3. Hourly wind speeds at NOAA buoy 44007 from March 2-10, 2018. Data courtesy of NERACOOS.

Although a few additional storm events occurred in January and February, it was the “bomb” nor’easter of early March which resulted in significant coastal flooding and erosion, and made the beaches in Maine vulnerable to subsequent events. This long-duration storm event included strong, sustained northeast winds over 15 mph from 3/2/2018 to 3/10/2018, with sustained wind speeds reaching close to 40 mph (Figure 3).

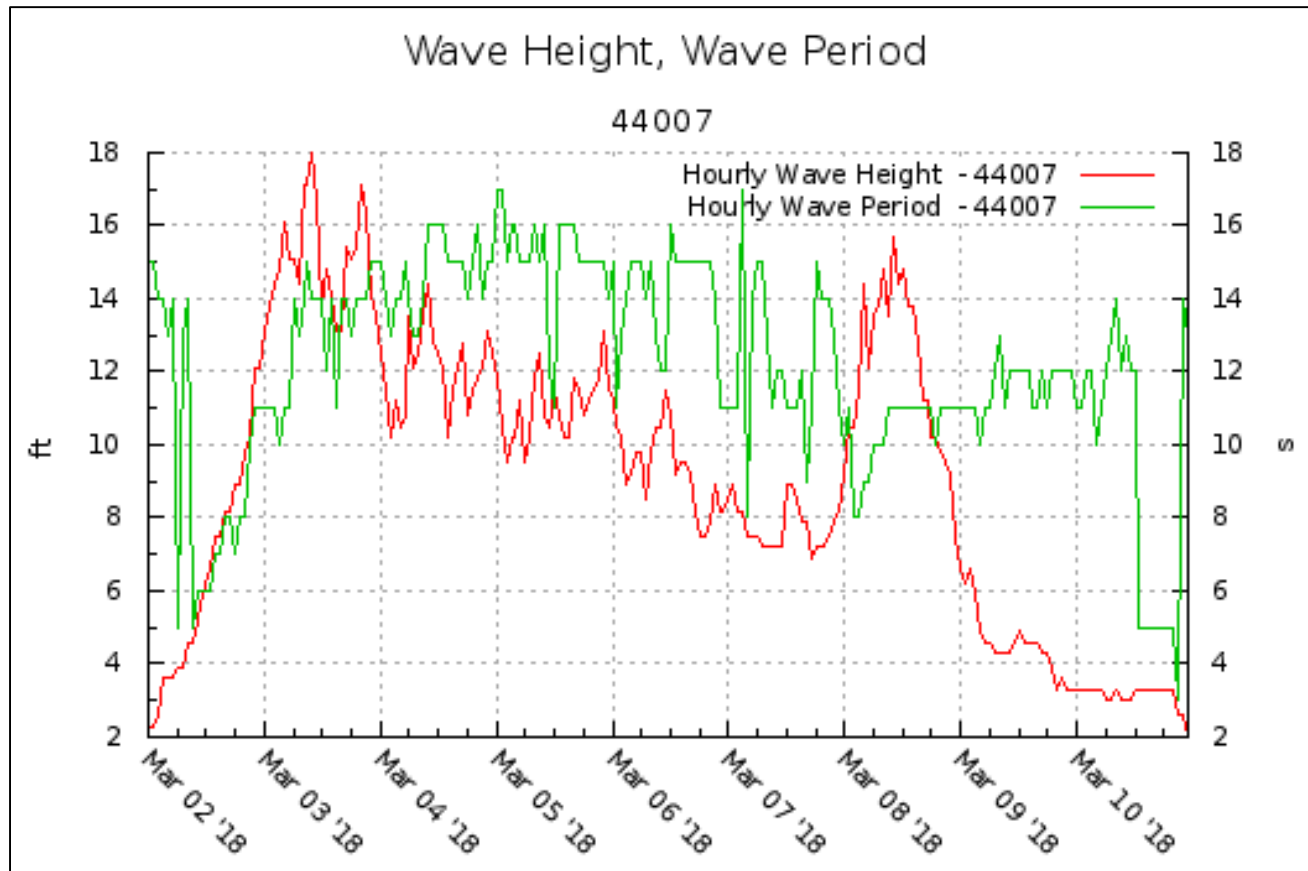
Figure 4. Significant wave height in feet (red line) and average hourly wave period in seconds (green line) at NOAA Buoy 44007 from March 2-10, 2018. Data courtesy of NERACOOS.

This period of sustained winds resulted in very large, battering waves which exceeded 10 feet with average periods between 14 to 16 seconds for a large portion of this time period (Figure 4).

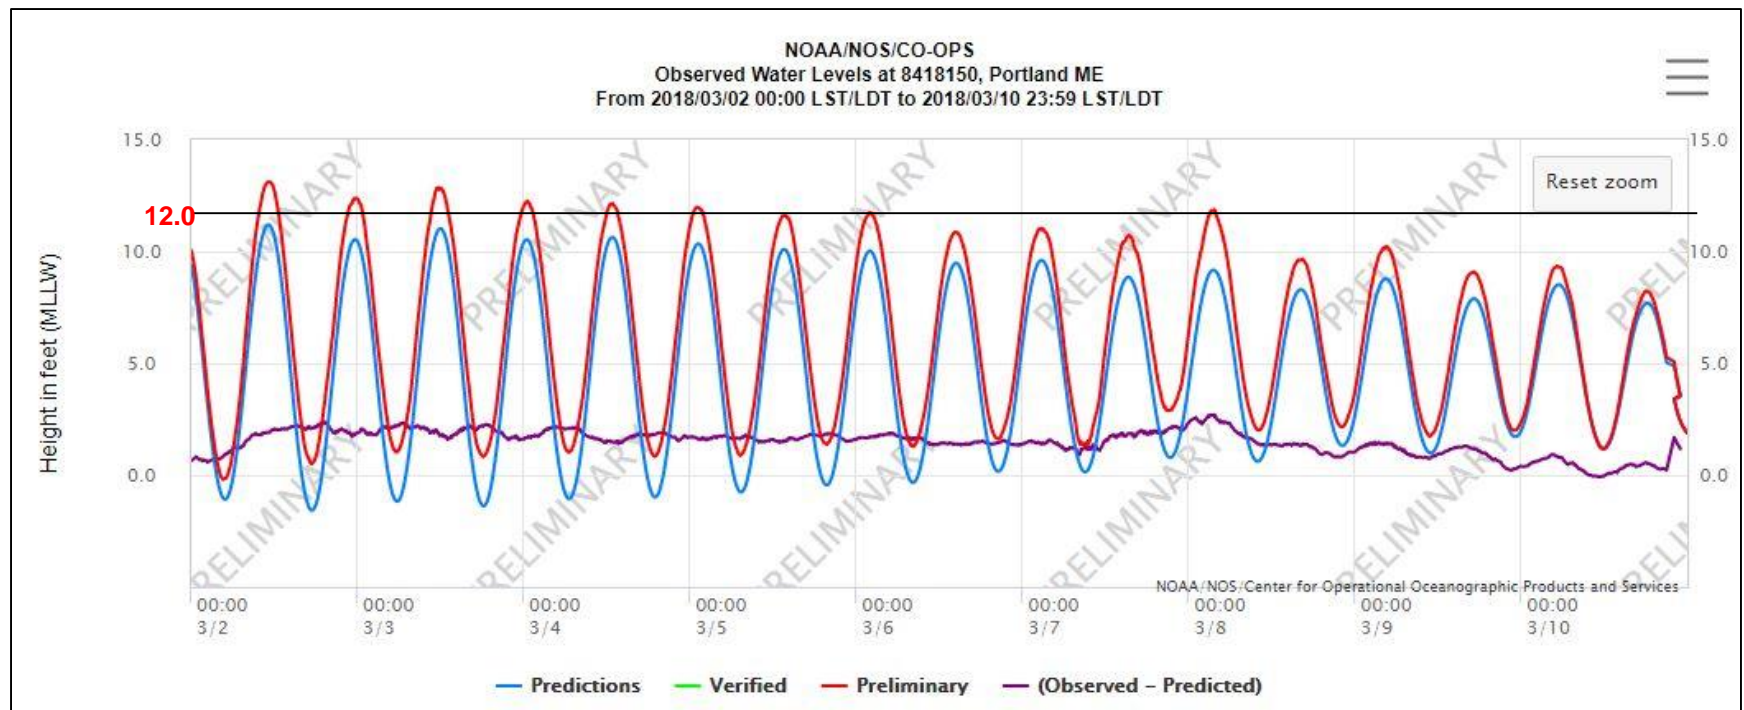
Figure 5. Preliminary water level at Portland, ME between March 2-10, 2018. Data courtesy of NOAA CO-OPs.

The combination of sustained winds and large waves resulted in water levels at Portland, ME that exceeded flood stage (12 feet MLLW) for 9 high tides from March 2 through March 10 (Figure 5). These sustained high water levels and waves and winds led to dramatic coastal erosion of the sandy beaches and dunes along southern Maine, making them more vulnerable to subsequent events. This event was followed by more nor'easters on March 12-14, March 20-22, and March 27-29. These events were more short lived and more typical of the “normal” nor’easter, but they continued to erode southern Maine beaches.

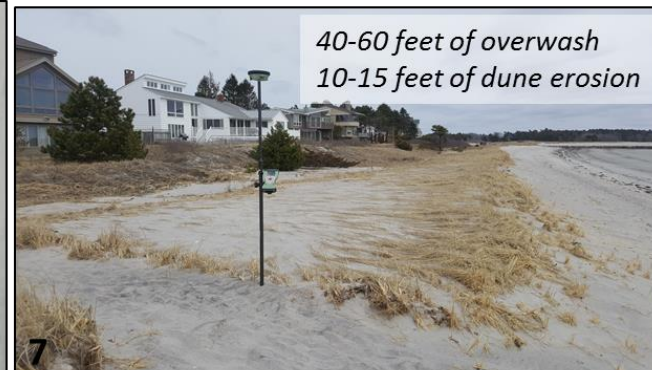
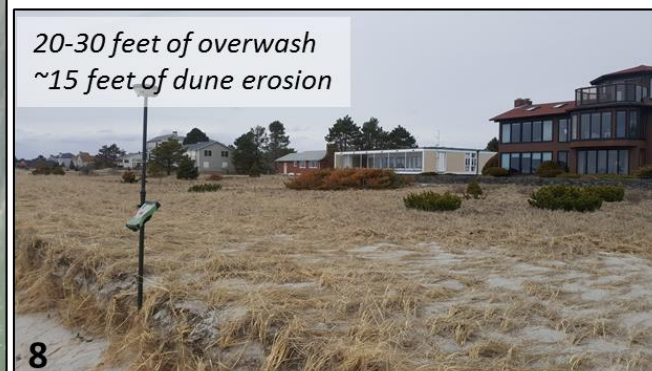
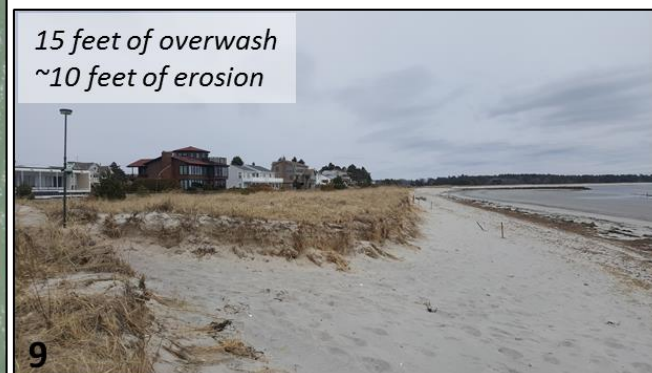
Winter 2018 Shoreline Changes at Pine Point Beach, Scarborough, Maine

Notes: Overwash and dune erosion just north of Hurd Park was minimal.

At Hurd Park, the dune paths allowed for overwash to penetrate up the paths and into the paved parking lot around 60-70 feet.

Just south of Hurd Park, overwash reached about 10-20 feet, and dune erosion was consistent at 5-10 feet.

Note that dune erosion was consistently slightly higher at access paths.

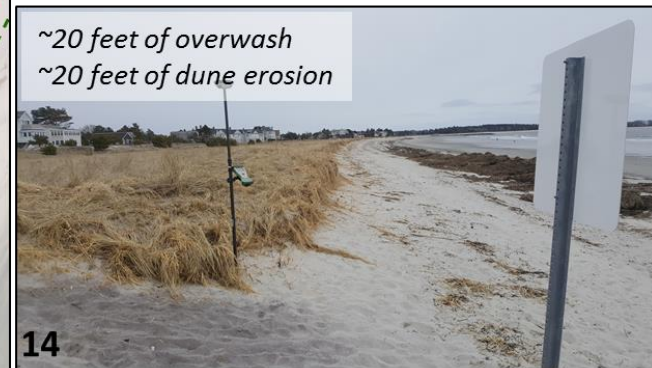
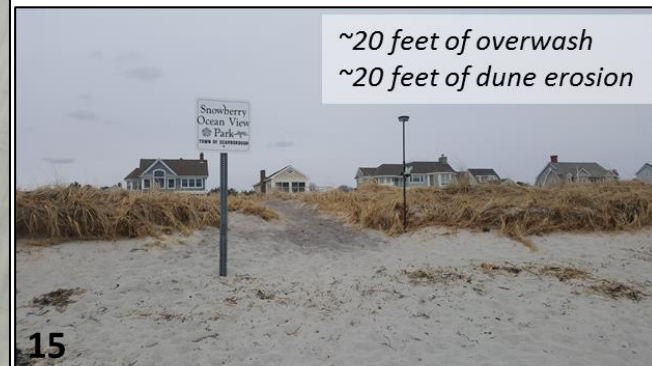
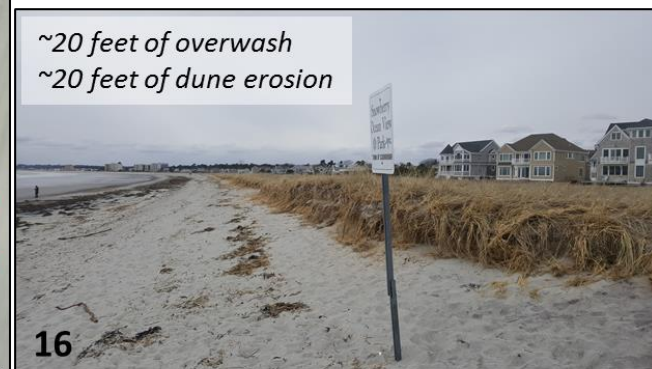
Winter 2018 Shoreline Changes at Pine Point Beach, Scarborough, Maine

Notes: From Oak Street to near Claudia Way, overwash averaged around 20 feet, with pockets up to 40 feet.

Dune erosion was relatively consistent around 15 feet.

Note that dune erosion was slightly higher at access paths.

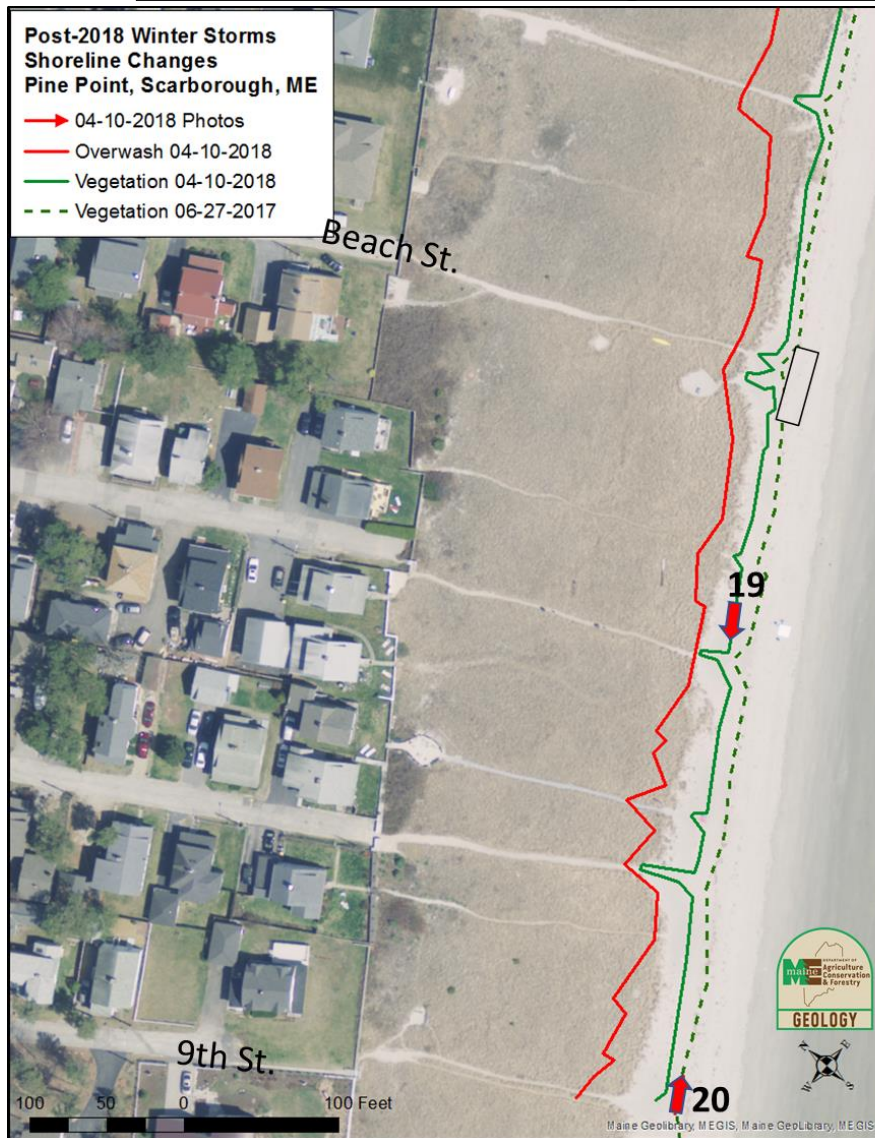
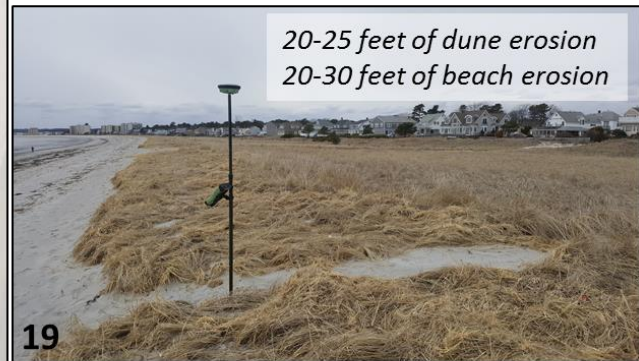
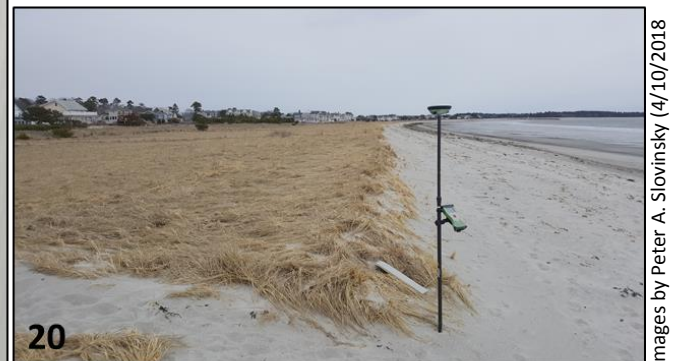
Notes: Between 9th St. and Beach St., overwash was about 15-20 feet, with pockets up to 50 feet.

Dune erosion was relatively consistent at around 10-15 feet.

Note that dune erosion was slightly higher at access paths.

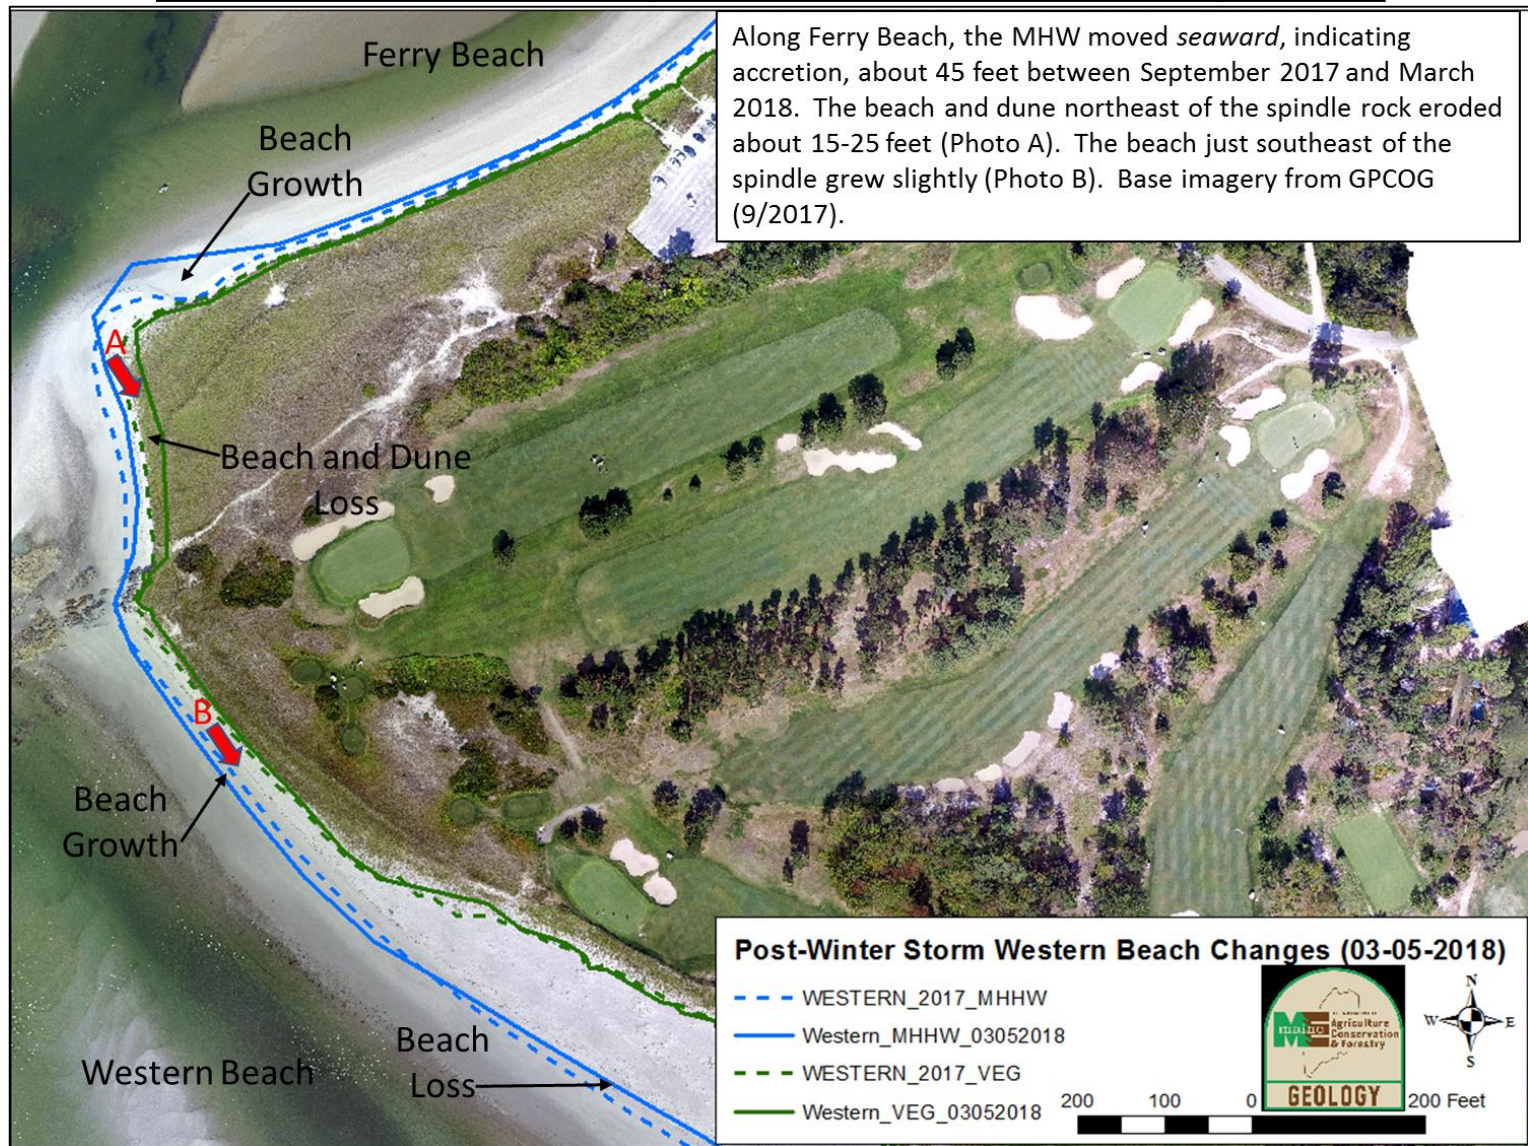
Winter 2018 Shoreline Changes at Western Beach, Scarborough, Maine

The **June 14, 2017 edge of dune** is shown as a **dashed (- - -) green** line.

The **June 14, 2017 Mean High Water** is shown as a **dashed (- - -) blue** line.

The **March 5, 2018 edge of dune** is shown as a **solid (—)green** line.

The **March 5, 2018 MHW** is shown as a **solid (—) blue** line.

For each section of beach shown, red arrows (➡) indicate the locations and directions of photographs taken of the different shoreline erosion features. These photographs are shown on the right side of the pages.

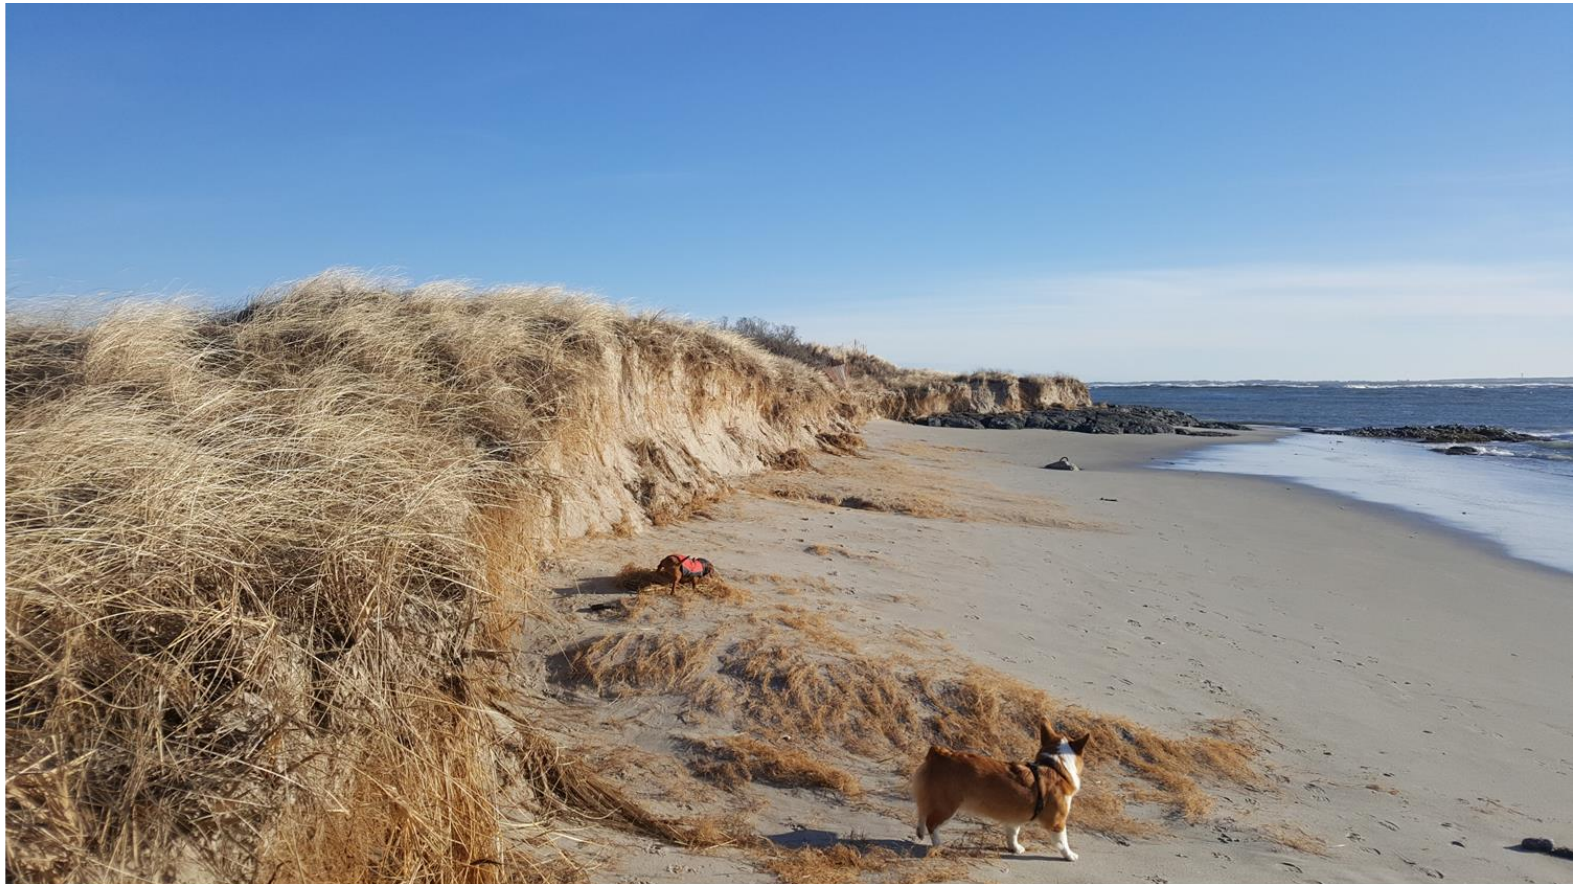
Photo A. Looking south at dune and beach erosion along Ferry Beach. The dune here eroded approximately 15 feet since summer 2017. Image by P.A. Slovinsky, MGS, 3/5/2018.

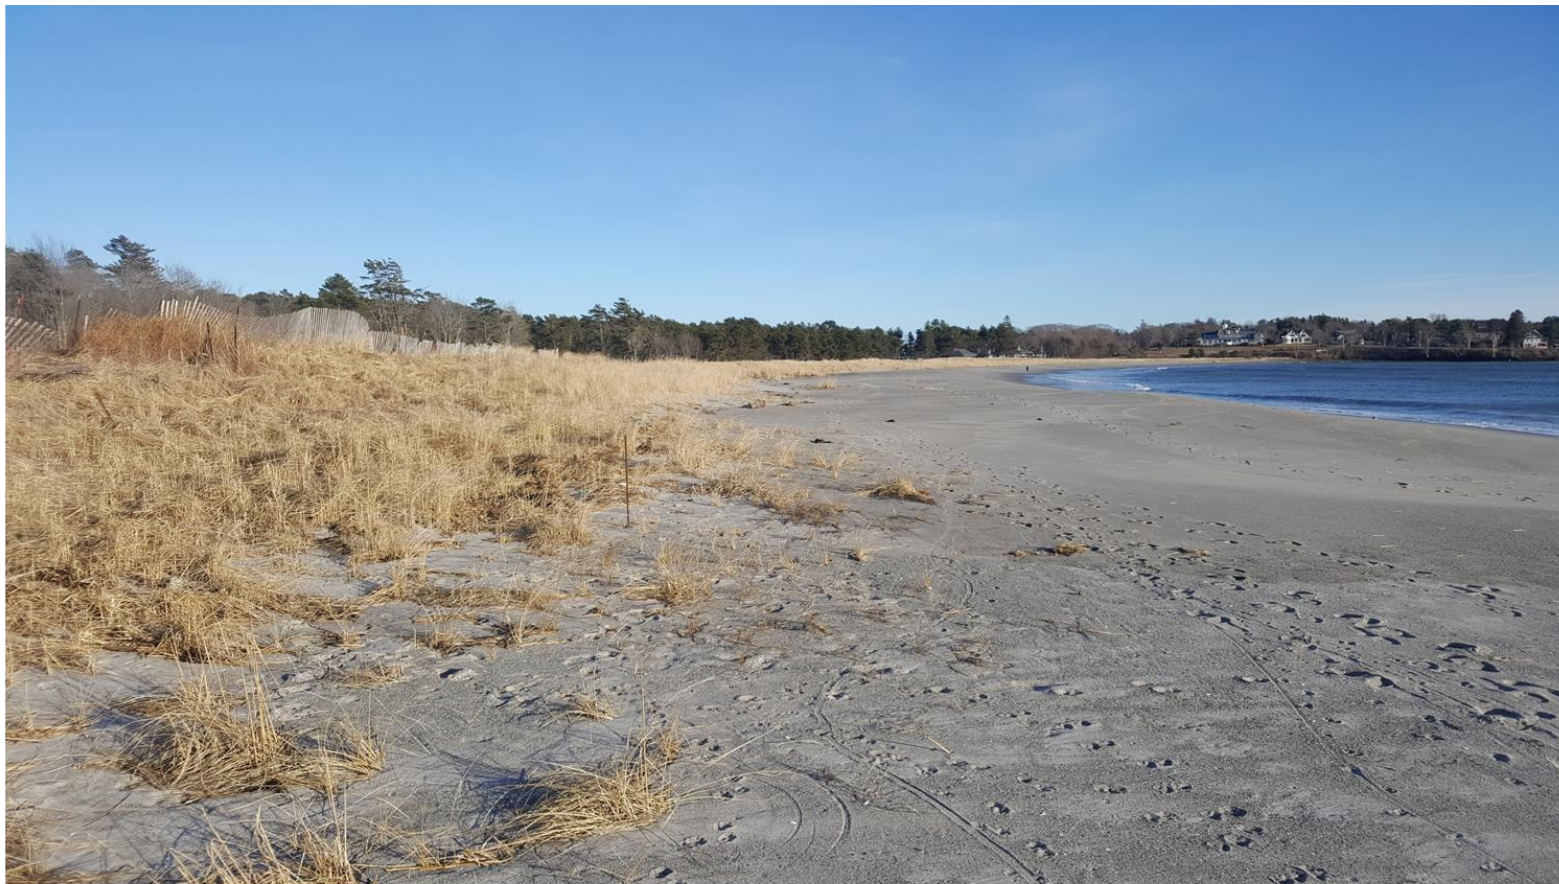
Photo B. Looking southeast at stable dune and berm growth along Western Beach. Along this stretch, the dune was stable and the berm grew seaward since summer 2017. Image by P.A. Slovinsky, MGS, 3/5/2018.

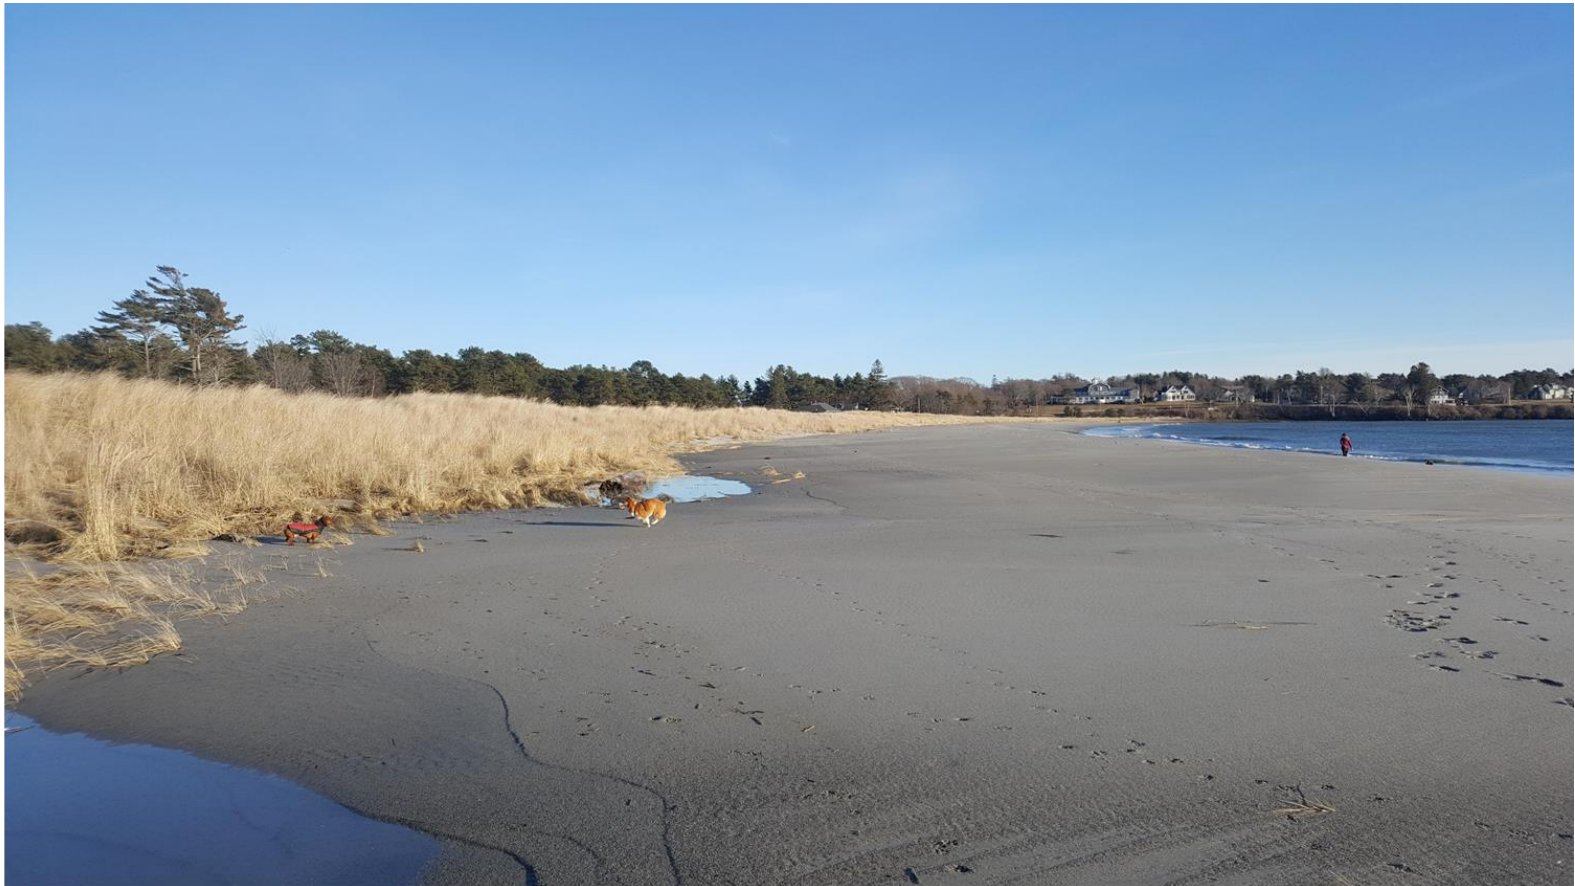
Photo C. Looking southeast at dune and overwashed berm along Western Beach. The dune along this stretch was stable. Although the MHW moved approximately 40 feet inland from summer of 2017, the berm clearly grew in elevation. Image by P.A. Slovinsky, MGS, 3/5/2018.

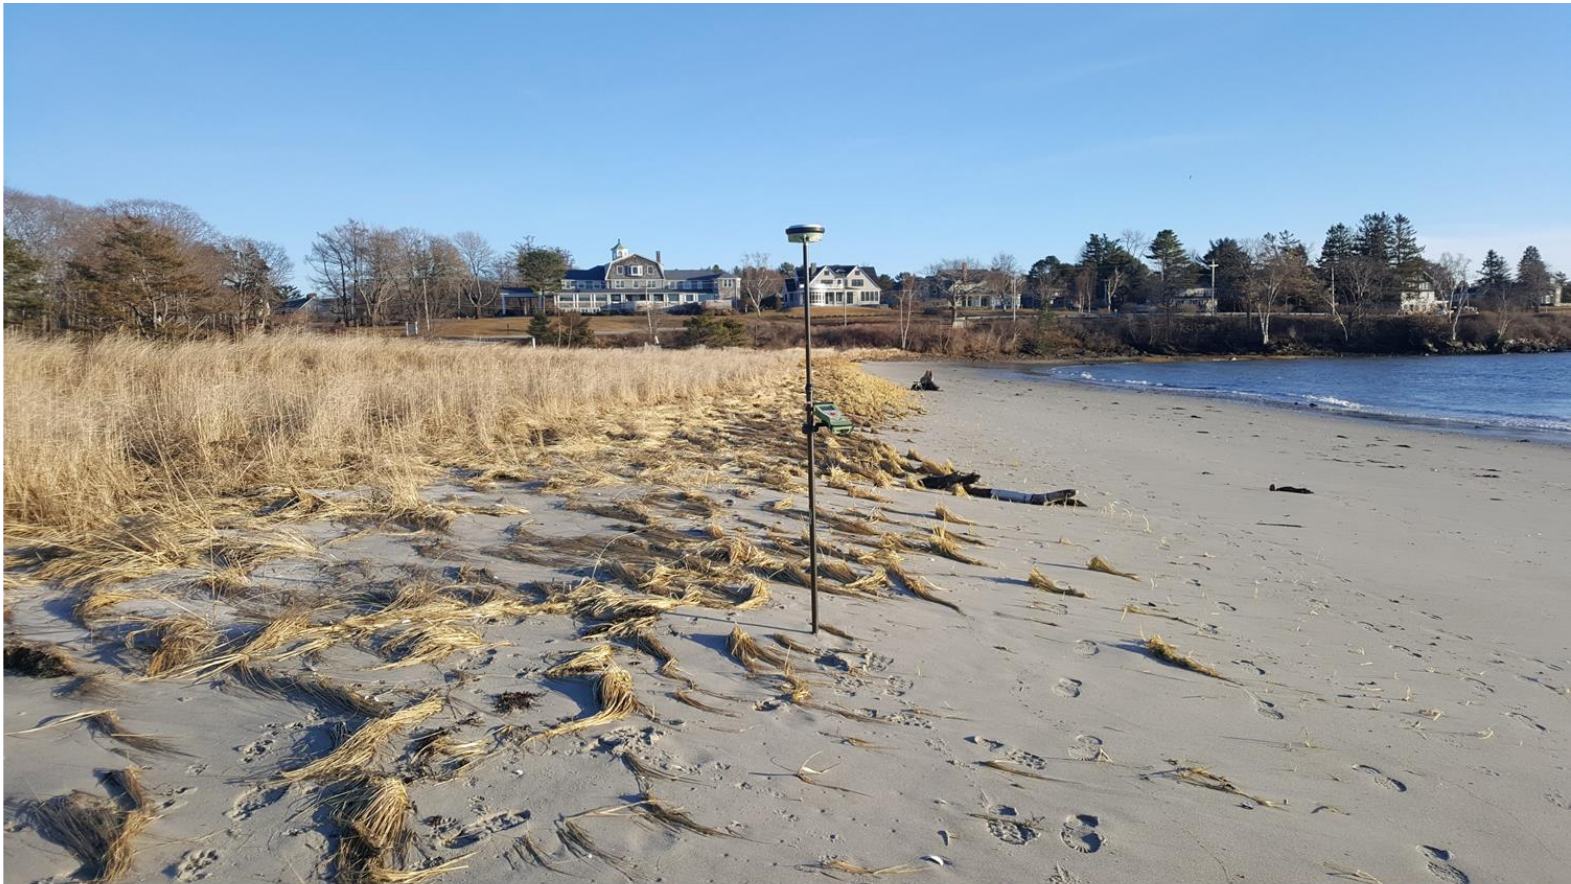
Photo D. Looking southeast at dune overtopping and beach erosion along Western Beach. The dune here was slightly eroded during the March 2018 events, but we expect this dune grass to re-establish this summer. Image by P.A. Slovinsky, MGS, 3/5/2018.
