**OPEN-FILE REPORT NO. NEIGC16C:A5**

**Title:** *Coastal Bluff Erosion, Landslides and Associated Salt Marsh  
Environments in Northern Casco Bay, Maine*

**Authors:** *Nicolas Whiteman, Joseph T. Kelley, Daniel F. Belknap, and Stephen  
M. Dickson*

**Date:** *October 2016*

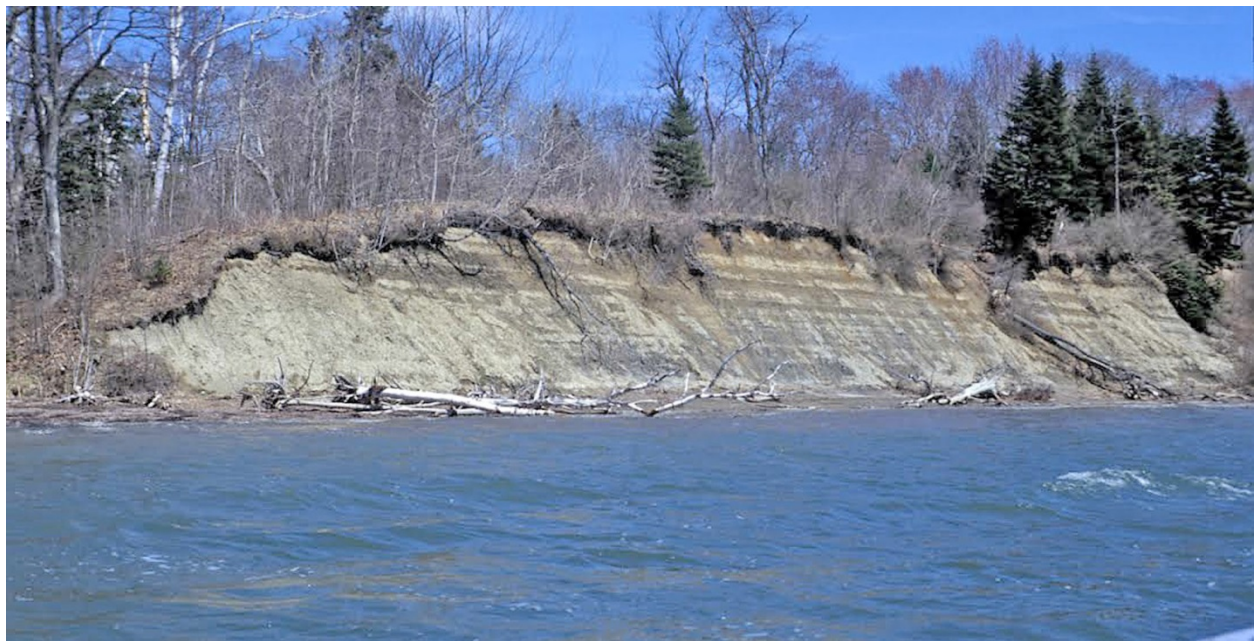
Figure 2 – Bunganuc Bluff glaciomarine Presumpscot Formation exposure, J.T. Kelley, April 2003.

Bluffs in Casco Bay are composed generally of till or glacial-marine muddy sediment (Kelley et al., 1989). They range from very slight up to 15 m (Fig. 2). The till is mostly thin ground moraine underlying the

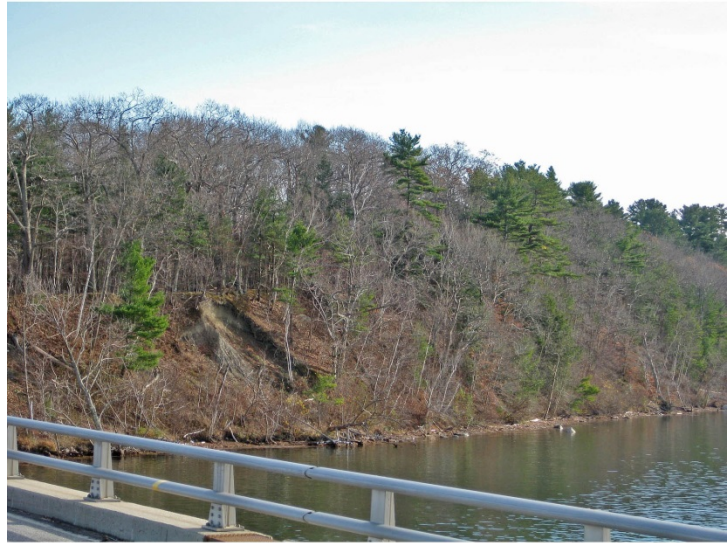
Figure 3 - Cousins Island till bluff, 11/16/12, Kara Jacobacci.

glacial-marine sediment. One moraine stretches discontinuously from the Portland peninsula to Cousins Island, where it is exposed on the northwest coastline (Fig. 3). Bluffs of glacial-marine sediment are more common than those of till. These bluffs have also been involved in major historic landslides throughout Casco Bay and upstream, along its estuaries and river valleys, as well as slower, chronic erosion.

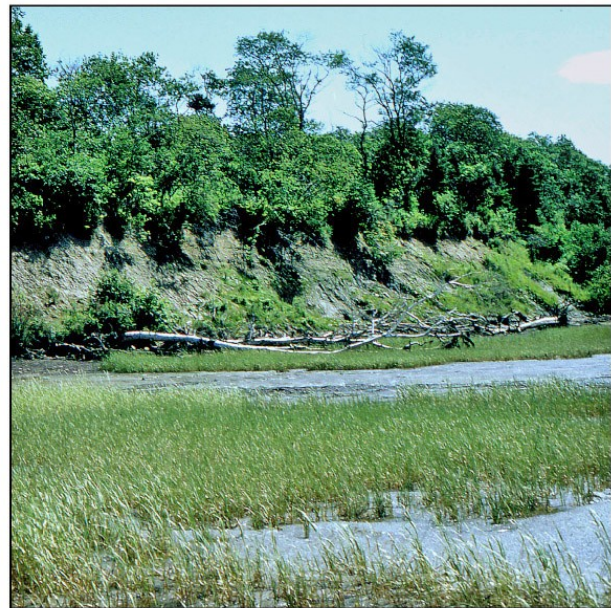
Figure 4 - detail from Bryant et al., 2002

**Highly unstable bluff** with an unvegetated bluff face and a salt marsh shoreline. Sediments on the bluff face are exposed and fallen tree trunks lie at the base of the bluff. A salt marsh has recently formed on the tidal flat, partly on the top of an old landslide deposit.

To inform the public about the hazards of bluff erosion, the Maine Geological Survey produced a series of Bluff Hazard Maps <http://www.maine.gov/dacf/mgs/pubs/online/bluffs/bluffs.htm> (Kelley and Dickson, 2000). These are available free on line and characterize the coast in terms of no bluff, stable bluff, unstable bluff and highly unstable bluff. The coastal environment at the toe of the bluff was also mapped as part of this series (Fig. 4).

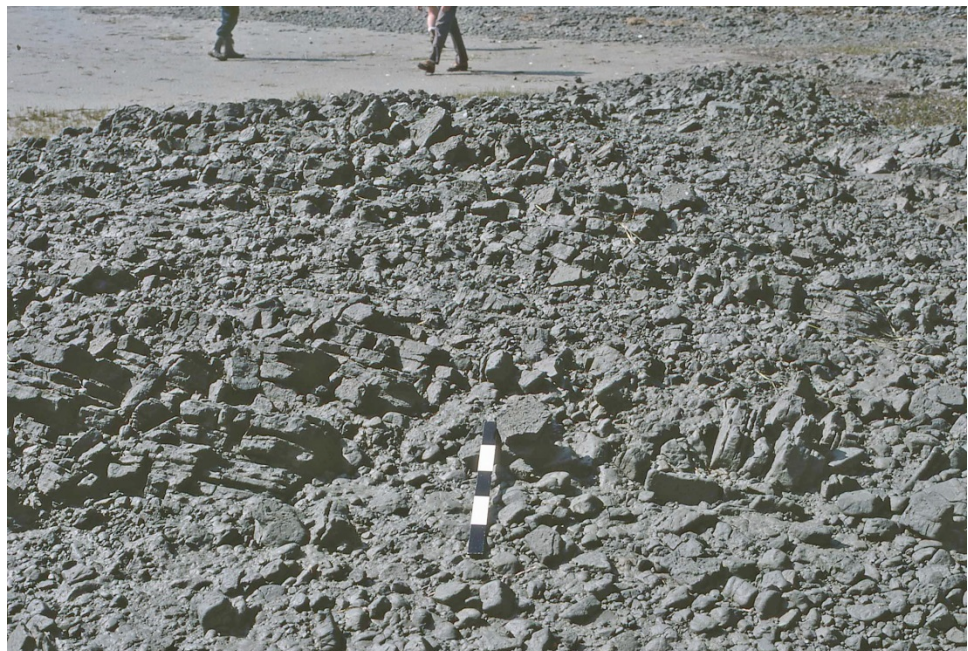
Figure 6 (previous page) – crumbled appearance of fine-bedded glaciomarine mud within slump outrunner block on the tidal flat, toe of Bunganuc bluff, 05/18/86 (D.F. Belknap).

Marshes also occur at the base of bluffs following landslides (Kelley et al., 1988). These sorts of geomorphological settings are found where a landslide deposit is planed off by waves and a low salt marsh colonizes the surface. Related to the bluff cycle (Fig. 5), marshes of this sort provide vivid documentation of a past landslide, with contorted glaciomarine mud underlying colonizing marsh (Figs. 6, 7).

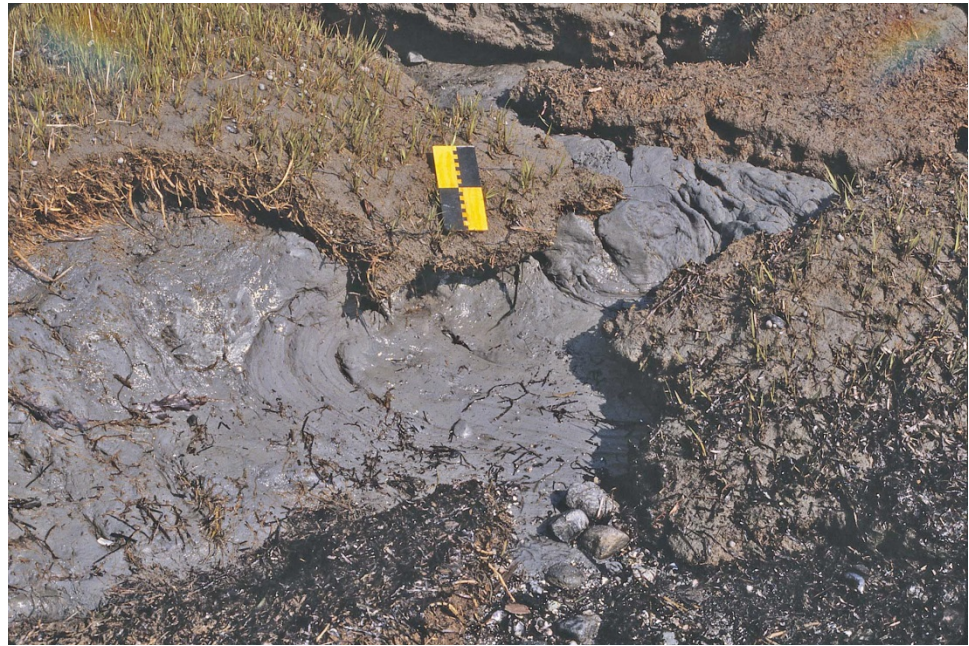
Figure 7 - Contorted glaciomarine mud from former slump, overlain by colonizing low salt marsh. Scale is 20 cm. Little Flying Point, Casco Bay, 05/20/85 (D.F. Belknap).

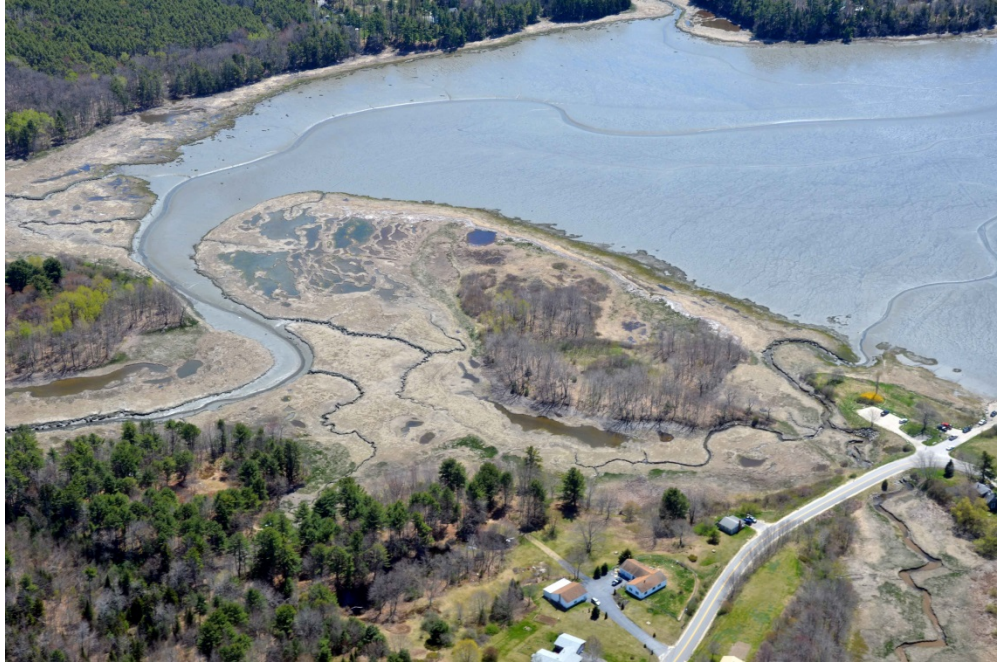
Figure 8 - Wharton Point from the air, looking SE, May 30, 2012.

Wharton Point was a Colonial-Era shipyard that has undergone many changes over time (Fig. 8). The surficial geology consists of eolian sandy deposits unconformably overlying the Presumpscot Formation (Fig. 9).

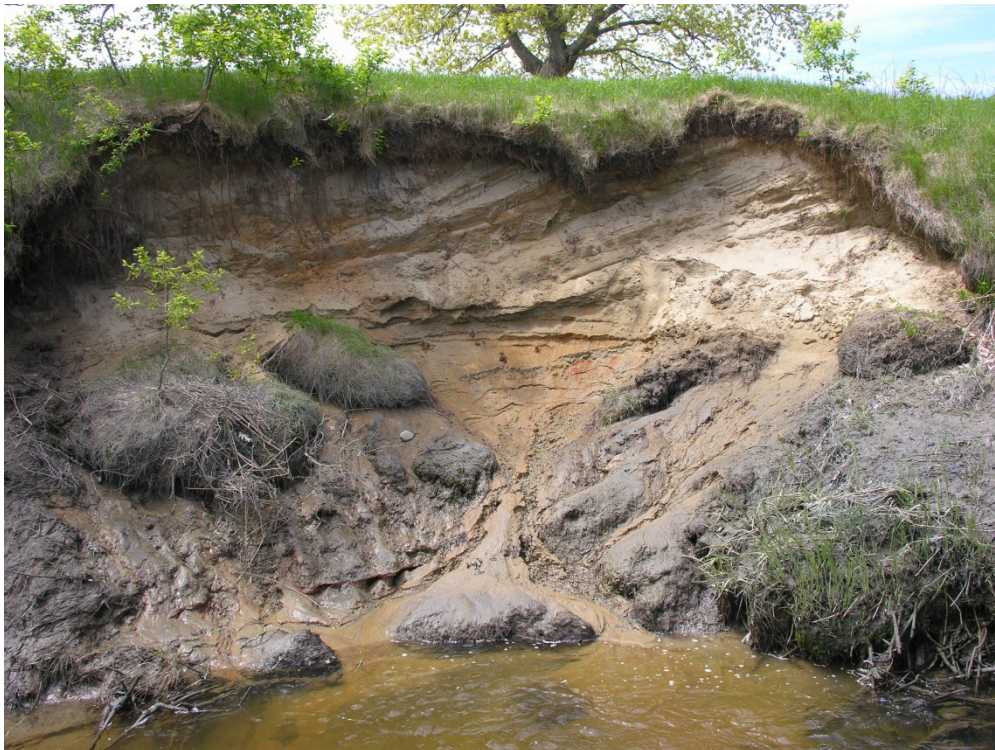
Figure 9 - Steeply dipping beds of eolian sand unconformably overlie glacial-marine mud in a tidal creek at Wharton Point.

The sand was likely derived from erosion of the Brunswick Sand Plain to the northeast. This sand plain is a regressive fluvial deposit that formed as post glacial sea level to near the present elevation, and the deposit likely blocked the Kennebec/Androscoggin Rivers from entering the sea here. In the 18<sup>th</sup> Century, this was a sand flat, but changed with coastal deforestation to supply logs for British masts. Mast boats from Britain loaded logs here and at nearby Mast Landing as well as built and repaired vessels. The silting in of the area from enhanced bluff mud filled the old shipyard and allowed salt marsh to grow seaward (Fig. 10).

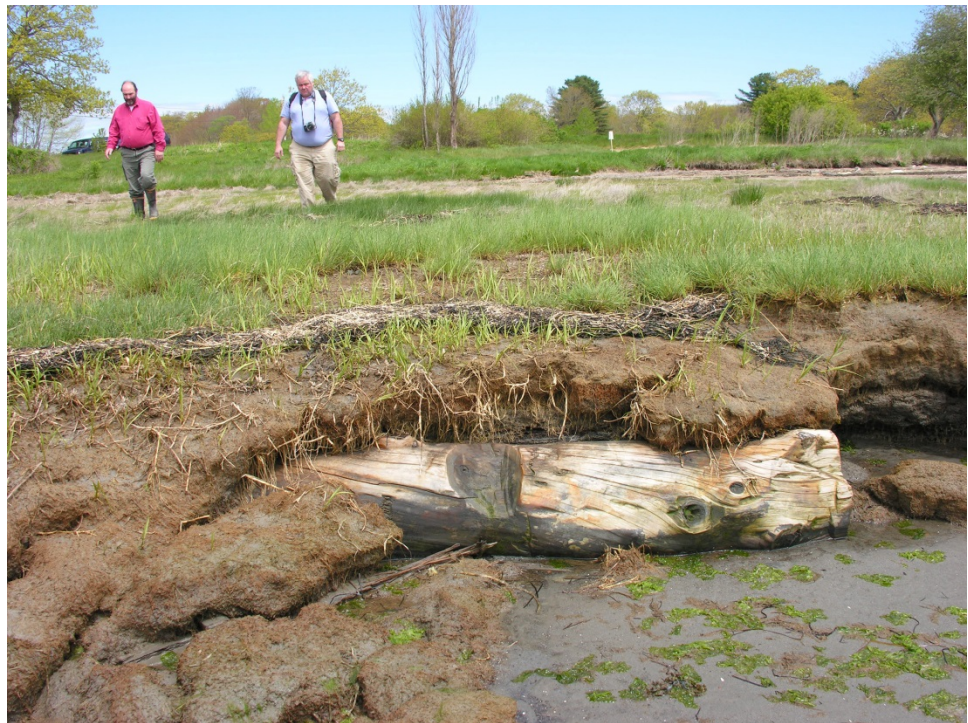
Figure 10 - Eroding salt marsh at Wharton Point exposed Colonial-Era worked log.
