Technical Report 16-15

Advanced Bridge Safety Initiative: Phase 2

Task 3- Instrumentation During Live Load Testing and Load Rating of Five Reinforced Concrete Slab Bridges

May 2016

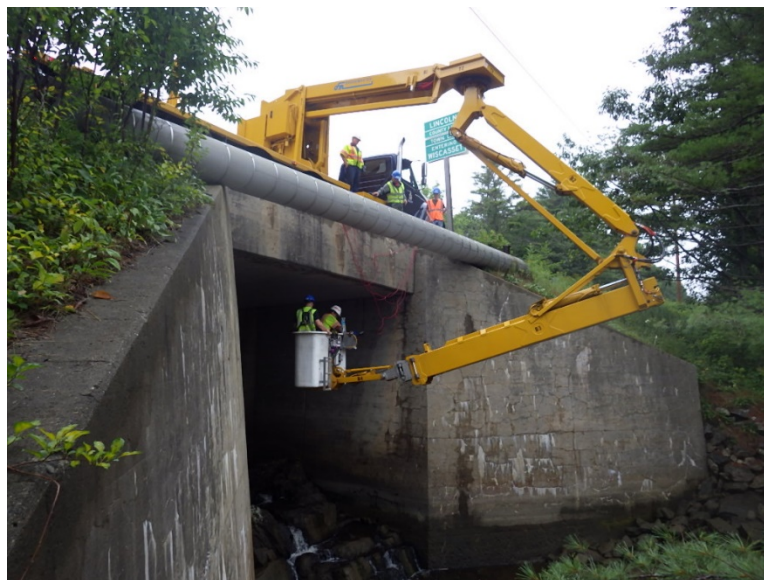
Figure 3: MaineDOT UBIT utilized to install sensors

Strain sensors were mounted under the bridges using a MaineDOT Under Bridge Inspection Truck (UBIT) as shown in Figure 3. The sensors were mounted to the concrete by first grinding the concrete to a fresh surface, cleaning the surface, then using the recommended concrete adhesive to connect the strain sensor tabs to the concrete. Strain sensor layout was optimized for each bridge, with individual sensor layouts shown in the appendices.

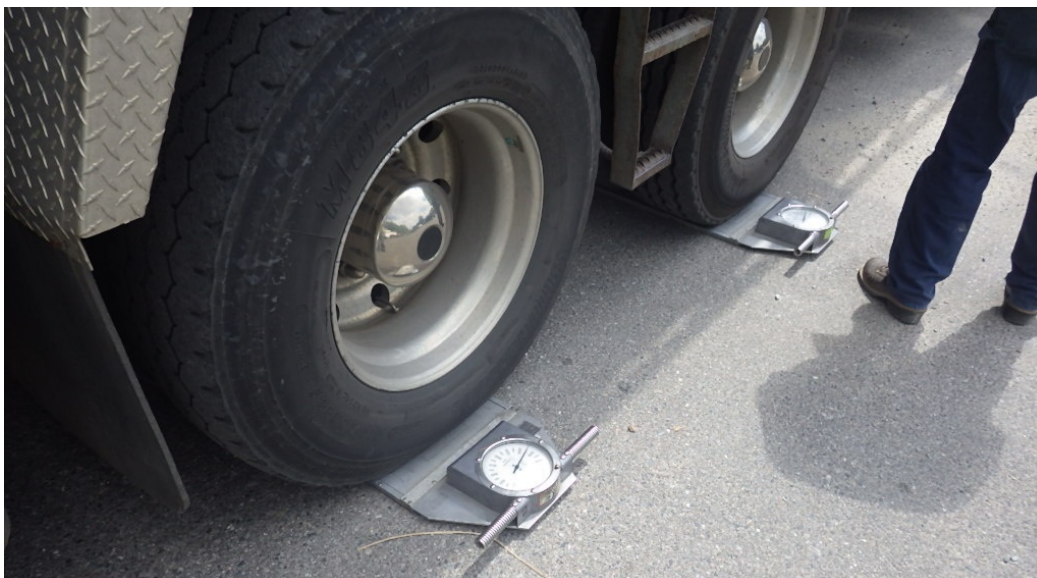
Figure 5: State highway patrol certified portable crane scales used to verify vehicle weight for each test

The crane used for this testing was a Grove TMS900E as shown in Figure 4. The crane was weighed using state patrol certified portable scales as shown in Figure 5. Each test was run with crane moving both directions on each side of the road in optimized load paths as is detailed in the appendices. In general, this was as close to the curb on both sides as possible to maximize the moment along the free edge of the bridge. The autoclicker was utilized to create marks in the data acquisition system at each wheel rotation to determine the vehicle location during the test, and the setup is shown in Figure 6.

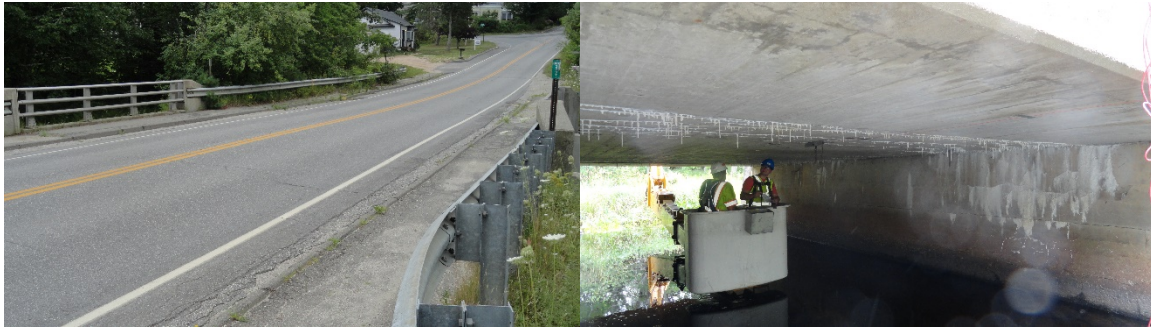
Figure 14: Penobscot No. 3297 overall configuration with sidewalks and new/ old/ new underneath

effectively transfer shear and could transfer significant longitudinal bending. Consistent with the MaineDOT load ratings and the uncertainty of load transfer across the joint, the initial FE models ignored the new sections of slab and conservatively treated the old portion of the slab as an independent structure. The general condition is shown in Figure 14, with the stelactites indicating the two joints between new/ old/ and new sections.

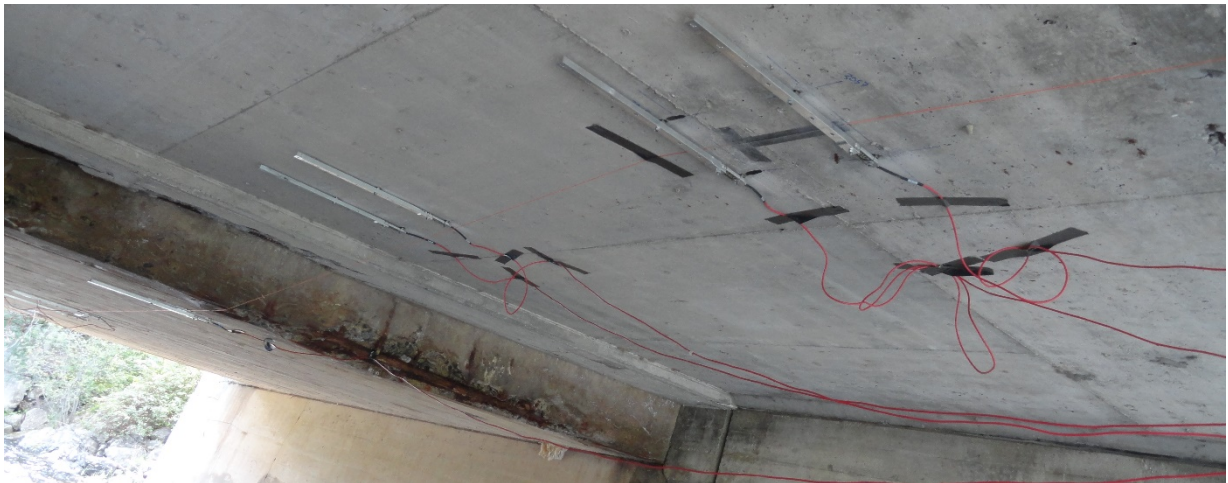
Figure 16: Smyrna No. 2250 underside general condition with joint detail

The Smyrna bridge consists of an original section and widened portions at both edges. The original portion of the structure represents approximately 70% of the roadway width between the curbs, and only the new portion on the north (upstream) side carries significant traffic. The general condition is shown in Figure 16 focused on a joint between old and new slabs.
