Maine Geologic Facts and Localities  
February, 2012

***Beach Scraping at Popham Beach State Park  
Phippsburg, Maine***

Text by  
Stephen M. Dickson

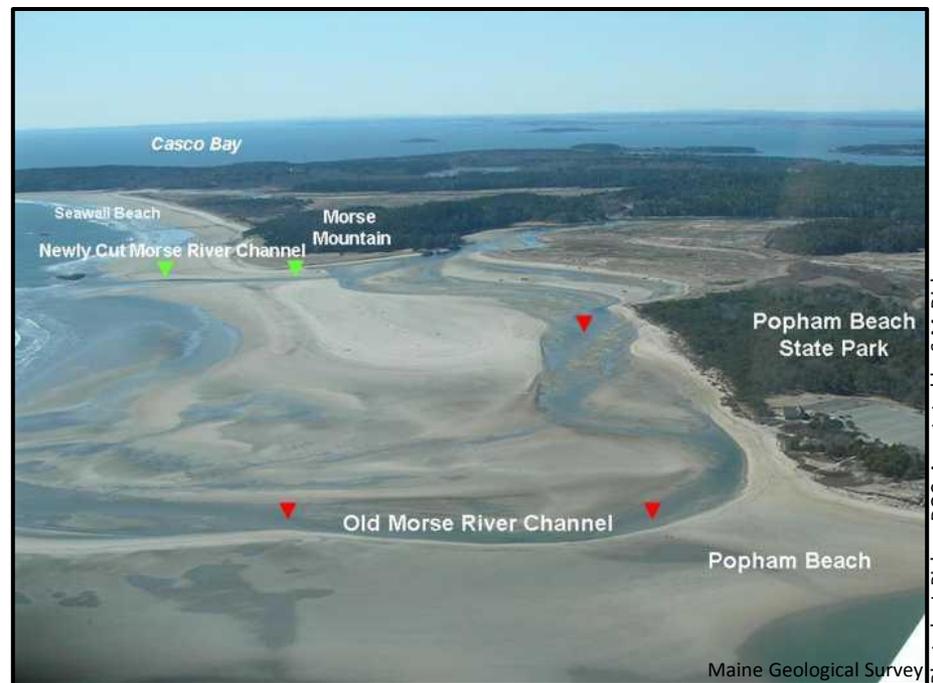
**Figure 1.** Since 2010 the Old Morse River has been choked with sand from the sand bar in the center of the picture and from sand carried up from the bottom of the photo. The accumulation of sand in the old channel has forced it to meander (curve) farther inland and threaten to undermine the bath house and leach field.

In the late winter of 2010, the Morse River cut a new channel to the sea during a period of storms and astronomically high tides (Dickson, 2011). This was a natural process and it resulted in the old channel of the Morse River becoming a back-barrier lagoon (tidal water body) between an offshore sand bar and sand dunes at [Popham Beach State Park](#) (Figure 1).

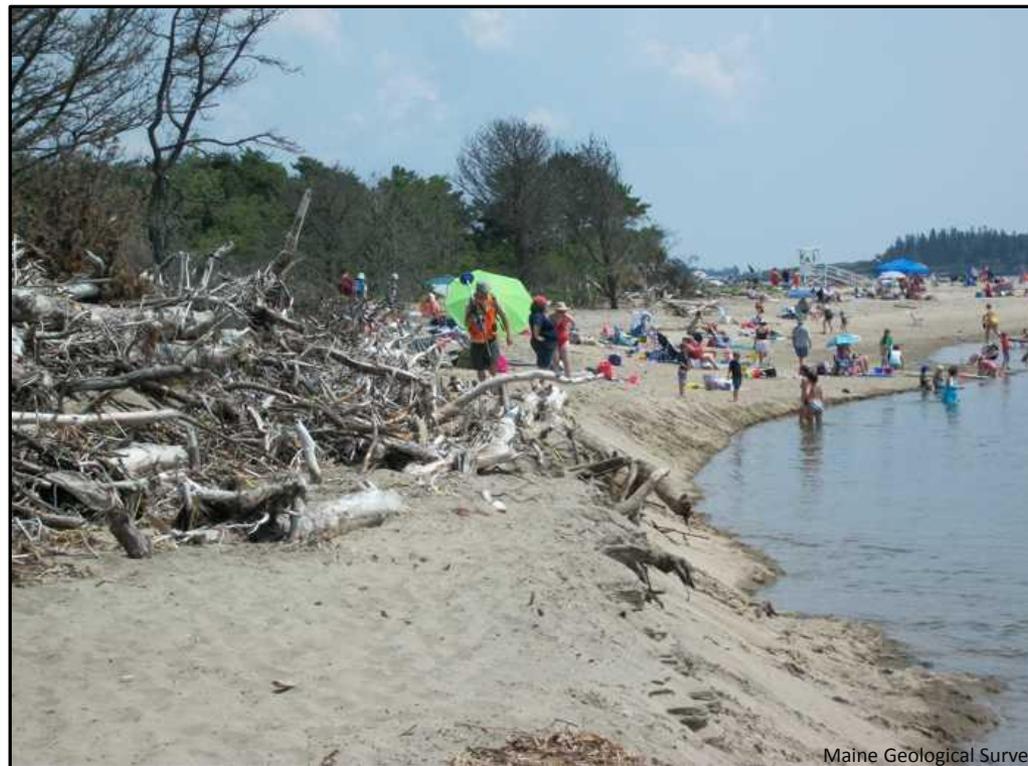
**Figure 2.** A view of the beach and tree wattles immediately seaward of the bath house on July 19, 2011. This shoreline shows up in Figure 5.

This cut bank continuously eroded sand to the point that the nearest corner of the bath house was about 25 feet from the top of a 10-foot high cut bank (Figure 2, Figure 3). Emergency protective measures taken in advance of the arrival of Hurricane Irene on August 29, 2011 (Fanelli and Fanelli, 2011) regrouped tree wattles at the toe of the embankment in front of the bath house.

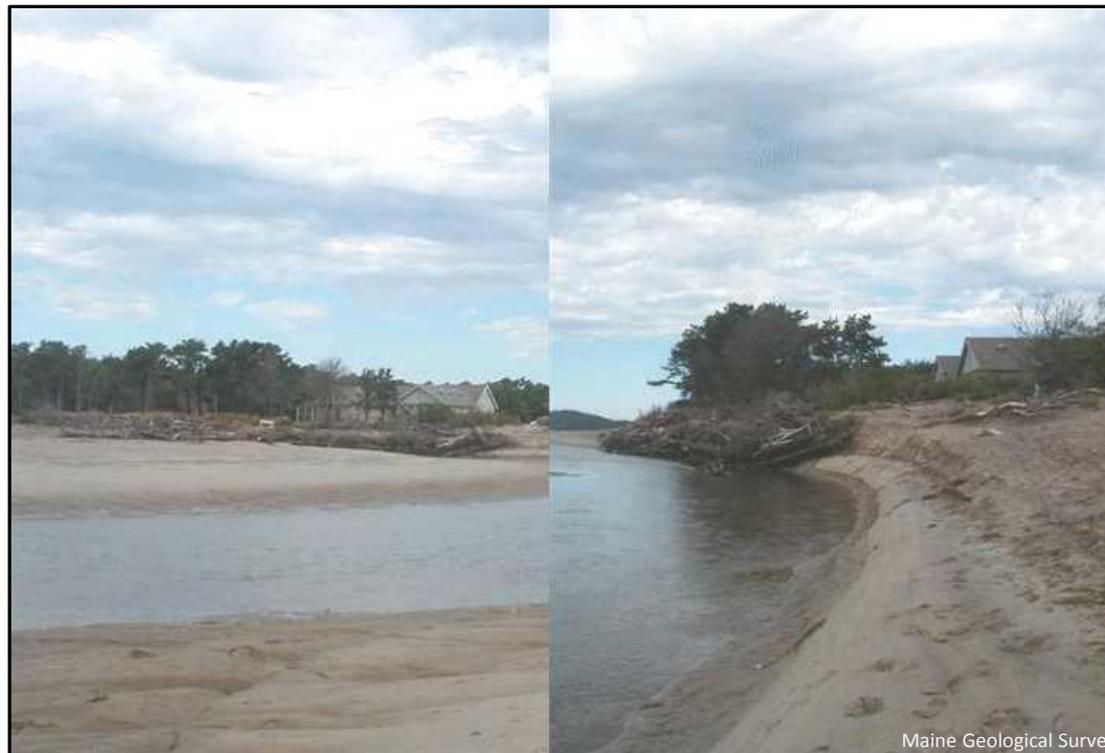
**Figure 3.** Photos taken on August 23, 2011 show the tree wattles are more exposed by erosion and the shoreline is closer to the west bath house. At high tide the waterline is about 4 feet higher up the bank.

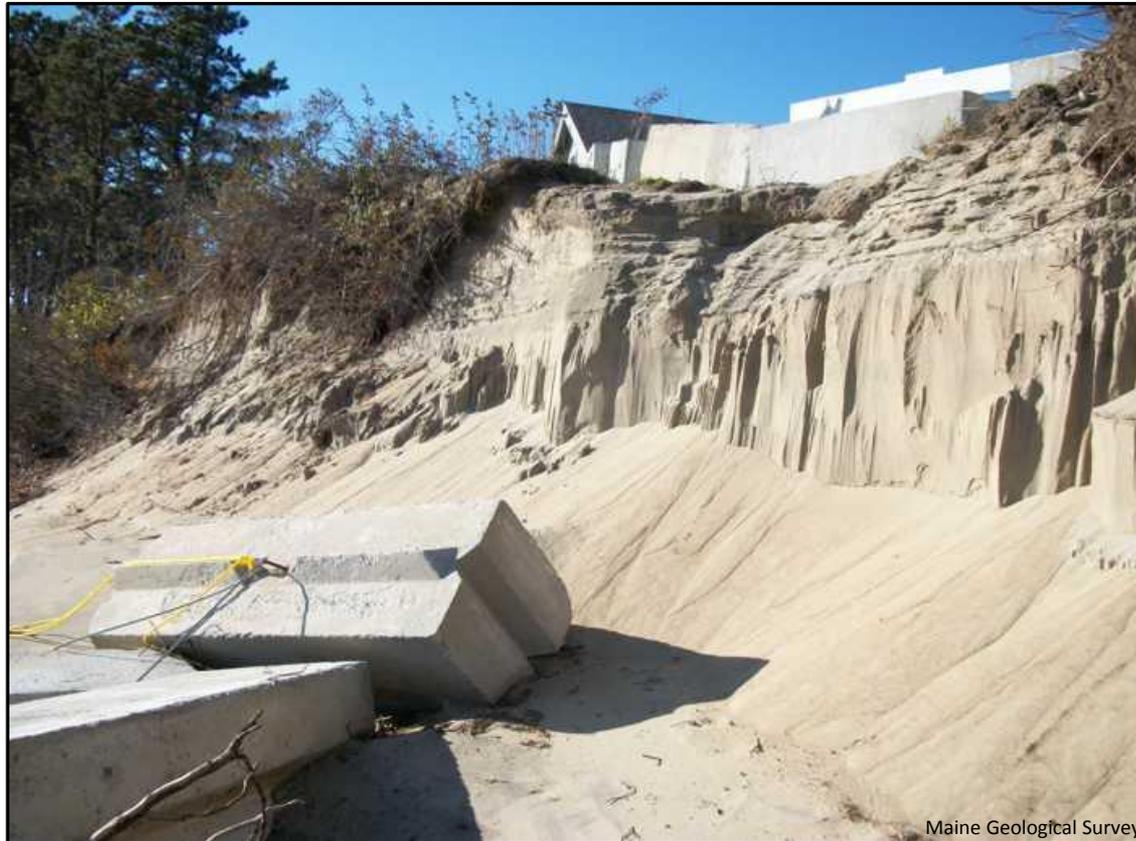
**Figure 4.** Ongoing erosion of the bank and sand immediately seaward of the bath house resulted in cement blocks being undercut and falling into the tidal channel.

Tidal current action resulted in about 8 cement blocks being undercut and falling into the channel (Figure 4).

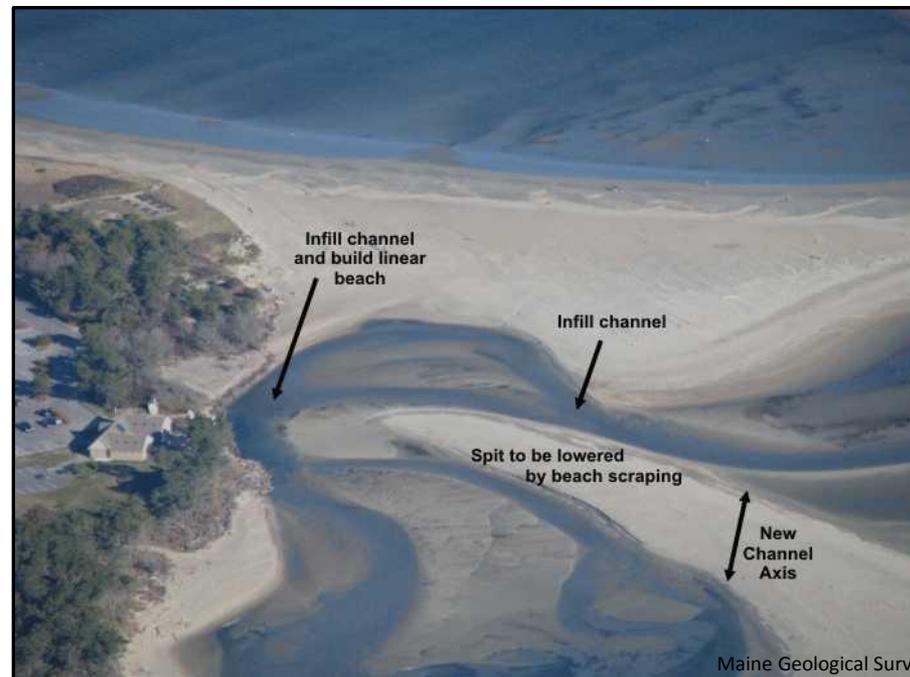
**Figure 7.** Pre-scraping conditions at the Old Morse River channel adjacent to the bath house. Sand would be moved from the spit to infill the channel in front of the bath house, restoring a beach slope, and plugging a constriction in the channel. Closing off the flow would also result in a new and shorter channel in the area marked New Channel Axis.

Beach scraping is a process of moving sand on a beach. The goal of beach scraping here was to redistribute and, following the natural onshore migrating direction, to infill the channel next to the bath house (Figure 7). This approach was considered the most natural way to quickly slow the erosion. In consultation with the U.S. Army Corps of Engineers and Maine Department of Environmental Protection, DOC applied and received permits for sand movement on the winter beach.

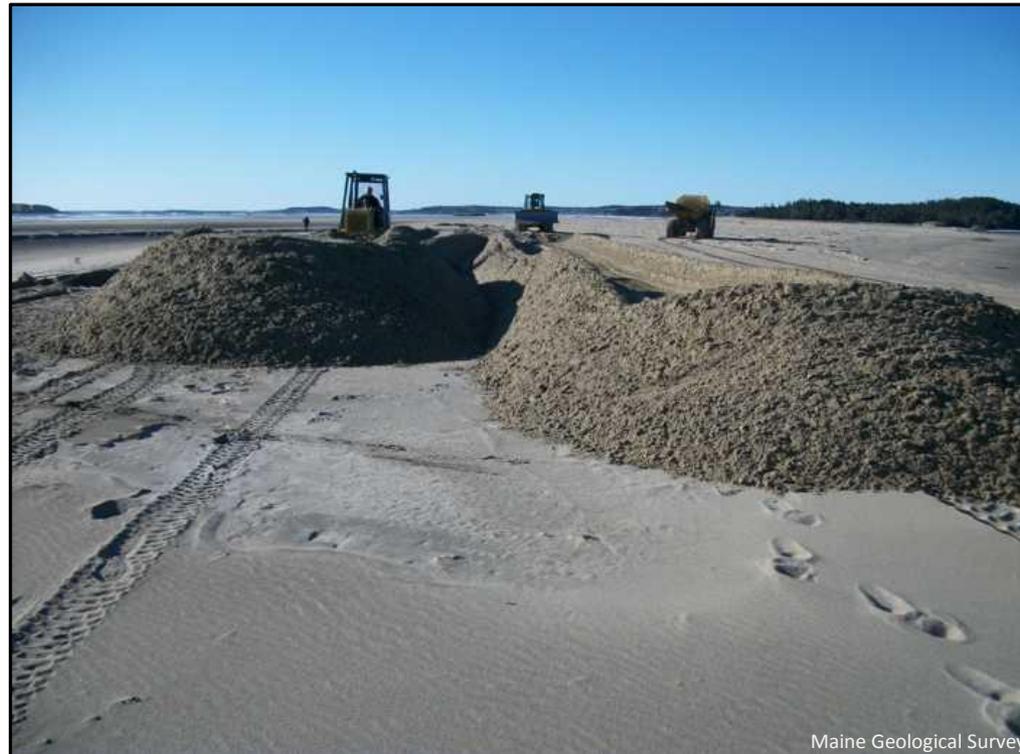
**Figure 8.** Beach scraping with bulldozers moved sand in a landward direction across the beach spit toward the bath house.

This effort was localized and took into consideration coastal processes, the beach sand budget, possible effects on neighboring properties, recent piping plover nesting habitat, and sensitive coastal sand dunes. The project did not import sand as is done in some beach restoration projects. Instead, sand was simply moved from one section of beach to another (Figure 8).

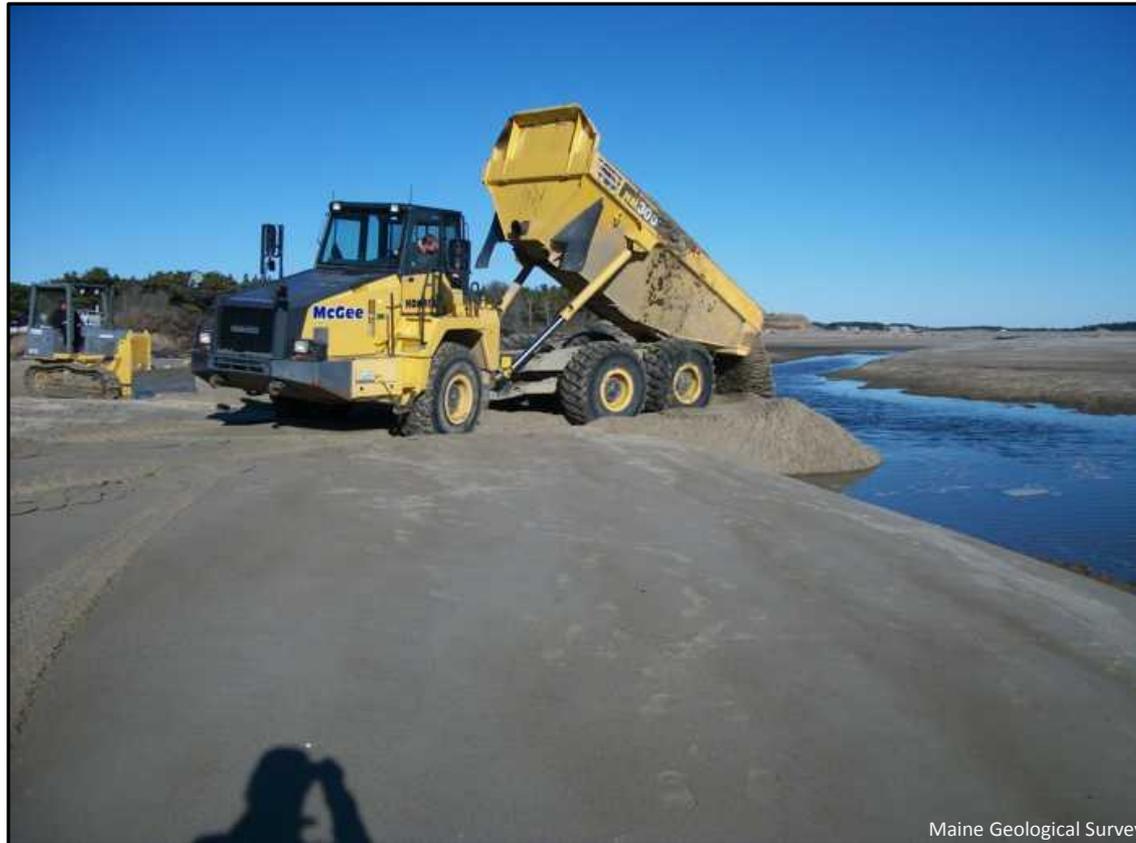
**Figure 9.** Sand from the spit was loaded into dump trucks and used to fill the tidal channel.

Beach scraping started on December 1, 2011 and was completed in a week. This effort was undertaken during daylight neap low-tide cycles and involved redistributing 10,000 cubic yards of beach sand in a landward direction (Figure 9).

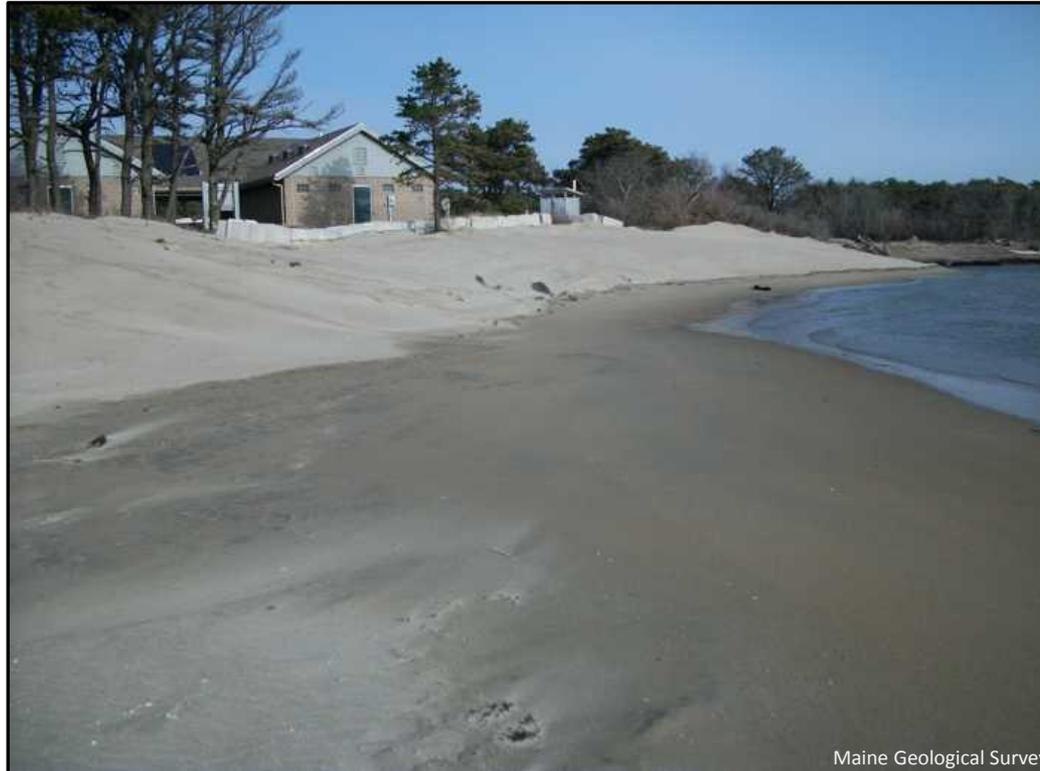
**Figure 10.** A view of the new beach face seaward of the bath house four days after it was created by beach scraping. Wind and wave action is gradually removing the tracks from the bulldozer. The tree wattles and vertical dune scarp are covered with sand. The recent high tide line is delineated at the upper reaches of the wet beach.

Channel infilling resulted in a landform that resembles the low-tide terrace that exists seaward of most beaches and occupies the lowest third of the tidal range. Most of the 10,000 cubic yards of sand was placed directly seaward of the bath house (Figure 10).

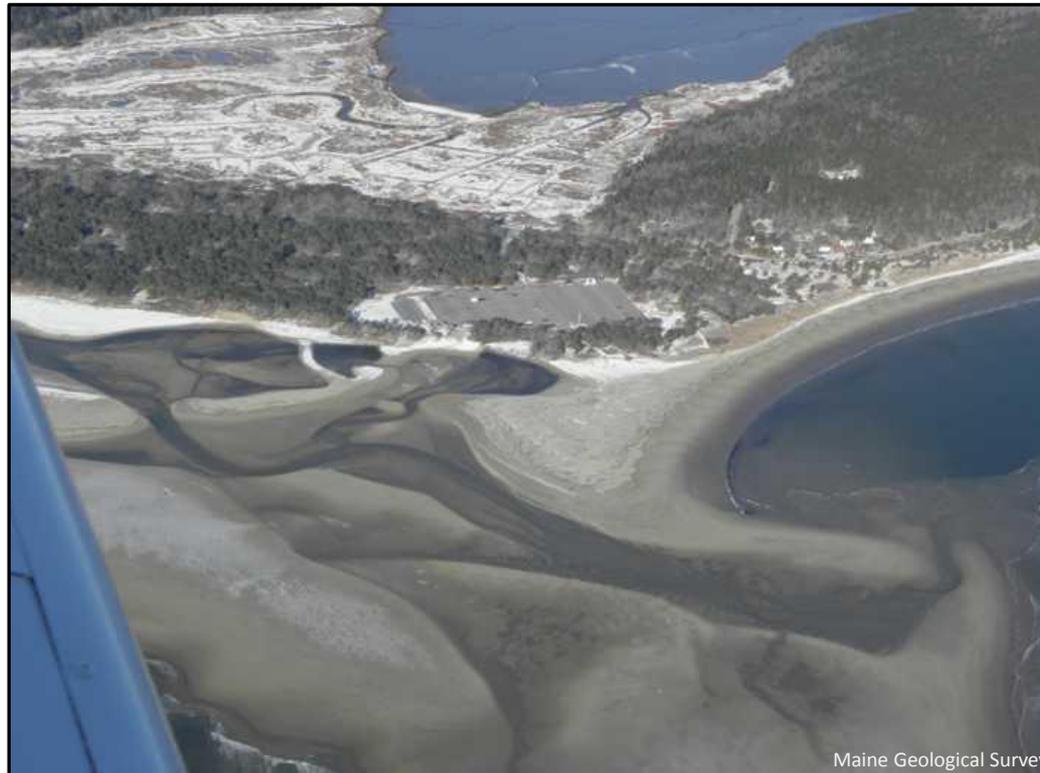
**Figure 11.** Beach scraping infilled the channel and built a beach just seaward of the bath house at the corner of the parking lot at Popham Beach State Park. The new beach face is snow-covered and sloped above the limits of the high tide to provide wave dissipation during winter storms.

Channel remnants remained in the form of troughs with standing water at low tide in areas upstream and downstream from the bath house. These troughs are likely to be ephemeral and infill once the tidal channel is displaced seaward (Figure 11).
