Maine Geologic Facts and Localities  
October, 2001

***Laudholm and Drakes Island Beaches:  
Before and After Beach Nourishment***

Text by  
Stephen M. Dickson

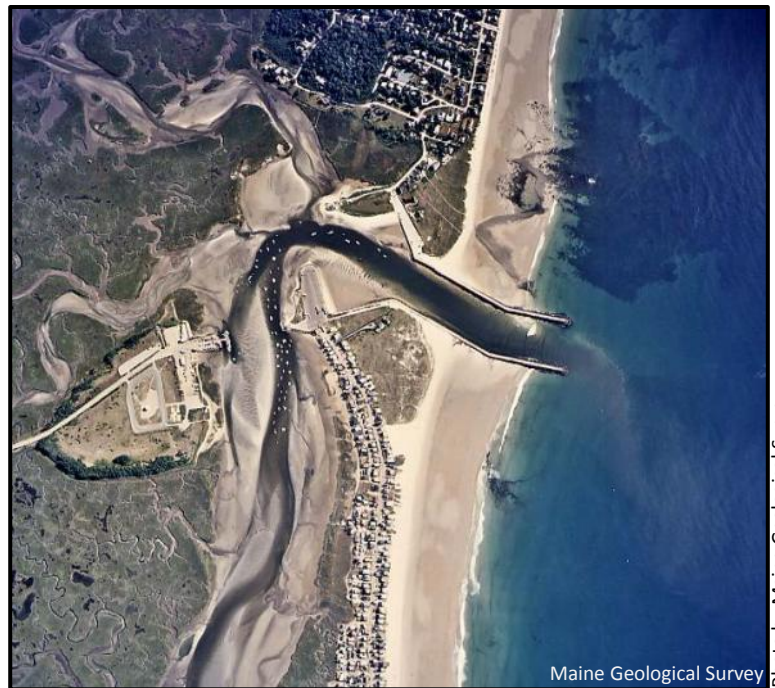
**Figure 1.** Air photo of Wells Harbor in the Webhannet River estuary, the tidal inlet with two stone jetties, and Wells and Drakes Island Beaches. Photo taken near low tide on July 16, 1995.

In the fall of 2000, sand from Wells Harbor (Figure 1; Figure 2) was dredged and pumped onto adjacent beaches. Lower Landing Road crosses the salt marsh to development on dredged sand placed on the marsh in the 1960s. Between the salt marsh of the Rachel Carson National Wildlife Refuge and Wells Beach are houses built on sand dunes of the barrier spit.

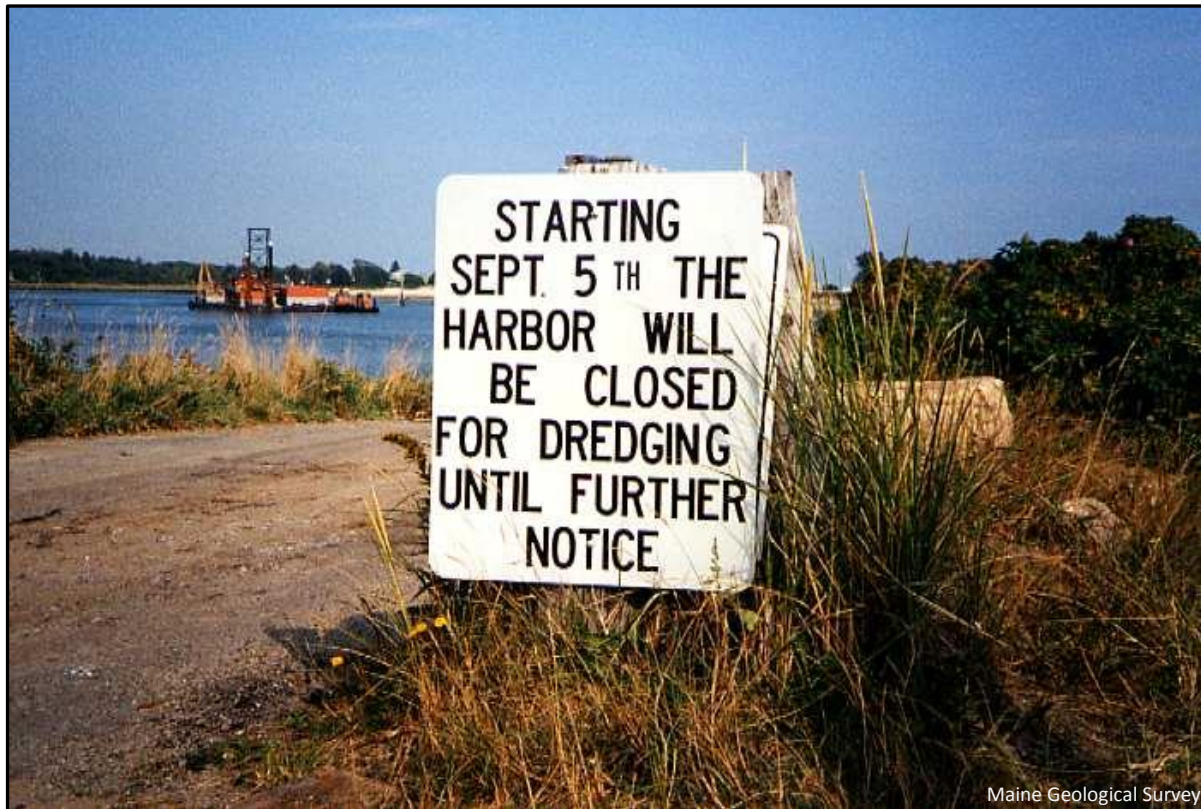
**Figure 2.** Wells Harbor was closed in the fall of 2000 for dredging the tidal inlet channel and part of the sandbars of the flood-tide delta. Part of the former federal anchorage was not dredged and placed in a conservation easement for preservation of some of the sandy intertidal flood-tide delta and adjacent salt marsh and channels.

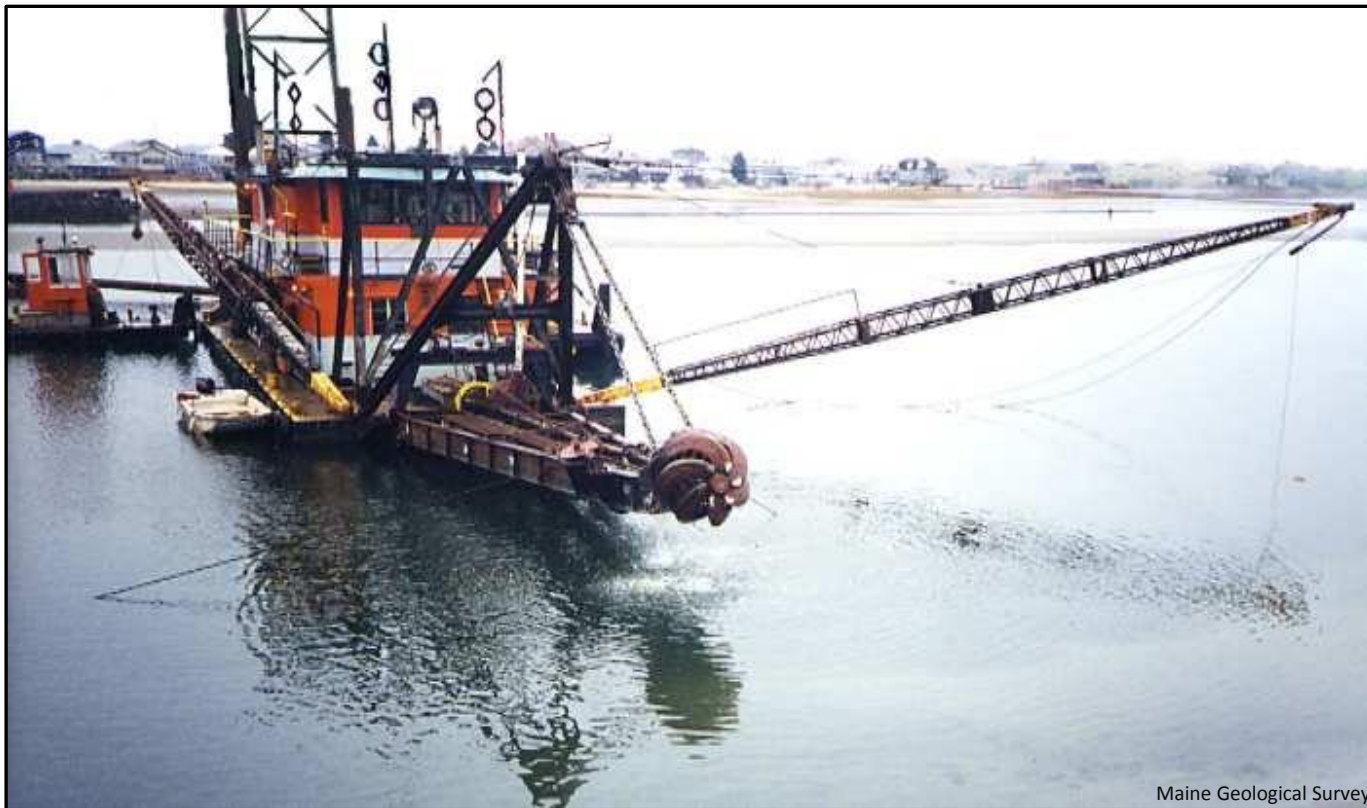
**Figure 3.** The suction dredge in Wells Harbor. The rotating cutter head is lifted out of water. Metal arms extend to either side of the dredge and have anchors that are used to position and move the cutter head on the bottom. Water and sediment are pumped through a floating pipeline to shore and then across the dunes to the beach.

In less than three months, about 180,000 cubic yards of sediment was pumped through pipelines onto Wells and Drakes Island Beaches from a suction dredge with a rotating cutter head (Figure 3).

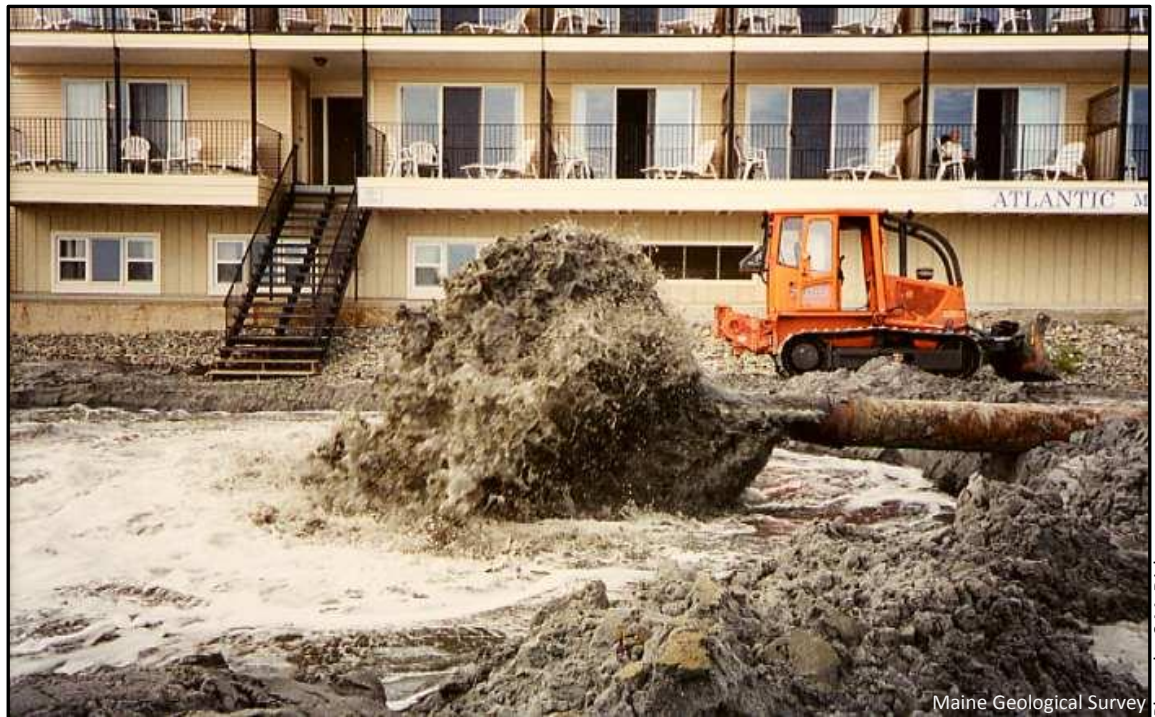
**Figure 4.** On the beach, the pipeline releases a slurry of water and sediment. Most of the sand was placed on Wells Beach and Drakes Island Beach in the form of a berm near seawalls or the frontal dune at the elevation just above the mean high-tide line.

At the end of a pipe, sand and water slurry was released on the beaches (Figure 4; Figure 5) at various points. As much as 6,000 to 8,000 cubic yards of sand were pumped onto the beach in a day. Dewatered sand was shaped with bulldozers into a higher beach profile with more sand at the high-tide line and in front of seawalls.

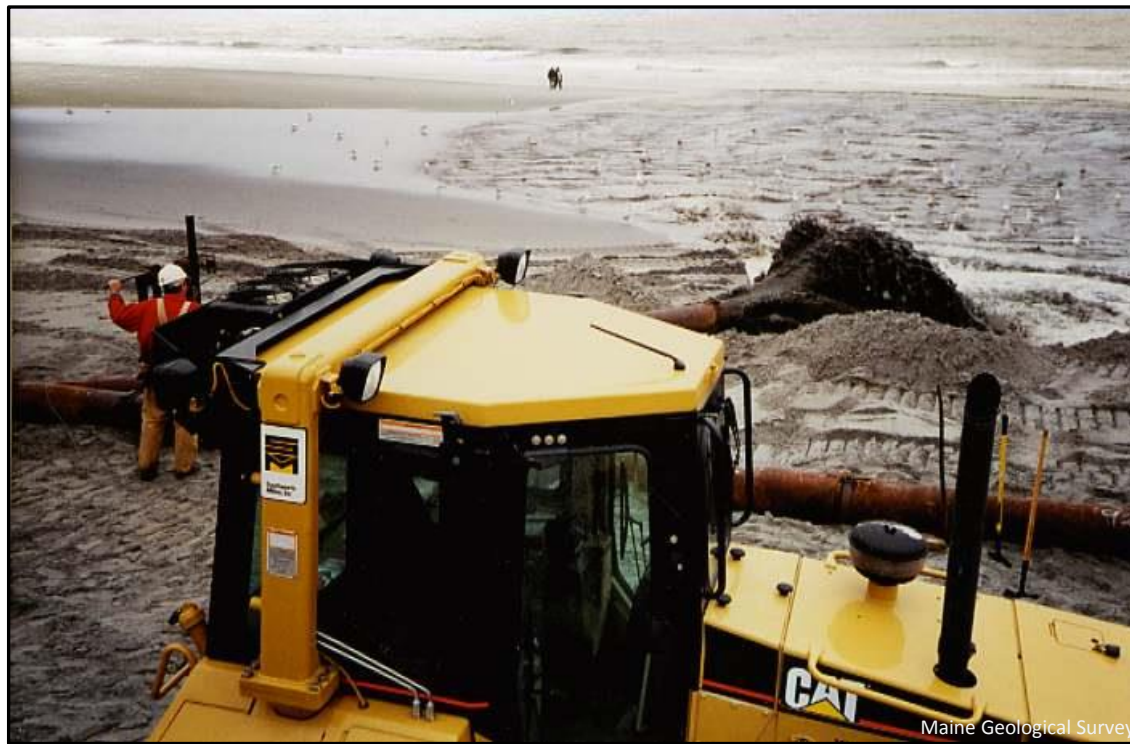
**Figure 5.** Nourishment built a berm out from Casino Point in Wells. After the slurry was dewatered, bulldozers formed an artificial terrace.

This nourishment occurred on the higher elevations of the beach profile in the vicinity of the berm, or area of summer sand accumulation. The elevation of the "fill" was marked on the Casino Point seawall with a red paint line. A visit to this location will show the paint line in relation to the current beach elevation. Since Casino Point is a headland, sand was dispersed away from it by wave action toward the beaches to the north and south.

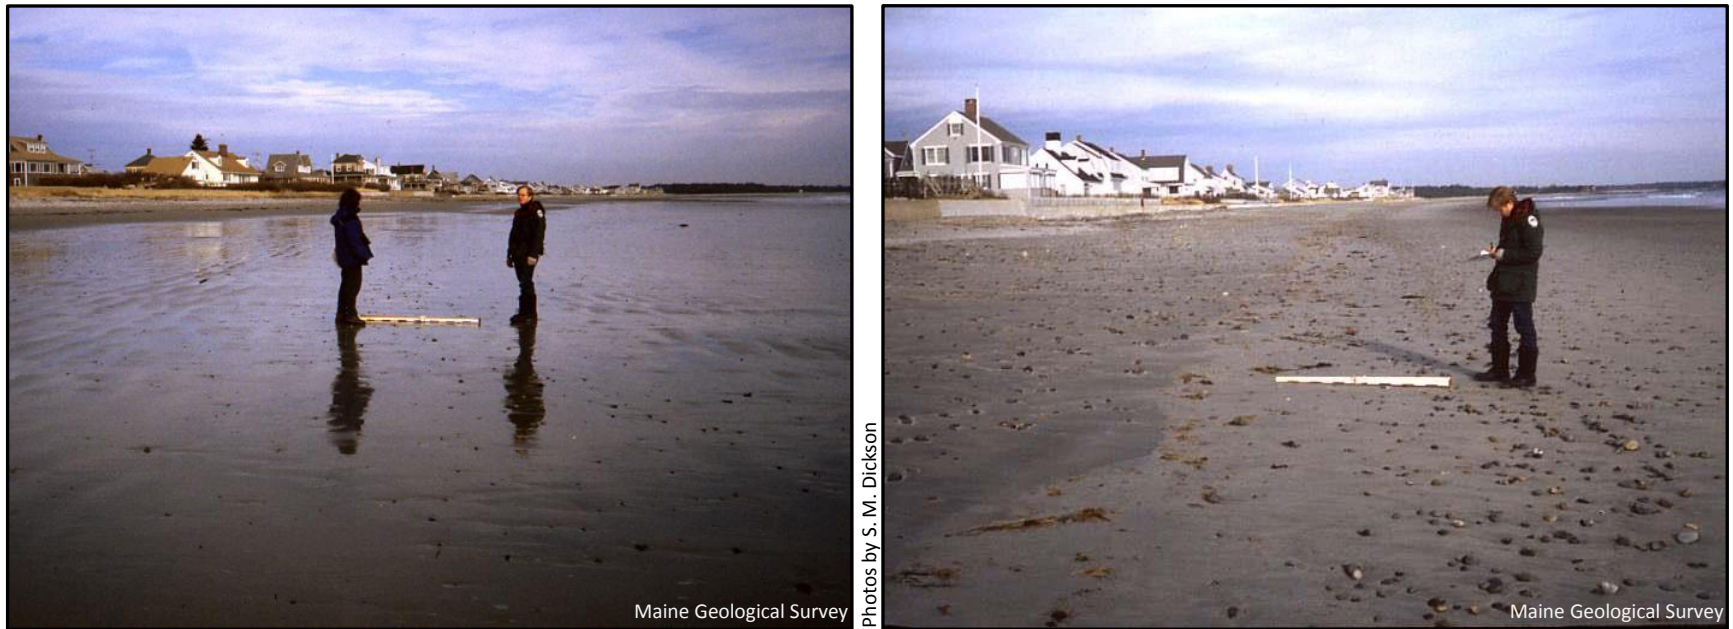
**Figure 13.** (Left) This profile line (Drakes Is. #1) is the nearest of six to the north jetty of the Webhannet River. The December 19, 2000 beach face has built up about 40 to 75 cm (16 to 30 in) vertically from the berm to the low-tide line. (Right) Drakes Is. #3. A December 19, 2000 picture shows mixed sand and gravel on the upper beach profile from dredged harbor sediment.

This new accumulation is from the redistribution of the nourishment alongshore to the south by the process of longshore drift and down the profile from wave action and the influence of gravity (Figure 13). This pattern of sand transport and accumulation has occurred since the 1960's, soon after the jetties were built (Kelley and Anderson, 2000).
