# *State of Maine's Beaches in 2011*

Maine Geological Survey  
DEPARTMENT OF AGRICULTURE, CONSERVATION AND FORESTRY  
Robert G. Marvinney, *State Geologist*

**Open-File No. 11-149**

2011

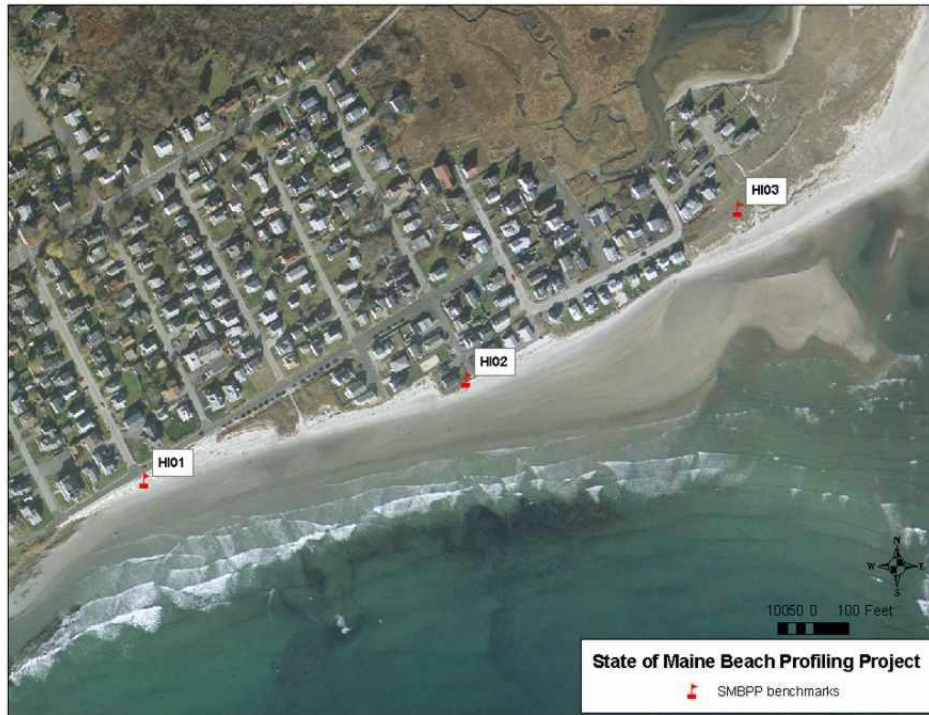
**Figure 5.** Location of beach profiles HI01 to HI03 at Higgins Beach, Scarborough. Base imagery from Maine Office of GIS.

A total of three beach profiles (HI01, HI02, and HI03) were available for comparison (Figure 5). The profiles extend from southwest to northeast, along the beach.

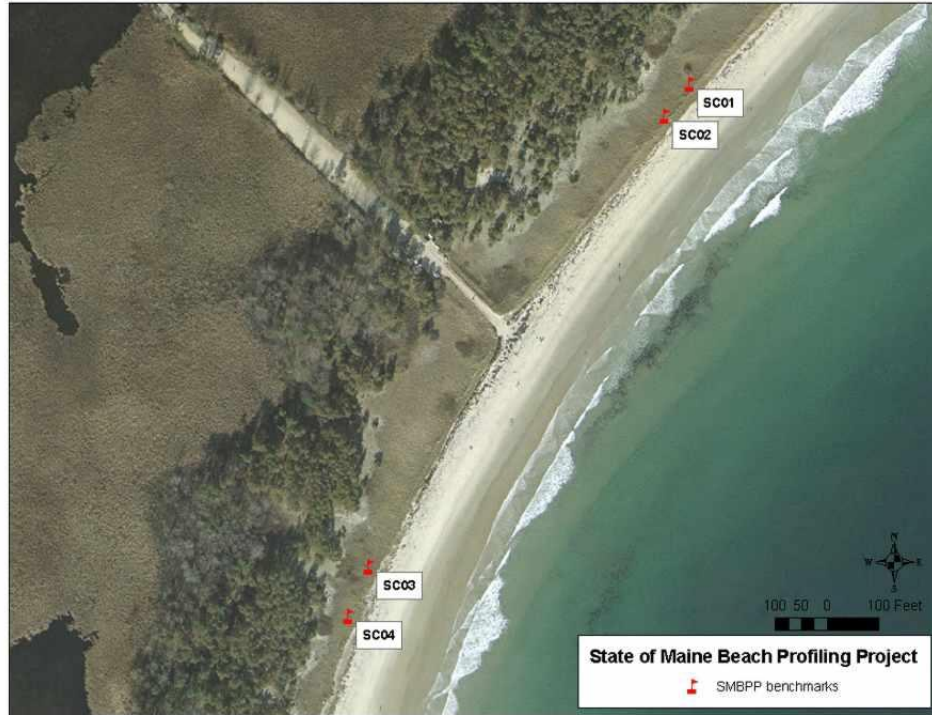
**Figure 12.** Location of beach profiles SC01 to SC04 at Scarborough Beach, Scarborough. Base imagery from Maine Office of GIS.

A total of four beach profiles (SC01 to SC04, Figure 12) were available for comparison. The profiles run chronologically from northeast to southwest along the beach. Stakes at SC02-SC03 were lost after the Patriots' Day Storm and relocated in the approximate area of the previous stakes.

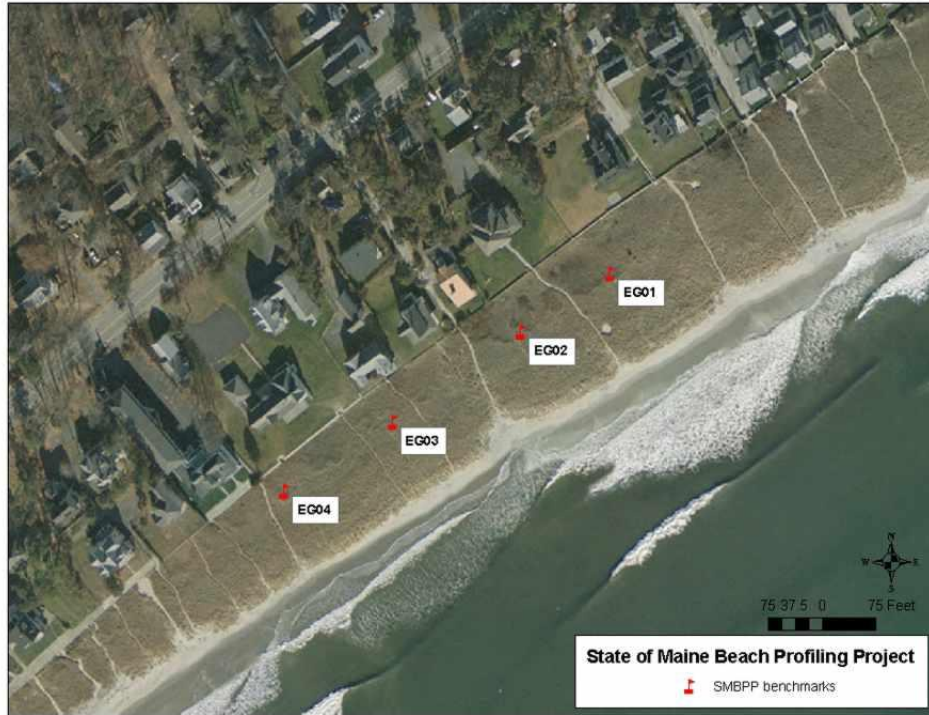
**Figure 21.** Location of beach profiles EG01 to EG04 at East Grand Beach, Scarborough. Base imagery from Maine Office of GIS.

A total of four beach profiles (EG01 to EG04, Figure 21) were available for comparison. The profiles extend northeast to southwest along East Grand Beach, clustered together. Volunteer notes indicate that the profiling stakes at all four locations were lost in the storm. New stakes were established in approximate previous locations.

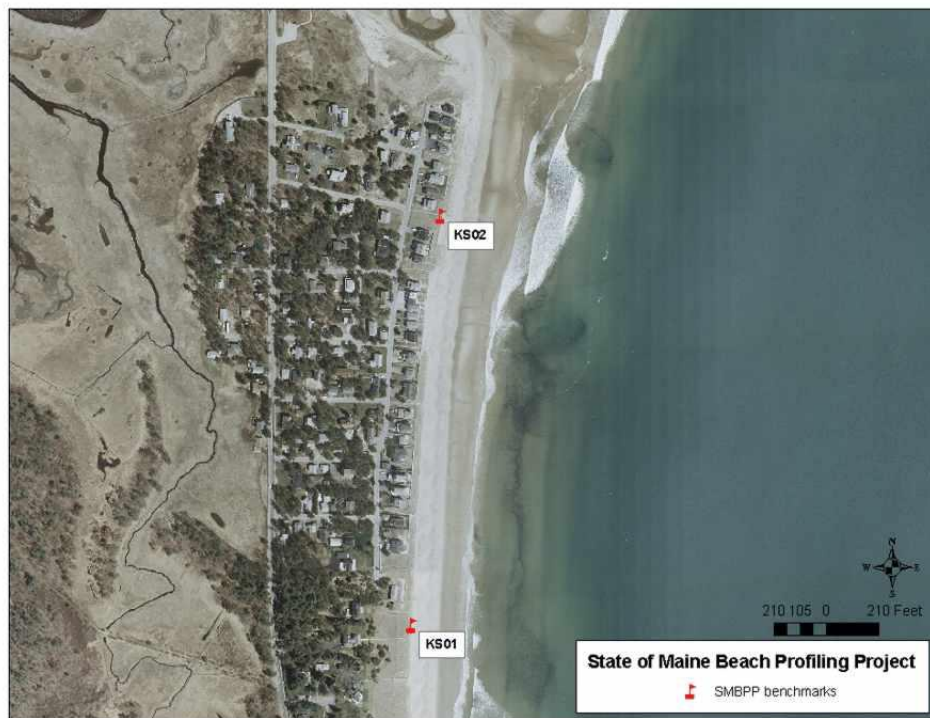
**Figure 30.** Location of beach profiles KS01 and KS02 at Kinney Shores, Saco. Base imagery from Maine Office of GIS.

A total of two beach profiles (KS01, KS02, Figure 30) were available for comparison. The profiles are located at either end of Kinney Shores, from south to north.

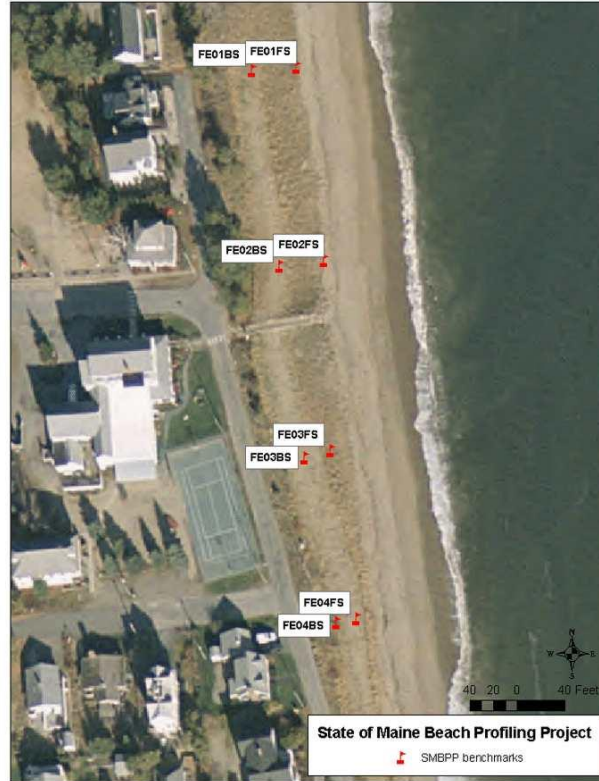
**Figure 35.** Location of beach profiles FE01 to FE04 (front and back stakes) at Ferry Beach, Saco. Base imagery from Maine Office of GIS.

A total of four beach profiles (FE01 to FE04, Figure 35) were available for comparison. It is important to note that for the 2009 assessment, the profile starting points were mislabeled. FE01 should be northernmost profile starting location, with FE04 being the southernmost. All profiles start in a natural dune. The front stake at FE04 was lost during the 2007 Patriots' Day storm, and profiling was re-established at a back stake in August 2007. New back stakes were placed for profiles FE01 and FE02, and new starting front and back stakes were placed for FE03 and FE04, in May 2010. The profiles extend north to south in chronological order.

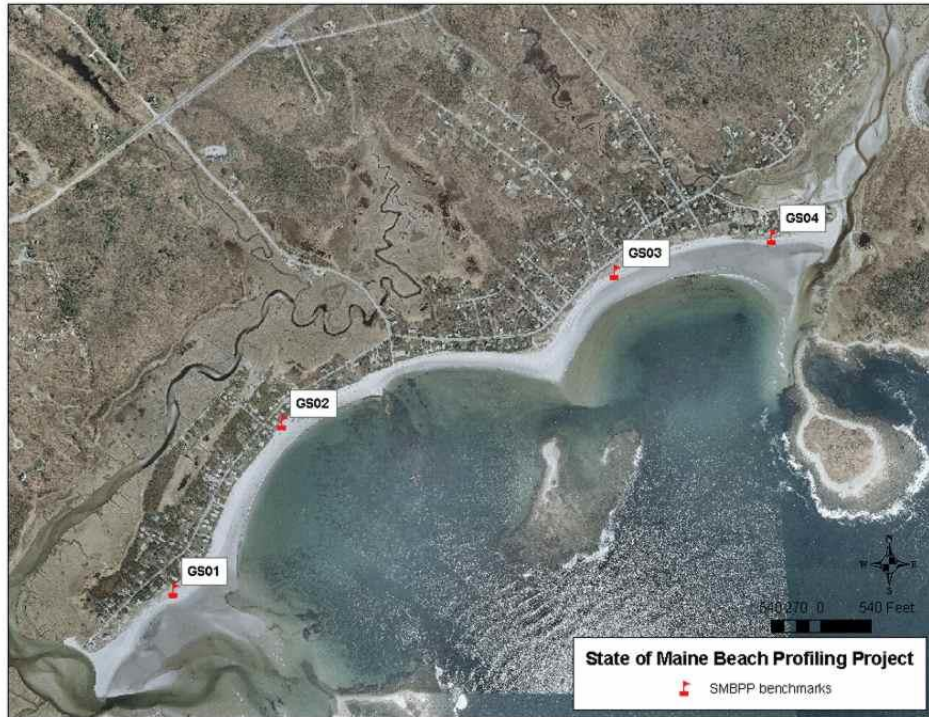
**Figure 44.** Location of beach profiles GR01 to GR04 at Goose Rocks Beach, Kennebunkport. Base imagery from Maine Office of GIS.

A total of four beach profiles (GR01 to GR04, Figure 44) were available for comparison. The profiles are spread along the beach, from southwest near the Batson River, to the northeast, near the Little River. It is important to note that all starting stakes were lost in the storm; however, new stakes were established by volunteers in approximate previous locations. In addition, volunteers have noted that the starting pins for profiles at GR03 and GR04 have been moved several times in late 2009 and 2010, so data may be flawed.

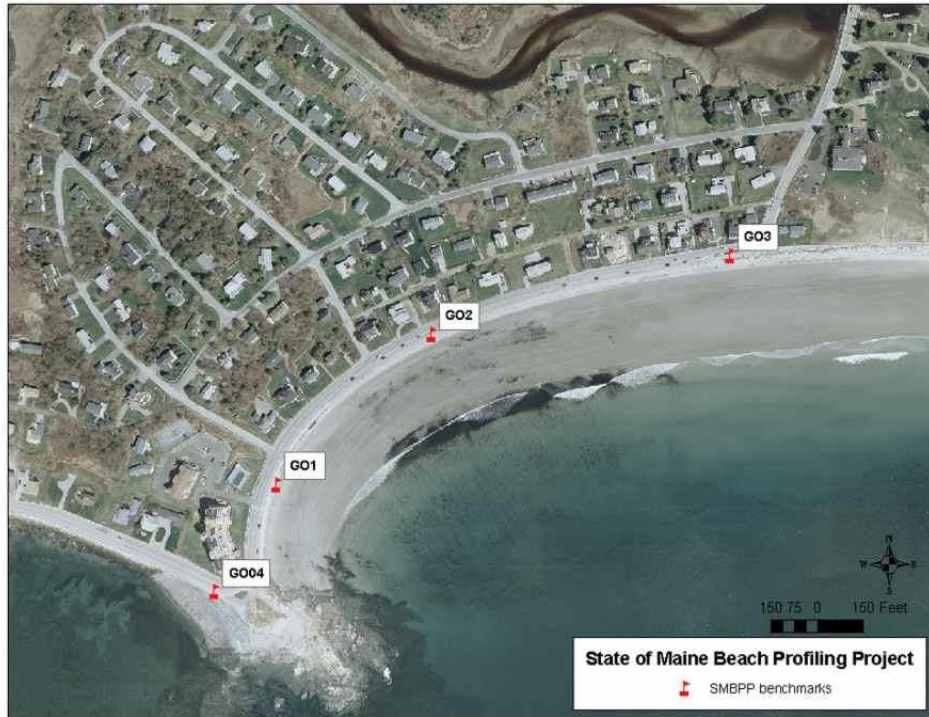
**Figure 53.** Location of beach profiles GO01 to GO04 at Goochs Beach and Middle Beach, Kennebunk. Base imagery from Maine Office of GIS.

A total of three of four beach profiles (GO02 to GO04, Figure 53) were available for comparison. Profile GO01 was lost during the storm, and profiling was not resumed until June 2007 at this location, we use the June 2007 as the "post-storm" profile. The profiles trend west to east along the beach for GO01 to GO03; GO04 is located on the adjacent beach to the west.

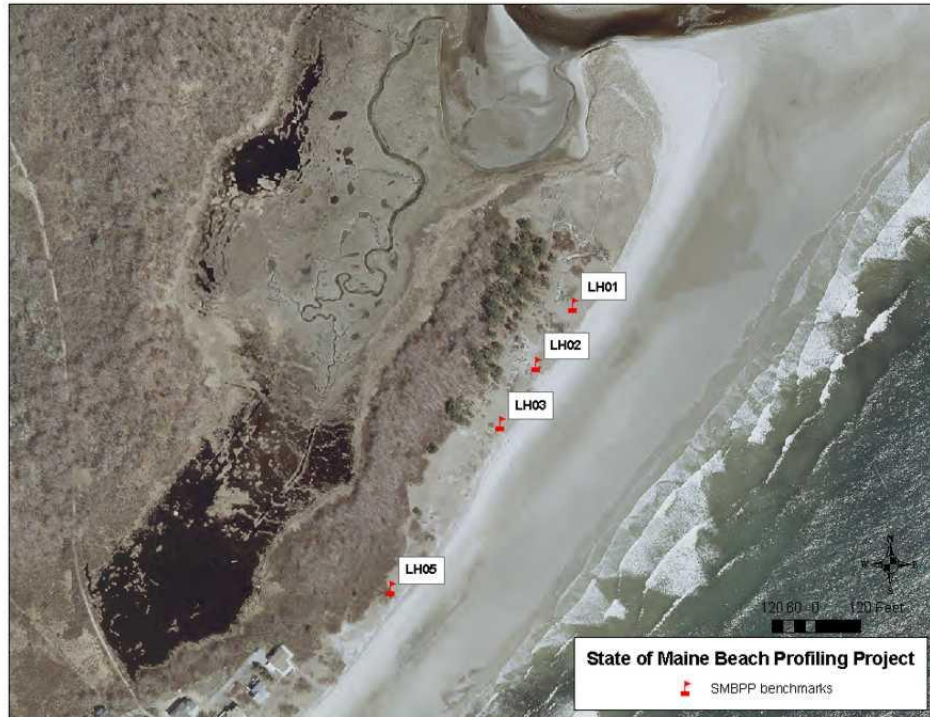
**Figure 62.** Location of beach profiles LH01 to LH03 and LH5 at Laudholm Beach, Wells. Base imagery from Maine Office of GIS.

Four beach profiles (LH01-03, LH05, Figure 62) were available for analysis of beach recovery. At LH01, the front profile stake was lost during the 2007 storm, and profiling was resumed at the back stake in June 2007. The profiles extend along a portion of the beach nearest the Little River, from northeast to southwest for profiles LH01-LH03; profile LH05 is located slightly farther to the southwest.

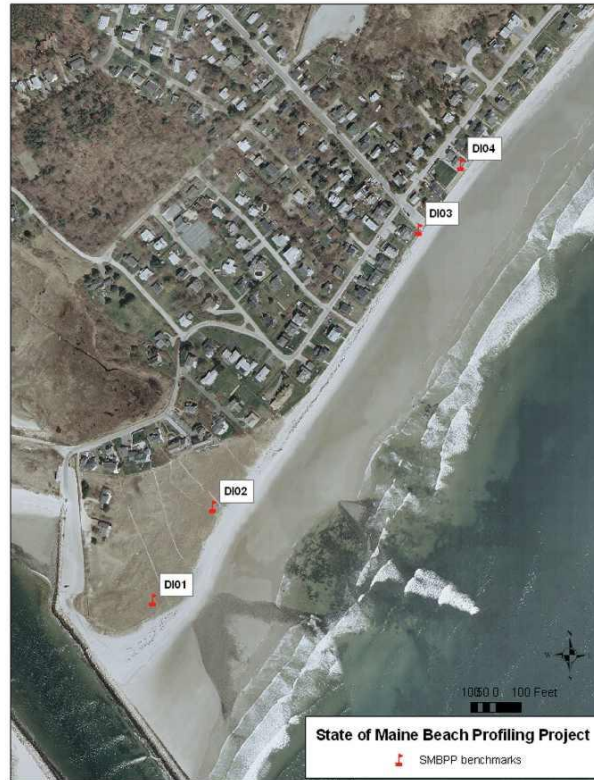
**Figure 71.** Location of beach profiles DI01 to DI04 at Drakes Island Beach, Wells. Base imagery from Maine Office of GIS.

Four beach profiles (DI01-DI04, Figure 71) were available for analysis. It appears that no profiles were entered in the online database in 2011, so analysis will end with comparison with July 2010 profiles. The profiles are placed from the southwest, near the Webhannet River, to the northeast.

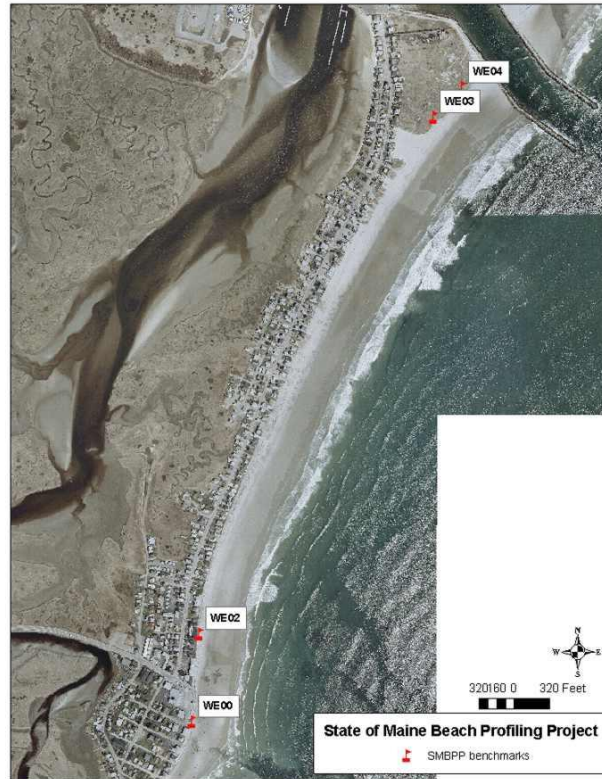
**Figure 80.** Location of beach profiles WE00 to WE04 at Wells Beach, Wells. Base imagery from Maine Office of GIS.

Four beach profiles (WE00, WE02-WE04, Figure 80) were available for analysis. The profiles are located from the southwest to northeast along Wells Beach.

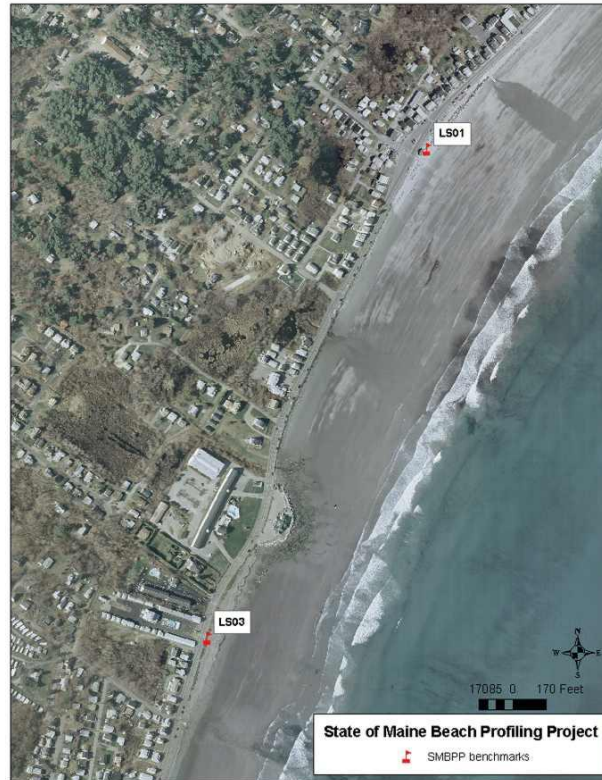
**Figure 92.** Location of beach profiles LS01 and LS03 at Long Sands Beach, York. Base imagery from Maine Office of GIS.

Two beach profiles (LS01 and LS03, Figure 92) were available for comparison. Profile LS02 was lost during the Patriots' Day Storm of 2007, and profiling not resumed. The profiles are spread from northeast to southwest along the beach.

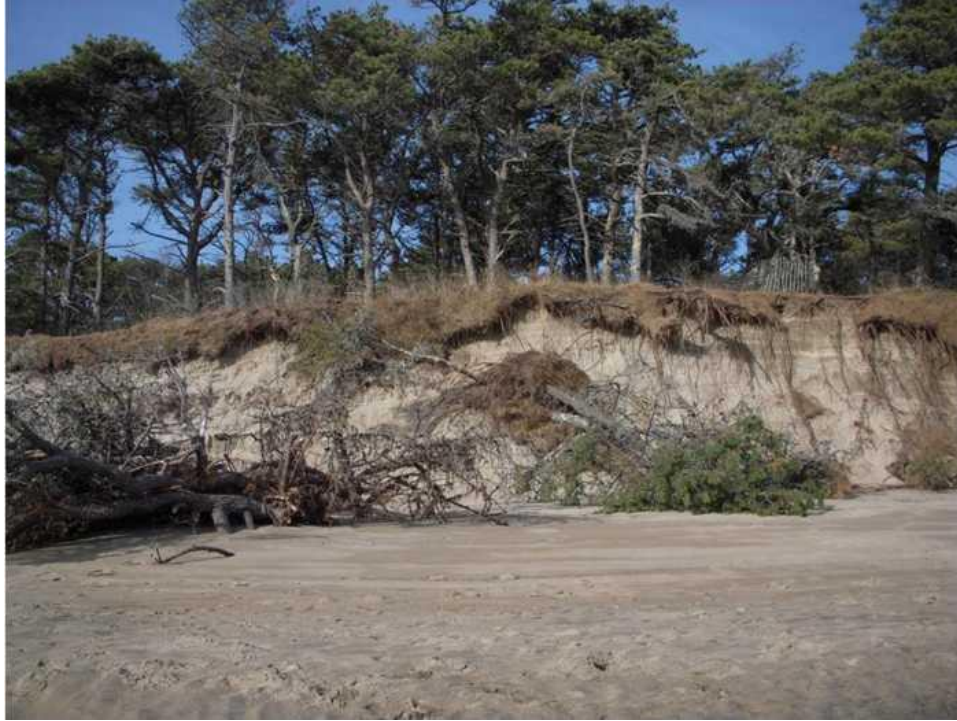
Near the western bath house at Popham Beach State Park, the river bank along West Beach eroded landward at a rate of 10 to 15 feet a week in November 2009 (Figure A2). Erosion was most rapid during storms but the ebb and flood currents in the Morse River most likely led to additional sand being swept away between storms along the outer bend in the river (Dickson, 2010 - Figure 15). The Department of Conservation considered and implemented a plan to slow erosion that included moving fallen trees downstream to the vicinity of the bath house. The goal was to emulate the natural process observed along the river bank nearby where fallen trees were slowing the flow, resulting in a wider beach, and reducing bank erosion and forest loss (Dickson, 2010).

**Figure A2.** A November 11, 2009 view of the edge of the Popham dunes and forest along West Beach. Pitch pine trees were actively being undercut by Morse River erosion and wave action and falling on West Beach. MGS file photo by S. M. Dickson.

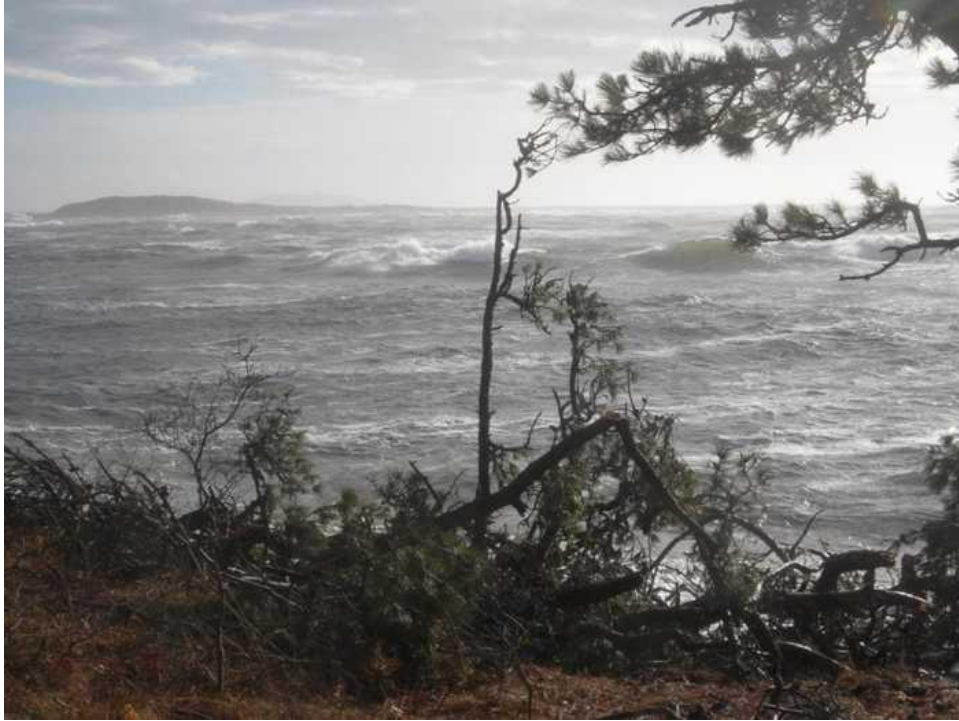
**Figure A3.** A December 3, 2009 southeaster sent large irregular surf directly to the edge of the Popham dunes and forest at high tide. Fortunately some of the surf broke offshore on sand bars and reduced the energy in the waves reaching the dunes. MGS file photo by S. M. Dickson.

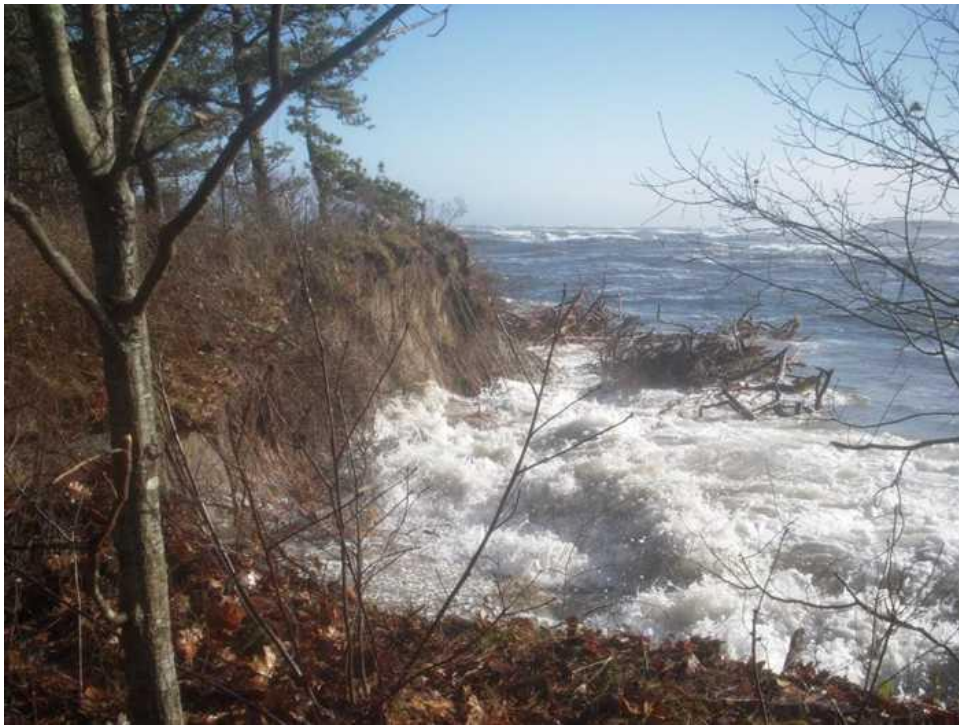
**Figure A4.** A December 3, 2009 southeaster sent large irregular surf directly to the edge of the Popham dunes and forest at high tide. As waves scoured the toe of the sand bluff, alongshore currents driven by the Morse River removed sand from the beach. MGS file photo by S. M. Dickson.

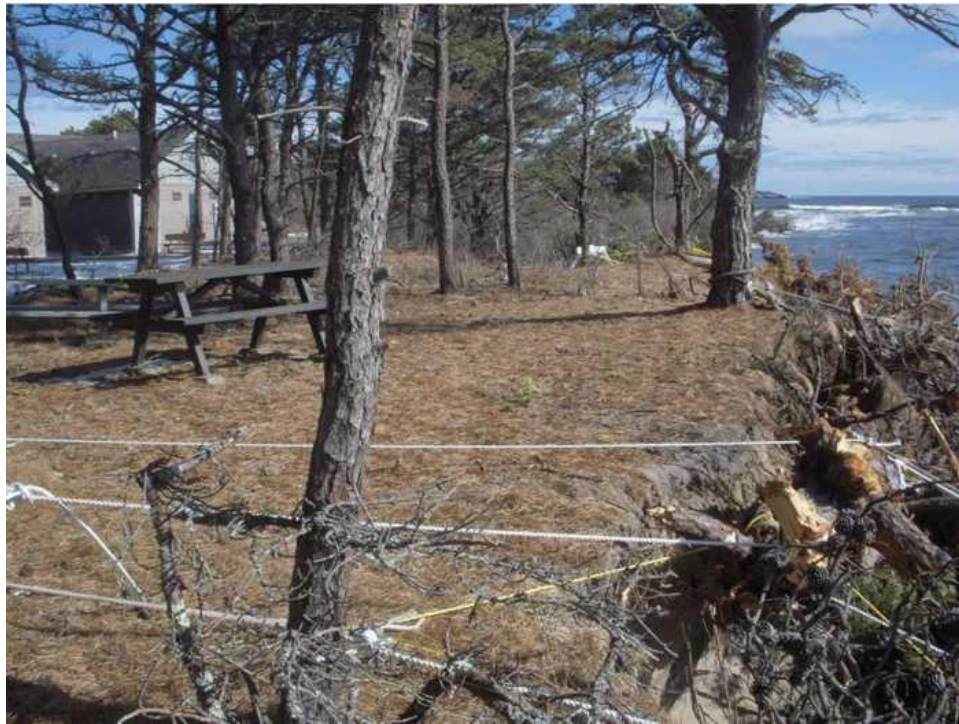
**Figure A5.** Each big storm moved the ocean 15 feet closer to the bath house. Only 75 feet of ground remained between the erosional scarp and the bath house. The vertical cut down to the beach is 5-10 feet below the grade the bath house sits on. Ropes tied fallen trees together and then were secured to living trees to hold them in place. MGS file photo by S. M. Dickson, February 17, 2010.

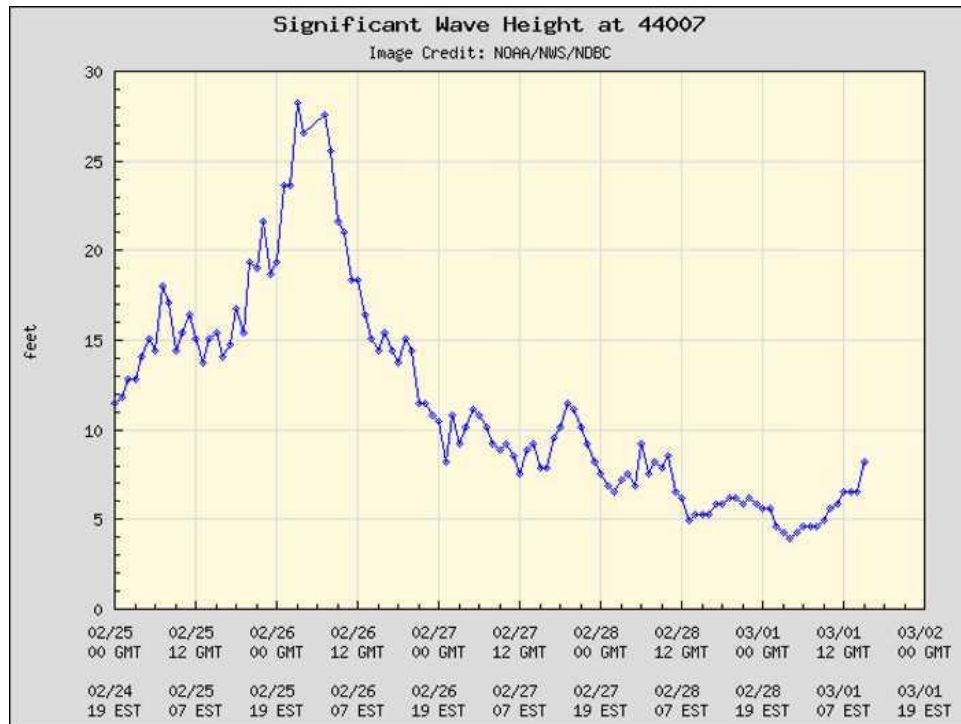
**Figure A6.** Waves at the Casco Bay buoy (No. 44007) off Portland recorded waves as high as 28 feet during the onset of a large storm on February 25-26, 2010. Waves, and thus surf at Popham Beach remained elevated into March. Significant wave height is the average of the one-third highest waves recorded over a period of 20 minutes. Image courtesy of the National Data Buoy Center at the National Oceanic and Atmospheric Administration.

With only a month left in the winter storm season, conditions were set up for a major storm in the Gulf of Maine the last week of February. Predicted tides would be some of the highest in a year. A storm centered over Connecticut developed a low barometric pressure of 972 millibars that created strong onshore winds along the Maine coast. On February 25, storm tides ran higher than normal as a result of the wind-driven surge. From February 25 to 26 waves at the Portland buoy were 15 to 28 feet (Figure A6). These extreme waves were only 2 to 3 feet below the historic October 1991 Perfect Storm and the April 2007 Patriots' Day Storm.

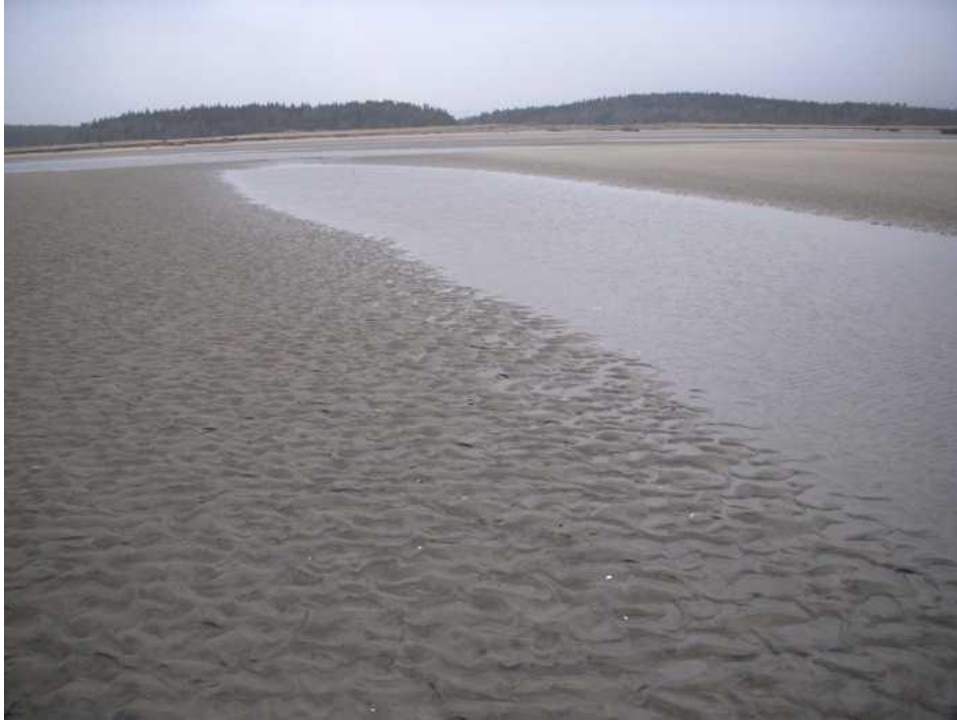
**Figure A7.** A view on February 27, 2010 from the Seawall Beach spit looking north toward West Beach at Popham Beach State Park. The washover channel (right) still holds water but is only a foot deep and well above the depth of the Morse River channel in the background. MGS file photo by S. M. Dickson.

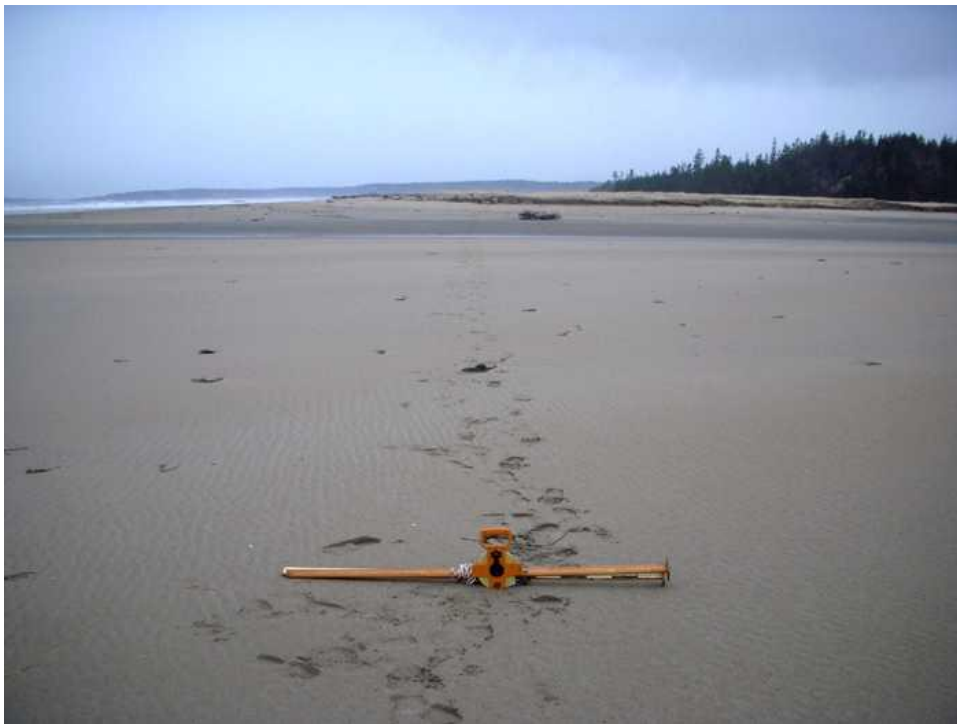
**Figure A8.** A view on February 27, 2010 on the Seawall Beach spit looking west toward Seawall Beach and across the incipient new channel of the Morse River (darker beach below the stranded tree). Emery Beach Profiling rods and tape measure in the foreground are at the eastern terminus of an elevation survey started at the dune in the background. The survey was conducted to check the new channel's width and depth. MGS file photo by S. M. Dickson.

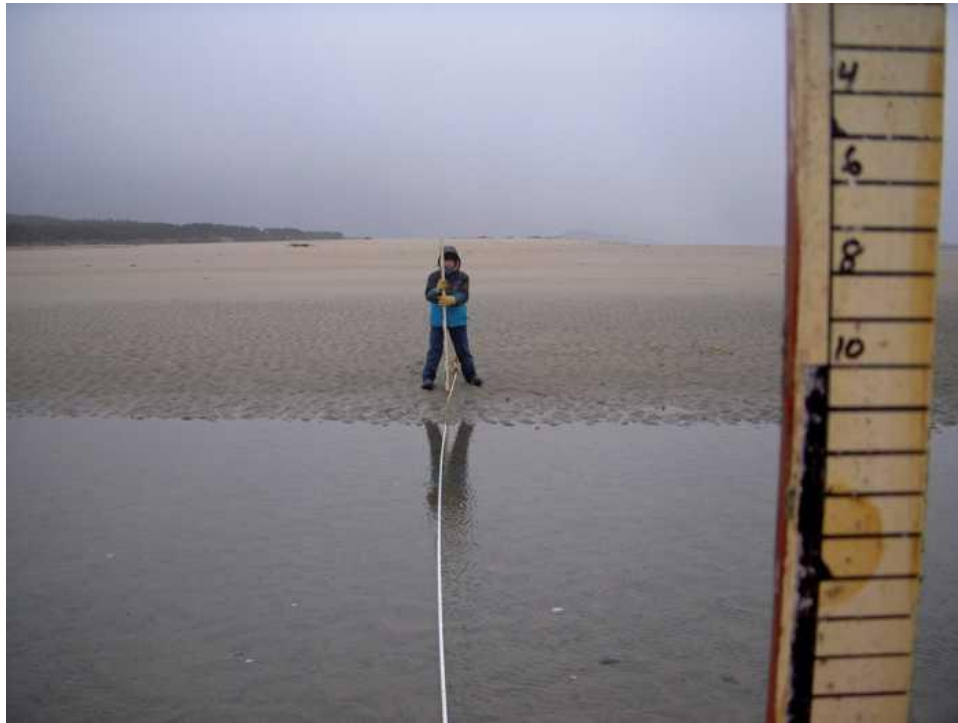
**Figure A9.** The Emery Beach Profile across the channel spanned the shallow channel that would become the new Morse River channel in about a week. Elevations are recorded in centimeters from the higher of two poles and a line with the horizon. February 27, 2010 MGS file photo by S. M. Dickson.

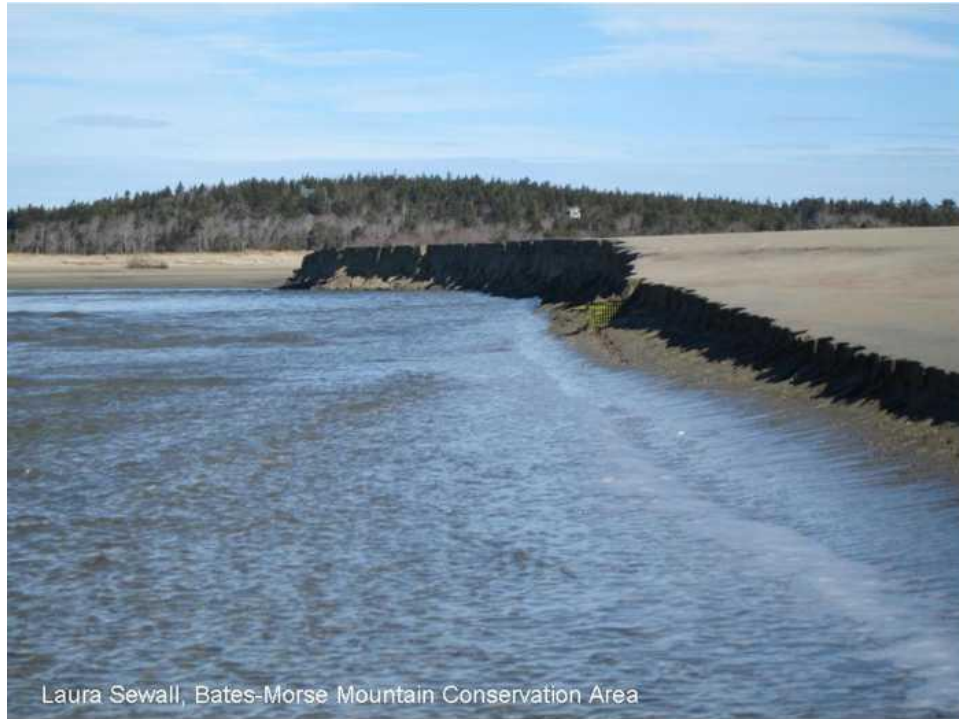
**Figure A12.** A photo from March 6, 2010 of the new Morse River channel looking north toward West Beach. The rapid downward erosion of the channel results in a steep vertical cut into the sand spit (right) where large blocks of sand fall into the flowing channel. Bank erosion even exhumed a buried yellow lobster trap. Photo courtesy of L. Sewall, Bates-Morse Mountain Conservation Area.

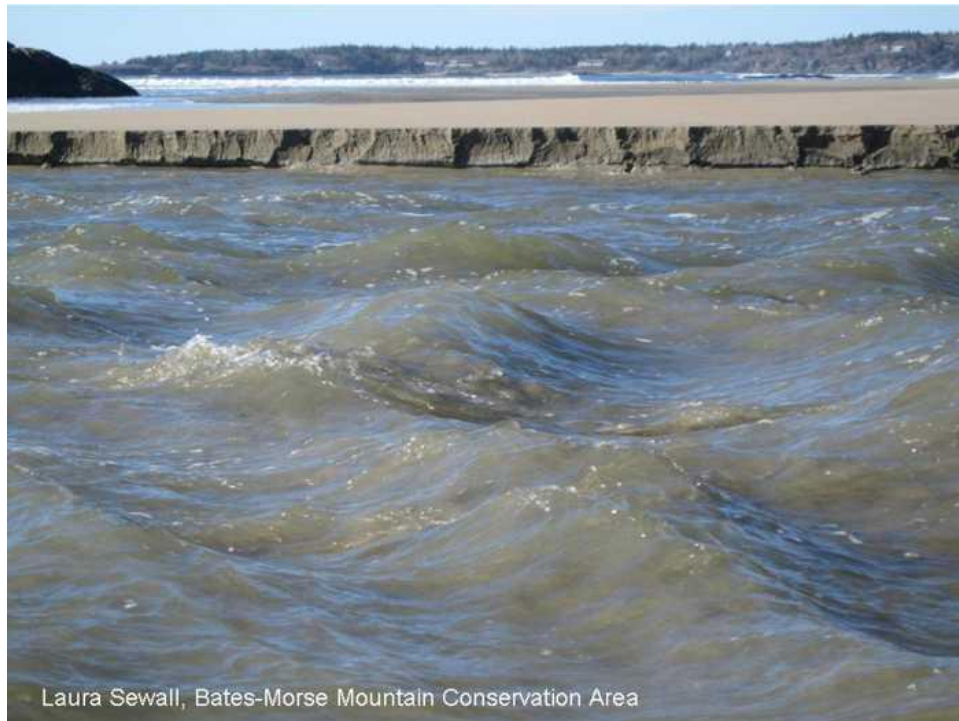
**Figure A13.** A photo from March 6, 2010 of the new Morse River with waves helping to suspend sand and scour the channel deeper. In the background is surf breaking on Seawall Beach. Photo courtesy of L. Sewall, Bates-Morse Mountain Conservation Area.

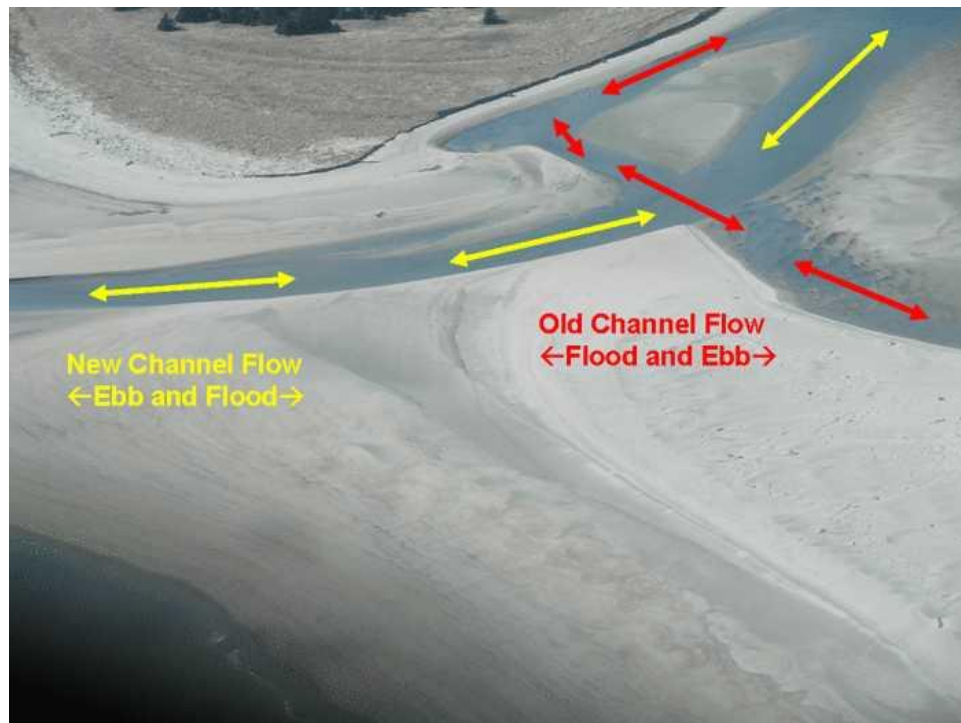
**Figure A14.** The Seawall Beach spit (sand bar) was cut by the February 25-26 storm. Large tides and surf continued to lower the bar for a week - through March 5 and 6 - when deep erosion formed a new tidal channel with a straighter and more direct course for the Morse River to the sea. Note the stranded tree on the far bank of the channel is the same one in Figure A8. Photo taken March 10, 2010 courtesy of J. Picher, DOC. Annotation by S. M. Dickson, MGS.

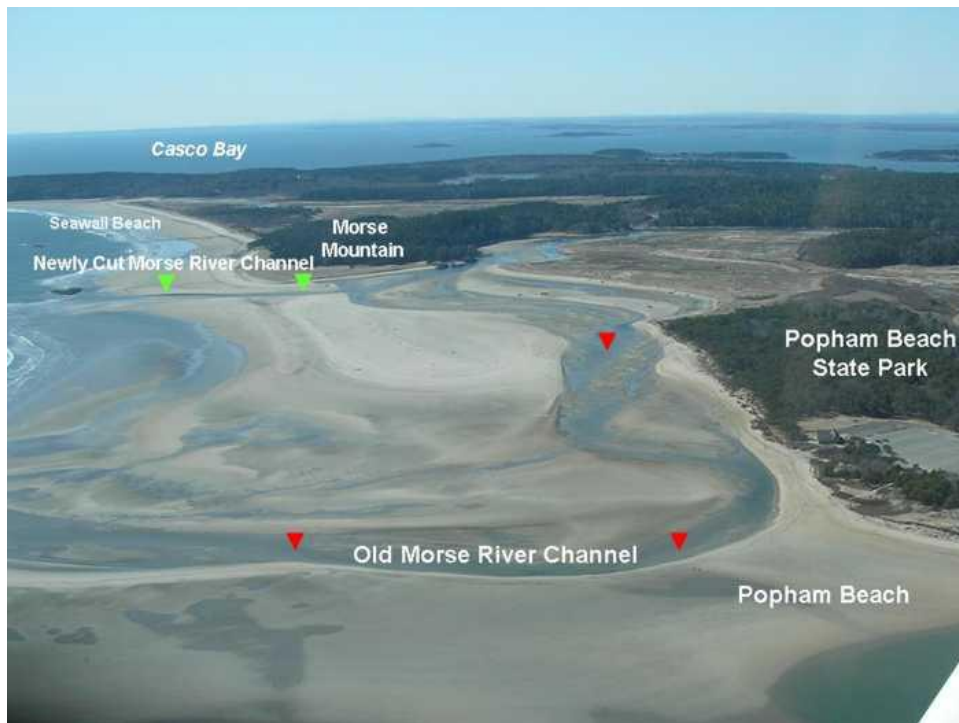
**Figure A16.** An aerial view from over Fox Island and its tombolo (sand bar in foreground leading to the state park dunes). The meandering course of the Old Morse River is marked by red triangles. The new channel is shown by green triangles. The newly formed sand island is in the center with Seawall Beach and Casco Bay in the background. Photo taken March 10, 2010 courtesy of J. Picher, DOC. Annotation by S. M. Dickson, MGS.

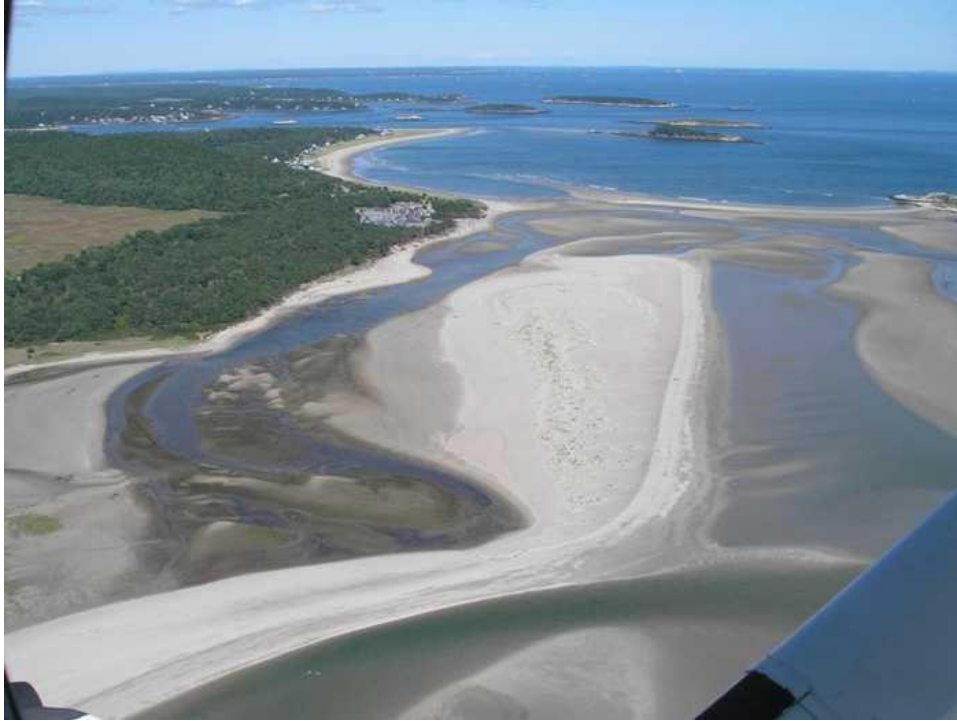
**Figure A18.** An aerial view of Popham Beach State Park and the sand island on August 20, 2010. In the foreground, sand has been transported off the island in a shoreward (left) direction and resulted in the infilling of the former Morse River channel. Photograph by J. Picher, DOC. Flight courtesy of the Maine Dept. of Marine Resources.

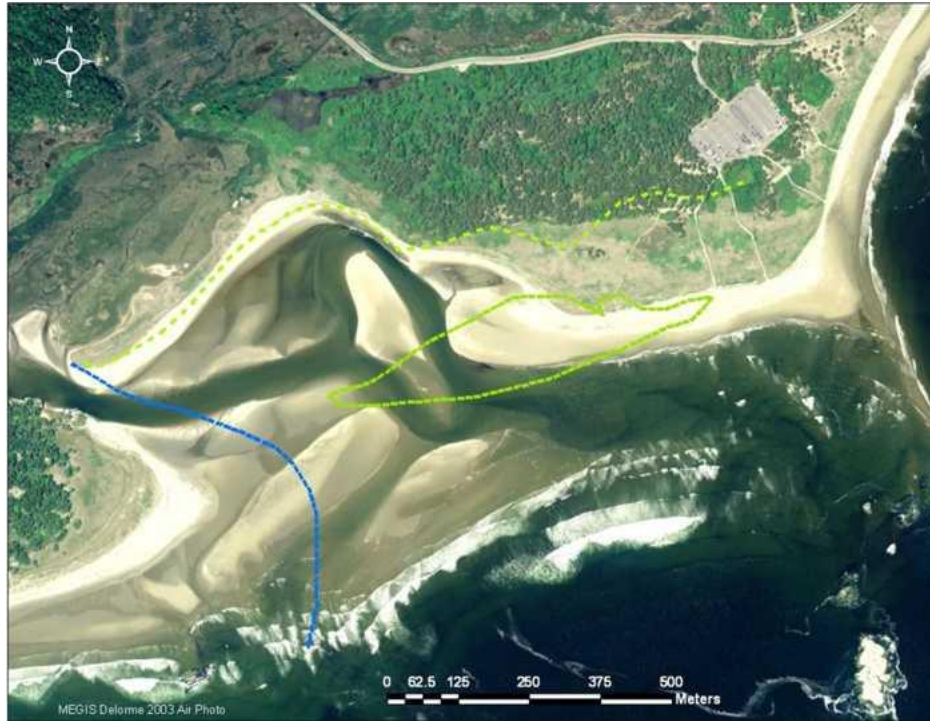
**Figure A20.** The October 29, 2010 island shoreline (LHTS, short dashed green line) is superimposed on a 2003 air photo. The fall 2010 island position slightly overlaps the 2003 dune field. The October dune/forest edge is shown in the upper dashed green line and the east bank of the Morse River is in the blue dashed line. Shoreline positions were recorded with a hand-held Garmin 12Map GPS. Photo courtesy of MEGIS/Delorme.

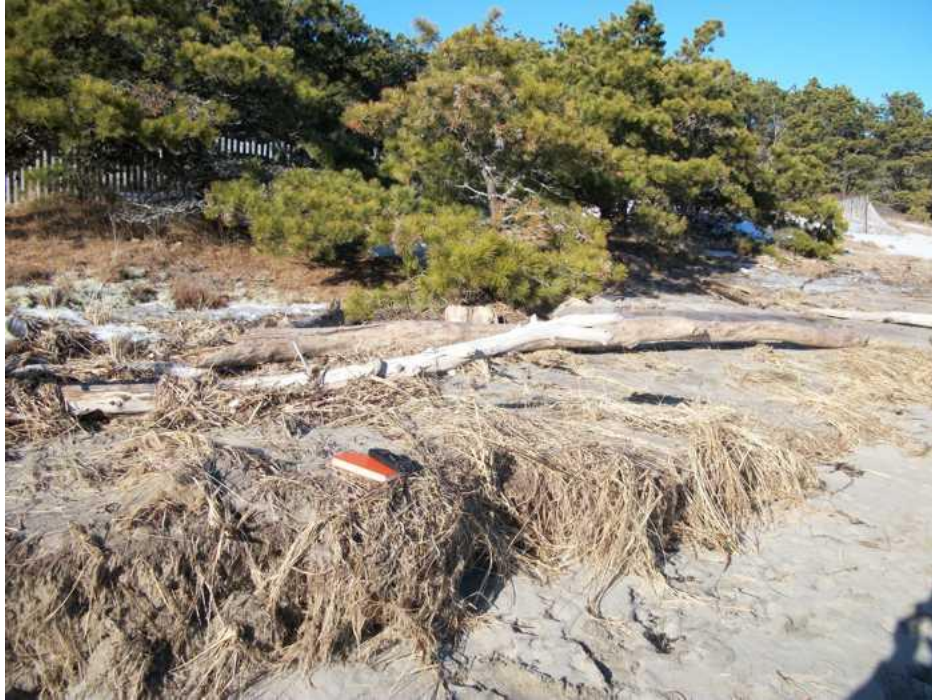
**Figure A22.** January 3, 2010 photo of low frontal dunes at the eastern end of East Beach. Storm waves and flooding have deposited sand and driftwood into the dunes. Erosion has removed some of the higher frontal dune ridge at this location so flooding is more able to reach farther inland. Photo by S. M. Dickson, MGS.

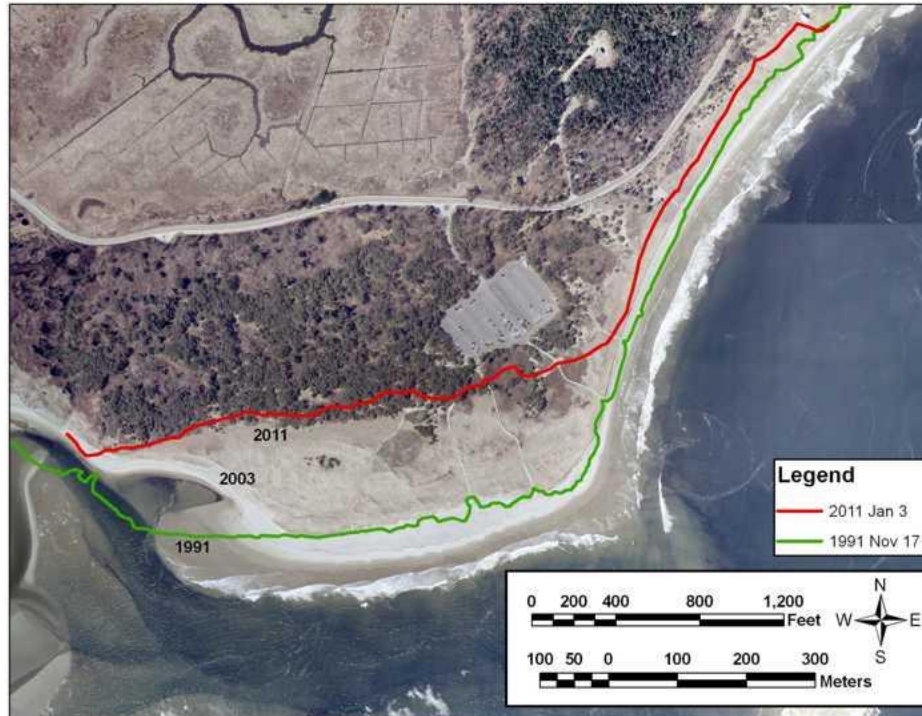
**Figure A23.** This map shows twenty years of shoreline change at Popham Beach State Park from 1991 to 2011 showing the maximum and minimum edge of the dunes. The largest dune area was present in 1991 and represents the most southerly extent of dunes at Center Beach in the last 30 years. From 1991 to 2003 (when the photo was taken) the Morse River removed dunes on the west side of the dune field but the center of the dune field remained stable. From 2003 to 2011 erosion by the Morse River progressed eastward (Figure A21). The smallest area of dunes since 1980 (not shown) occurred in 2011. The 1991 shoreline from an historical vertical photograph about 3 weeks after the Perfect Storm (October 31, 1991), shows an irregular dune edge. The 2011 shoreline was recorded using a hand-held Garmin 12Map GPS. Air photo (6-6-03) courtesy of the Maine Office of GIS. Graphic by S. M. Dickson, MGS.
