Maine Geologic Facts and Localities  
November, 2008

***Seawall and Popham Beach Dynamics***  
***Phippsburg, Maine***

Text by  
Stephen M. Dickson

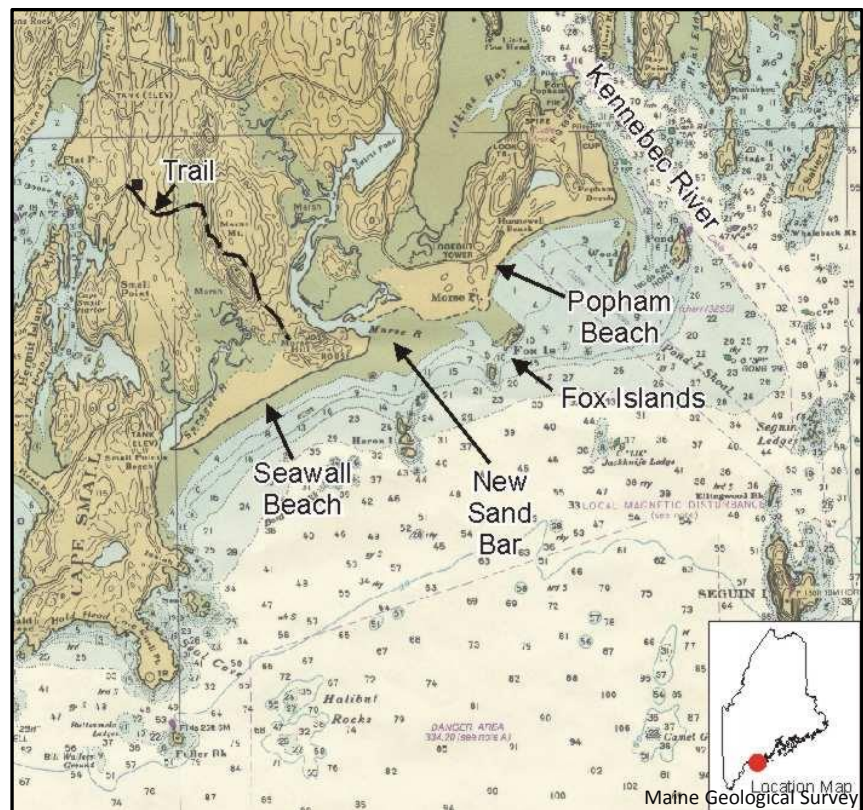
**Figure 1.** Nautical chart of mid-coast Maine with the locations of the mouth of the Kennebec River next to Popham Beach, Fox Islands just seaward of Popham Beach State Park, Morse River, and Seawall Beach adjacent to Small Point.

Access to the mouth of the Morse River can be from the east via Popham Beach State Park or from the west via Seawall Beach. In order to see the new beach spit first-hand or to walk out on it when the tide is low, a hike from Route 216 will lead to the beach and the spit (Figure 1).

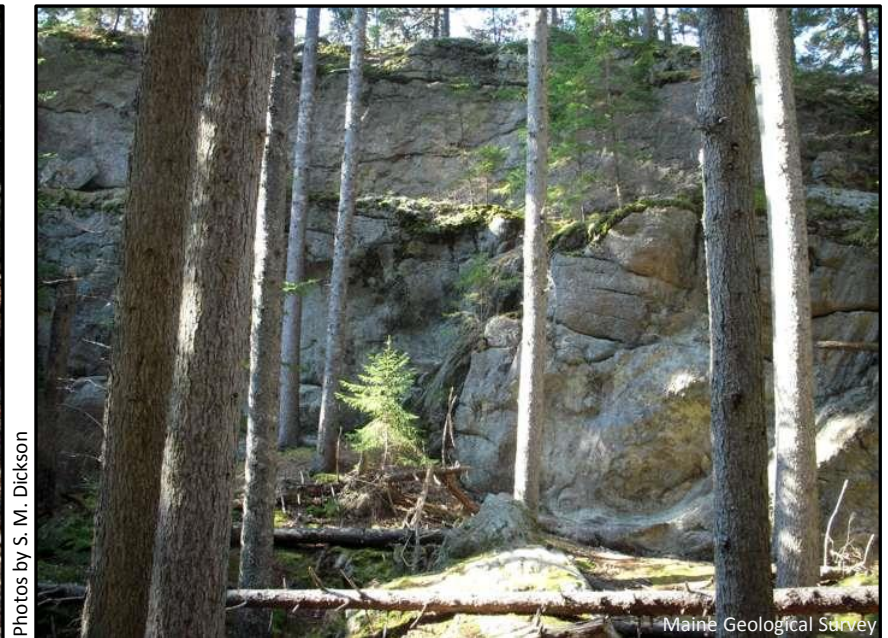
**Figure 2.** (Left) A view of the hiking path. (Right) Vertical outcrop of bedrock along the trail.

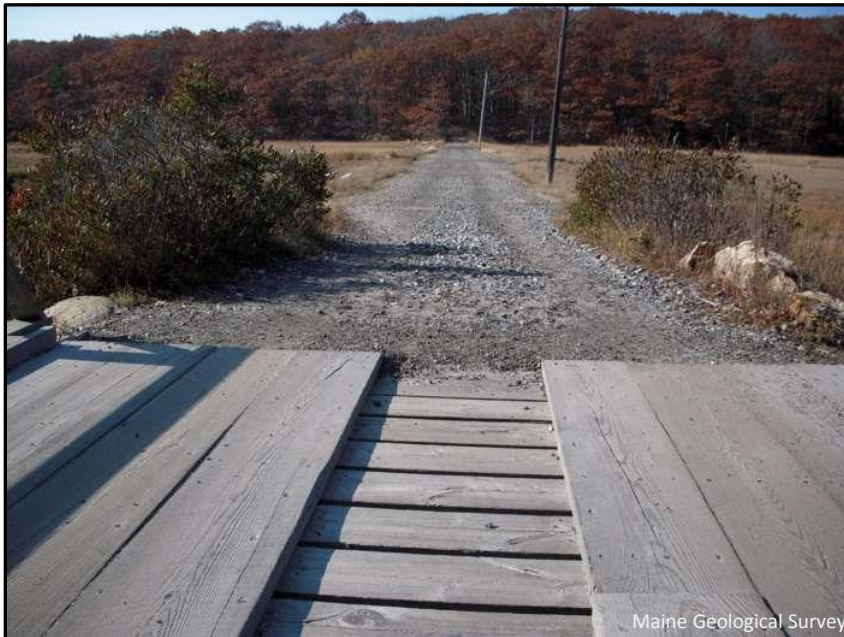
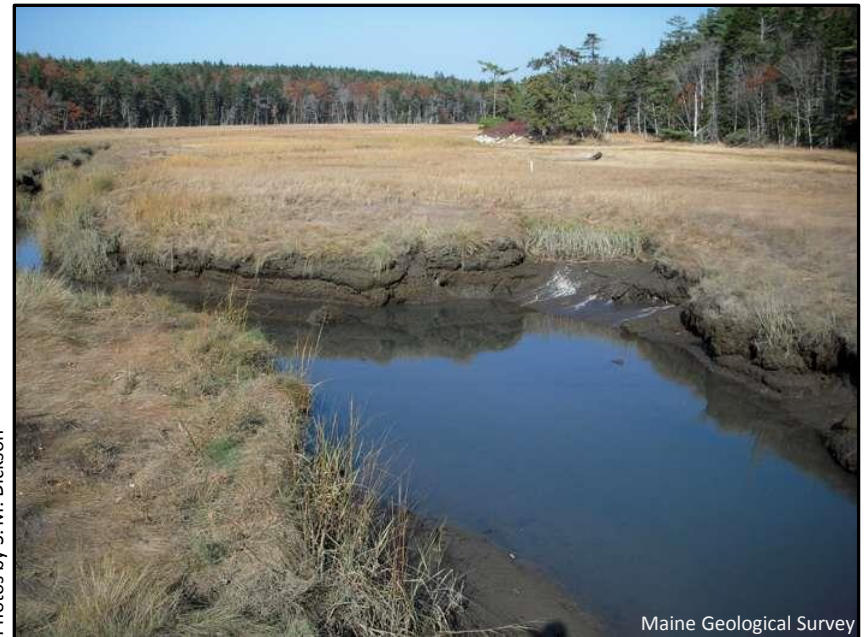
**Figure 3.** (Left) The path crosses the Sprague River and salt marsh. A culvert allows tidal currents to flow beneath the path. This is an area where Bates College, The Nature Conservancy, the Small Point Association, The Natural Resources Conservation service and others began a salt marsh restoration effort in 2002. (Right) A view of Sprague River channel.

Note that the marsh crossings are about at the level of the spring high tide (high salt marsh), so if tide predictions are over 10 feet (which happens only a few times a year) the path may be covered with salt water at the time of high tide.

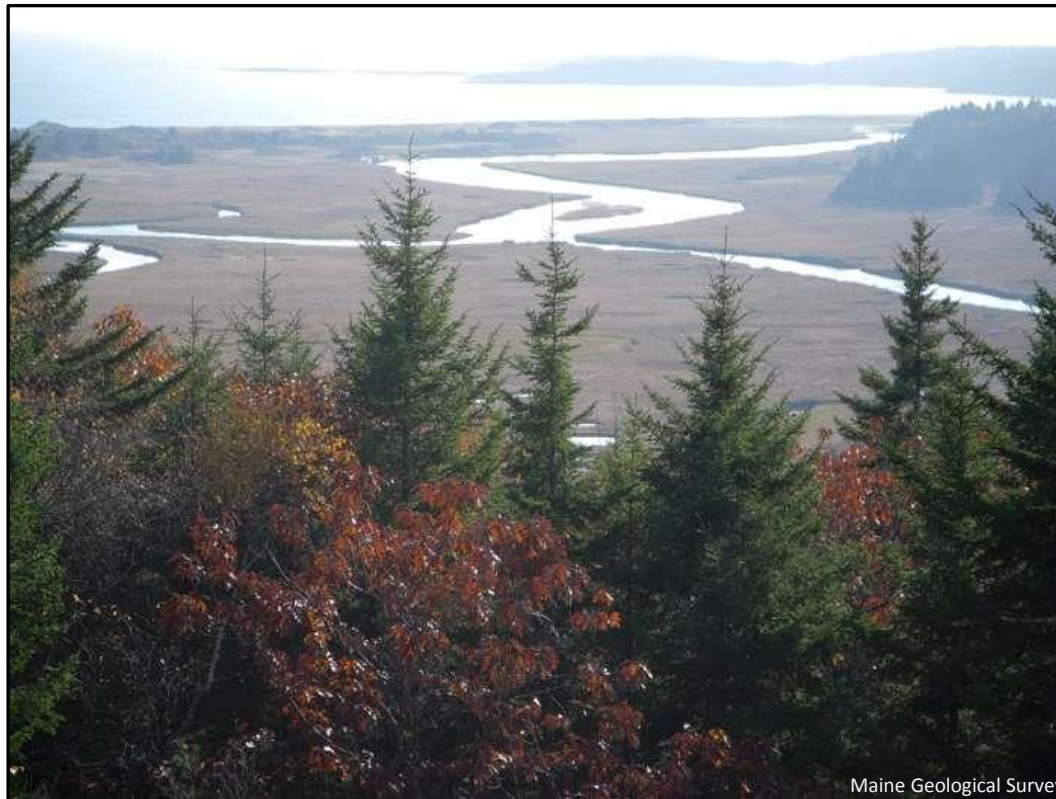
**Figure 4.** A view from Morse Mountain of the Seawall coastal barrier system. Seawall Beach is on the far side of the dunes. The overlook also provides a panorama of low-lying hills and Casco Bay to the east

Before reaching the beach it is possible to walk up Morse Mountain on a short side trail for an overlook to see the ocean, barrier dune system, and back-barrier salt marshes of Seawall Beach and the Sprague River (Figure 4). From Morse Mountain it is even possible to see Casco Bay on a clear day.

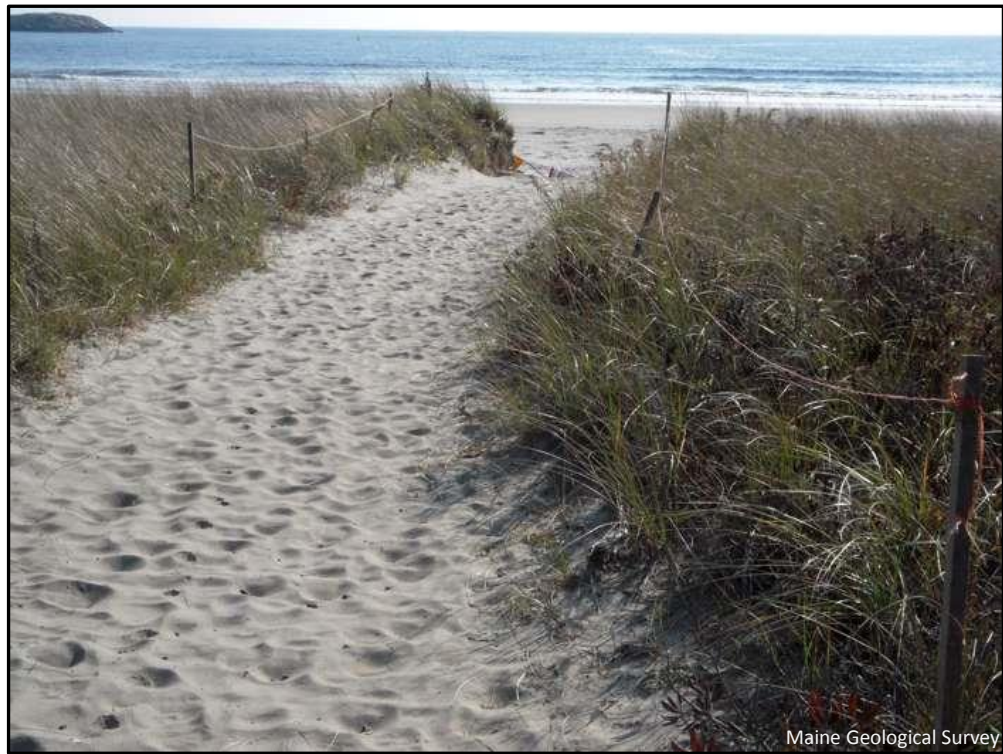
**Figure 5.** The path turns from gravel and asphalt to soft sand at the entrance to the beach. From the high point shown in the path it is possible to see the large frontal dune system of Seawall beach.

At the end of the main trail, the path crosses through mature back dunes and the frontal dune (Figure 5). Seawall Beach is one of Maine's finest beaches. The beach is important habitat for [piping plovers](#) and [least terns](#) and signs at the entrance to the beach will inform visitors of what they look like and how to avoid disturbing them in nesting season in the summer.

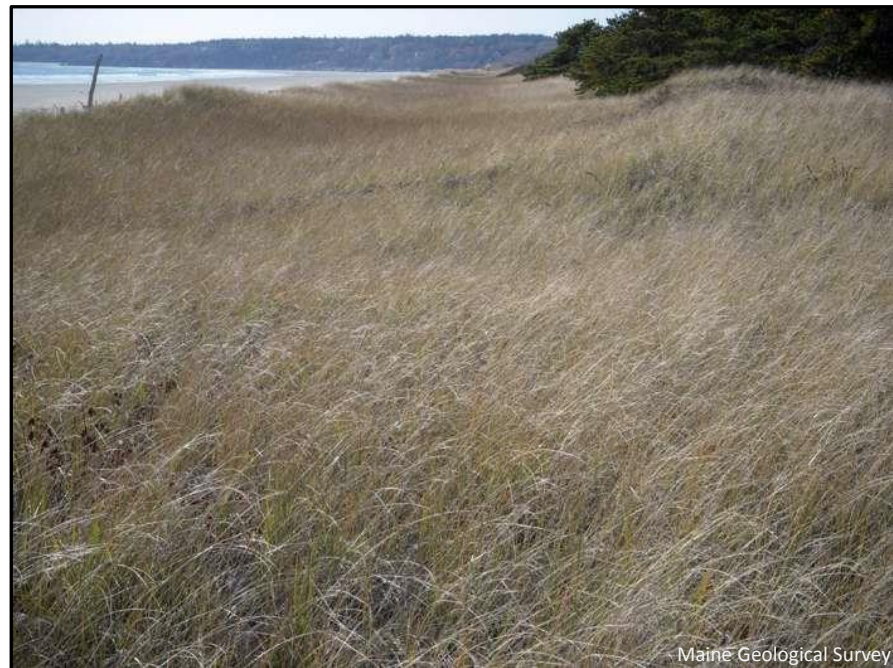
**Figure 6.** The frontal dune ridge at Seawall Beach. The rise in the dune ridge to the right side of the photo is a relict dune scarp from the Blizzard of February 1978. The storm created coastal flooding, and large surf eroded the dune well inland of where it is today. This 100-year storm left a legacy in many of Maine's frontal dunes similar to that seen here.

It is very linear and has a natural frontal dune ridge (Figure 6) and no seawalls as the name might suggest. Winter erosion can lead to dune loss and the formation of a vertical drop or scarp that runs along the frontal dune. As you approach the beach on the dune path look to the right (southwest) and note the change in dune elevations that are vegetated with [American beachgrass](#). See if you can see signs of fresh sand washed into the dune from recent ocean storms. This process, called overwash, leads to the dunes building in elevation and being more storm resistant.

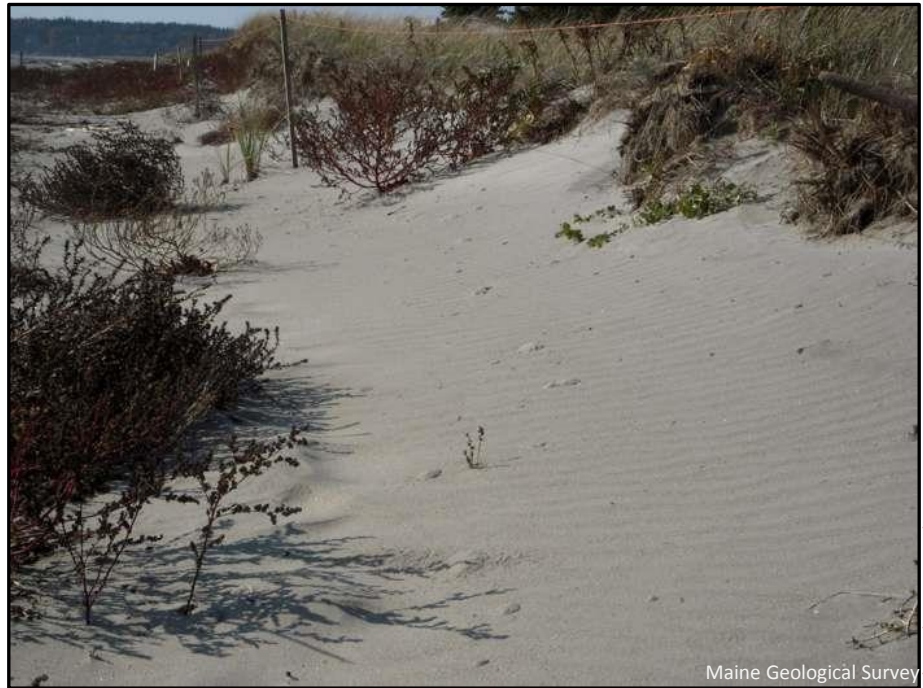
**Figure 7.** The seaward edge of the frontal dune has a vertical drop to the beach created by storm wave erosion. Here a wind-blown sand ramp has formed up against the dune scarp.

The dune scarp that forms in winter can be "repaired" naturally by wind and wave action. Waves can push sand up from the beach during high tides or periods of surf all the way to the toe of the dune. Wind can blow dried beach sand up against the dune scarp and produce what geologists call an eolian ramp (Figure 7). These processes of accumulation on the seaward edge of the dune help repair winter storm damage and also provide sand for beach grass to grow in during the summer. The beach berm or relatively flat sand accumulation in front of the dune also collects seaweed, driftwood, shells, and litter.

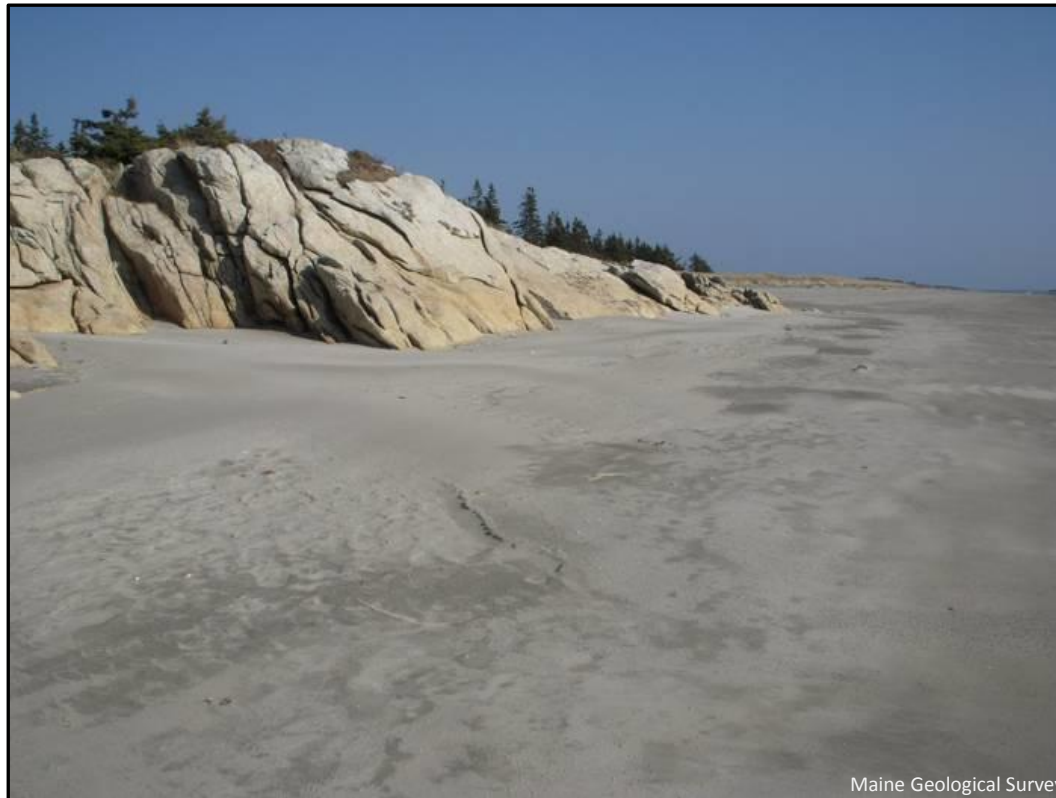
**Figure 8.** A view east from the path entrance to a bedrock outcrop of Devonian granite on the beach. When the tide is high it may not be possible to walk on a dry beach around the outcrop to reach the beach spit in the distance.

A walk along the beach to the east (left from the path entrance) leads to the beach spit and the Morse River. The dune gives way to a bedrock outcrop that rises directly from the beach (Figure 8). At high tide it may be necessary to get around the outcrop either by wading or climbing over its steep slopes.

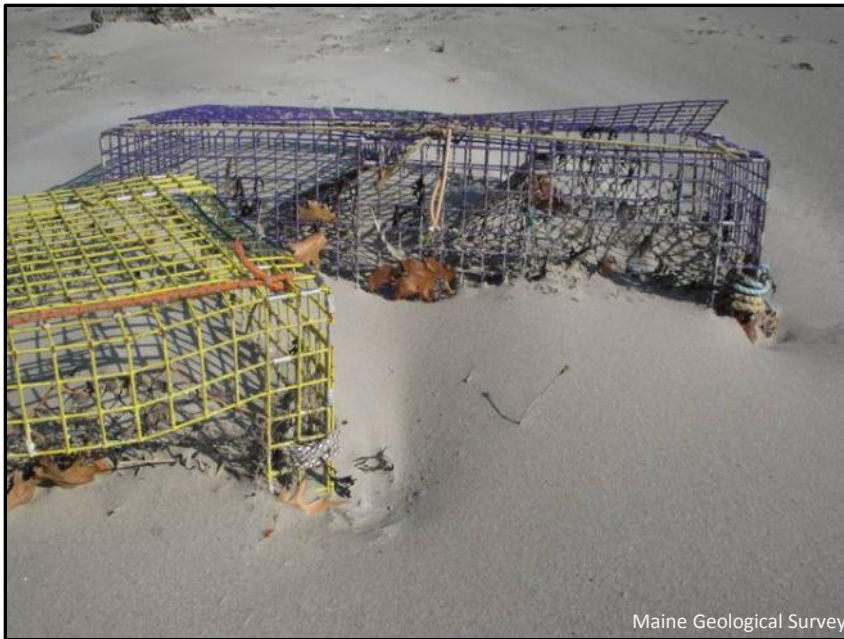
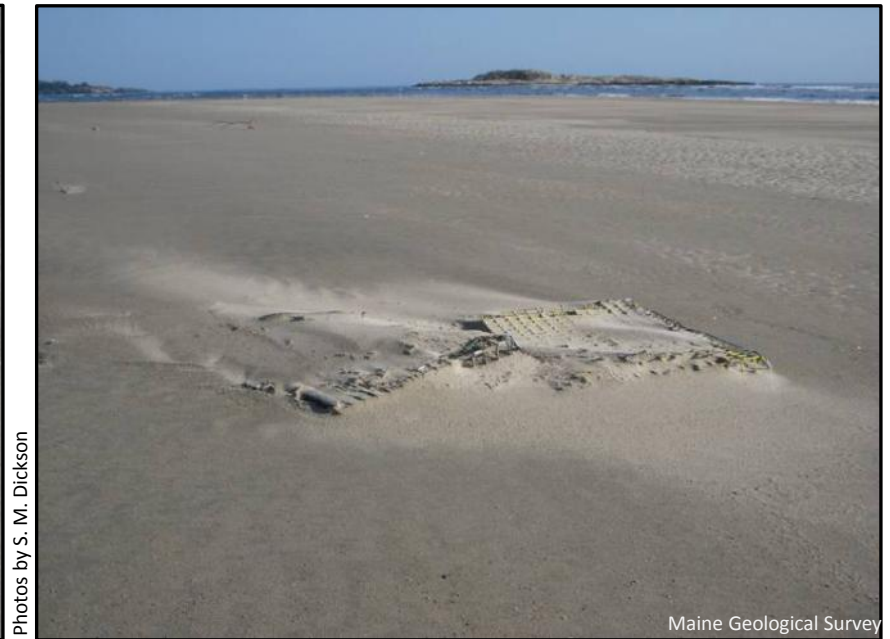
**Figure 9.** (Left) Surf washes loose lobster traps ashore. Any obstacle on the beach profile will slow wind and lead to sand deposition. Here sand is infilling the traps. (Right) Two lobster traps are buried in the intertidal beach profile.

Along the walk you may find stranded lobster traps among other items that have been pushed ashore by surf. Along with driftwood, lobster traps act as sand traps (Figure 9). At the end of the vegetated sand dune you will reach the beach spit and channel of the Morse River.

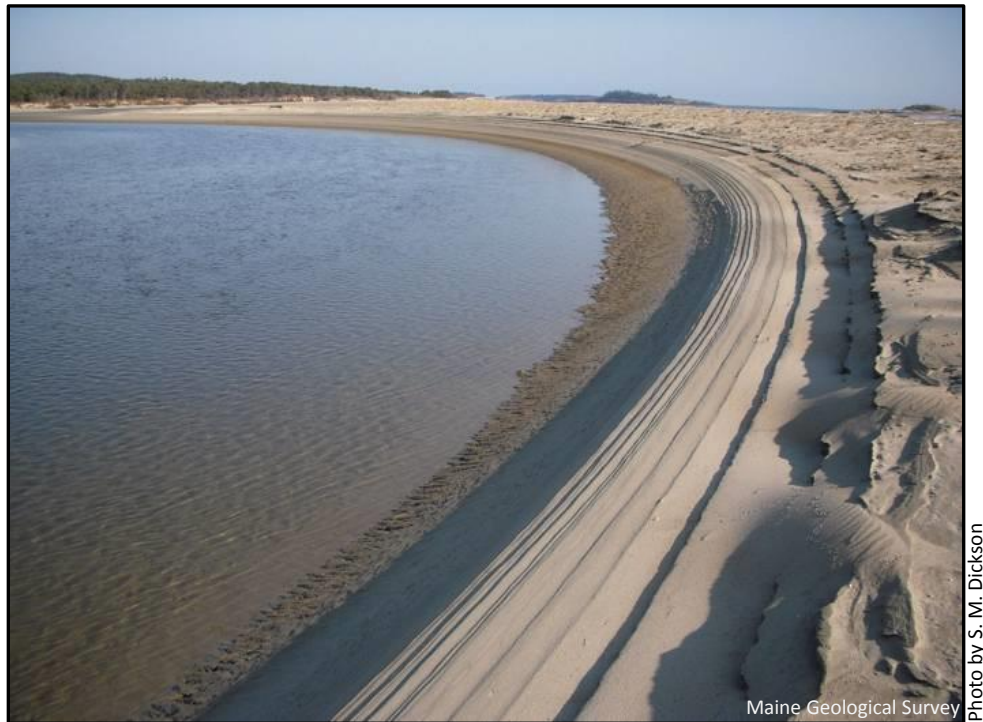
**Figure 10.** A view of the south bank of the Morse River where the Seawall Beach dunes end.

The Morse River separates Seawall Beach from Popham Beach. In November 2008 the channel was located along its usual course next to a bedrock outcrop behind Seawall Beach. As it made its way to sea the river took a sharp bend to the east and flowed toward Popham Beach (Figure 10). Be cautious on the bank of the river. Sand can be soft and it is possible to slip off the bank and into the river. The Morse River flows out to sea during the ebbing (falling) tide and into the salt marsh on a flooding (rising) tide. At the mid-tide level (either ebb or flood) the currents will be the strongest and the most dangerous.

Over time, the cut bank (outer bend in the channel shown in Figure 10) may erode more of the spit and allow the Morse River to cut a more direct and less sinuous path to the sea. It is hard to predict when this might happen. It may take a period of extremely high tides - and thus strong ebbing tidal currents - or a storm with flooding that covers the back-barrier salt marsh with a surplus of water that wants to exit directly to the sea on a falling tide. In any case, an extreme event may accelerate the natural cycle of channel migration.

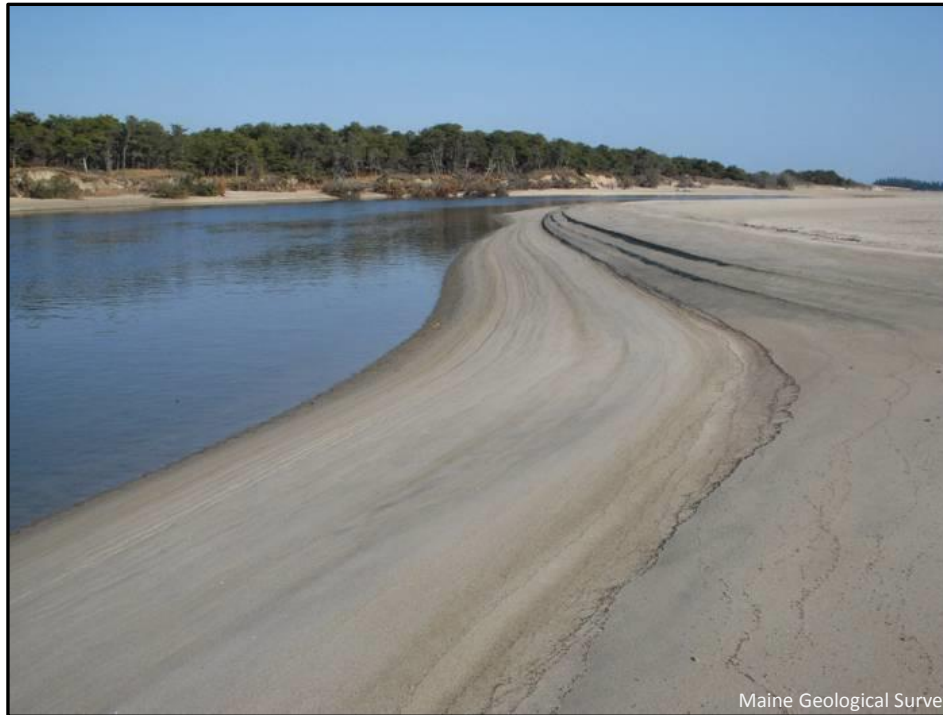
**Figure 11.** A second view of the south bank of the Morse River and Seawall Beach spit closer to the end than shown in Figure 10. The spit curves landward and diverts the Morse River toward Popham Beach State Park in the background. Note how the spit elevation changes where a lobe of sand projects to the left. This lobe is a former terminus of the spit that has since built eastward. At least two such spit lobes were present in November 2008.

A walk along the beach spit to the east and adjacent to the Morse River offers a chance to examine the shape (morphology) of spit accretion. In November 2008 there were several lobate deposits on the landward side of the spit that mark times of sand accumulation and buildup (Figure 11).

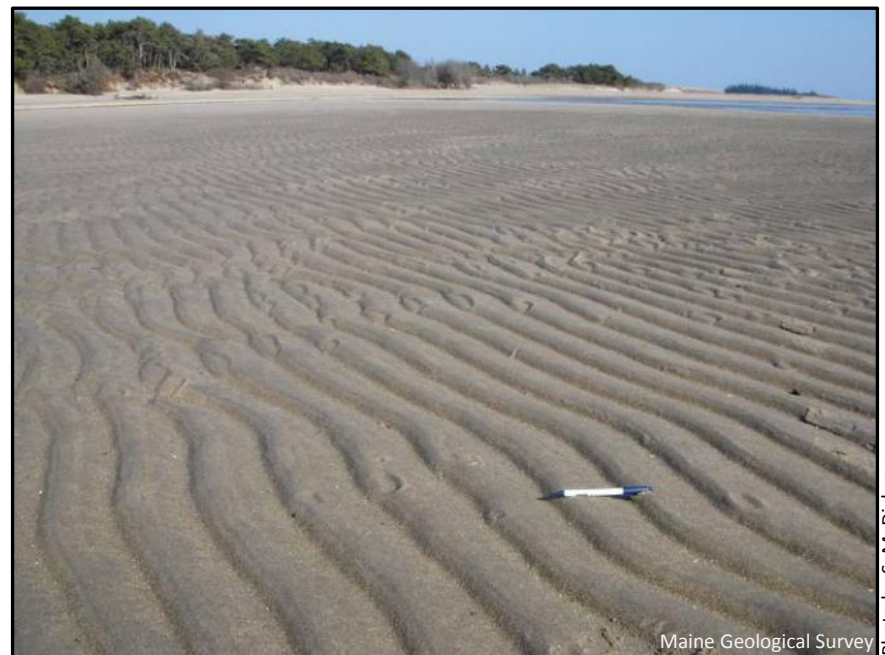
**Figure 12.** Linear-crested sand ripples shown in this photo are slightly asymmetrical. The steeper side faces the direction of net sand transport.

As you walk farther out on the spit (tide permitting) you will see a general lowering of the sand elevation and a variety of sand ripples on the surface (Figure 12-15). The eastern end of the spit has lower elevations and is overtopped by more of the tidal cycle (Figure 12). Across much of the spit at the eastern end, net sand transport is in a shoreward direction across the top of the spit. Close examination often shows that the crests of the ripples have a reversed asymmetry indicating seaward transport on the last phase of the ebbing current across the spit, just prior to their exposure in the air. In places the ripples appear "flat topped" due to flow reversal on a falling tide.

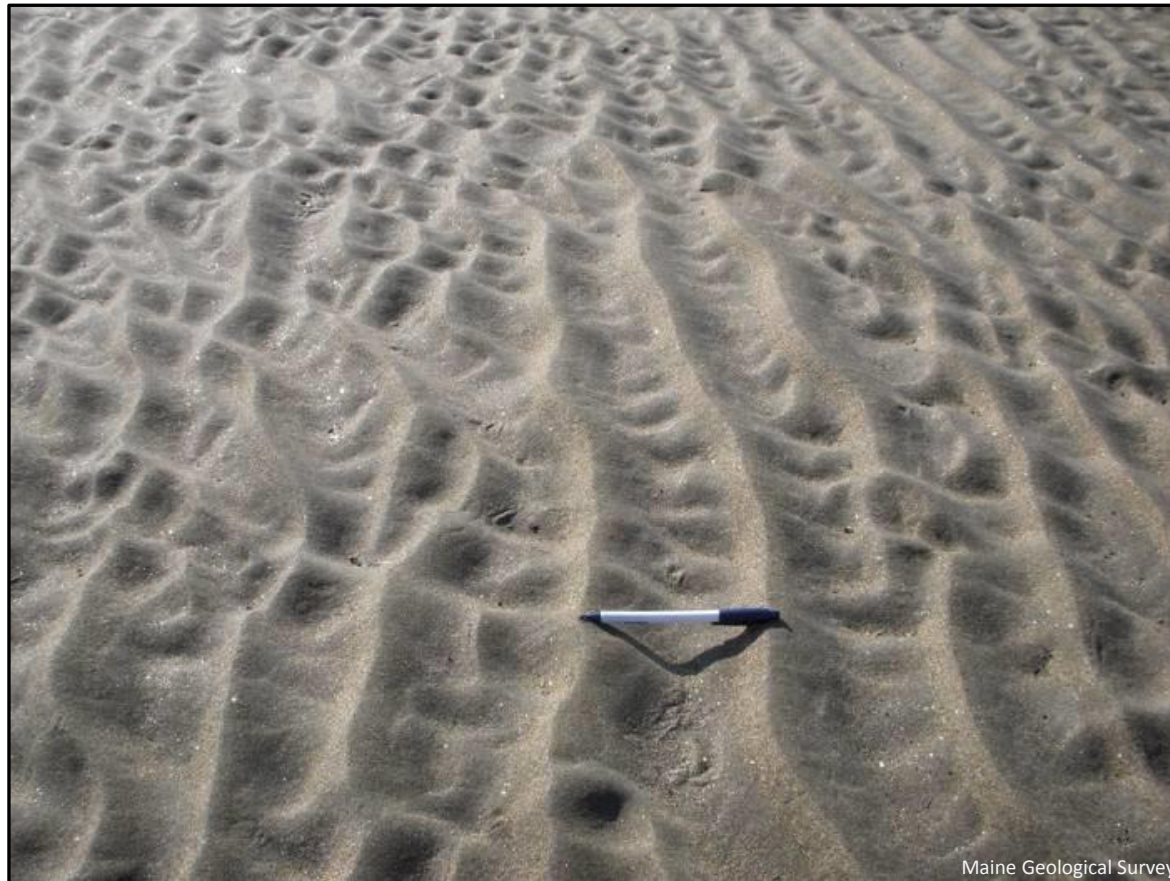
**Figure 13.** Linear ripples in this photograph have a secondary set of smaller ripples in the troughs.

As the tide falls across the spit, water drains through the troughs and carries sand in miniature channels where the smaller ripples form (Figure 13).

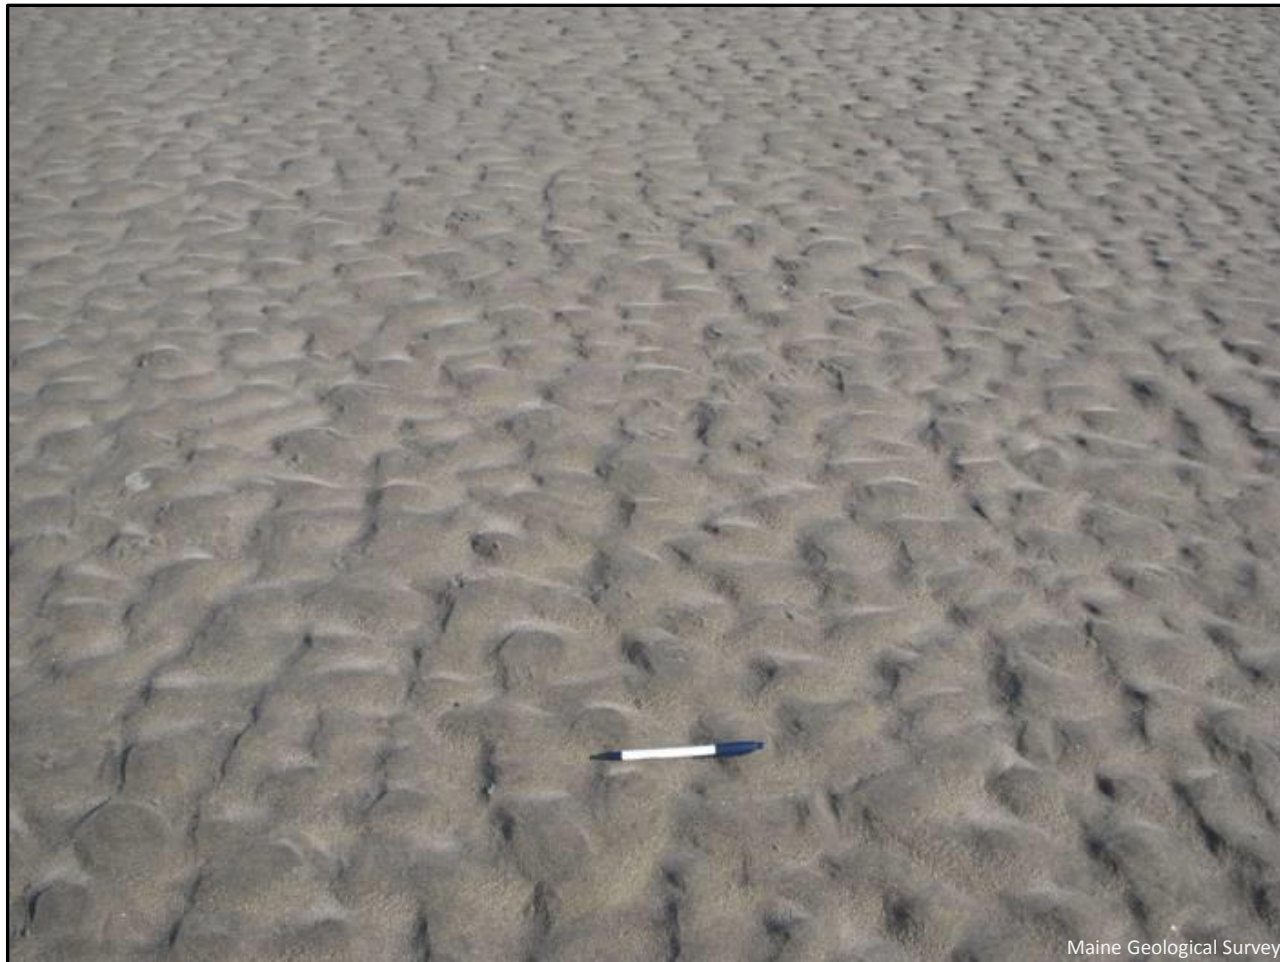
**Figure 14.** Three-dimensional ripples have sinuous crests and a more hummocky shape than linear ripples. These ripples can indicate faster currents than those that formed the linear ripples.

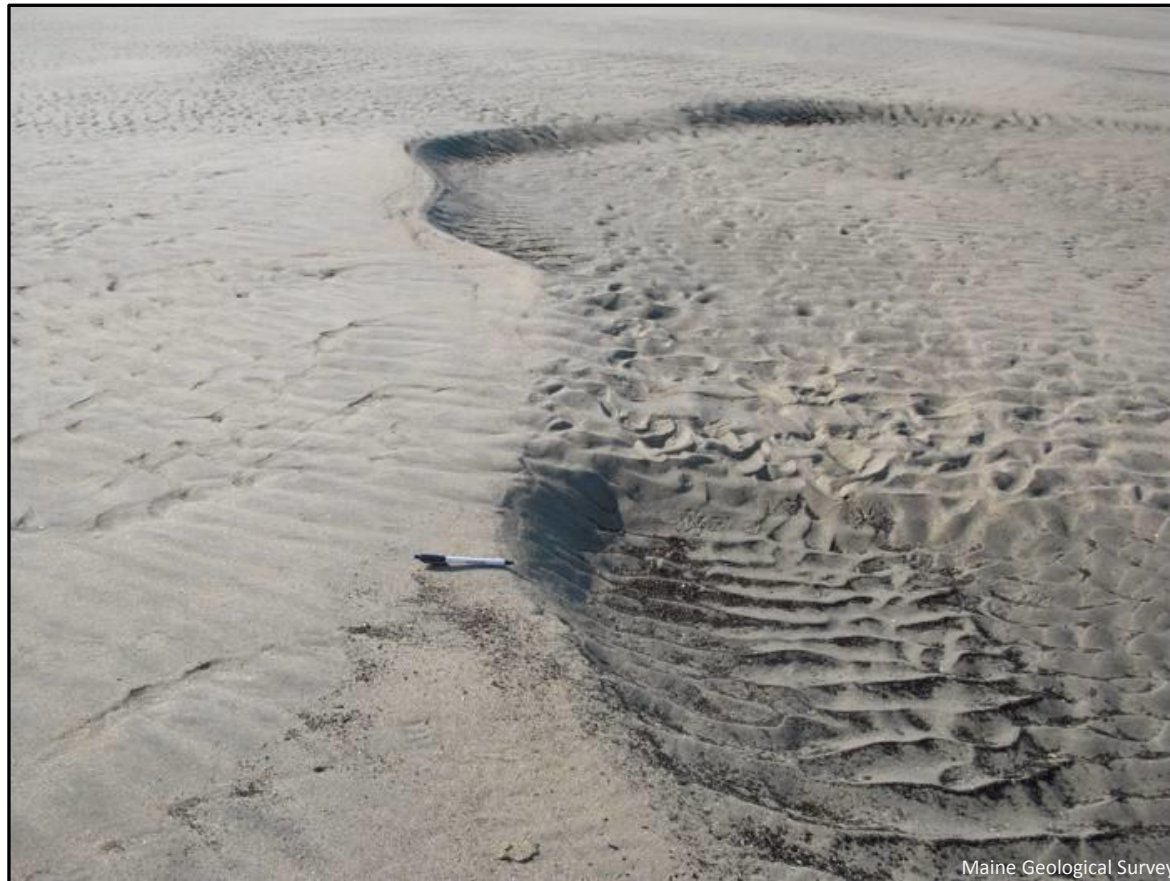
**Figure 15.** A few places on the spit also have larger sand forms called megaripples.

Megaripples are troughs or deeper holes that also contain smaller ripples formed by waves and currents. When the tide covers these features, walking through them in a current can be challenging.

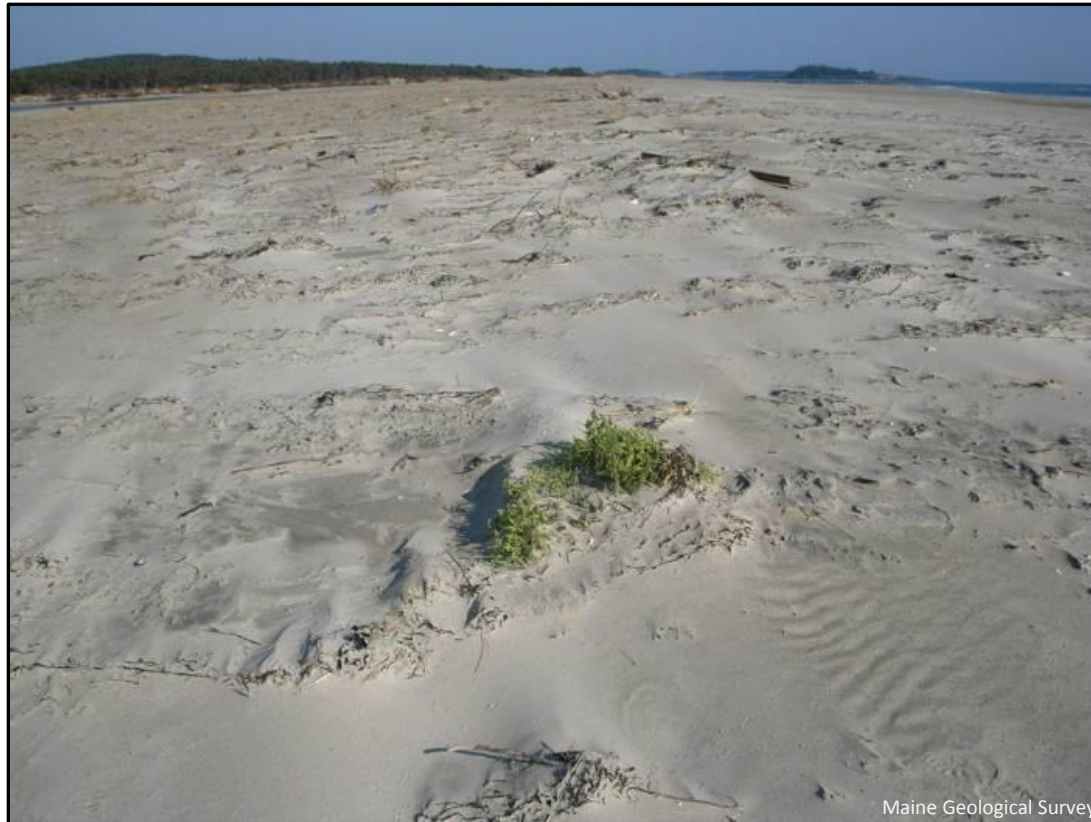
**Figure 16.** The highest portion of the spit is an area of sparse vegetation and hummocky topography. In addition to vegetation, driftwood and wrack (dried seaweed) trap sand on the spit surface. Smooth patches of sand are areas of wind-blown sand accumulation.

Compare this to the hummocky and sparsely vegetated axis of the spit that rises above the tides and is affected by wind action as well as waves (Figure 16).

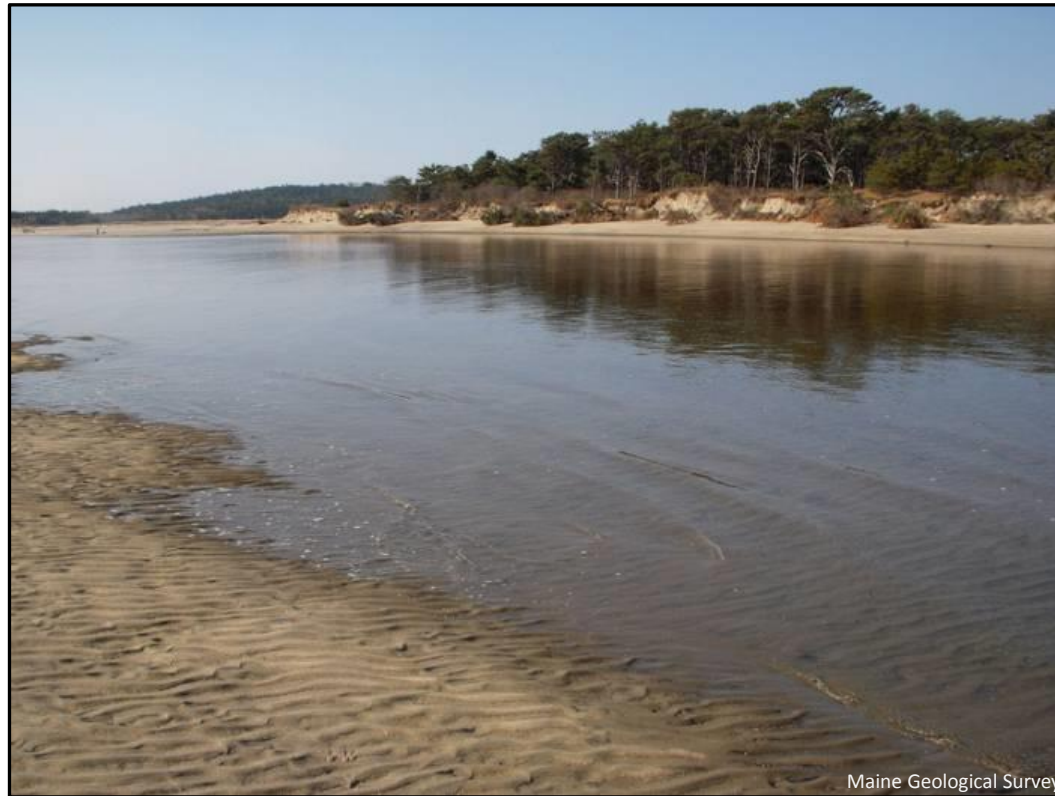
**Figure 17.** A view from the Seawall Beach spit across the Morse River to the west beach at Popham Beach State Park. Fallen trees and high dune scarps are common along most of this stretch of the park's shoreline.

From the spit it is possible to look across the Morse River and see the loss of dunes caused by the undercutting by the river. As described in March 2008 ([Dickson, 2008](#)) the channel has scoured sand and led to shoreline migration into dunes that have existed for more than 50 years (Figure 17).

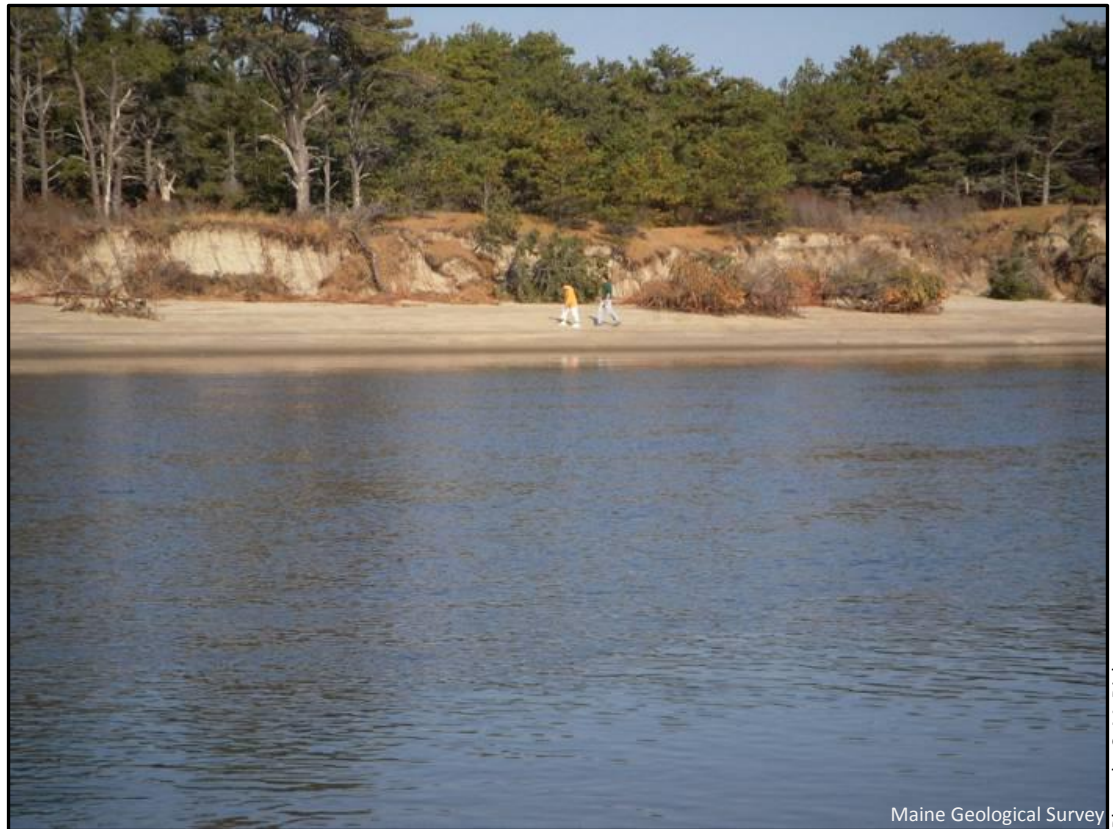
**Figure 18.** Erosion of the dunes and maritime forest at Popham Beach State Park is visible from the Seawall Beach spit. Sand that is eroded from the park is swept by ebb currents (to the right) and flood currents (to the left) and redistributed to other parts of the beach and also onto the beach spit.

Along Popham Beach State Parks' west beach, numerous trees are falling into the channel and across the beach (Figure 17-19) and entire trees are carried by the river currents elsewhere along the beach.

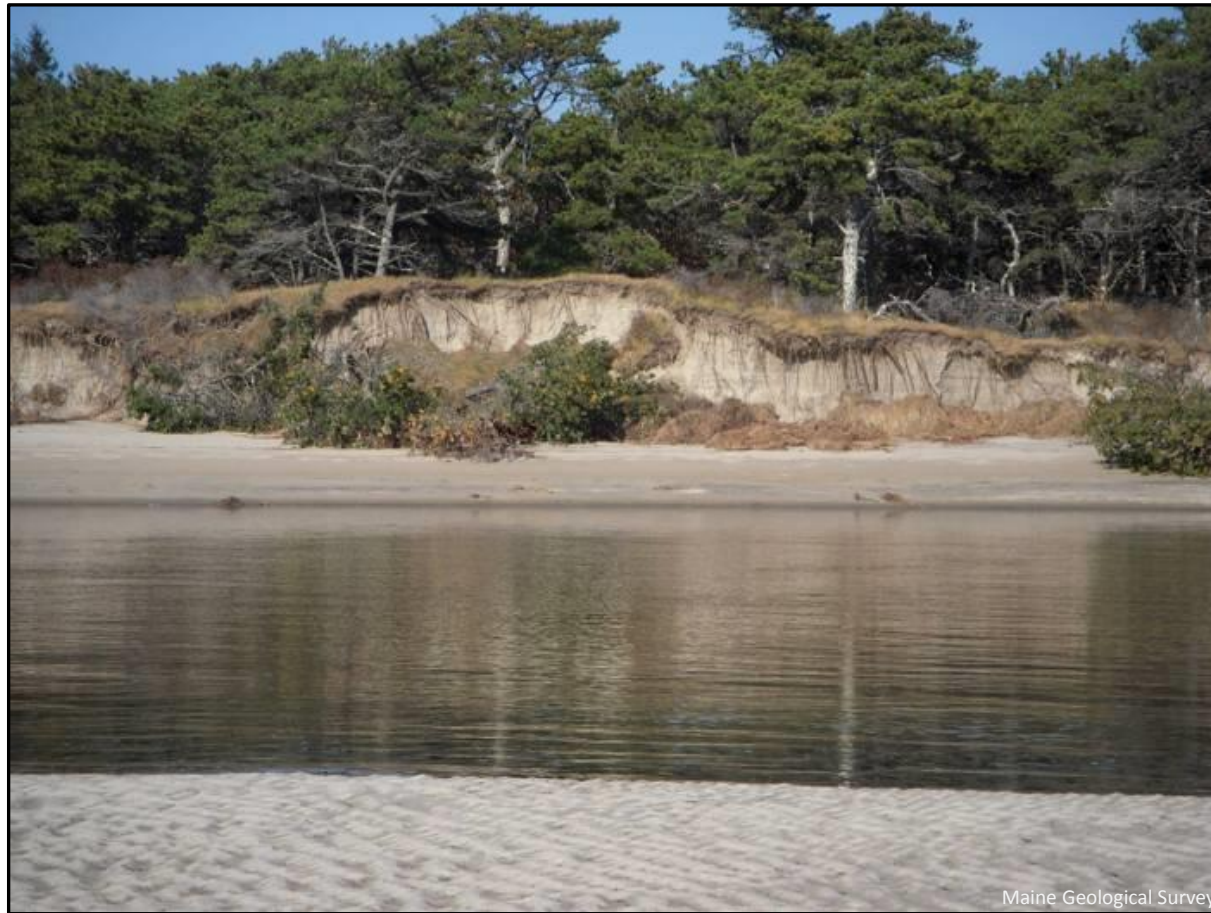
**Figure 19.** Loss of relict dunes at Popham Beach state park is severe along the bank of the Morse River. The pitch pine forest has been growing for at least 50 years based on historical aerial photographs. Near the eastern end of the Seawall Beach spit the Morse River channel is directed close to the state park beach in the background.

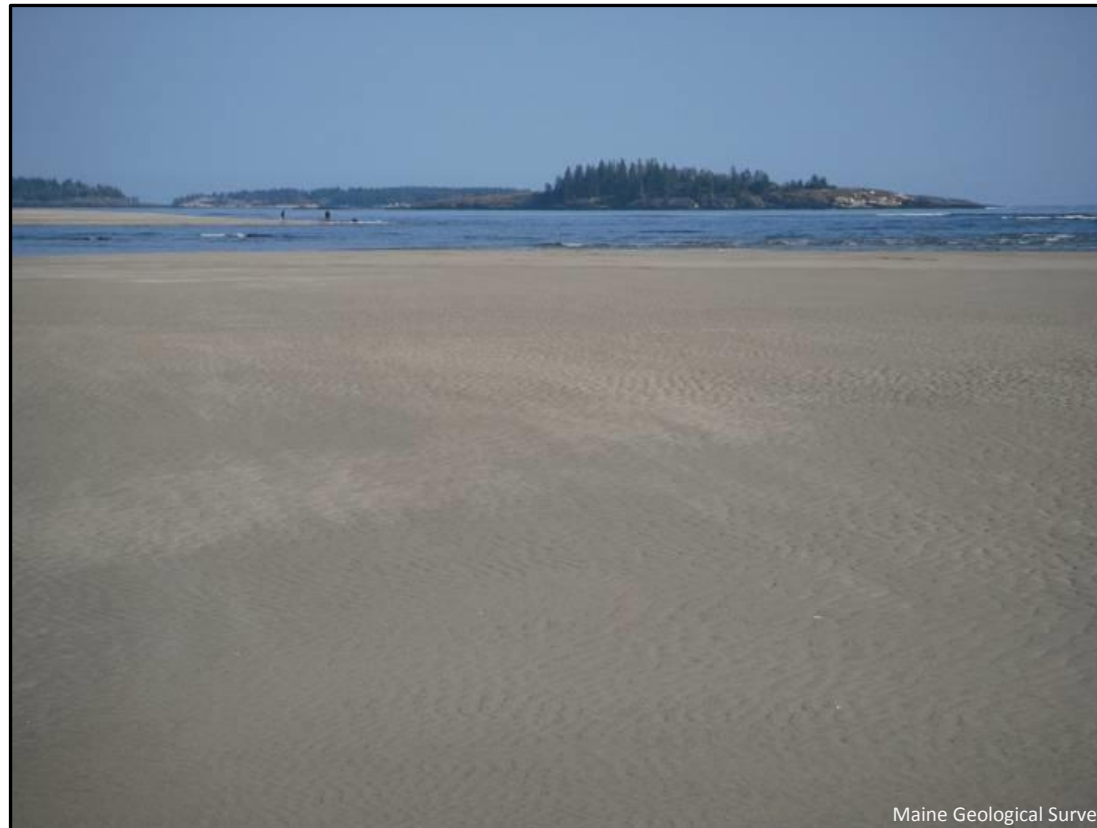
**Figure 20.** The eastern end of the Seawall Beach spit gradually slopes into the Morse River channel. This photograph was taken at mid-tide looking east. It shows a rising tide submerging the Fox Island tombolo (where the people are standing). The forested Wood Island and Kennebec River mouth are in the background.

As of November 2008, the Morse River still had a channel that ebbed easterly across the Fox Island tombolo (Figure 20). See [Dickson \(2008\)](#) for additional discussion of the tombolo.

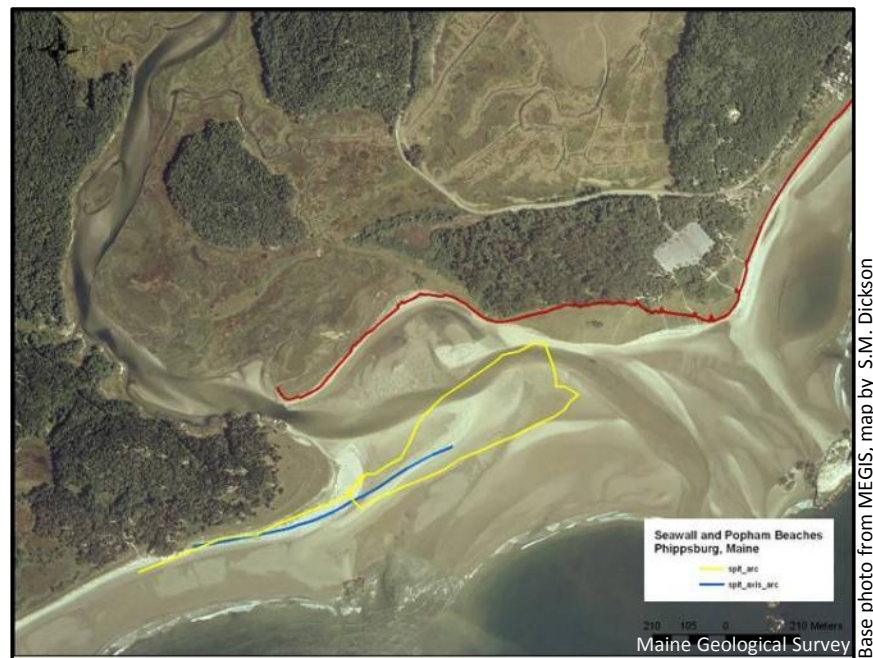
Figure 21 is a map of the Seawall and Popham Beaches. The yellow line marks the November 2008 position of the last high tide swash line (elevation approximately 8 feet above mean lower low water) and serves as a contour to outline the spit as well as the berm edge along Seawall Beach. The blue line approximates the highest elevations on the beach spit where they could be mapped in November 4, 2008. The spit becomes very flat on the eastern end so a ridge could not be mapped. The red line is a June 7, 2007 shoreline survey along the seaward edge of the dune at Popham Beach State Park conducted by MGS.

**Figure 21.** Map of the Seawall Beach, Morse River, and Popham Beach in Phippsburg, Maine. The base air photo is from August 23, 2005, courtesy of the Maine Office of GIS and Seth Barker of the Maine Department of Marine Resources.

Shoreline change along Popham Beach in the last few years has been nothing less than dramatic. Figure 21 shows a vertical air photograph of the Morse River inlet, sand bars, and dunes on both beaches. The extensive loss of vegetated dunes at Popham Beach State Park is shown by a June 2007 shoreline surveyed by the Maine Geological Survey. A November 2008 survey of the extent of the beach spit above a recent tide (approximately 8 feet above mean lower low water) shows how the spit has prograded into the former channel of the Morse River.

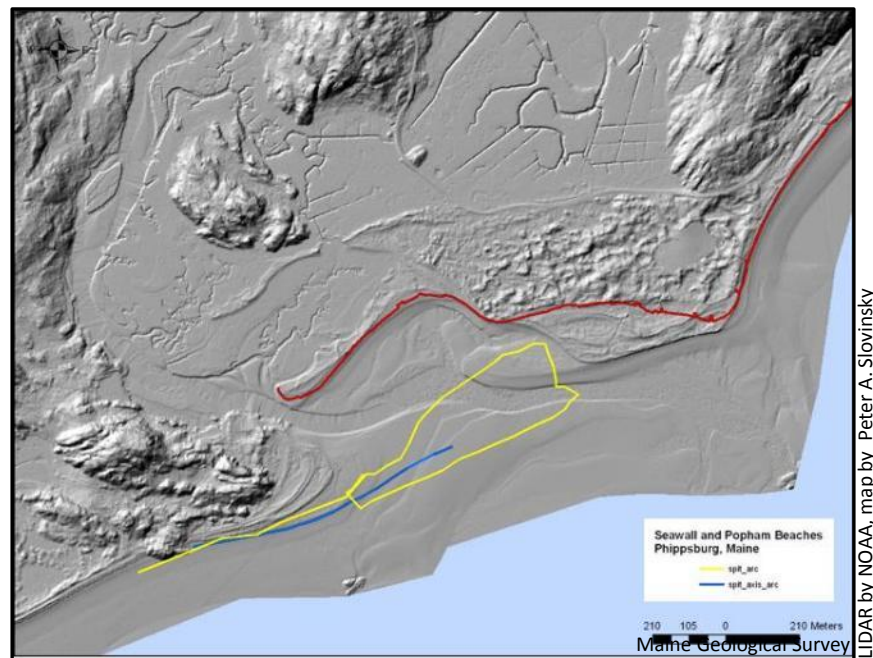
Figure 22 is a shaded relief map of Seawall and Popham Beaches. The yellow line marks the November 2008 position of the last high tide swash line (elevation approximately 8 feet above mean lower low water) and serves as a contour of the spit as well as the berm edge along the Seawall Beach dunes. The blue line approximates the highest elevations on the beach spit where they could be mapped in November 2008. The spit becomes very flat on the eastern end so a ridge could not be mapped. The red line is a June 7, 2007 shoreline survey along the seaward edge of the dune at Popham Beach State Park conducted by MGS.

**Figure 22.** Shaded relief map of Seawall and Popham Beaches. The shaded relief image was generated by Peter A. Slovinsky of the Maine Geological Survey using NOAA Coastal Services Center LIDAR data acquired in 2004.

A shaded relief map (Figure 22) was generated using high-resolution topographic data (LIDAR) acquired in 2004 by the NOAA Coastal Services Center for the Maine Geological Survey. In this map the Morse River channel shows up as a flat area that is now beneath the beach spit. Easterly growth of the spit has forced the Morse River north and against the beach and dunes at Popham Beach State Park.
