Maine Forestry Best Management Practices Use and Effectiveness 2008

Department of Conservation
Maine Forest Service
22 State House Station
Augusta, Maine 04333
Forest Policy and Management Division

August 2009

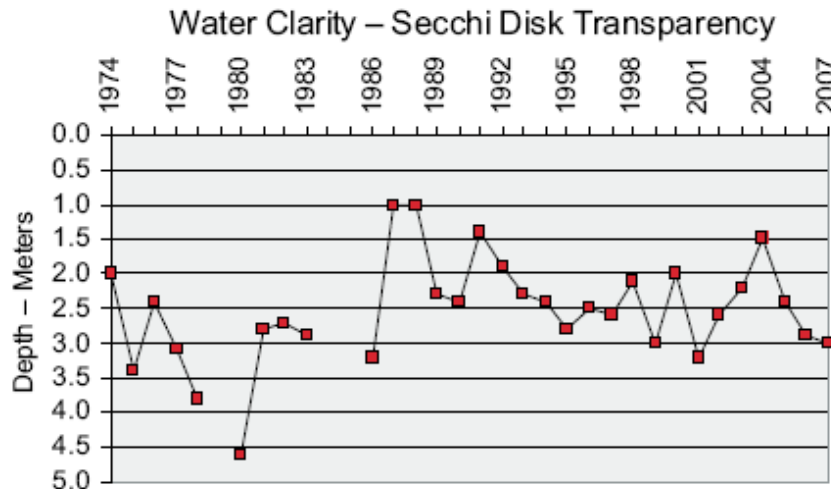
Located in Aroostook County, Madawaska Lake experienced declining water quality beginning in the 1980s when increased timber harvesting, road building and shoreland development in the watershed contributed excess phosphorus and sediment to the lake. As a result, Maine Department of Environmental Protection (MDEP) added Madawaska Lake to the state's 1988 Clean Water Act section 303(d) list of impaired waters. The lake's water quality began improving in the mid-1990s, due to changes in statewide forestry standards, improved regulatory oversight of development and the implementation of forestry BMPs. MDEP removed Madawaska Lake from its section 303(d) impaired waters list in 2006.⁵

Water clarity in Madawaska Lake abruptly declined in 1987. From 1987 to 1992 the lake suffered four nuisance algae blooms (SDT < 2.0 meters). Since 1993 water clarity has improved, and the lake has been free of algae blooms for 14 of the past 15 years. (Note: no data were collected in 1979, 1984 and 1985.)
