Maine State Cultural Building Augusta, Maine : Exterior Building Facade Investigation

Harriman Architects & Engineers

Project No. 09594

October 16, 2009
Final

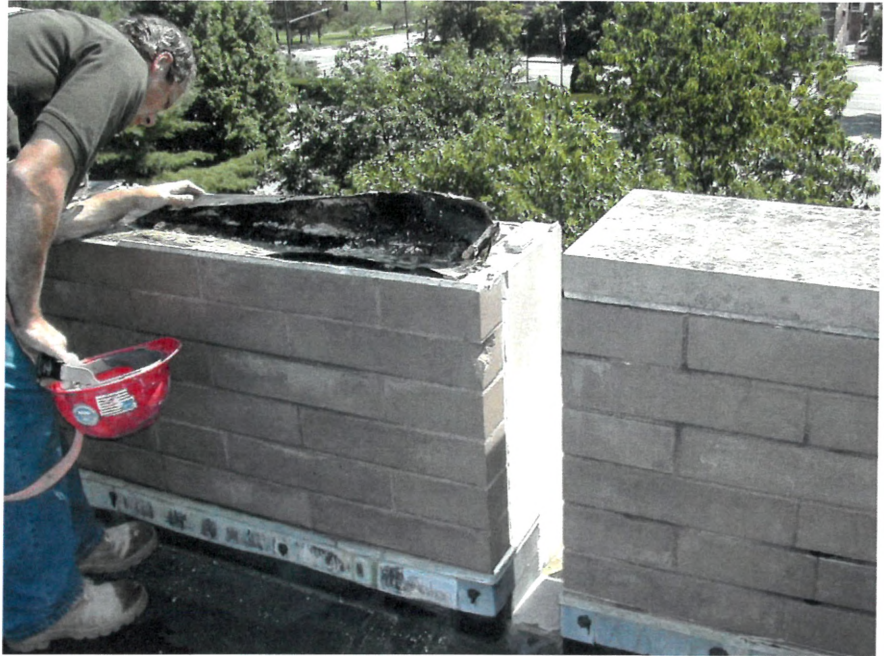
To determine the condition of the existing wall system, a location on three sides of the building was selected. The parapet cap on the southeast corner was removed to observe the anchorage details of the components and installation of the flashings and the condition of the cavity. The limestone cap was removed as part of the existing conditions field observation. Per Harriman's request, a second limestone cap on the north side of the building was removed by Consigli Construction. See Parapets southeast corner inside (tab 4) for more information.

*EP6 - Southeast corner
parapet cap removed*

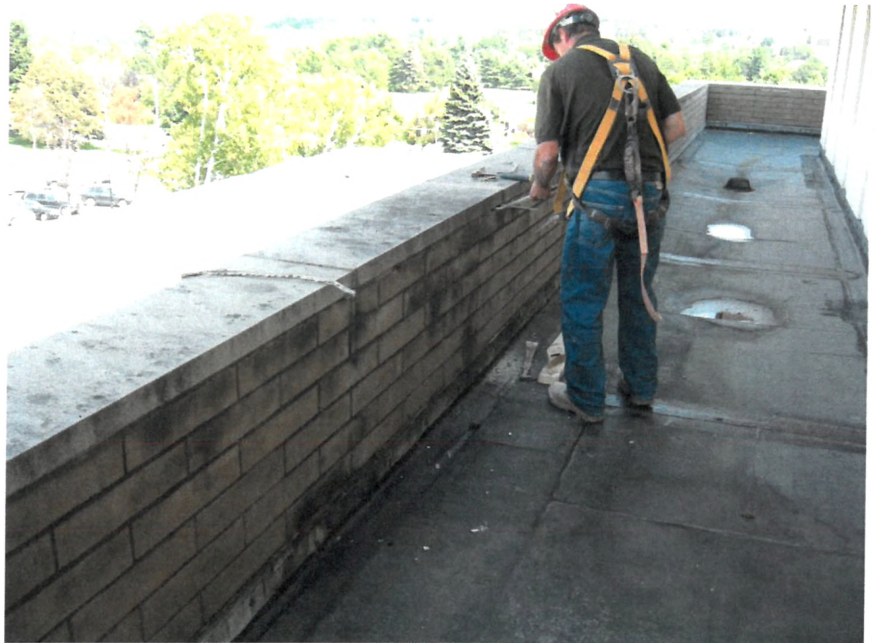
*EP7 - North side
parapet cap removed*

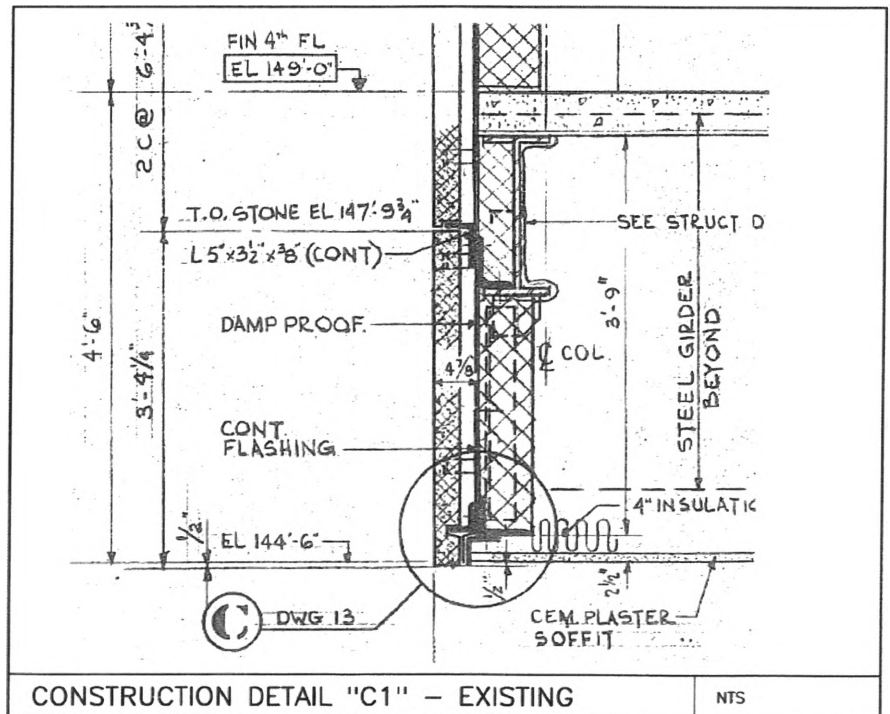
AB3 - Construction
detail C1 - existing

Image AB3 details the bottom row of panels and the two rows of angle support and their connection to the structural frame of the building. This area was our focus for panel removal for the reasons outlined.

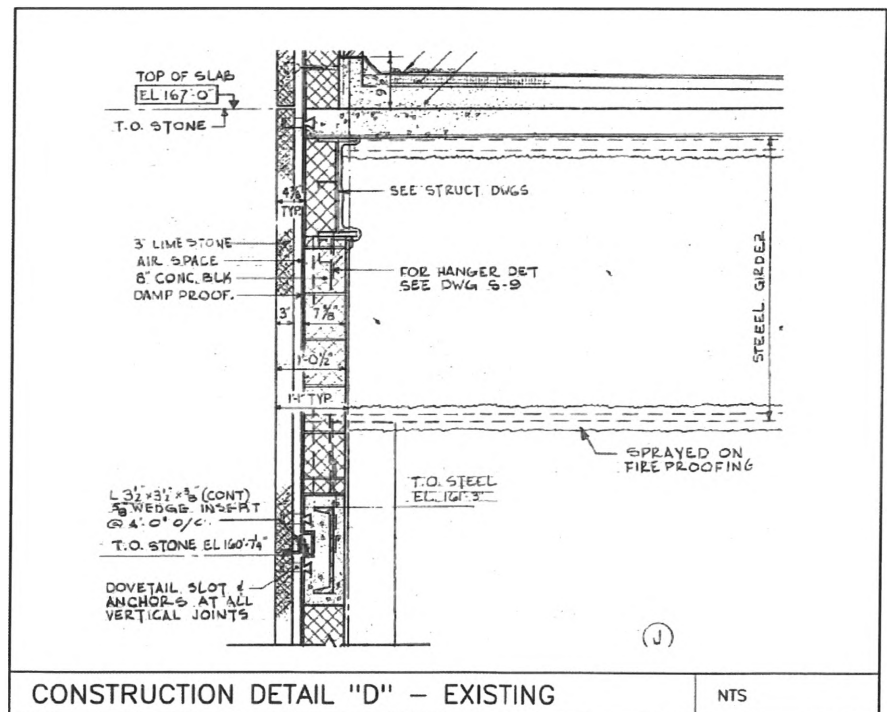
AB4 - Construction
detail D - existing

Image AB4 details the top row panel support and its orientation and connection to the building frame. The concrete-encased steel channel is supported from the perimeter roof beam and encased with concrete so the CMU backup could be installed on both sides. The structural question with this support line is its connection to the structural column on each end. Based upon the difficulties of a forensic removal, this question could not be evaluated. The structural analyses contained within this report will outline the potential issues with this support location. Also of concern with this detail is the use of a wedge anchor and bolted connection to this angle with an elongated bolt hole. The potential of slippage due to loads could be the potential contributor to a compressive load failure. The observation notes from the locations with similar angle support connection will be noted in more detail.

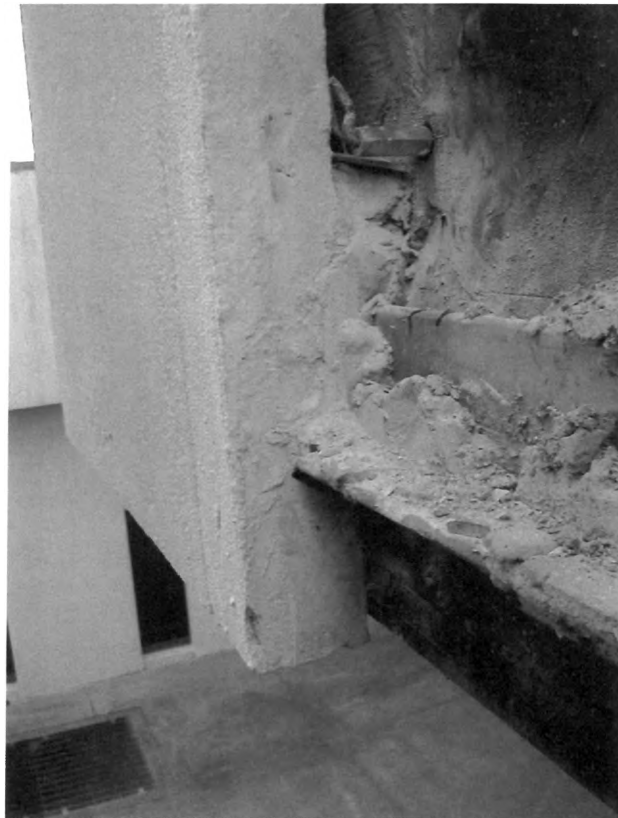
PR3-2 and PR3-3 - The panels were set in a continuous bed of grout at the support angle, grouted together, and the panel anchor shown was cut off and bent back during the removal process. The details are consistent with other locations and constructed as detailed. The amount of grout that piled up behind the side panel during its installation is a concern and would make the weeping of the cavity through the intended detail very difficult to accomplish. Image PR3-2 shows the connections and galvanized angle support of the first and second row was installed as detailed. Image PR3-3 shows that there is a considerable amount of grout that is adhered to the angle above; the documented detail calls for this joint to be a caulked joint. In this same figure, note the striations in the panel face above it – these striations are a direct result of how the panel was cut out at the quarry.

*PR3-2 - Panel north on
support angle*

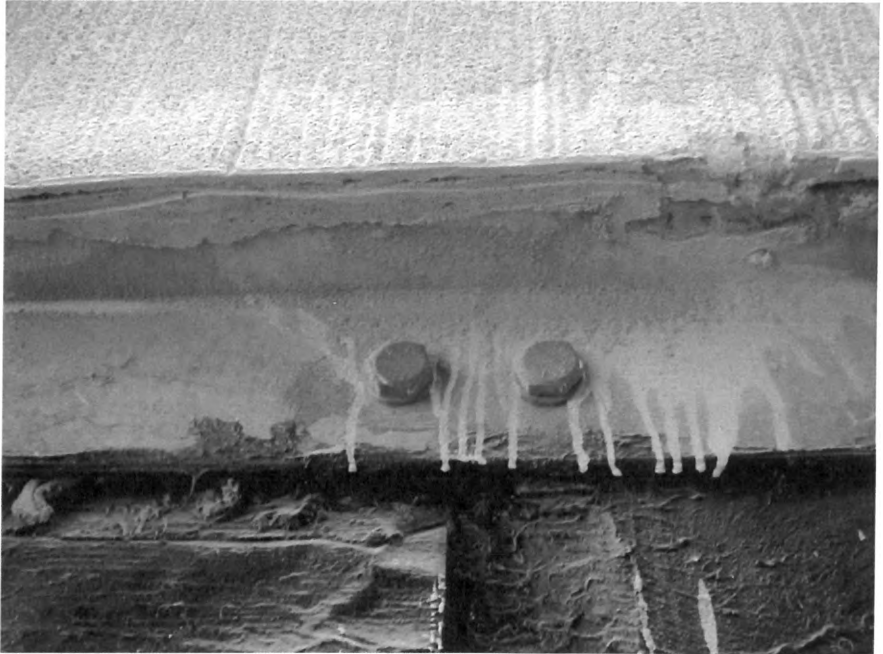
*PR3-3 - Horizontal
support angle connector and
grout bed*

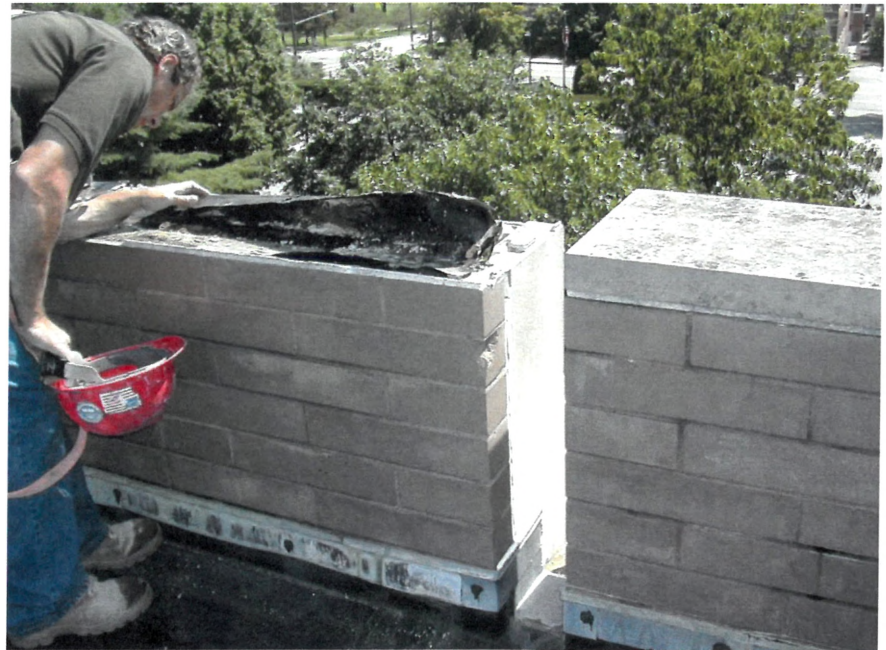
Image PR4-1, PR4-2, PR4-3, PR4-4 – These parapet locations were defined by Harriman as a definite location for forensic removal after our initial walkthrough to view the building. The location of the limestone cap removal was easily identifiable through the existing documents. Once removed, our observation indicates that the parapet was constructed as detailed. The limestone cap spans the backup wall system and the façade panel and is held in place thru a series of metal pins inserted into the top of the panel and the CMU or brick backup. The cap joints were grouted together, raked out, a sealant applied and a lead strip joint cover inserted into the wet sealant joint. A layer of fabric coated copper flashing was installed over the backup system and limestone face panel. Image PR4-1 shows a worker from Consigli construction in the process of removing a cap on the north side, this a field time decision based on the discovery on the southeast corner. The construction at this location was similar to the southeast corner. One of the primary reasons for removal at this location is the amount of surface mold on the inside of the parapet face and the extensive amount of face stains on the limestone panel faces on the north facing exposure.

*PR4-1 - South east corner
cap removed*

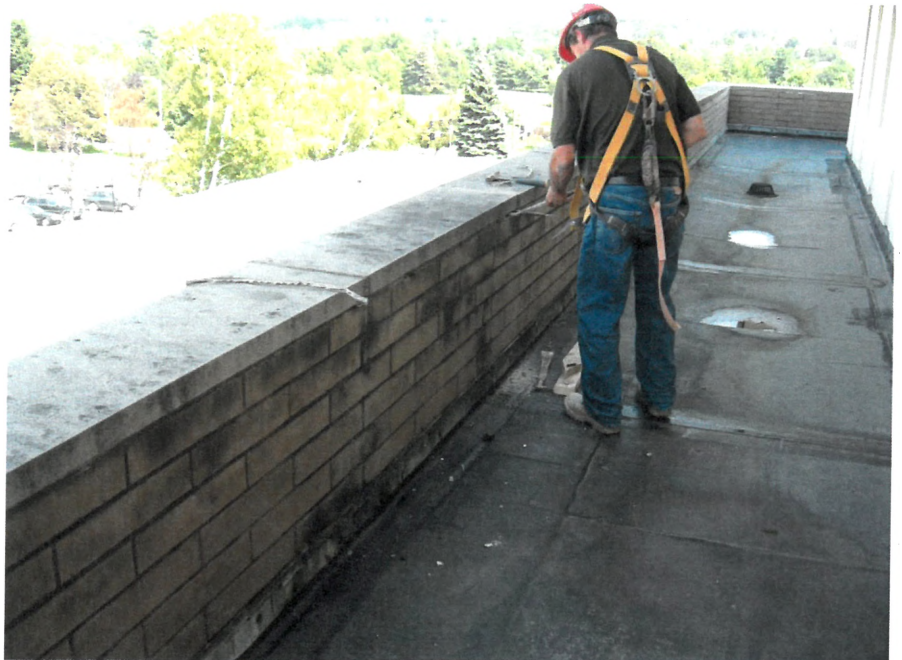
*PR4-3 - Cap removal
north side*

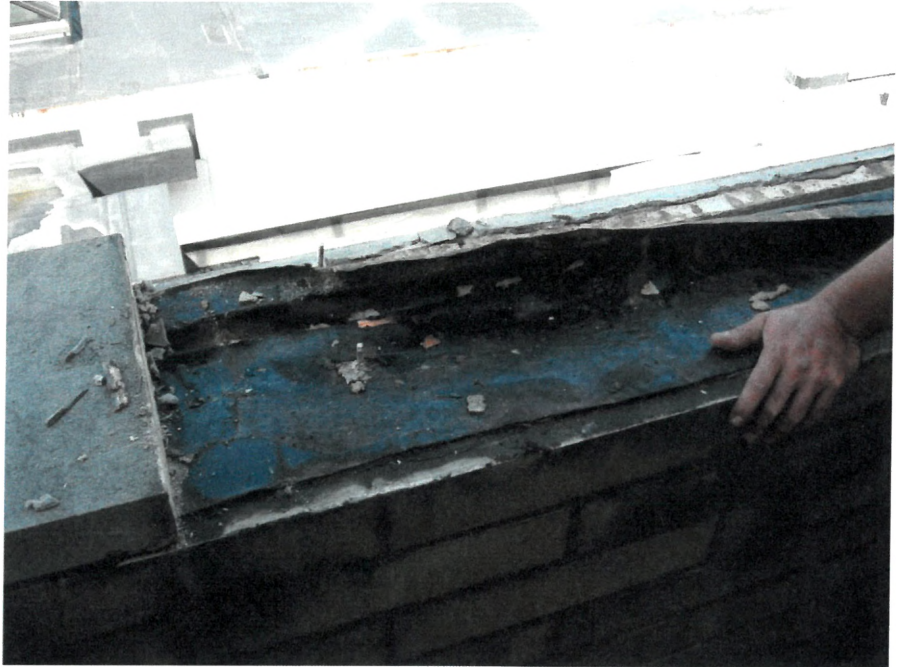
*PR4-4 - Cap removal
north side*

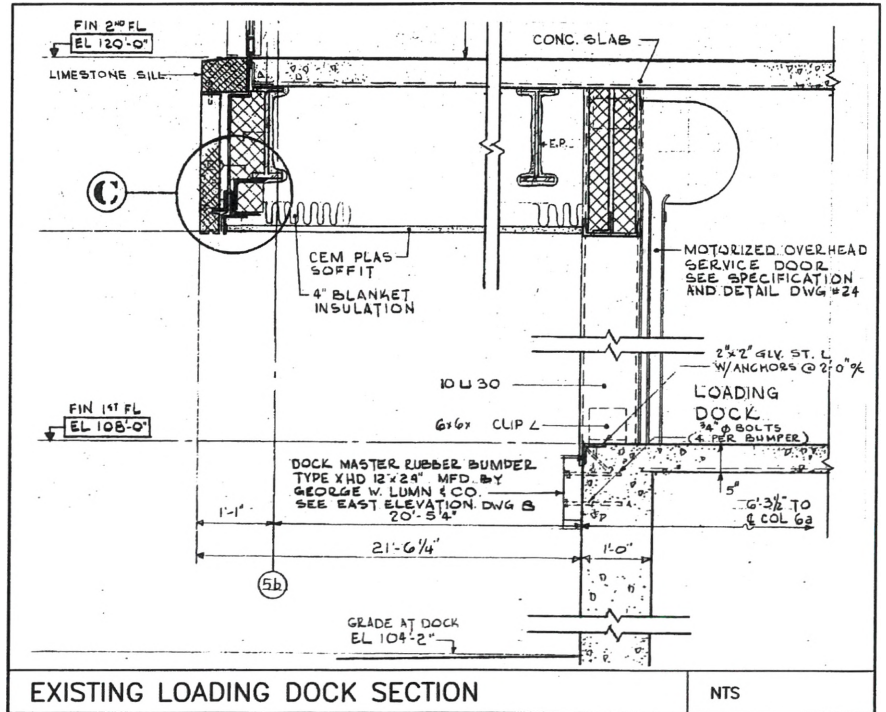
LD1 - Existing Loading Dock Section Detail

The damage to the limestone panels – LD1 – is a result of tractor trailer deliveries to the receiving door. The damage was caused from the impact from trailer box hitting and breaking off the bottom section of the limestone panel. Image LD2 shows the construction document detail of a similar connection at the limestone panel with a slot and seat on a support angle. The structural support frame at this opening does not appear to have been compromised by these incidents. The cement plaster soffit has been damaged beyond repair due to the impact of the trailer box. Our observation has shown that the soffit is bulging out and we can safely assume that the hung metal support system for the ceiling has been bent out of plumb and cannot be corrected to its original position without complete removal and replacement.

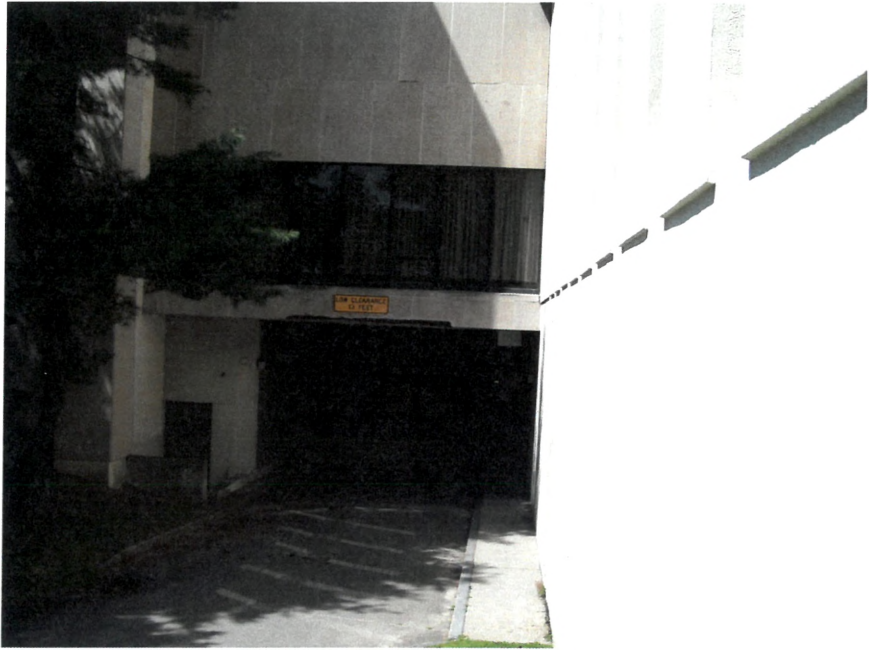
*LD3 - Loading dock door
entry*

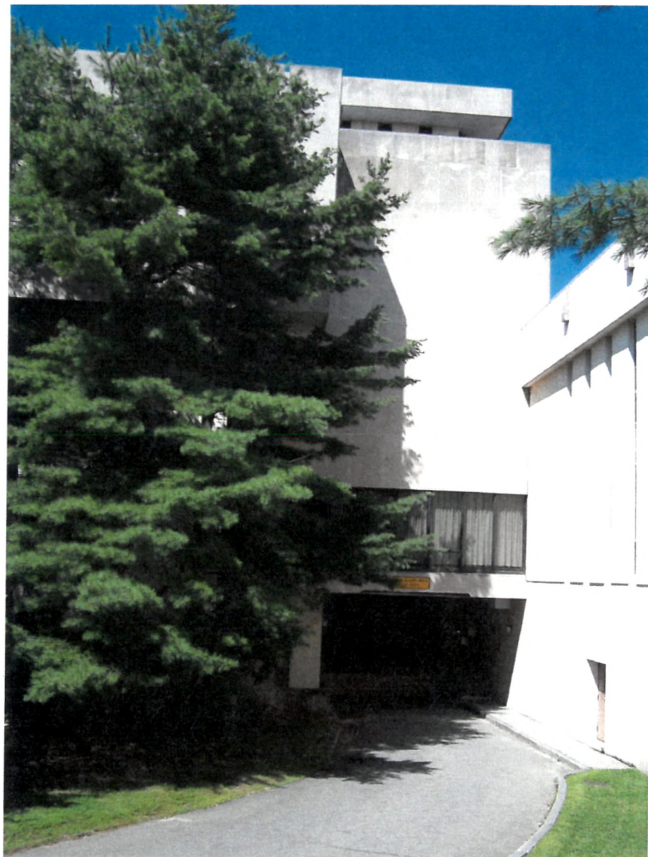
*LD4 - Loading dock door
entry*

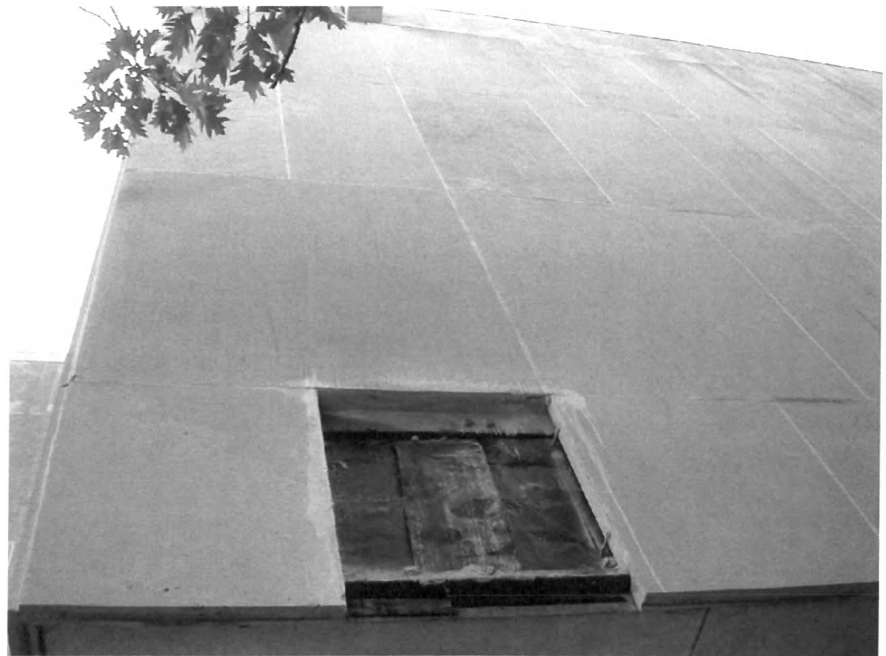
(Image S5)

One of the most common causes of failure in stone curtain wall systems is deterioration of steel support angles by corrosion of the steel resulting from water intrusion behind the curtain wall panel veneer. In order to evaluate the extent to which this circumstance might be the cause of the stone failures, single-panel sections of the stone cladding were removed from the building at three locations of the façade, one each on the south, west and east elevations of the limestone curtain wall. These panels were located at the base course of the stone, at about the fourth floor level, where the worst effects would be expected to be found. Upon removal of the panels, it was discovered that the existing construction was built in accordance with the details of the construction drawings (Image S5). An inspection of the shelf angles and their hangers found that not only was there little evidence of damage to the steel of the relief angles, the condition of the shelf angles themselves was excellent, almost like new. The hangers showed some surface oxidation, but there was no significant deterioration noted.

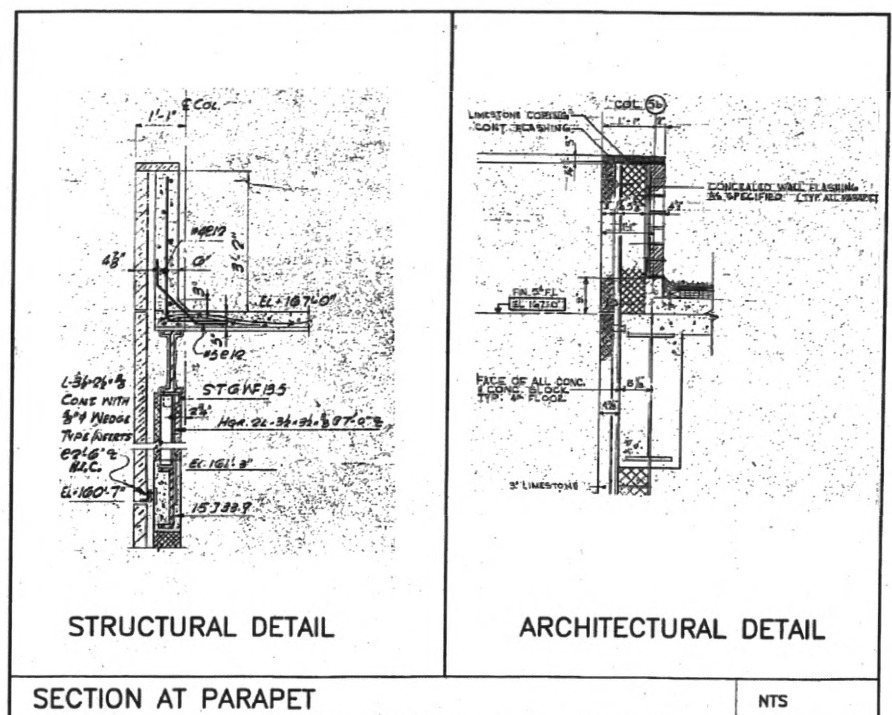
Image S9 Section at
Parapet

A section of the fifth floor roof parapet was opened on the east elevation, near the southern-most roof scupper, to inspect the existing condition of the construction for parapets and their scupper detail. The design structural drawings indicate that the structural parapet wall, which extends vertically about 3 ½ feet above the level of the roof slab and acts as back-up support for the limestone curtain-wall, was to be constructed using a cantilevered cast-in-place concrete wall. In contrast to this, the architectural drawings indicate that the back-up wall for the parapets was to be of concrete masonry. When the stone coping of the parapet section was removed, it was discovered that the structural wall was not constructed in accordance with the structural details, but rather was constructed according to the details of the architectural sections i.e., constructed of concrete unit masonry (Image S9).

During the field observations, it was found that the masonry back-up wall could be displaced laterally by a man pushing at the top of the wall. This suggests that the masonry of the back-up wall may not have been positively dowelled to the concrete roof slab, despite such direction shown on the structural drawings, and that, therefore, the stability of the roof parapets is based simply on the mass of the masonry there. The result is that the entire, existing parapet masonry wall is not a reliable structure for lateral support of the limestone slabs of the parapet curtain-wall, and that there is a potential for failure of the parapets under large, dynamic wind loads or the occurrence of a seismic event. Essentially, the

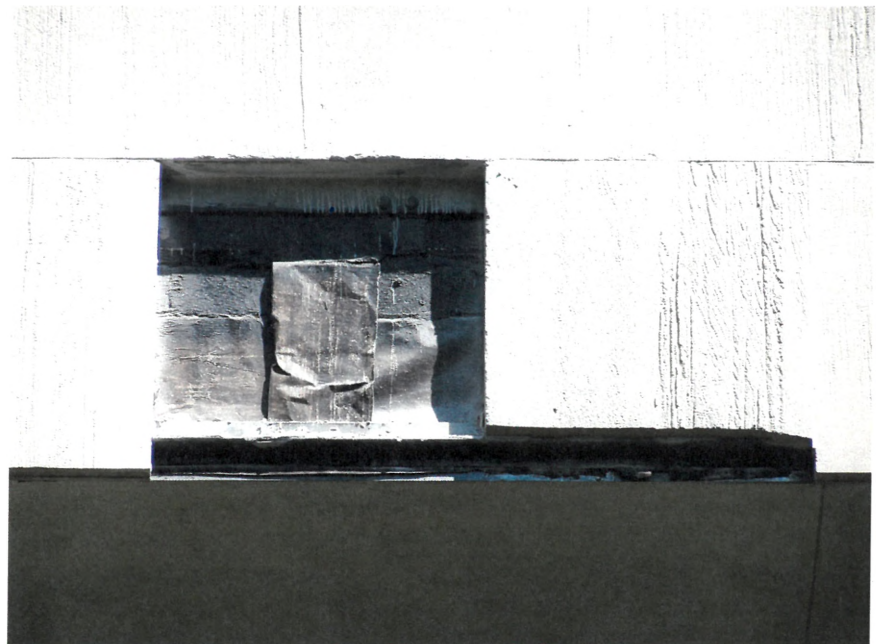
Image S10

The limestone panels that are the curtain-wall are cut into 3" thick slabs. The typical panel dimension for the first, bottom course is approximately 3 ft. wide x 3'-4" high. The typical intermediate course panels are 3 ft. wide and 6'-4" high. Some of the intermediate course panels are double-width, near control joints and the building corners, to suit the architectural panel spacing scheme. The backs of the bottom course panels have a continuous, horizontal dado-cut recess at about 4" above the bottom of the individual slabs, to form a continuous bearing seat that receives the out-standing leg of the lower relief angle, and to provide for architectural concealment of that support and a boundary for the finished soffit of the building cantilever. The depth of the cut is about 1 3/4" into the back of the panel, resulting in a remaining thickness of stone of only 1 1/4" out of the total 3" thickness. Failure of several of the first course limestone panels has occurred because horizontal cracks formed along the dado recess, causing the bottom 4" of the panel extension, below the relief angle seat, to separate and fall off (Images S10 & S11). Due to a history of this type of failure, Indiana Limestone Institute of America, Inc. (ILI) does not recommend the use of this design detail for limestone curtain-wall panels.
