Maine Geologic Facts and Localities
November, 2007

Brunswick, Maine Patriots' Day 2007 Landslide

Text by
Michael E. Foley

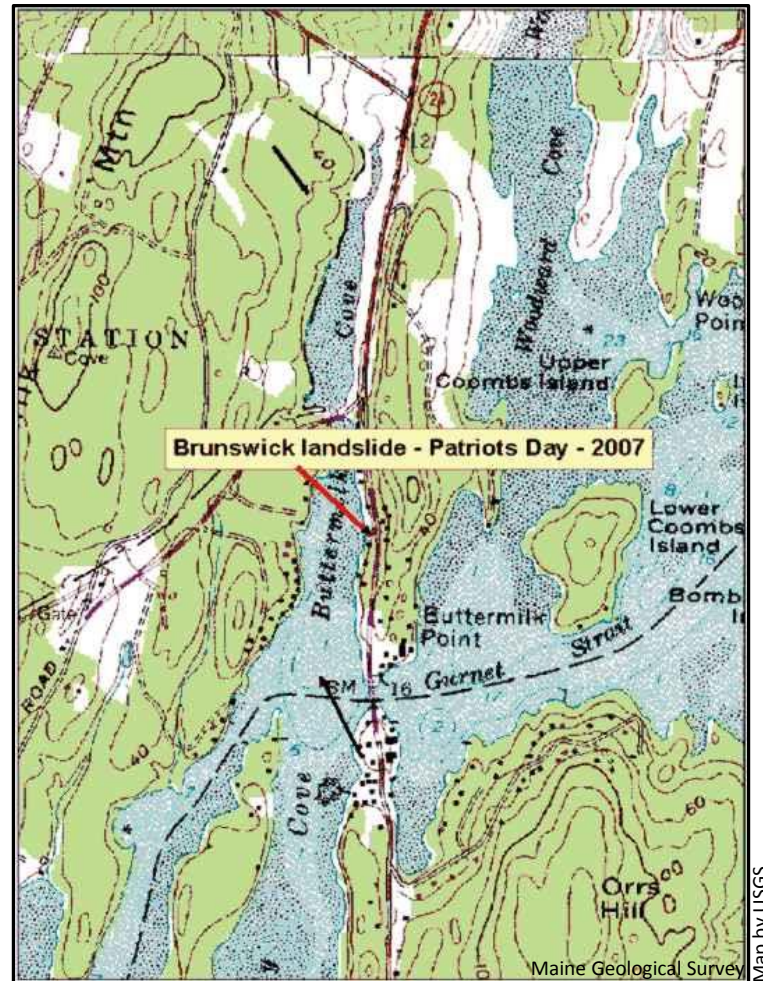
The slide occurred along a steep bluff (Bryant and others, 2002) adjacent to Route 24 (Gurnet Road) (Figure 3). The bluff top was about 30 feet above sea level (Figure 1, Right).

Figure 3. Topographic map showing location of the April 16, 2007 landslide in Brunswick.

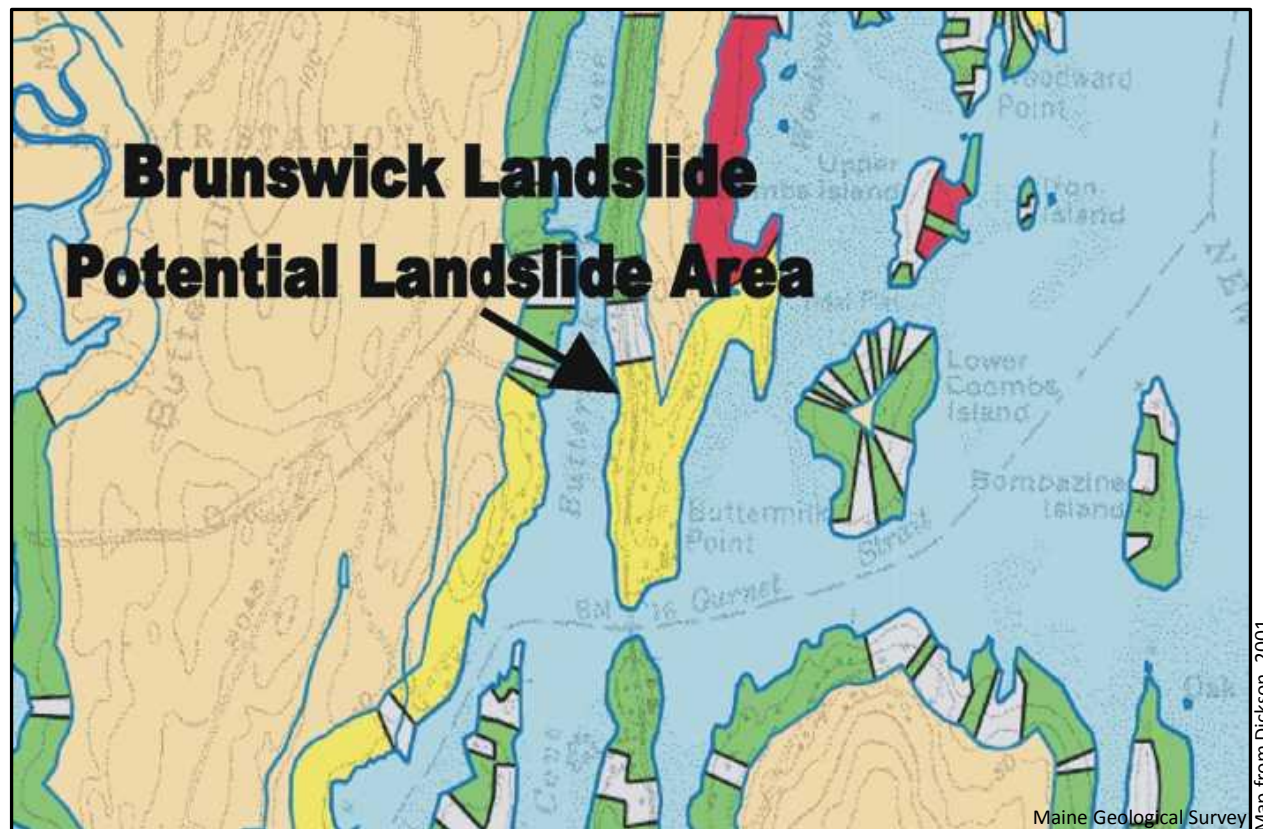
This shoreline has been mapped by the Maine Geological Survey as a "Potential Landslide Area" (Dickson, 2001; Figure 4).

Figure 4. Brunswick landslide located in the yellow map unit, a Maine Geological Survey "Potential Landslide Hazard Area."
