# Bridge-in-a-Backpack™ Task 6: Guidelines for Long Term Inspection and Maintenance, 2016

## Technical Report 16-12

### *Bridge-in-a-Backpack™*

### *Task 6: Guidelines for Long Term Inspection and Maintenance*

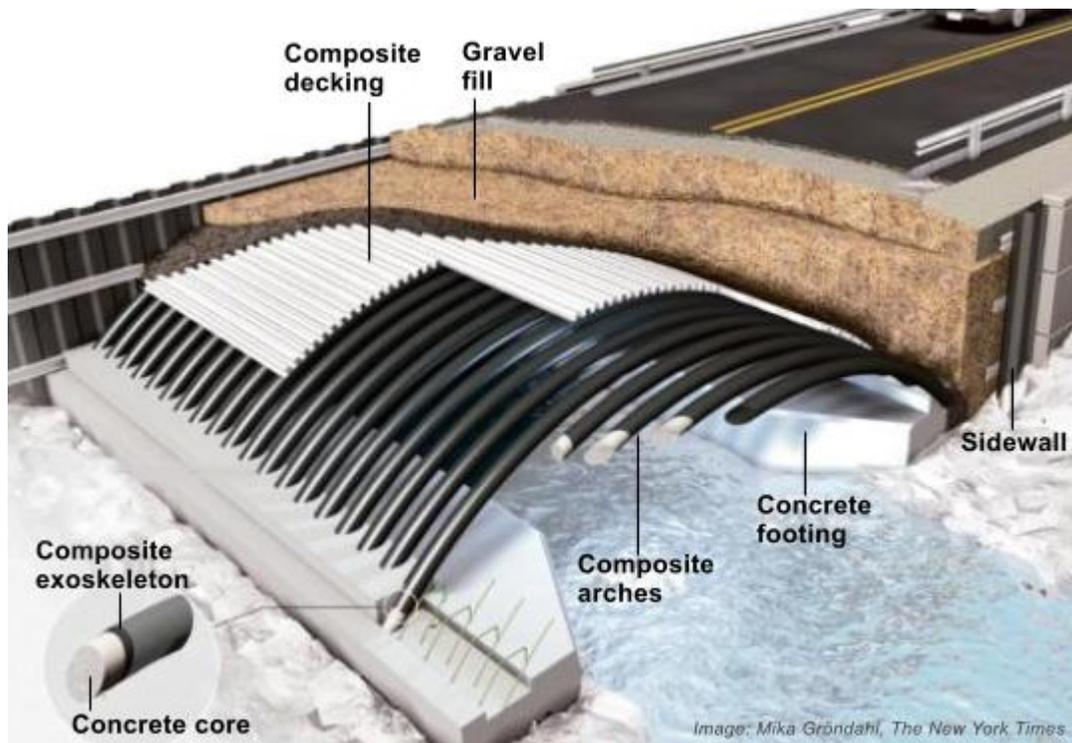
Figure 1: Typical Bridge in a Backpack System

The University of Maine in collaboration with Advanced Infrastructure Technologies (AIT) and the Army Corp of Engineers has developed the Bridge-in-a-Backpack™ system. As Dagher et al [1] and Colgrove [2] describe, this Bridge-in-a-Backpack™ (BiaB) system consists of a buried arch bridge system including structurally integrated stay-in-place concrete-filled fiber-reinforced-polymer (FRP) tubes (CFFTs) as main structural members, an FRP or concrete deck, foundations, and headwalls holding back soil. Parts of a typical BiaB system are shown in Figure 1. The FRP composite tube, typically constructed of braided carbon-glass material within a vinylester resin (VE-based GFRP), provides a stay-in-place form for the concrete and tensile reinforcement as a structurally integrated part of the arch composite section. As such, the durability and structural performance of the FRP composite tube and its bond with the concrete throughout the design life are critical to the overall system durability. The FRP tube is exposed to both the environment on the exterior, and the concrete on the interior, and these dual exposure durability requirements must be taken into account during design, and carefully monitored through inspection during service life to detect damage or degradation that could impact strength or serviceability.

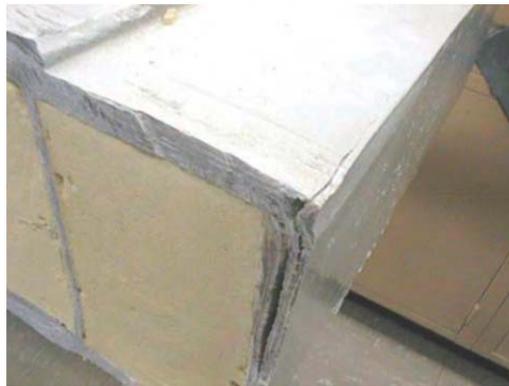
**Figure 2: Voids resulting in surface cracks (Ryan et al [3])**

Ryan et al [3] describes voids and delaminations are regions where the FRP shell or layers of the FRP shell have separated from each other. Voids could be present from construction when air pockets form between the concrete and FRP shell. Delaminations could be caused by impact, excessive flexure or poor quality control during manufacturing. Figure 2 shows a void and resulting surface crack of a foam filled FRP structure. Figure 3 shows a delamination due to a puncture.

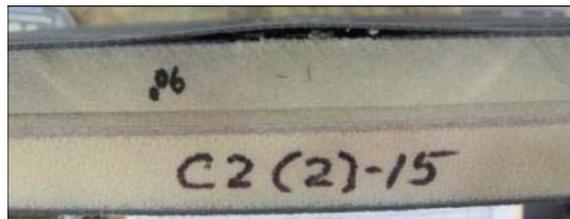
**Figure 3: Delamination due to puncture (Kittridge et al [11])**

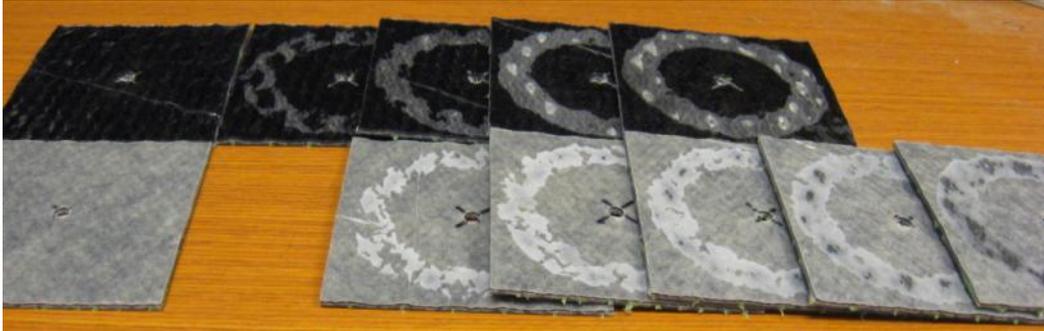
Discoloration may be indicative of structural problems. Whitening due to abrasion or excessive strain such as that seen in Figure 4 is detectable with visual inspection and can be minor or severe depending on the level of damage to the fibers.

**Figure 4: Discoloration due to abrasion, study samples**

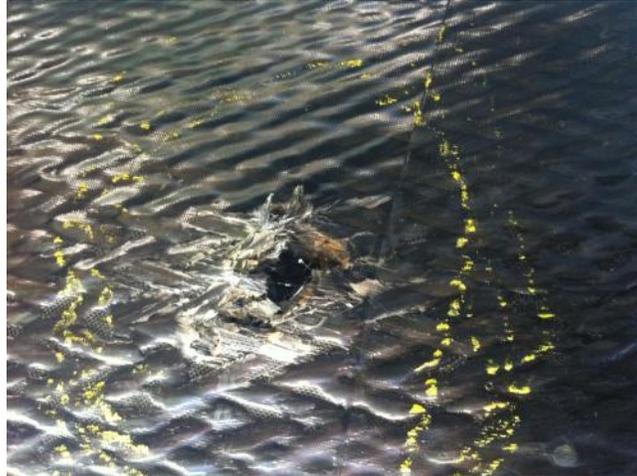
**Figure 5: Full puncture/hole in carbon fiber laminate**

According to the **BRIDGE INSPECTOR'S MANUAL**, Ryan et al [3], punctures, holes, and cracks may result from impact of vehicles, debris such as logs or rocks, or other deficiency left untreated. Full or partial punctures may result in additional cracking and delaminations. A puncture in a BiaB composite CFFT with a puncture can be seen in Figure 5. The damage shown in Figure 5 is quite small and not an immediate structural concern, but would need to be sealed with a small surface patch to prevent the ingress of water or chemicals and which could cause future degradation of the FRP.

Fiber exposure often occurs along with other types of damage, such as punctures, abrasion, fire, or scratches and gouges. This is a serious condition due to the significant exposure to fibers and should be remedied. Along with the fiber exposure shown in Figure 2, Figure 4, Figure 5, Figure 9, and Figure 10, fiber exposure due to fire is shown in Figure 8.

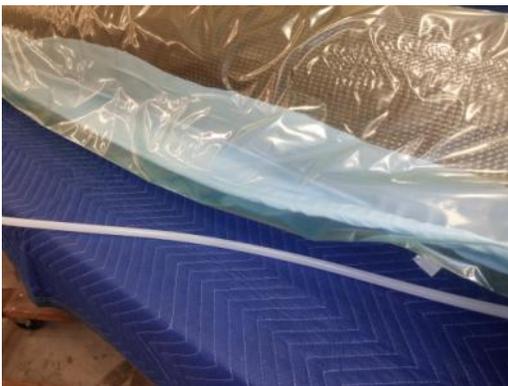
**Figure 6: Bagging film wrinkles acceptable in the resin layer of a BiaB FRP tube**

Wrinkling can occur in multiple areas of the FRP. This can occur in the fabric in the lamina itself, which is generally due to fabrication control issues, and is evaluated for acceptance prior to shipment of the FRP tube. Another type of wrinkling can occur in the bagging film as shown in Figure 6, causing a resin wrinkle as shown in Figure 7. This type of wrinkling is normal for this type of FRP tube structure and not a structural concern. Wrinkling can also be due to high compression stresses in a thin composite, which results in buckling of the tows or fibers. While tow buckling is certainly a sign of structural distress, it is highly unlikely that it would occur in a BiaB tube since the concrete carries the vast majority of the compressive stresses.

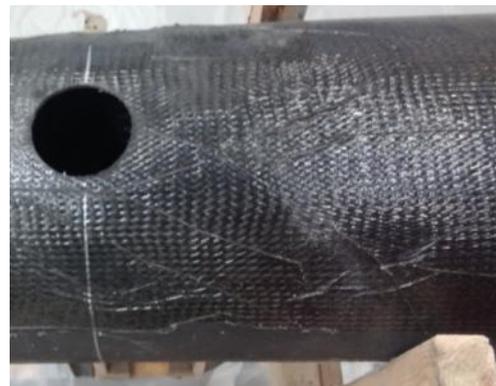
**Figure 7: Acceptable wrinkling in the resin layer of a BiaB FRP tube**

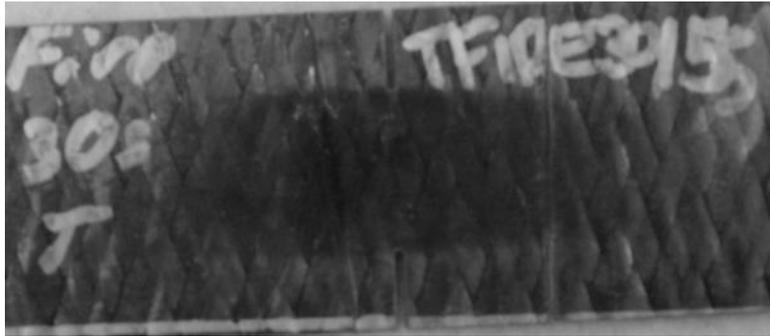
**Figure 8: Fibers exposed due to fire damage**

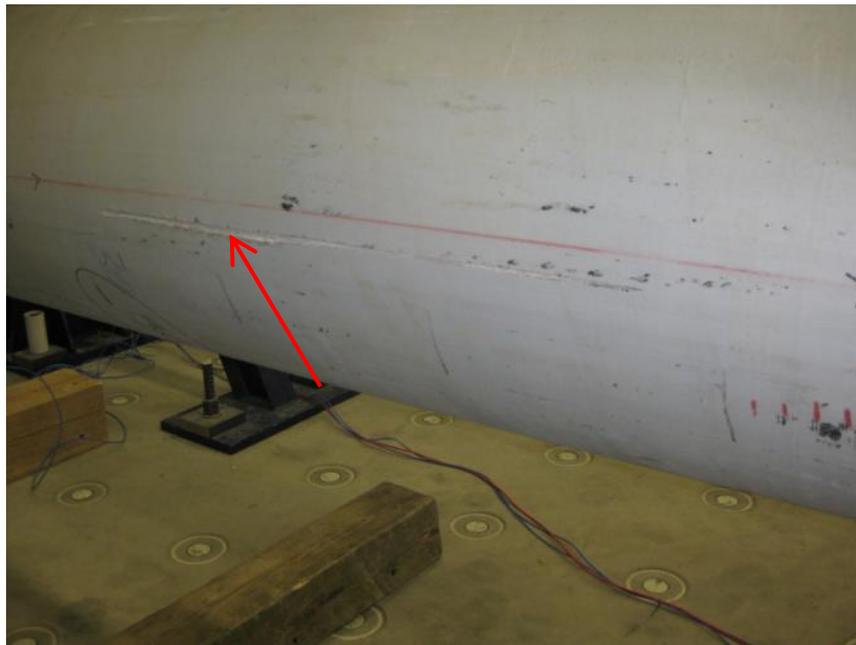
**Figure 9: Scratch in FRP pile**

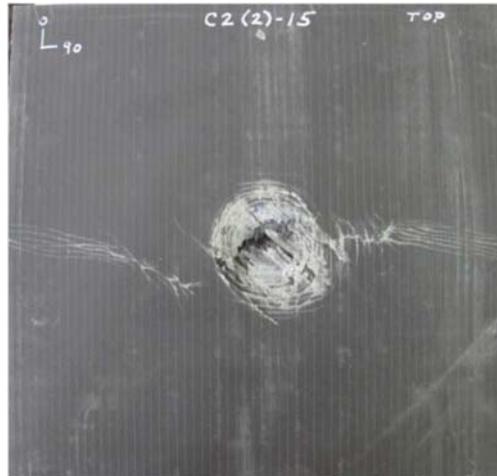
**Figure 10: Cracks form around a puncture (Kittridge et al [11])**

Cracks can form along with other types of damage, and can lead to fiber exposure. Major cracks should be repaired due to the possibility of decrease of structural capacity or exposure of fibers to damaging conditions. Cracks are shown around a puncture damage area in Figure 10.

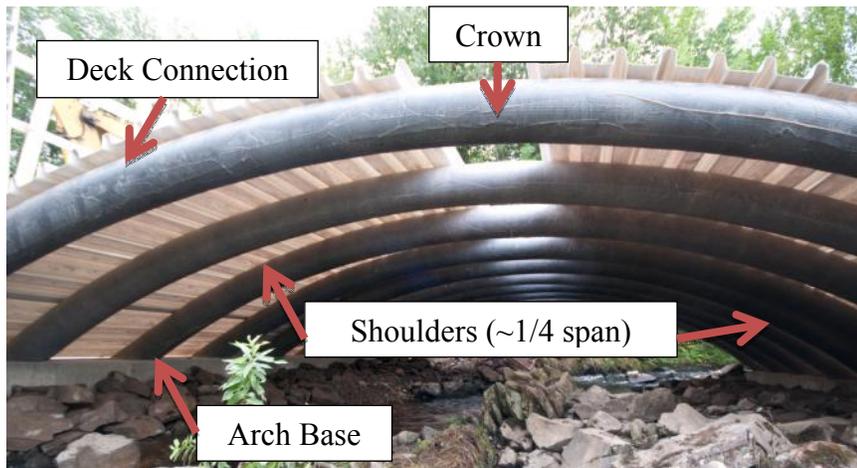
Figure 11: Typical key inspection locations, McGee Bridge under construction

Key locations for inspection of the tubular composite arches include the crown, shoulders (approximate quarter span), and bases of arch where they are embedded in the foundation. Dagher et al [1] has described these are the locations of peak moments and stresses. Additionally, any splices and connections to FRP headwalls and decking are areas to inspect. These areas are shown in Figure 11 and Figure 12.

1. Crown – area of peak moment. Look for distress, particularly discoloration due to excessive strain or excessive deflections
2. Shoulders – area of peak moment. Look for distress, particularly discoloration due to excessive strain or excessive deflections
3. Arch bases – area of peak axial load. Look for distress, particularly discoloration due to excessive strain or splitting of cross section or foundation
4. Splices (as applicable) – look for signs of increased separation of splice components, delaminations, cracks or other deficiencies.
5. Headwall and Deck connections (as applicable) – look for signs of increased separation of connection components, delaminations, cracks, punching or other deficiencies.

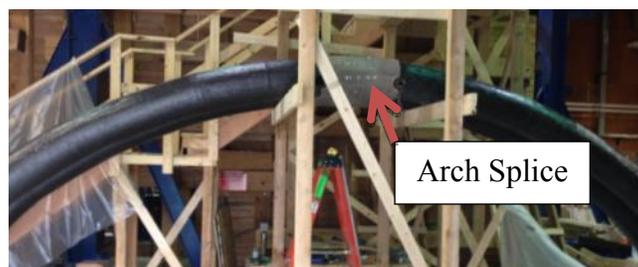
Figure 12: Key inspection location, spliced arch in laboratory

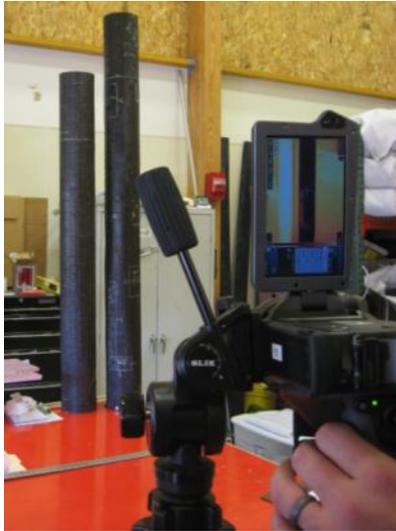
**Figure 13: Infrared camera in use**

As described by Kittridge et al [11], a FLIR SC620 infrared (IR) camera for conducting thermography inspections was used by the Composite Center. This portable camera along with the accompanying ExaminIR analysis software is a high performance IR system used for science and research applications. It has 640×480 resolution, a temperature range of -40°C to 500°C (-40°F to 932°F), accuracy of ±2°C (±3.6°F), 0.65 mrad spatial resolution, and a thermal sensitivity of ≤55 mK. Data (including full field radiometric temperature measurements) are captured either as still images or streaming video. Changes in heat transfer rate (and therefore surface temperature) due to internal flaws create an image that highlights various defects. A photograph of the SC620 is provided in Figure 13.

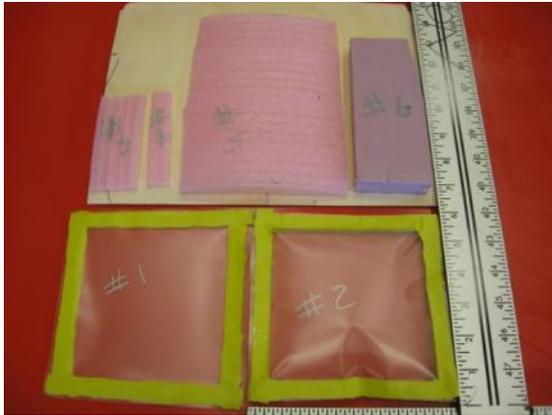
**Figure 14: Materials used to create artificial voids**

The specimens were 6.5 inch diameter hybrid glass/carbon fiber FRP tubes, nominally 6 feet long, with multiple artificial voids directly on the inside of the FRP shell. All tubes were mapped for actual locations, only two are marked on the exterior for locations of actual voids. To produce the voids several materials were used that included  $\frac{3}{4}$  inch Foamular 250 foam board insulation,  $\frac{1}{4}$  foam sill seal, and air pockets formed by sandwiching plastic film with tacky tape. Two different thicknesses of the plastic film air pocket were created. Various size foam blocks were used as well for simulating air voids between concrete and CFRP tube. These materials can be seen in Figure 14 prior to installation. The installed materials can be seen in one tube in Figure 15.

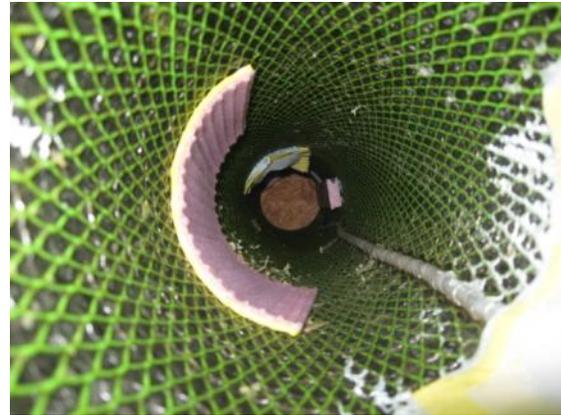
**Figure 15: Inside of tube with artificial voids**

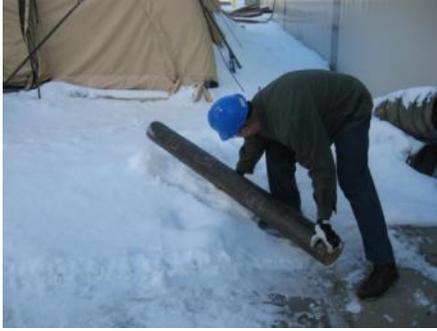
Figure 16: Filling tube with snow

Tubes were filled with snow by packing the snow lightly and tapping the bottom of the tube lightly on the ground by picking it up approximately 6 inches and dropping the plugged end on the ground. This was repeated until the tube was filled to desired level as seen in Figure 16 and Figure 17.

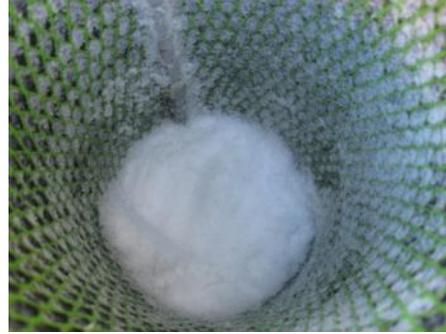
Figure 17: Snow filled tube

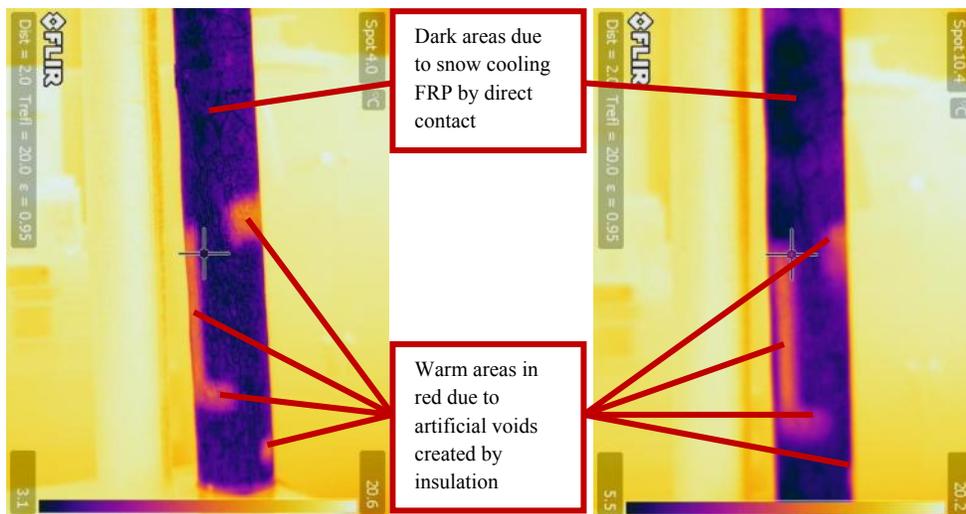
Figure 18: Snow filled tube inside

Figure 19: Snow filled tube inside

Once filled the tubes were brought back inside the composites lab and placed in front of the FLIR 600 camera. Photographs were taken of surface temperatures at predetermined time intervals, recording the temperature variances on the outside surface of the CFRP tube as seen in Figure 18 and Figure 19.

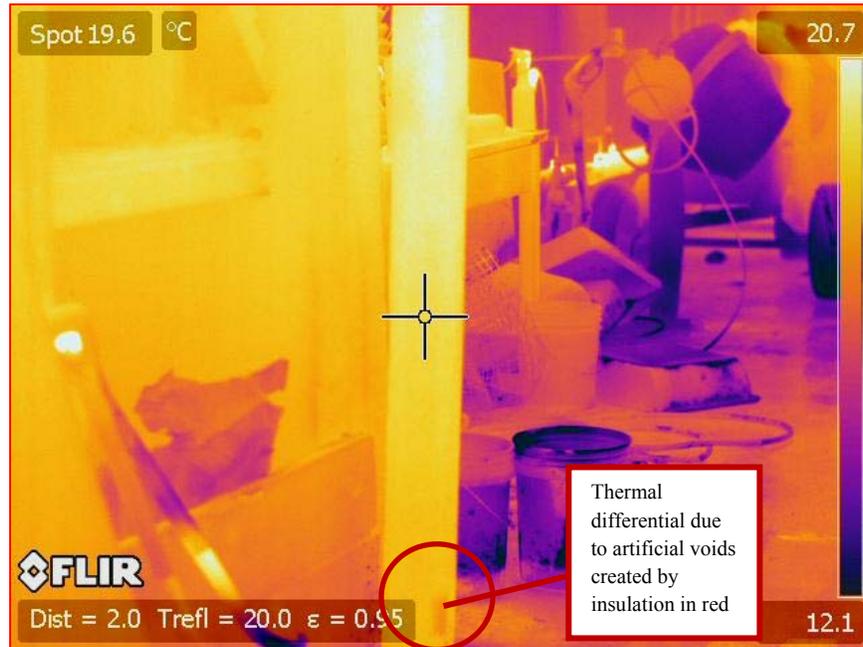
Figure 20: Partially filled Tube K, 12:24, time since filling ~30 minutes

Images are shown for one placement. Tube K was partially filled by hand starting at 11:40 on April 6, 2012. A series of images was taken after filling starting at 12:24 and continuing for roughly half an hour. The first is shown in Figure 20 and the last in Figure 21.

The IR thermography successfully detected the artificial void during filling, and was able to be detected in images ranging from half an hour after filling to an hour after filling. The ability to see the void was greatly diminished roughly an hour after concrete placement, but is still detectible as Figure 21 shows. Based on this experimentation, IR thermography could be used during concrete placement to successfully detect voids before the concrete has cured. This ability could be used to consolidate the concrete causing the void before curing, thus allowing defects to be removed while there is still opportunity to do very simply cost effectively.

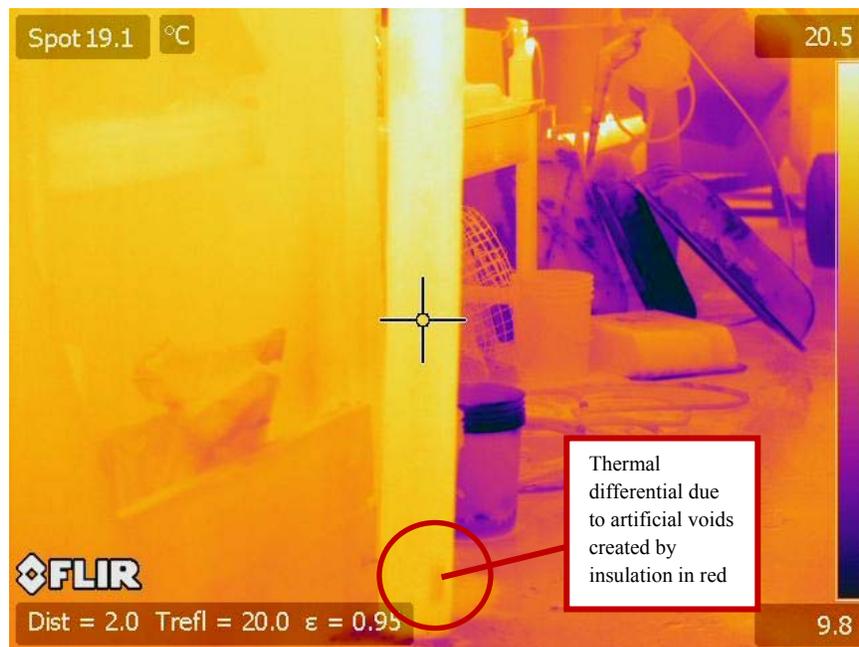
Figure 21: Partially filled Tube K at 12:49, time since filling ~55 minutes

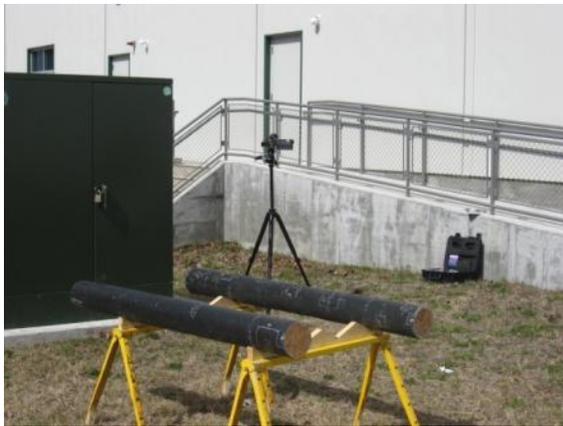
**Figure 22: Tubes outside of lab**

Concrete filled tubes were placed outside on several occasions for inspection with IR thermography. This simulated in place conditions for BiaB inspections. Various environmental conditions were evaluated including direct sunlight, overcast conditions and early and late day conditions with relatively rapid changes in ambient air temperature. Figure 22 shows the CFFTs outside of the laboratory for inspection. Tubes were checked for effects of thermal changes in air temperatures and direct radiation heating from the sun. As can be seen from the thermal photo in Figure 23, 2 voids were seen by their darker color indicating a temperature variance.

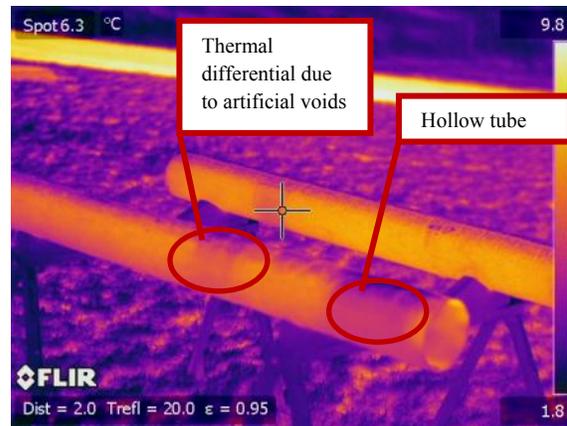
**Figure 23: Tubes inspected with IR**

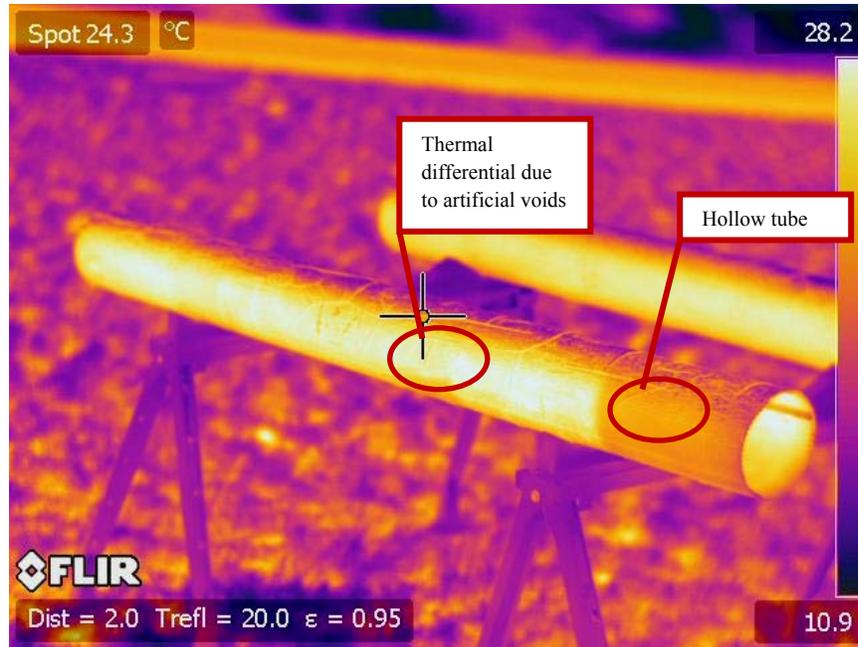
It was difficult to detect the voids on sunny days where there was direct heating of the surface of the FRP as is shown in Figure 24.

Figure 24: Tubes in direct sunlight

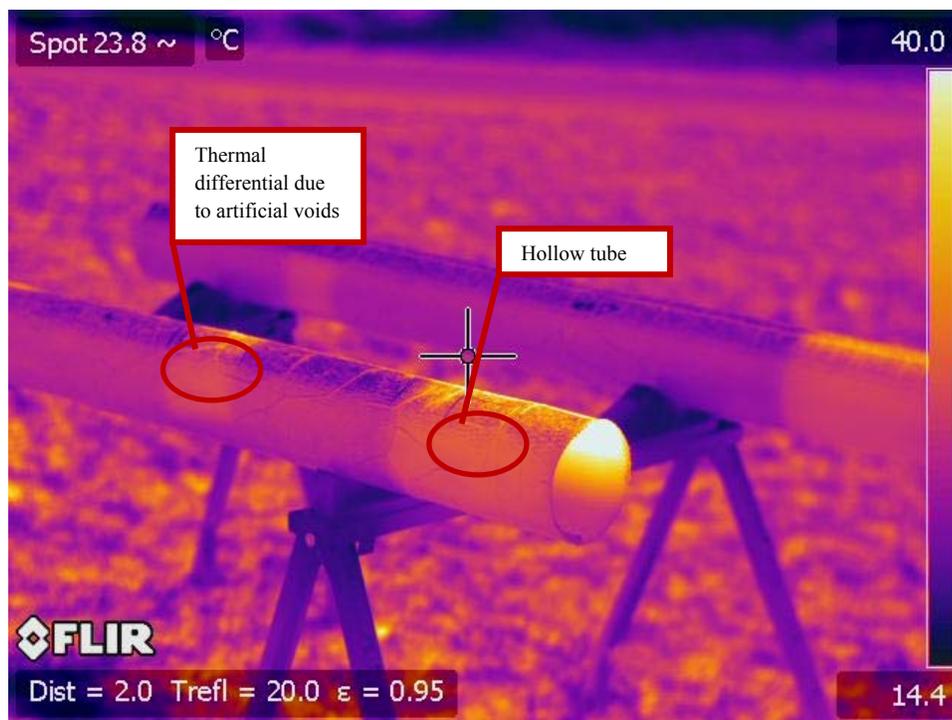
The best results for finding the voids came on overcast days with higher temperature variance from overnight to the mid-day as is shown in Figure 25.

Figure 25: Tubes in cloudy skies

This experimentation IR thermography on CFFTs in exterior conditions shows the ability of the inspection methodology to detect voids in large field in various environmental conditions. The best detection occurred when large temperature differentials were present between the thermal mass of the concrete and exterior ambient temperature.
