Coastal Landslide Hazards

York Harbor Quadrangle, Maine

Coastal landslide hazard mapping by
Stephen M. Dickson

Open-File No. 01-553
2001

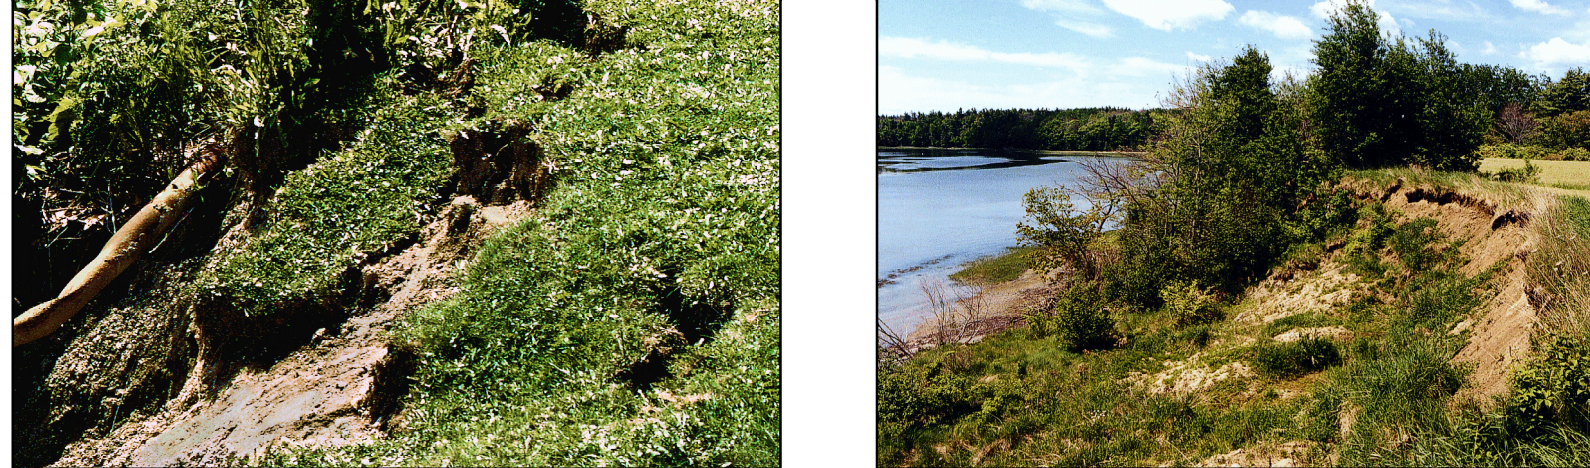
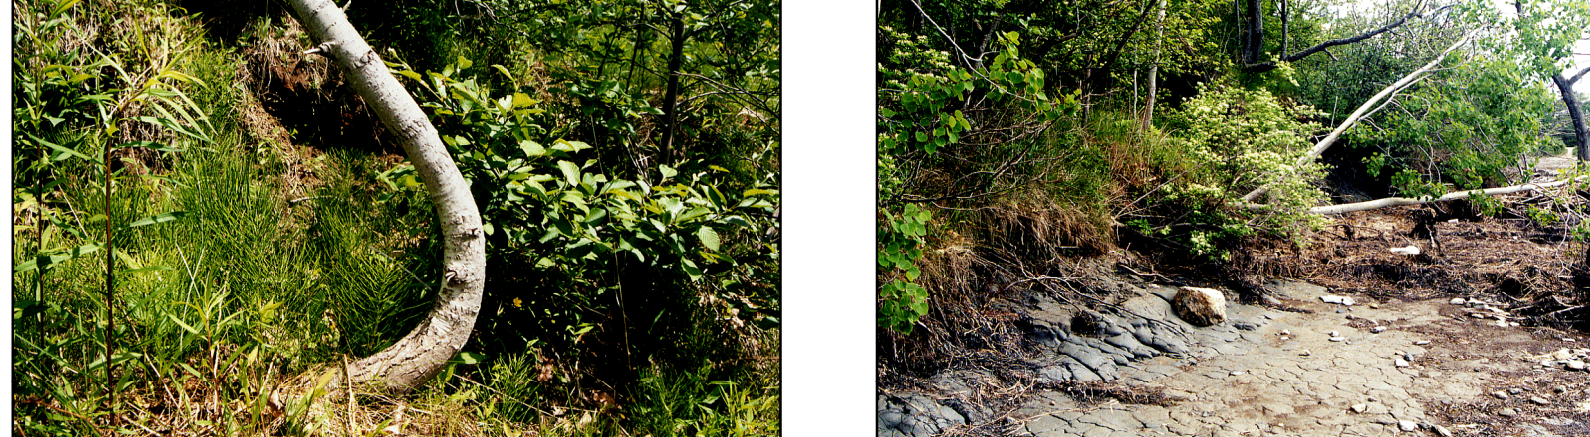
Evidence of Ground Motion and Instability on a Coastal Bluff

Careful observation of the land surface, vegetation, and shape of a coastal bluff reveals evidence of instability. Starting at the top of a bluff, an irregular or arcuate edge can indicate past landslides or areas of increased coastal erosion (Figure 3). When a weak point on a bluff fails, the slide moves inward into the slope face forming a curve around the original point of failure. Tension cracks may form near a weak zone where the soil surface is moving downslope (Figure 4). These cracks appear as splits in the ground where the soil and vegetation have moved apart. Cracks may be visible along the top edge of the bluff or on the bluff face itself. On the slope of a bluff, a hummocky land surface or terraces indicate past slumping or landslides (Figure 5). Unvegetated slump scars or slopes are obvious evidence of rapid soil movement. A bowl-shaped slope often shows the location of a former landslide, with the center of the bowl as the area of greatest failure. Distorted vegetation provides evidence of soil creep or former landslides. Tree trunks curved near their base are evidence of downslope movement (Figure 6). Trees tilted at different angles are evidence of former slides or undercutting by erosion. At the base of a bluff, toppled trees and bare roots are evidence of erosion that steepens the bluff (Figure 7). Undercutting and steepening of the bluff may destabilize the slope and lead to increased erosion and possibly a landslide. Lobes or terraces of sediment in the intertidal zone are often remnants of old landslides. Although the evidence of earth movement listed above cannot predict a landslide, it is useful to recognize unstable shorelines. This landslide evidence is related to factors listed below that influence landslide risk.
