# Coastal Landslide Hazards

## Monhegan Quadrangle, Maine

Open-File No. 01-525  
2001

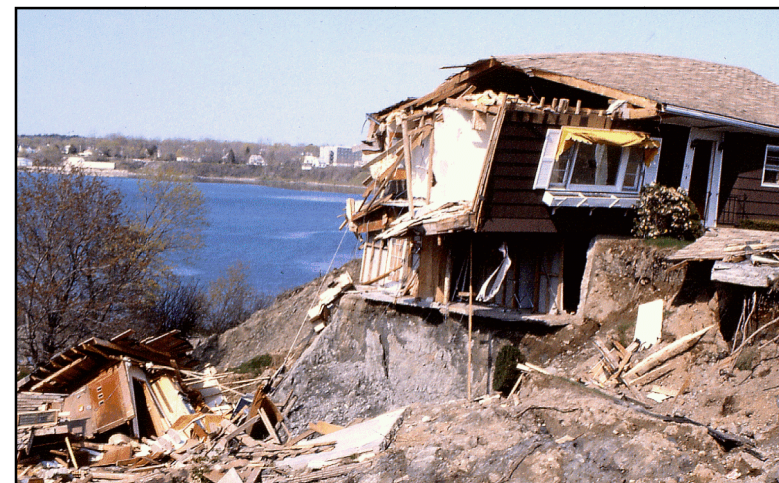
Figure 1. A clay bluff on the north shore of Rockland Harbor failed in 1996. This landslide formed a new scarp about 200 feet landward of the original top of the bluff in just a few hours. Two homes were destroyed as a result of this catastrophic slide (see Berry and others, 1996).

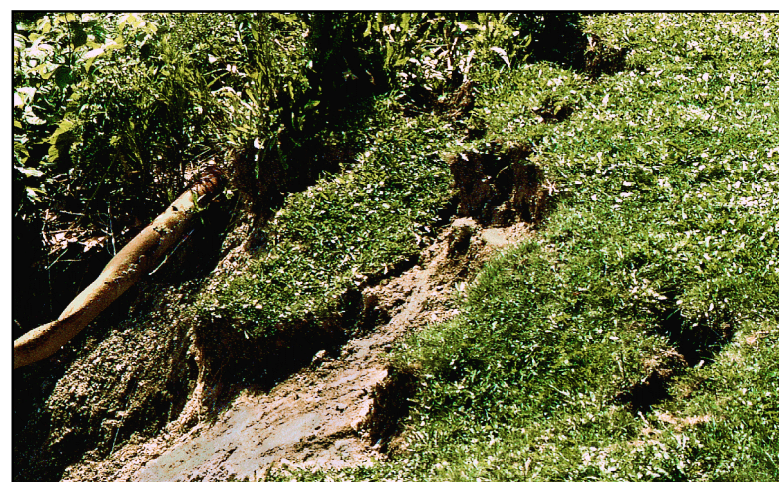
Figure 4. Downslope forces within a bluff cause surface layers to stretch. When the tension becomes great enough, a crack forms and the pressure is released. These "tension cracks" may form on the top edge of the bluff or on the bluff slope itself. They indicate instability and motion within the bluff. Some cracks are deep and extend below the soil layer.

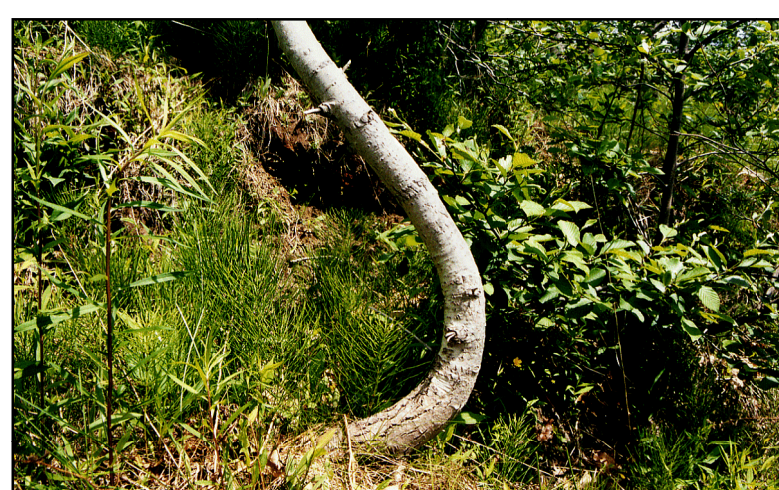
Figure 5. Wave erosion at the base of a bluff removes slope sediment and steepens the bluff. Erosion has undercut the trees in the photo above and caused them to tilt toward the ocean. This steepening reduces the stability of the bluff, and a landslide may result. Ongoing sea-level rise along the Maine coast will cause wave erosion at the base of coastal bluffs and continue to make some coastal bluffs at risk of experiencing a landslide.
