# Coastal Bluffs

## Classification and Mapping of Maine's Coastal Bluffs

## Sargentville Quadrangle, Maine

Open-File No. 02-211

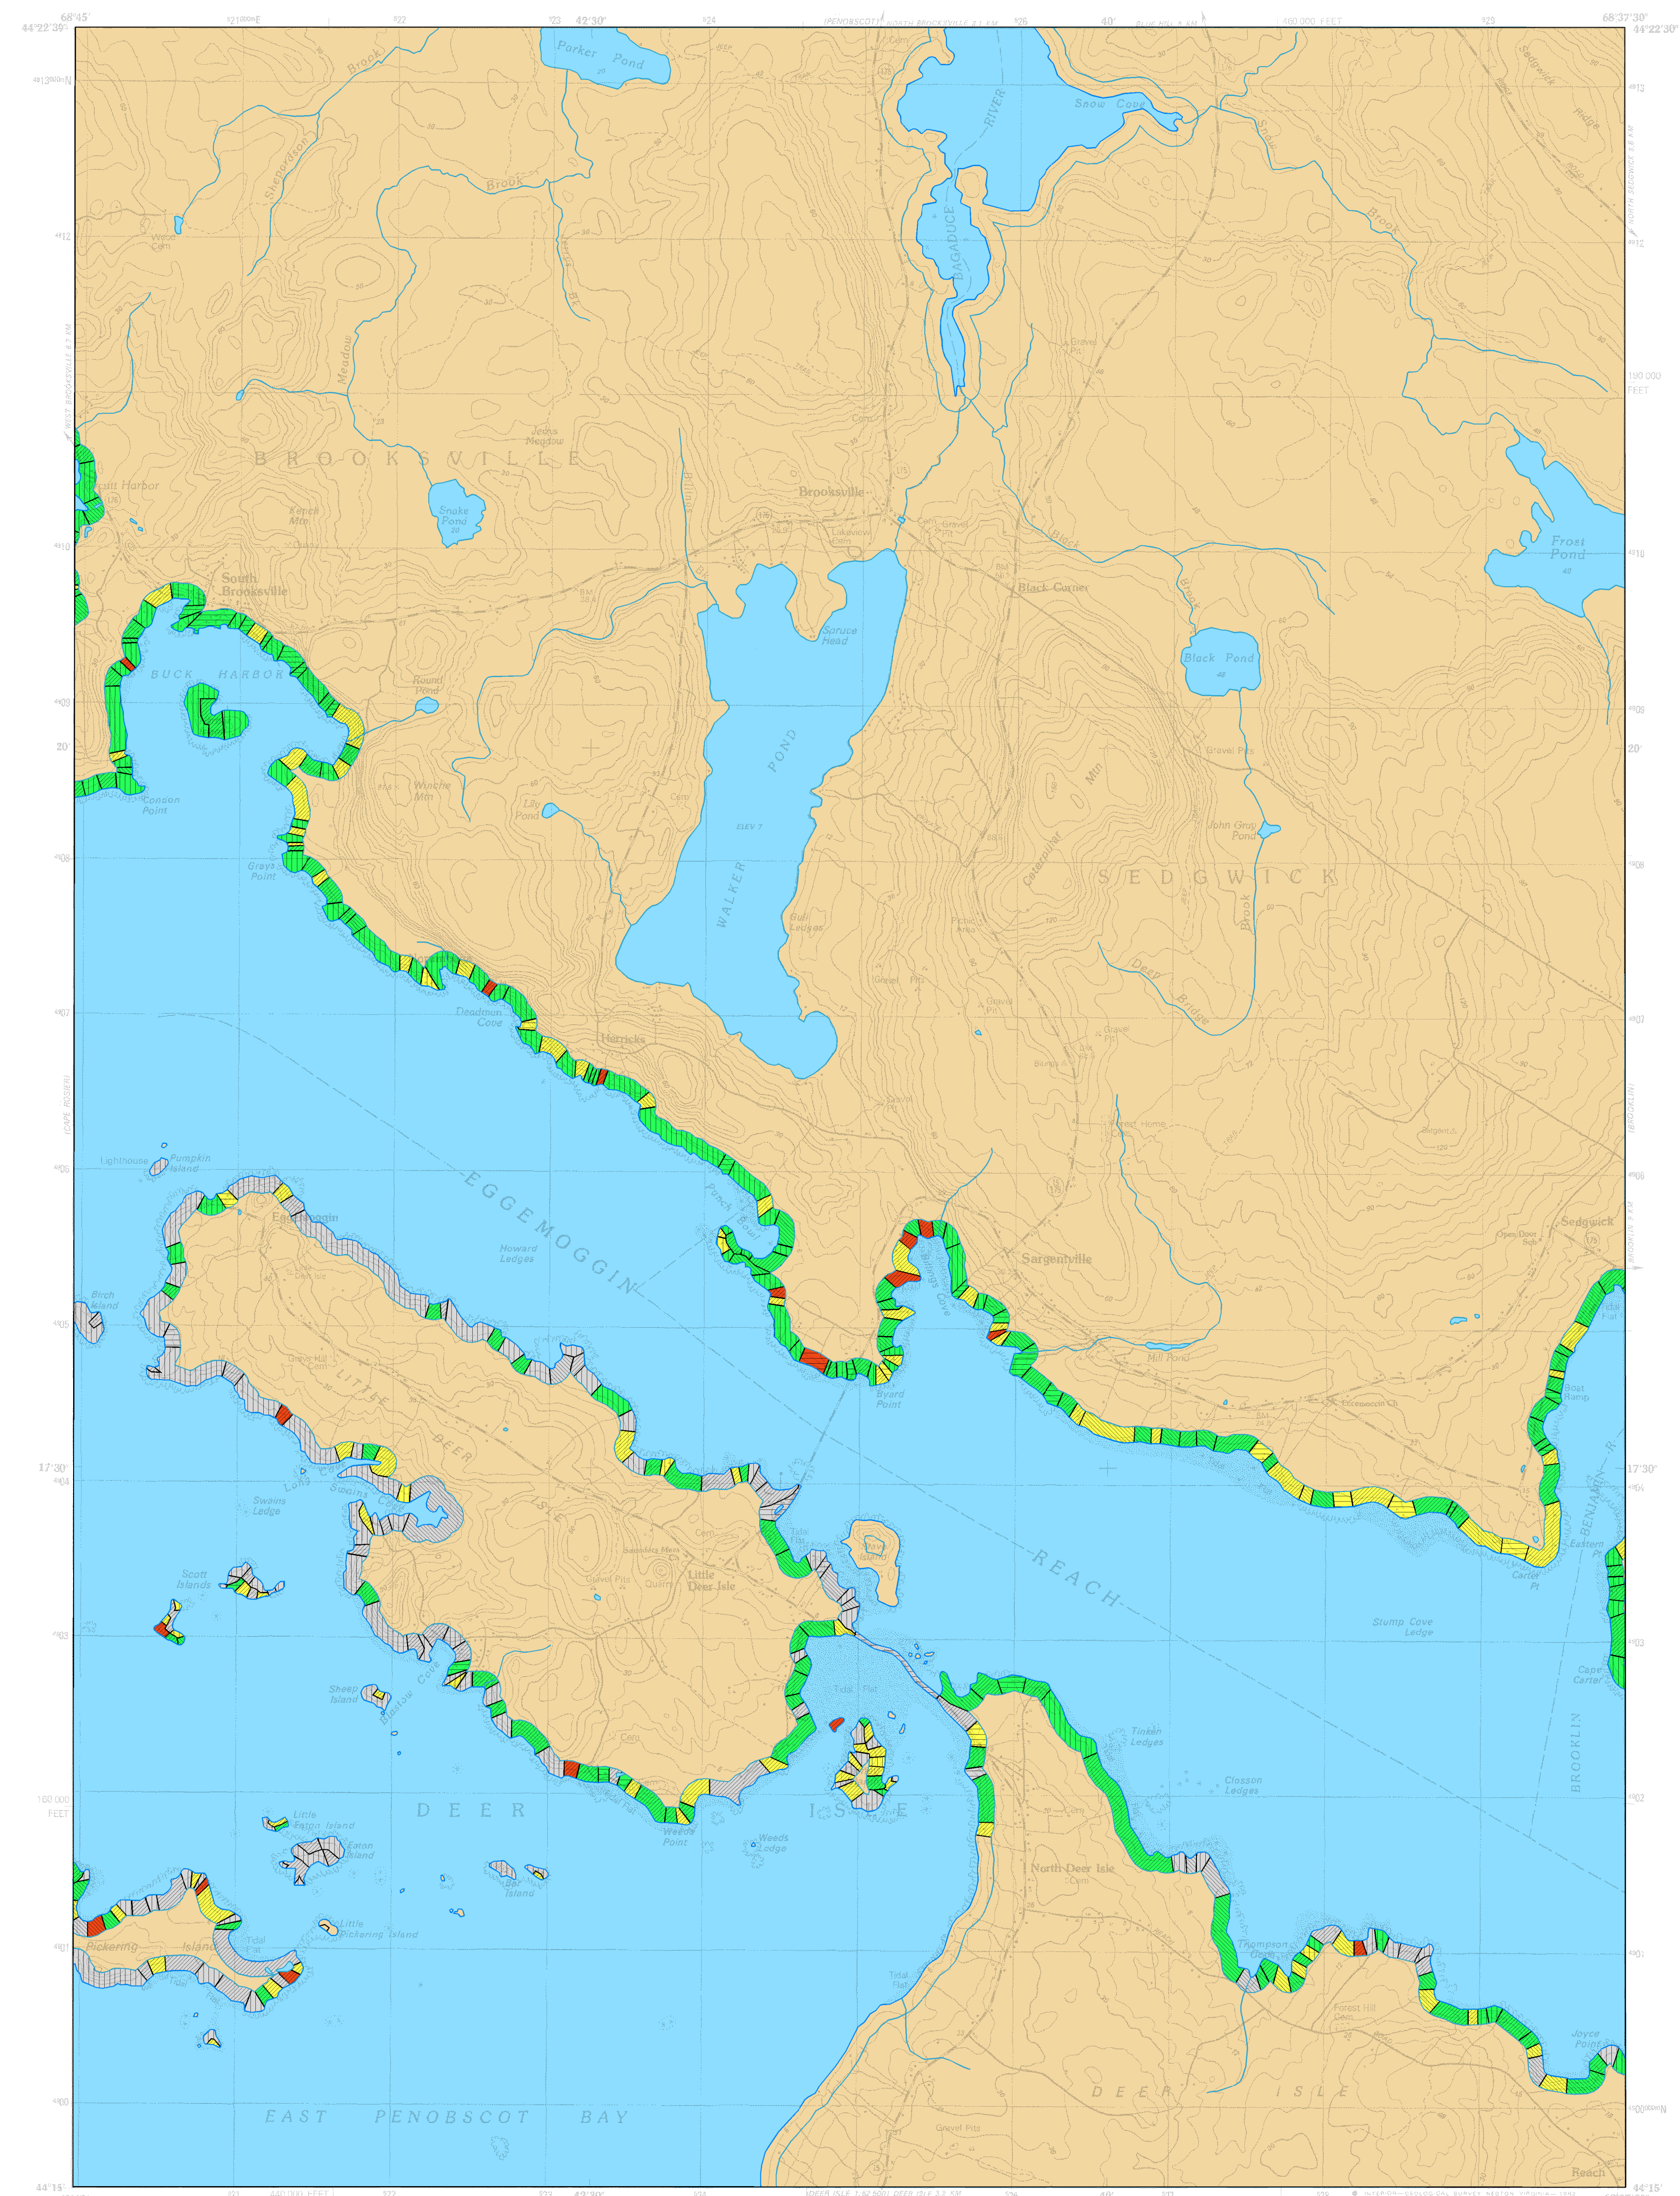
Topographic base from U.S. Geological Survey Sargentville quadrangle, scale 1:24,000 using standard U.S. Geological Survey topographic map symbols.  
Index at left shows adjacent maps in this series.

**Note:** The classification of the bluff is indicated by a colored, patterned band extending landward from the shoreline (dark blue line). The width of the band is NOT related to the width of the bluff. Stability rank refers to RECENT bluff face activity.

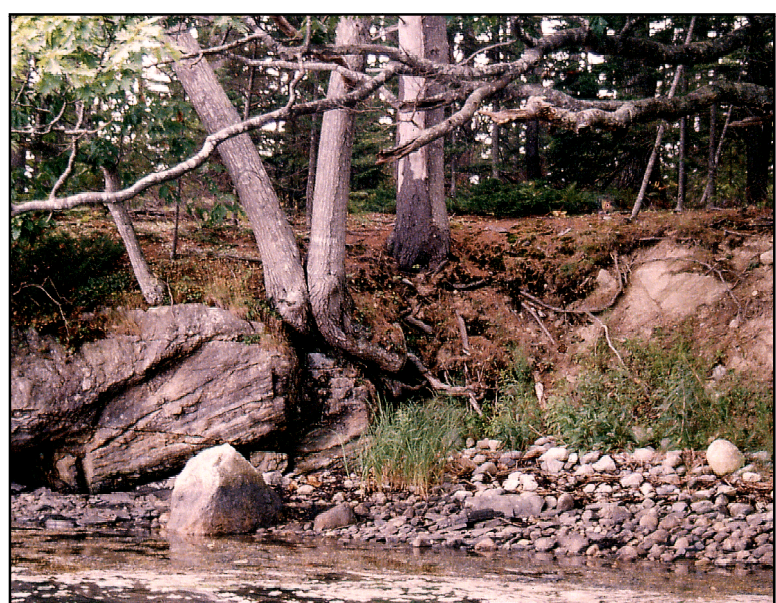
**Map Resolution**  
Since these are regional maps, some shorelines may contain small areas that are unstable. A bluff, too small to appear on the map, is shown in the photo. This bluff exhibits the characteristics of an unstable bluff: curved tree trunks, exposed roots, and bare ground on a steep slope. It is an area to be concerned about on a local scale. However, this degree of detail is not shown on the map above.

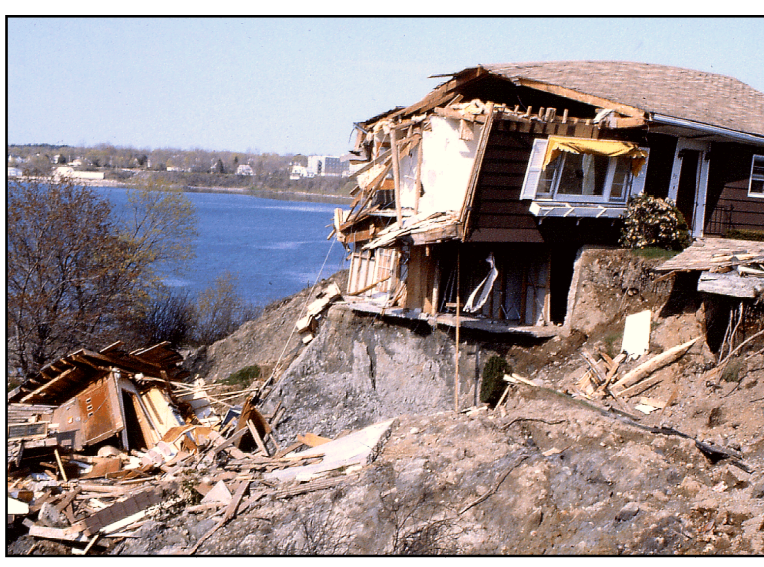
A 1996 landslide in Rockland Harbor (photo below) occurred in an area where the bluff face is classified as unstable. In addition, the bluff had all the characteristics (a-d) listed above. This fact is emphasized by the map above does not indicate sites with a potential for catastrophic landslides. Additional factors need to be considered beyond the appearance of the bluff face and type of shoreline below the bluff. Maps of topography, surficial sediments, and Coastal Landslide Hazards are available from the Maine Geological Survey to help assess the landslide potential in an area.

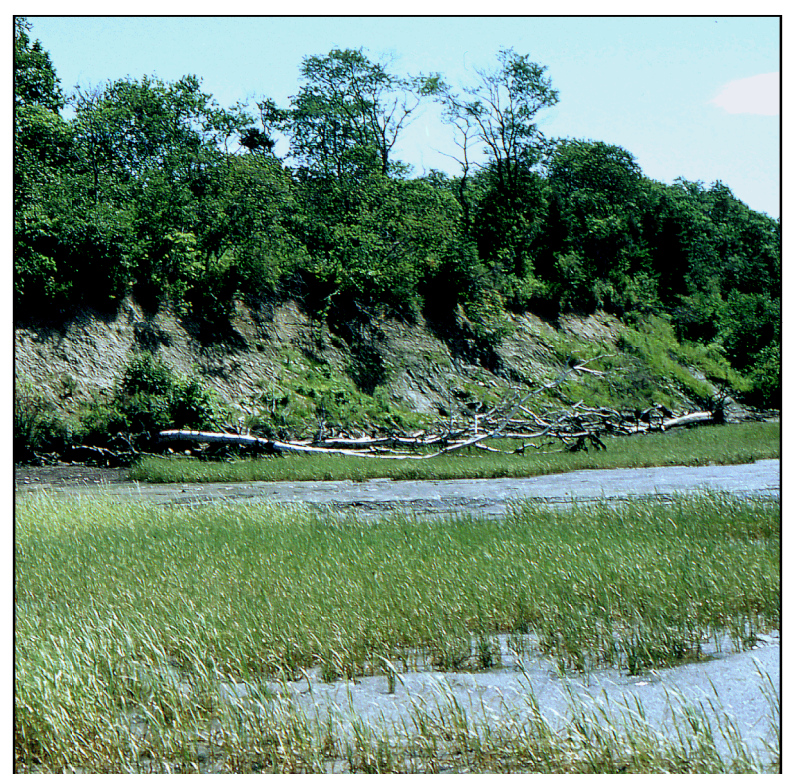
**Highly unstable bluff** with an unvegetated bluff face and a salt marsh shoreline. Sediments on the bluff face are exposed and fallen tree trunks lie at the base of the bluff. A salt marsh has recently formed on the tidal flat, partly on the top of an old landslide deposit.

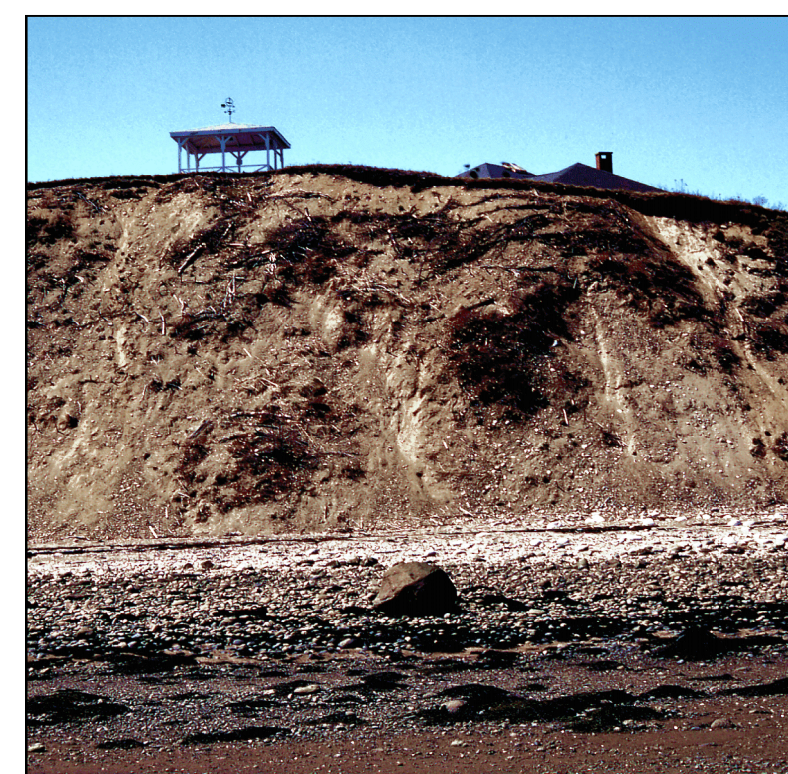
**Highly unstable bluff** with an unvegetated bluff face and a salt marsh shoreline. The bluff face is too unstable to support vegetation. This bluff, a glacial esker, is eroded by waves to create a mixed sand and gravel beach in front of the bluff.

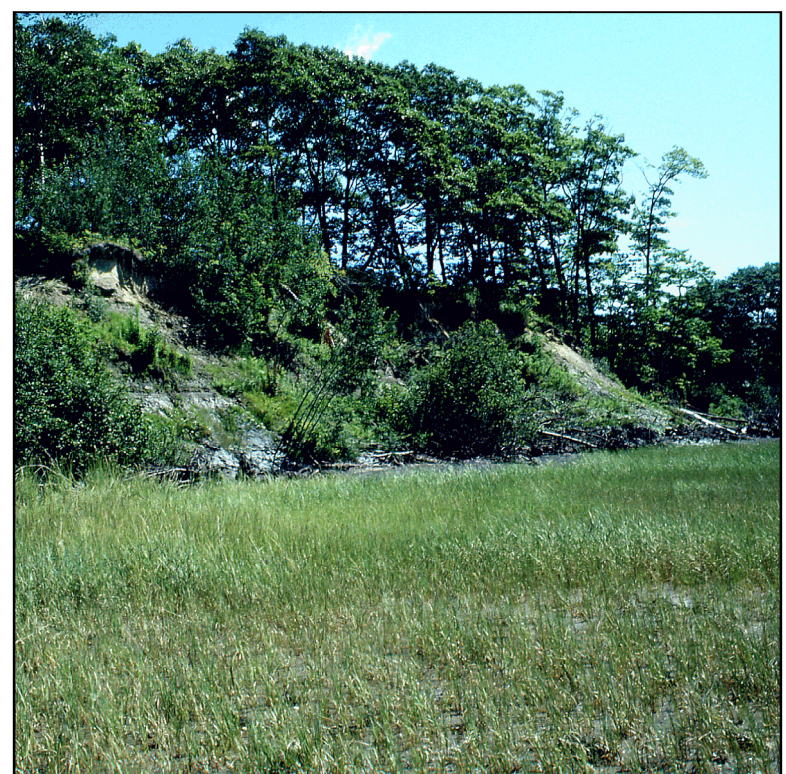
**Unstable bluff** with a partially vegetated bluff face and a salt marsh shoreline. This bluff, protected by a salt marsh, remains unstable. There are small bushes on the bluff as well as small non-vegetated areas that indicate continuing bluff retreat.

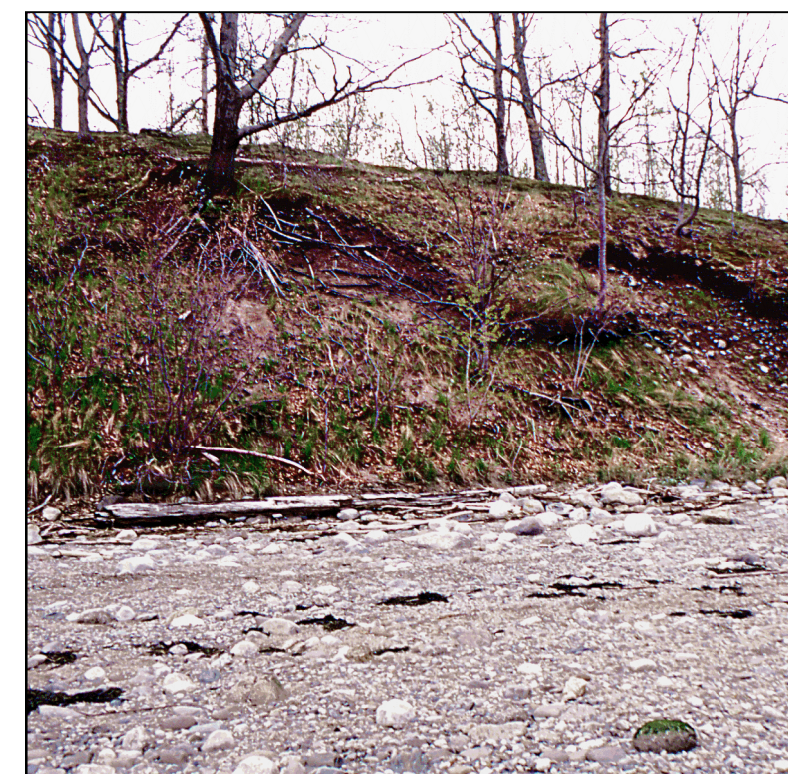
**Unstable bluff** with a partially vegetated bluff face and a beach/gravel flat shoreline. Slump scars on the bluff face expose sand, gravel, and roots. Fine sediments are removed by waves and currents, leaving gravel to form a beach at the base of the bluff.

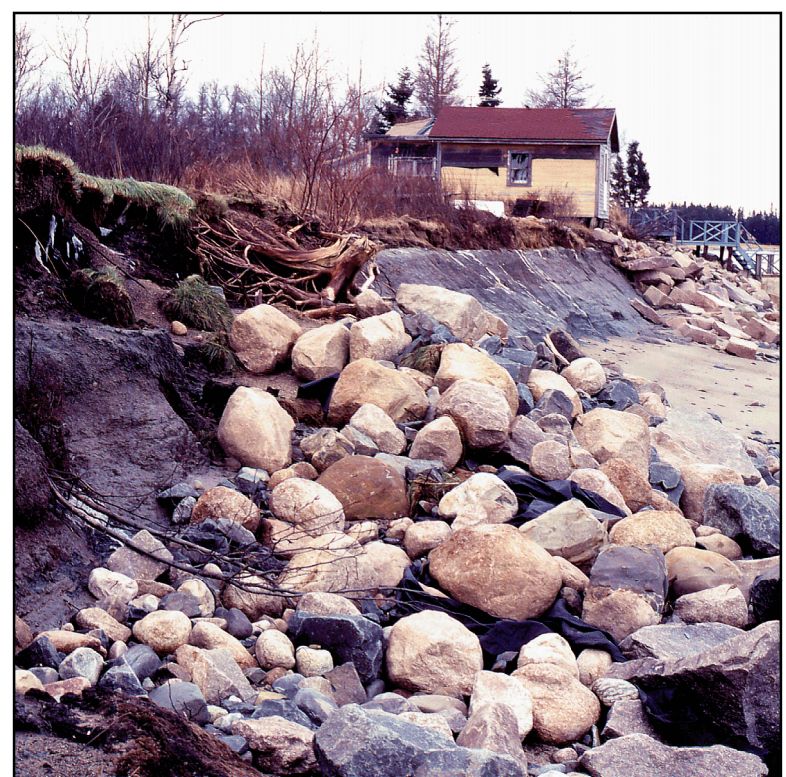
**Highly unstable bluff** with an unvegetated bluff face and an armored shoreline. This armored bluff is eroding despite an effort to shore it up with riprap, or loosely piled stone blocks. Maintenance at this site could improve bluff stability.

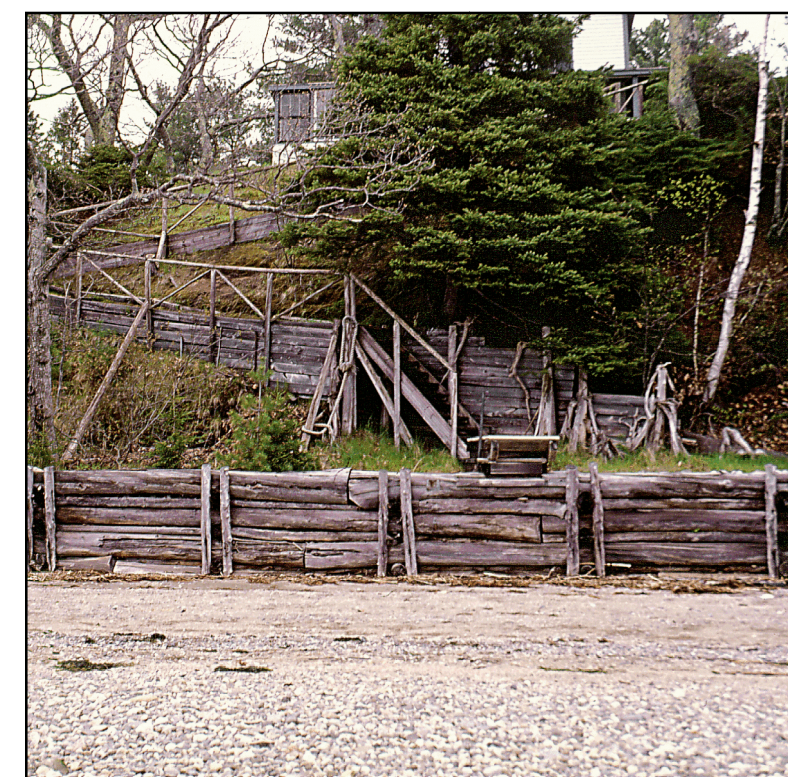
**Stable bluff** with a vegetated bluff face and an armored shoreline. The bluff face is fully vegetated and supports a mature stand of trees with vertical trunks. The presence of a wooden bulkhead suggests that erosion has occurred in the past.

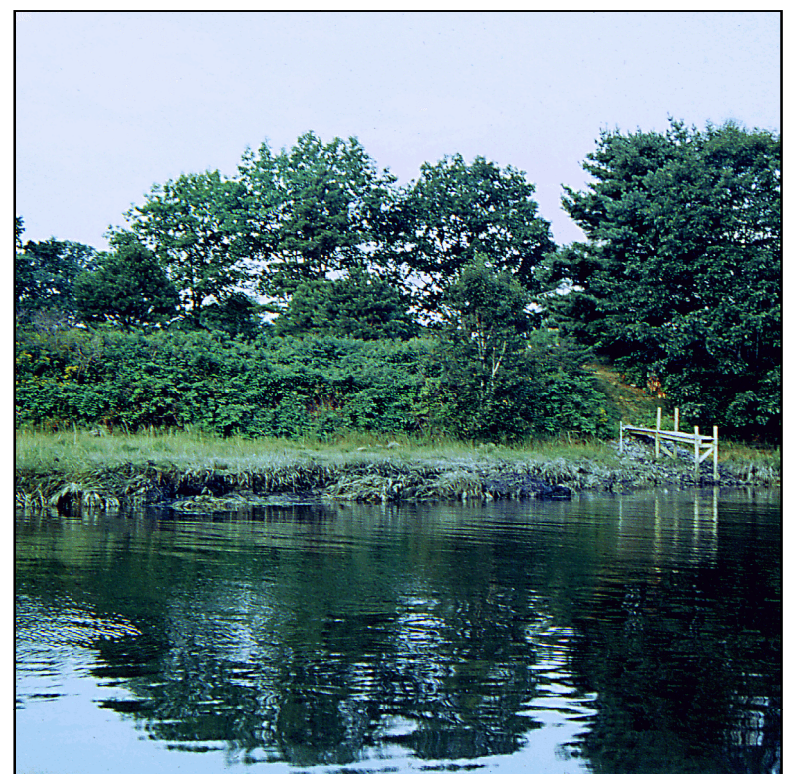
**Stable bluff** with a vegetated bluff face and a salt marsh shoreline. A low bluff face is covered by shrubs landward of a salt marsh terrace. In this location the mature marsh protects the base of the bluff from rapid erosion and slows bluff recession or retreat.
