# Coastal Bluffs

## Classification and Mapping of Maine's Coastal Bluffs

## Islesboro Quadrangle, Maine

**Open-File No. 03-22**  
**2003**  
This map supersedes Open-File Map 02-192.

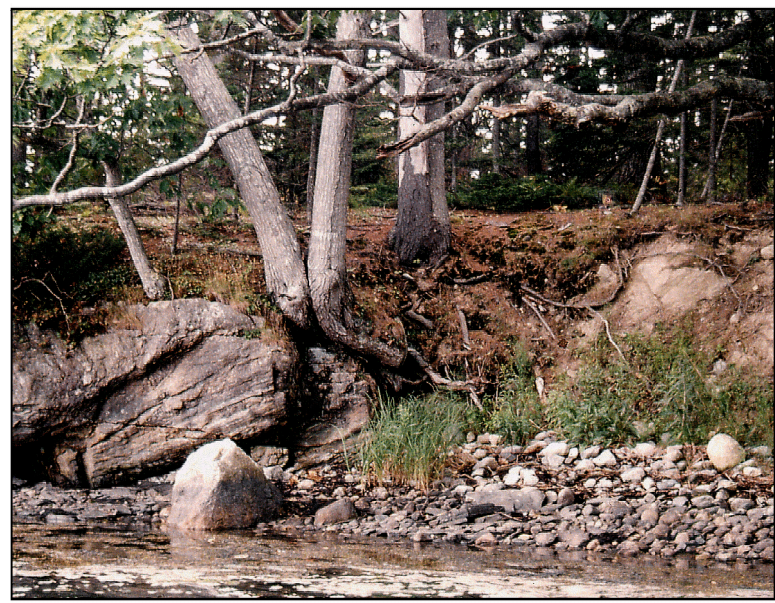
Since these are regional maps, some shores mapped as stable may contain small areas that are unstable. A bluff, too small to appear on the map, is shown in the photo. This bluff exhibits the characteristics of an unstable bluff: curved tree trunks, exposed roots, and bare ground on a steep slope. It is an area to be concerned about on a local scale. However, this degree of detail is not shown on the map above.

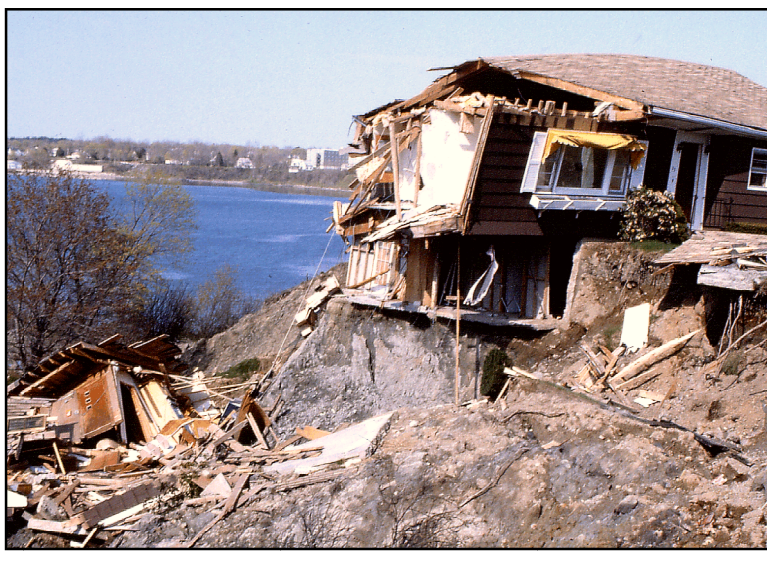
A 1996 landslide in Rockland Harbor (photo below) occurred in an area where the bluff face is classified as unstable. The map above does not indicate sites with a potential for catastrophic landslides. Additional factors need to be considered beyond the appearance of the bluff face and type of shoreline below the bluff. Maps of topography, surficial sediments, and Coastal Landslide Hazards are available from the Maine Geological Survey to help assess the landslide potential in an area.

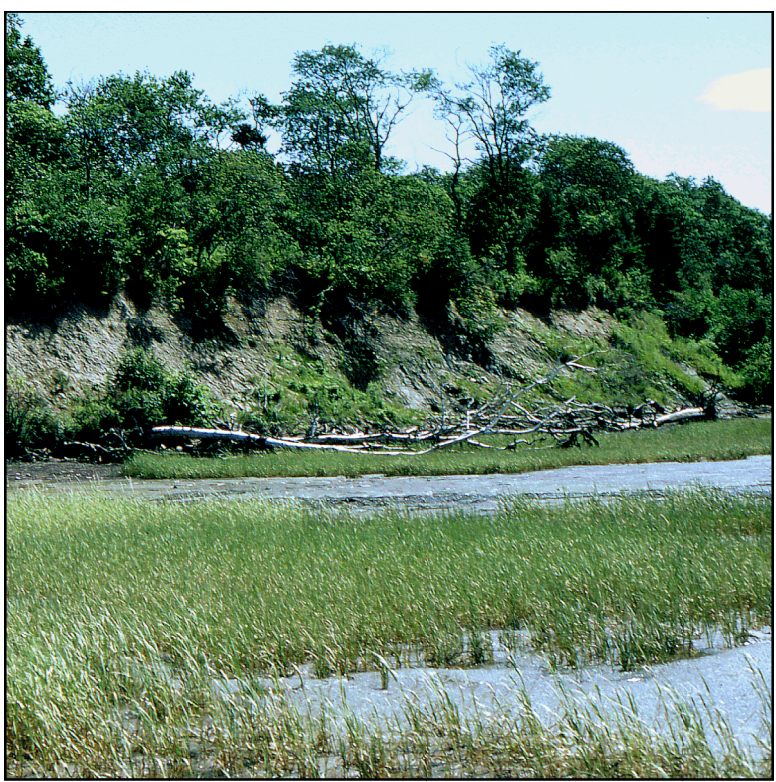
**Highly unstable bluff** with an unvegetated bluff face and a salt marsh shoreline. Sediments on the bluff face are exposed and fallen tree trunks lie at the base of the bluff. A salt marsh has recently formed on the tidal flat, partly on the top of an old landslide deposit.

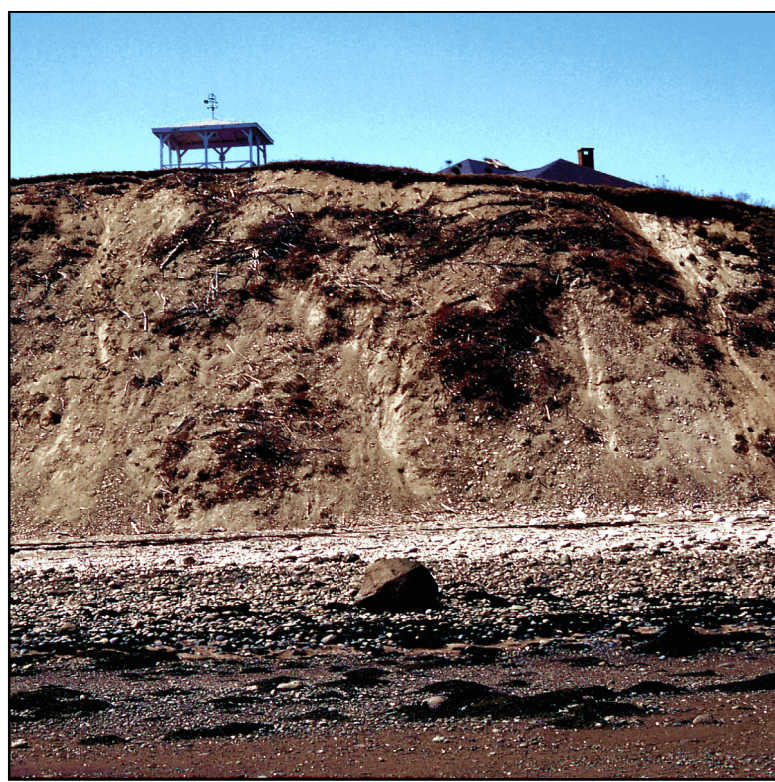
**Highly unstable bluff** with an unvegetated bluff face and a beach/gravel flat shoreline. The bluff face is too unstable to support vegetation. This bluff, a glacial esker, is eroded by waves to create a mixed sand and gravel beach in front of the bluff.

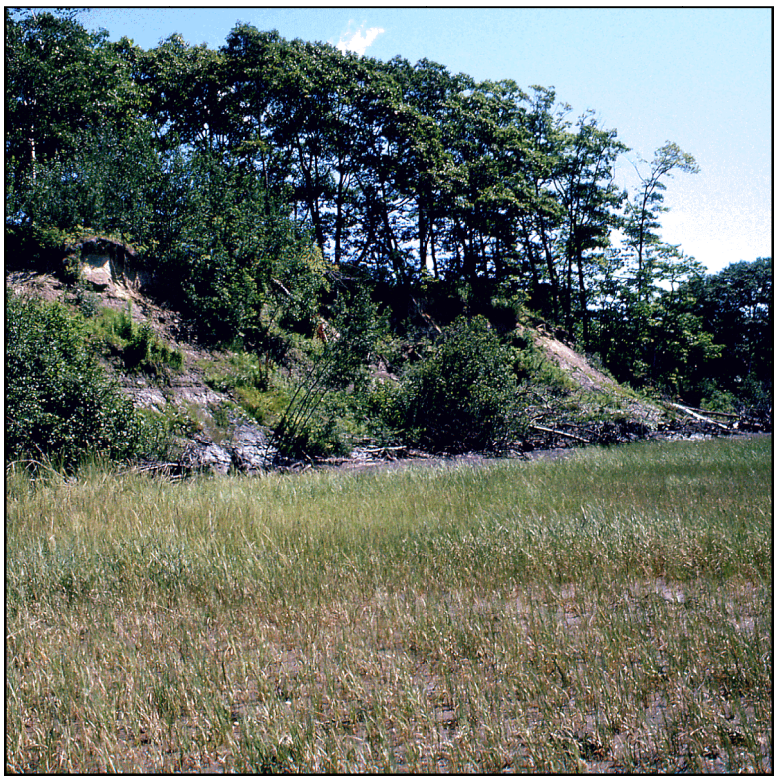
**Unstable bluff** with a partially vegetated bluff face and a salt marsh shoreline. This bluff, protected by a salt marsh, remains unstable. There are small bushes on the bluff as well as small non-vegetated areas that indicate continuing bluff retreat.

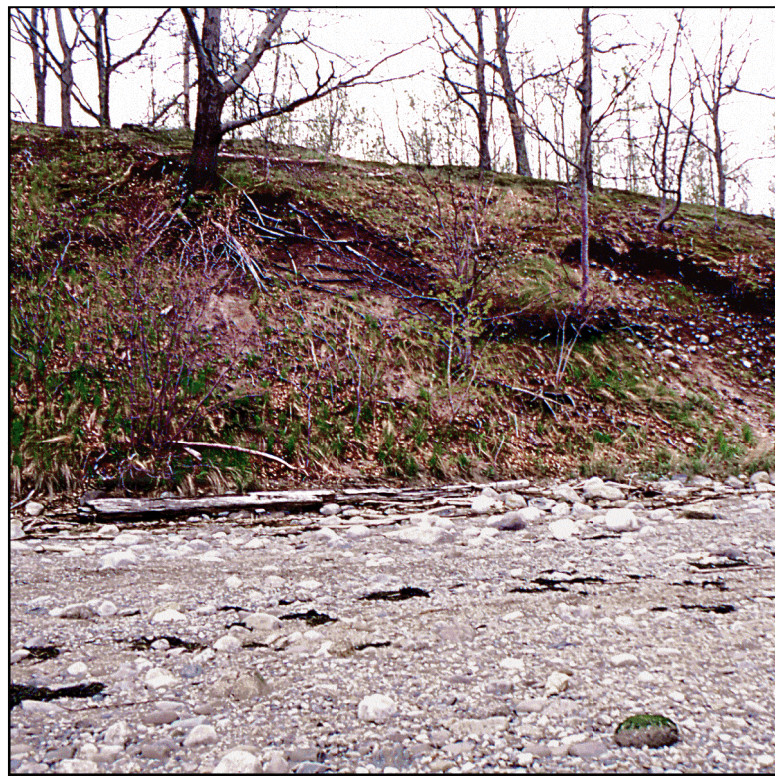
**Unstable bluff** with a partially vegetated bluff face and a beach/gravel flat shoreline. Slump scars on the bluff face expose sand, gravel, and roots. Fine sediments are removed by waves and currents, leaving gravel to form a beach at the base of the bluff.

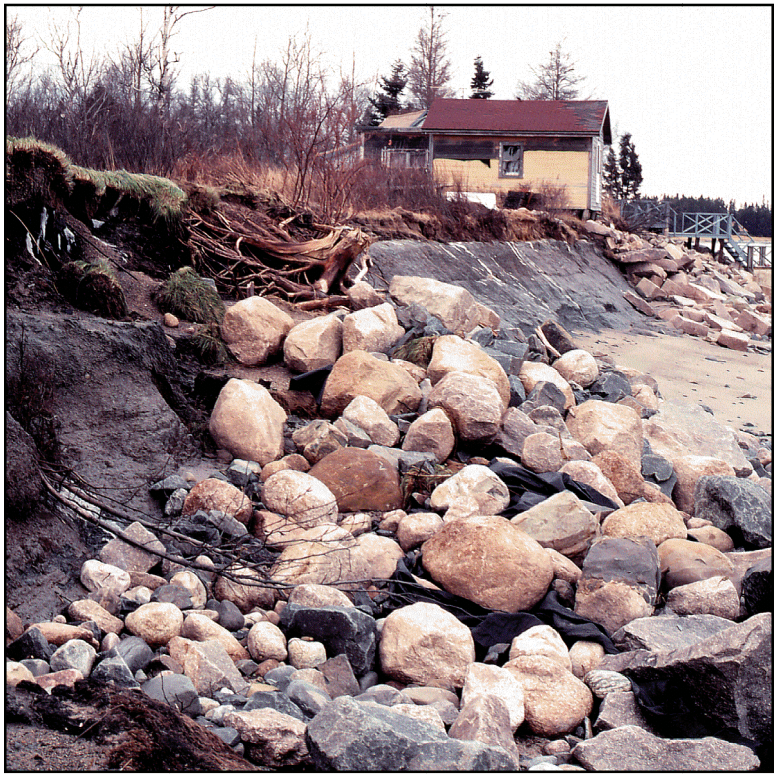
**Highly unstable bluff** with an unvegetated bluff face and an armored shoreline. This armored bluff is eroding despite an effort to shore it up with riprap, or loosely piled stone blocks. Maintenance at this site could improve bluff stability.

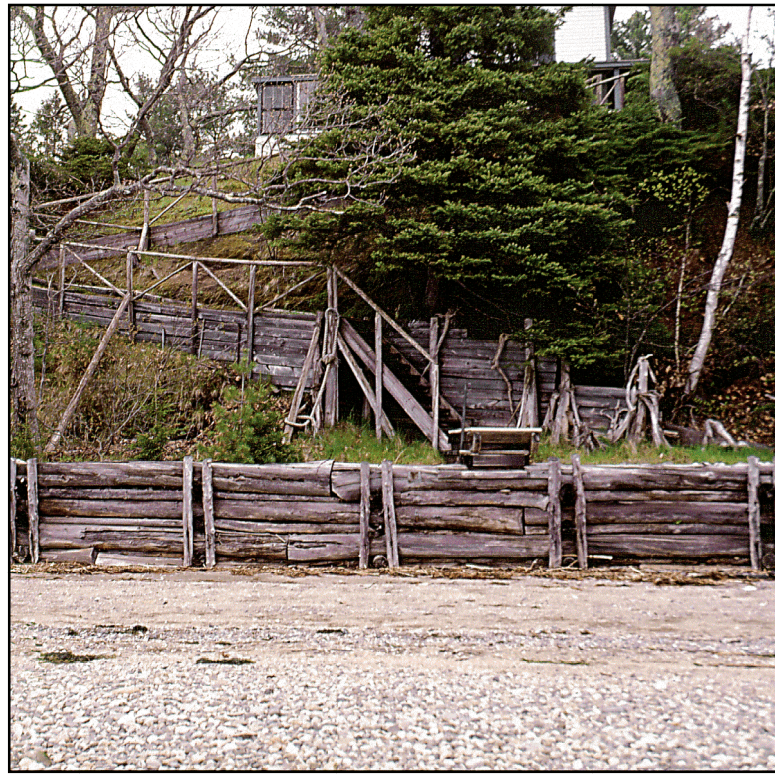
**Stable bluff** with a vegetated bluff face and an armored shoreline. The bluff face is fully vegetated and supports a mature stand of trees with vertical trunks. The presence of a wooden bulkhead suggests that erosion has occurred in the past.

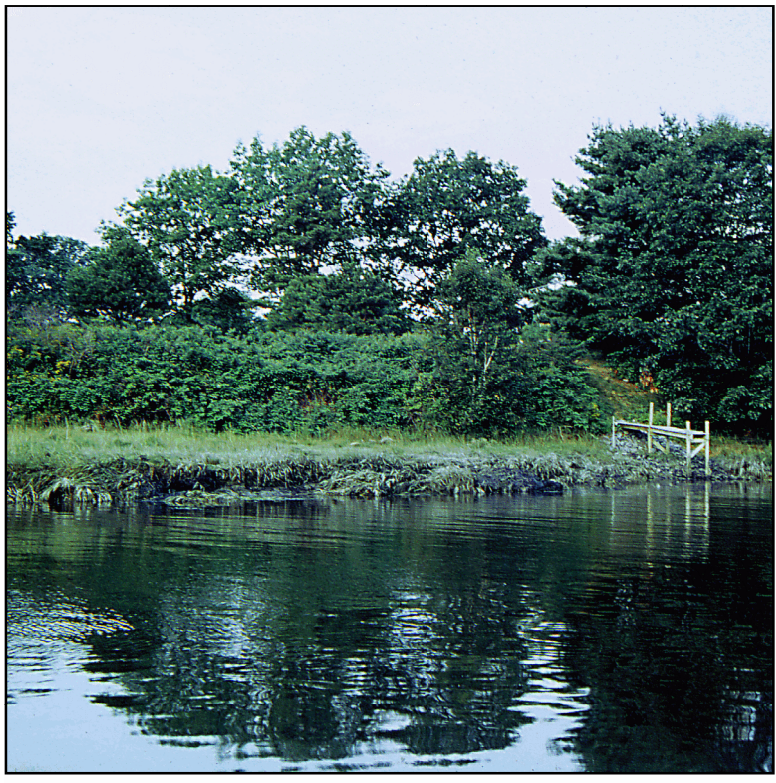
**Stable bluff** with a vegetated bluff face and a salt marsh shoreline. A low bluff face is covered by shrubs landward of a salt marsh terrace. In this location the mature marsh protects the base of the bluff from rapid erosion and slows bluff recession or retreat.

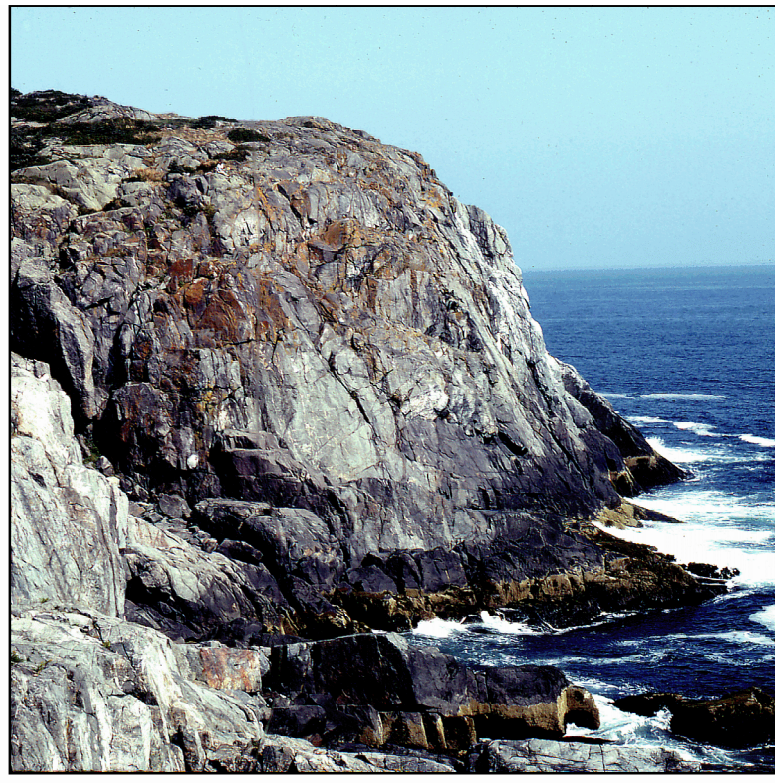
**No bluff** with a ledge shoreline. A steep slope on the bedrock surface is not a bluff. On this map, bluffs must be made of sedimentary material, generally with 3 feet or more relief. This shoreline type is very slow to change.
