# Coastal Bluffs

## Classification and Mapping of Maine's Coastal Bluffs

# Bois Bubert Quadrangle, Maine

Open-File No. 04-18

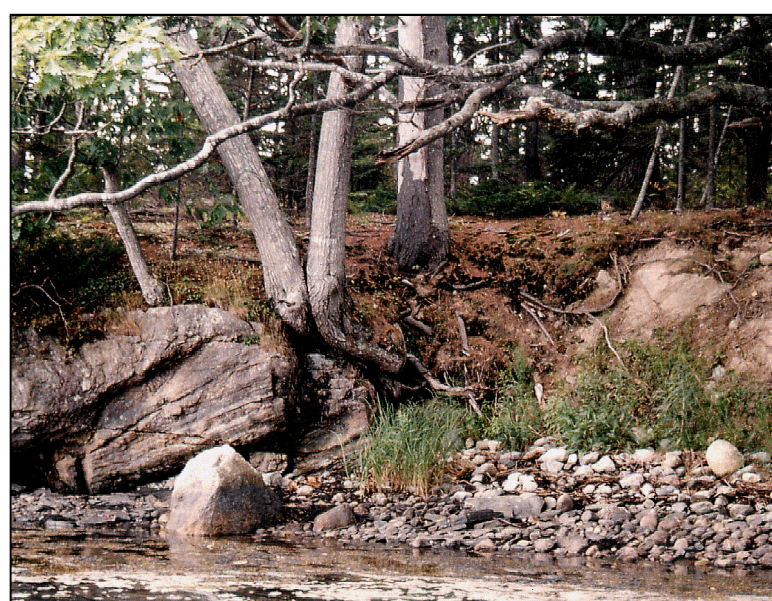
**Map Resolution**  
Since these are regional maps, some shores mapped as stable may contain small areas that are unstable. A bluff, too small to appear on the map, is shown in the photo. This bluff exhibits the characteristics of an unstable bluff: curved tree trunks, exposed roots, and bare ground on a steep slope. It is an area to be concerned about on a local scale. However, this degree of detail is not shown on the map above.

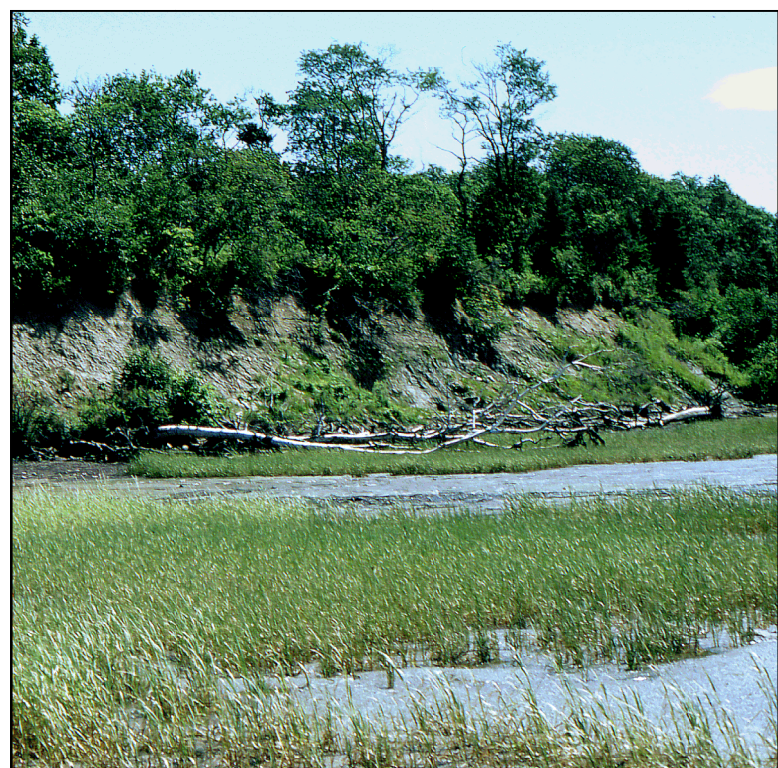
**Highly unstable bluff** with an unvegetated bluff face and a salt marsh shoreline. Sediments on the bluff face are exposed and fallen tree trunks lie at the base of the bluff. A salt marsh has recently formed on the tidal flat, partly on the top of an old landslide deposit.

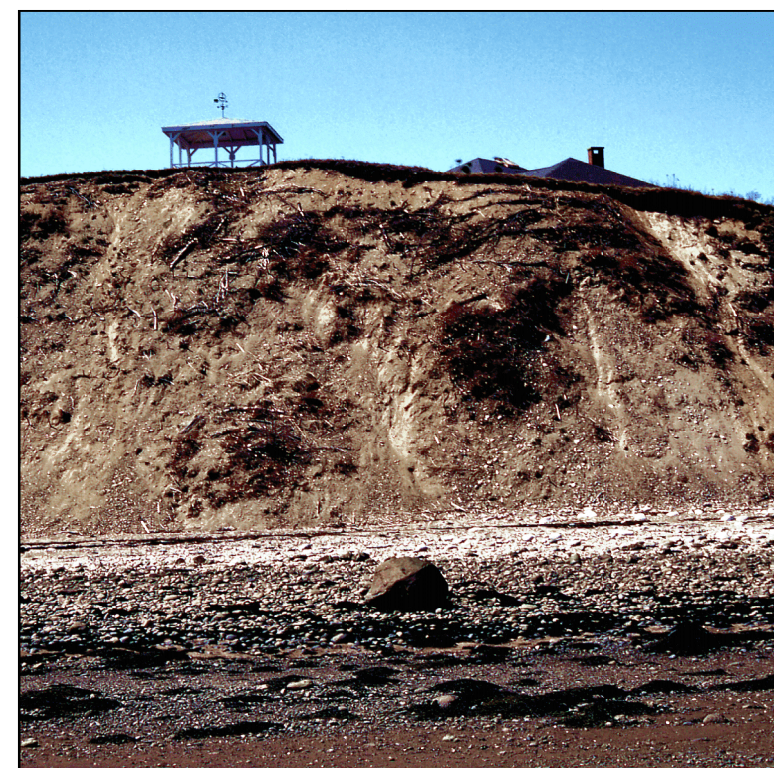
**Highly unstable bluff** with an unvegetated bluff face and a beach/gravel flat shoreline. The bluff face is too unstable to support vegetation. This bluff, a glacial esker, is eroded by waves to create a mixed sand and gravel beach in front of the bluff.

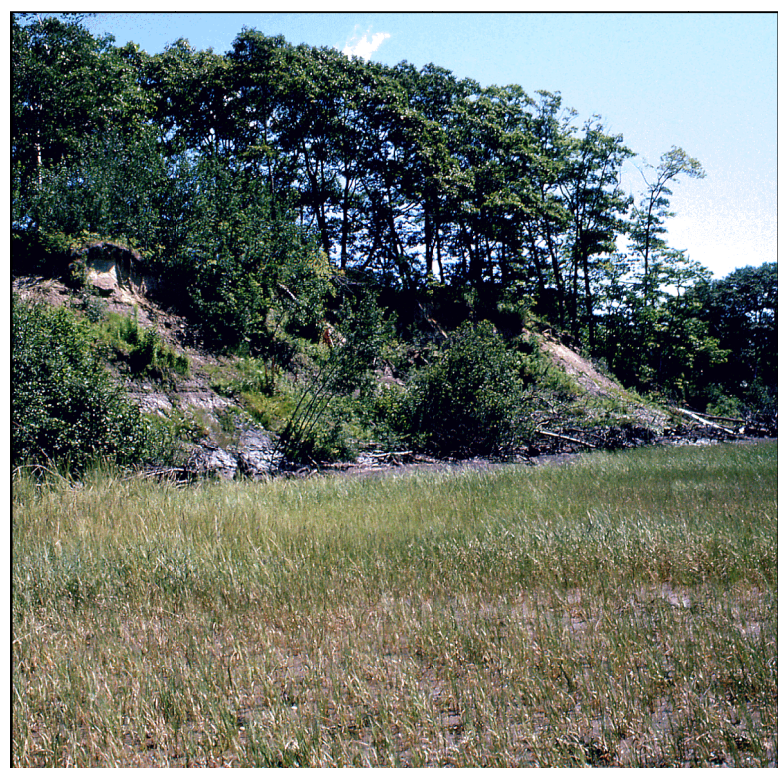
**Unstable bluff** with a partially vegetated bluff face and a salt marsh shoreline. This bluff, protected by a salt marsh, remains unstable. There are small bushes on the bluff as well as small non-vegetated areas that indicate continuing bluff retreat.

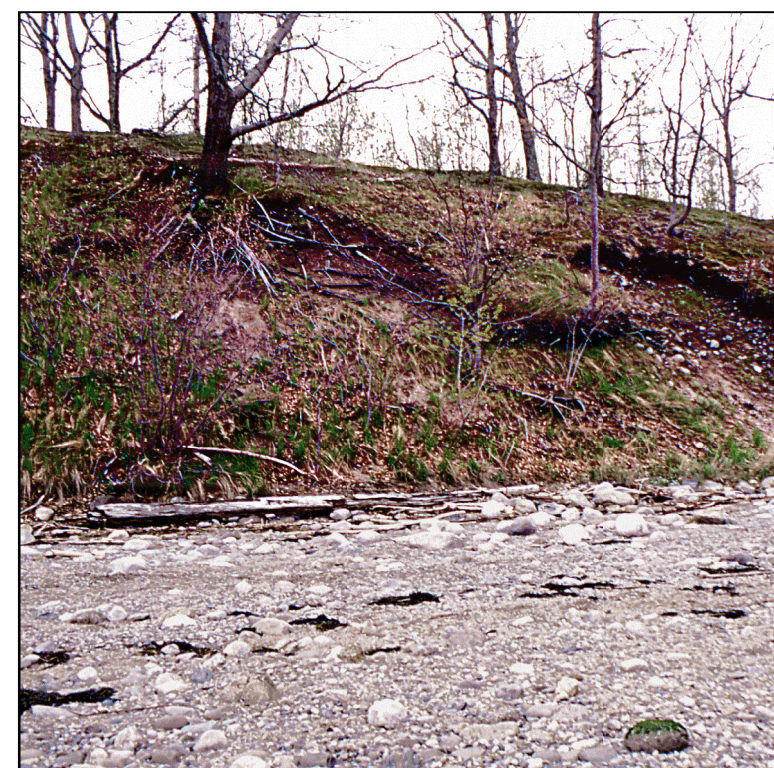
**Unstable bluff** with a partially vegetated bluff face and a beach/gravel flat shoreline. Slump scars on the bluff face expose sand, gravel, and roots. Fine sediments are removed by waves and currents, leaving gravel to form a beach at the base of the bluff.

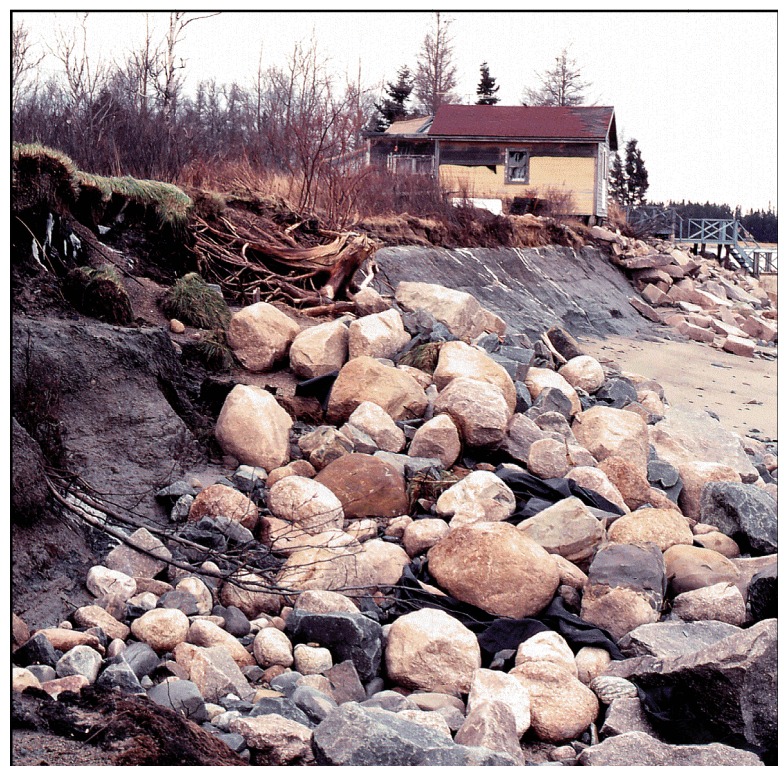
**Highly unstable bluff** with an unvegetated bluff face and an armored shoreline. This armored bluff is eroding despite an effort to shore it up with riprap, or loosely piled stone blocks. Maintenance at this site could improve bluff stability.

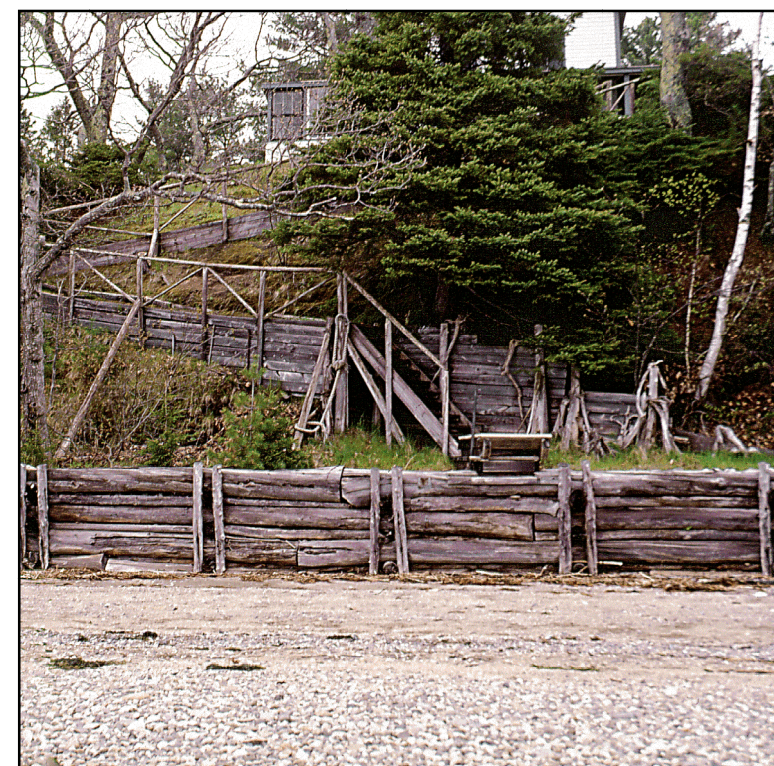
**Stable bluff** with a vegetated bluff face and an armored shoreline. The bluff face is fully vegetated and supports a mature stand of trees with vertical trunks. The presence of a wooden bulkhead suggests that erosion has occurred in the past.

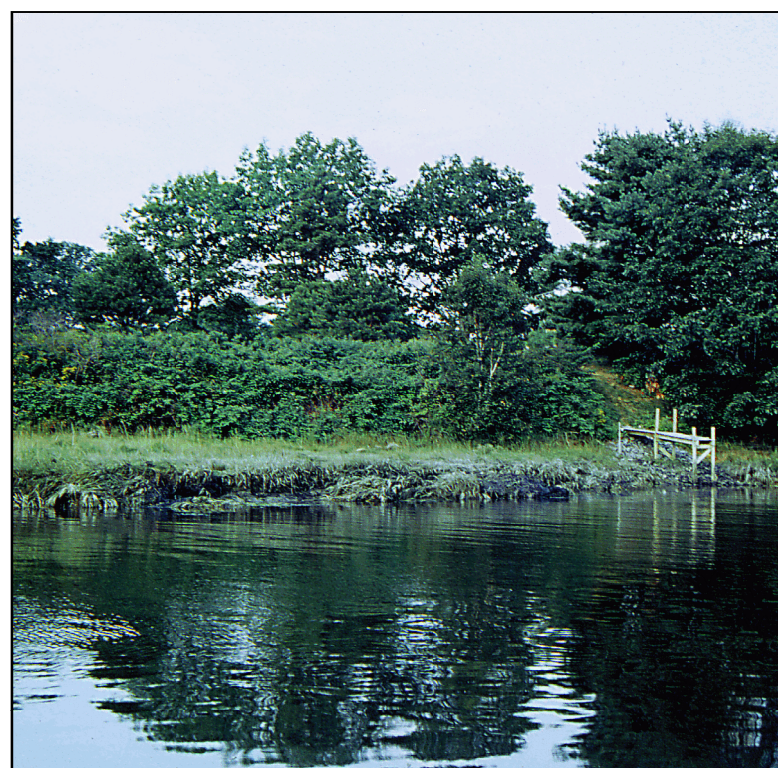
**Stable bluff** with a vegetated bluff face and a salt marsh shoreline. A low bluff face is covered by shrubs landward of a salt marsh terrace. In this location the mature marsh protects the base of the bluff from rapid erosion and slows bluff recession or retreat.
