Coastal Landslide Hazards

Bass Harbor Quadrangle, Maine

Open-File No. 05-32

2005

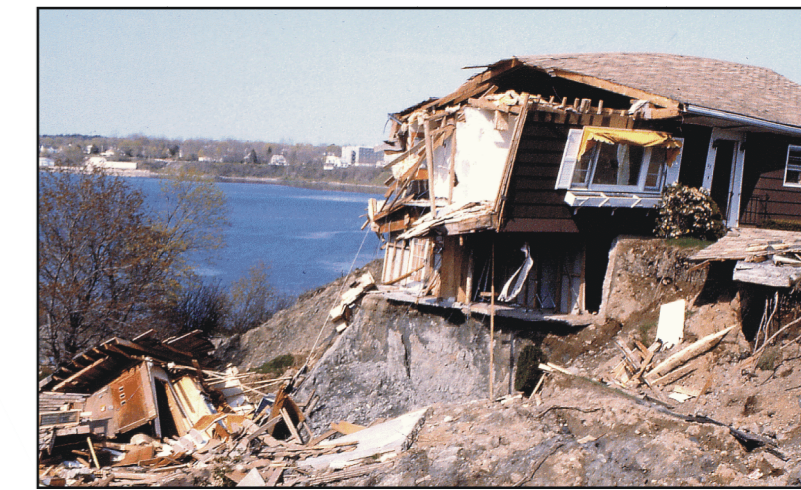
Figure 1. A clay bluff on the north shore of Rockland Harbor failed in 1996. This landslide formed a new scarp about 200 feet landward of the original top of the bluff in just a few hours. Two homes were destroyed as a result of this catastrophic slide (see Berry and others, 1996).

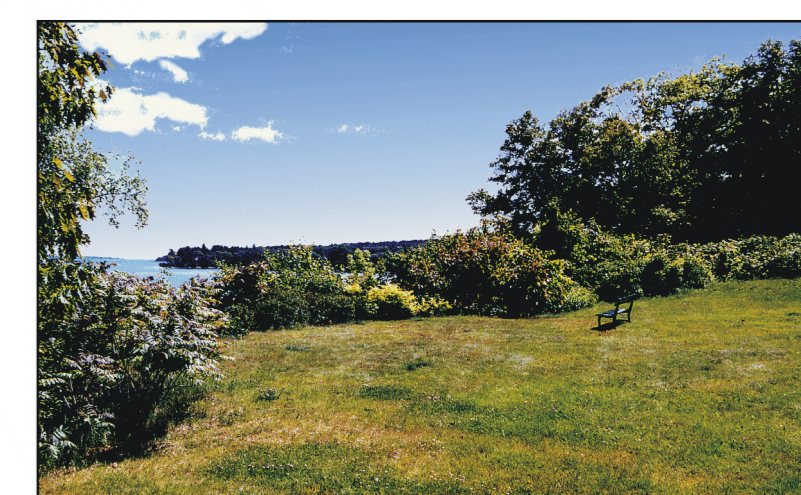
Figure 3. The shape of the top edge of a bluff can be an indicator of landslide risk. Clay bluffs often fail at points of weakness. Such a "slump" can expand into a larger landslide that cuts into the bluff and forms a curve around the original point of failure. Multiple slides and slumps will form an irregular or arcuate top edge to the bluff as shown in the photo above. Bluffs made of coarse materials or sand have a more even upper edge caused by a more constant rate of erosion along the bluff face.

Careful observation of the land surface, vegetation, and shape of a coastal bluff reveals evidence of instability. Starting at the top of a bluff, an irregular or arcuate edge can indicate past landslides or areas of increased coastal erosion (Figure 3). When a weak point on a bluff fails, the slide moves inward into the slope face forming a curve around the original point of failure. Tension cracks may form near a weak zone where the soil surface is moving downslope (Figure 4). These cracks appear as splits in the ground where the soil and vegetation have moved apart. Cracks may be visible along the top edge of the bluff or on the bluff face itself. On the slope of a bluff, a hummocky land surface or terraces indicate past slumping or landslides (Figure 5). Unvegetated slump scars or slopes are obvious evidence of rapid soil movement. A bowl-shaped slope often shows the location of a former landslide, with the center of the bowl as the area of greatest failure. Distorted vegetation provides evidence of soil creep or former landslides. Tree trunks curved near their base are evidence of downslope movement (Figure 6). Trees tilted at different angles are evidence of former slides or undercutting by erosion. At the base of a bluff, topped trees and bare roots are evidence of erosion that steepens the bluff (Figure 7). Undercutting and steepening of the bluff may destabilize the slope and lead to increased erosion and possibly a landslide. Lobes or terraces of sediment in the intertidal zone are often remnants of old landslides. Although the evidence of earth movement listed above cannot predict a landslide, it is used to recognize unstable shorelines. This landform evidence is related to factors listed below that influence landslide risk.

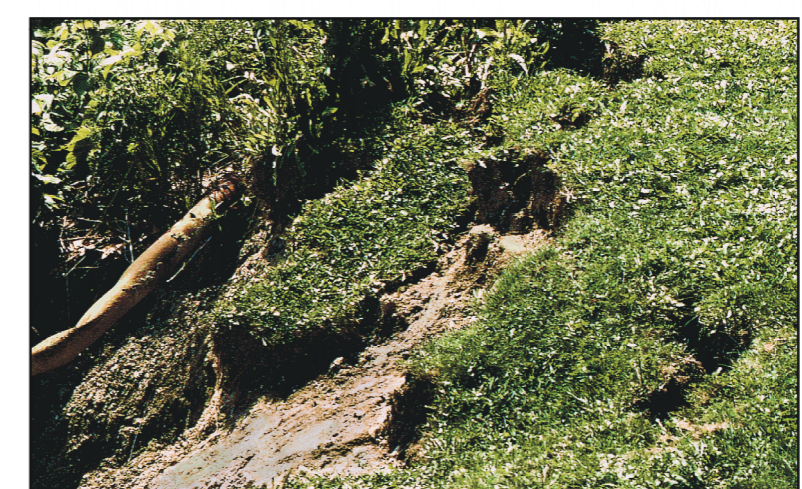
Figure 4. Downslope forces within a bluff cause surface layers to stretch. When tension cracks are great enough, a crack forms and the pressure is released. These "tension cracks" may form on the top edge of the bluff or on the bluff slope itself. They indicate instability and motion within the bluff. Some cracks are deep and extend below the soil layer.

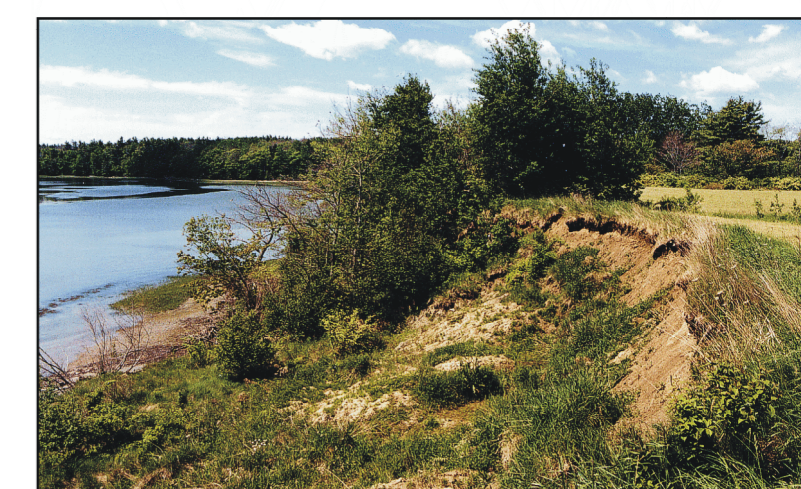
Figure 5. Terraces on a hummocky land surface on the slope of a bluff can indicate a former landslide. Terraces can be the surface of downslope blocks which moved during a slide. Vegetation on the surface of these blocks may be tilted in various directions. The irregular land surface may also occur in a bowl-shaped depression below an arcuate top edge of the bluff, additional evidence of a former landslide.

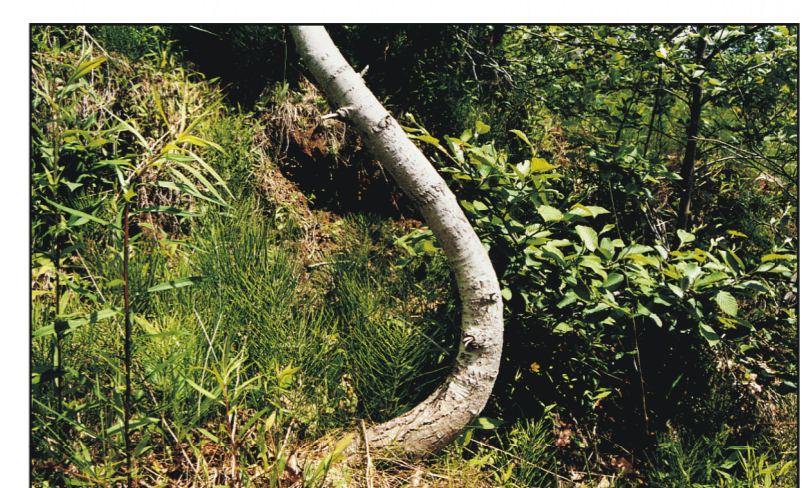
Figure 6. Soil "creep" or downslope movement of soil on a slope, will cause tree trunks to tilt toward the base of the slope. As a moving tree continues to grow, the trunk will curve as the tree tries to right itself toward the sun. Landslides will also cause tree trunks to become curved.

Vegetation. Types, shapes, and distribution of vegetation above and on a bluff face can be used as an indication of site stability. In areas where the soil has shifted, either due to previous landslides or to gradual surface creep, many tree trunks can become tilted or twisted in the same direction. Curved tree trunks near the roots often indicate land movement down the face of a bluff. Large trees on the bluff face may be moved by wind and resulting root motion may loosen bluff sediment. Natural vegetation that consists only of small shrubs and trees may indicate recent bluff erosion or a landslide.

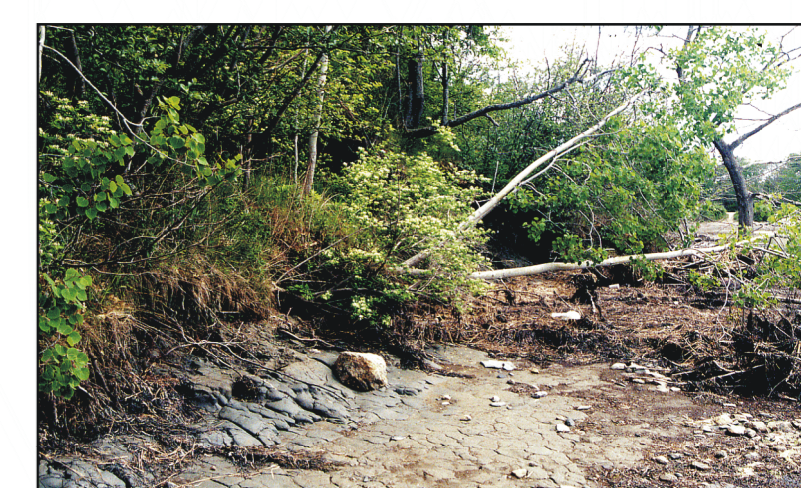
Figure 7. Wave erosion at the base of a bluff removes slope sediment and steepens the bluff. Erosion has undercut the trees in the photo above and caused them to tilt toward the ocean. This steepening reduces the stability of the bluff, and a landslide may result. Ongoing sea-level rise along the Maine coast will cause wave erosion at the base of coastal bluffs and continue to make some coastal bluffs at risk of experiencing a landslide.
