# Coastal Landslide Hazards

# Seal Harbor Quadrangle, Maine

## Open-File No. 05-34

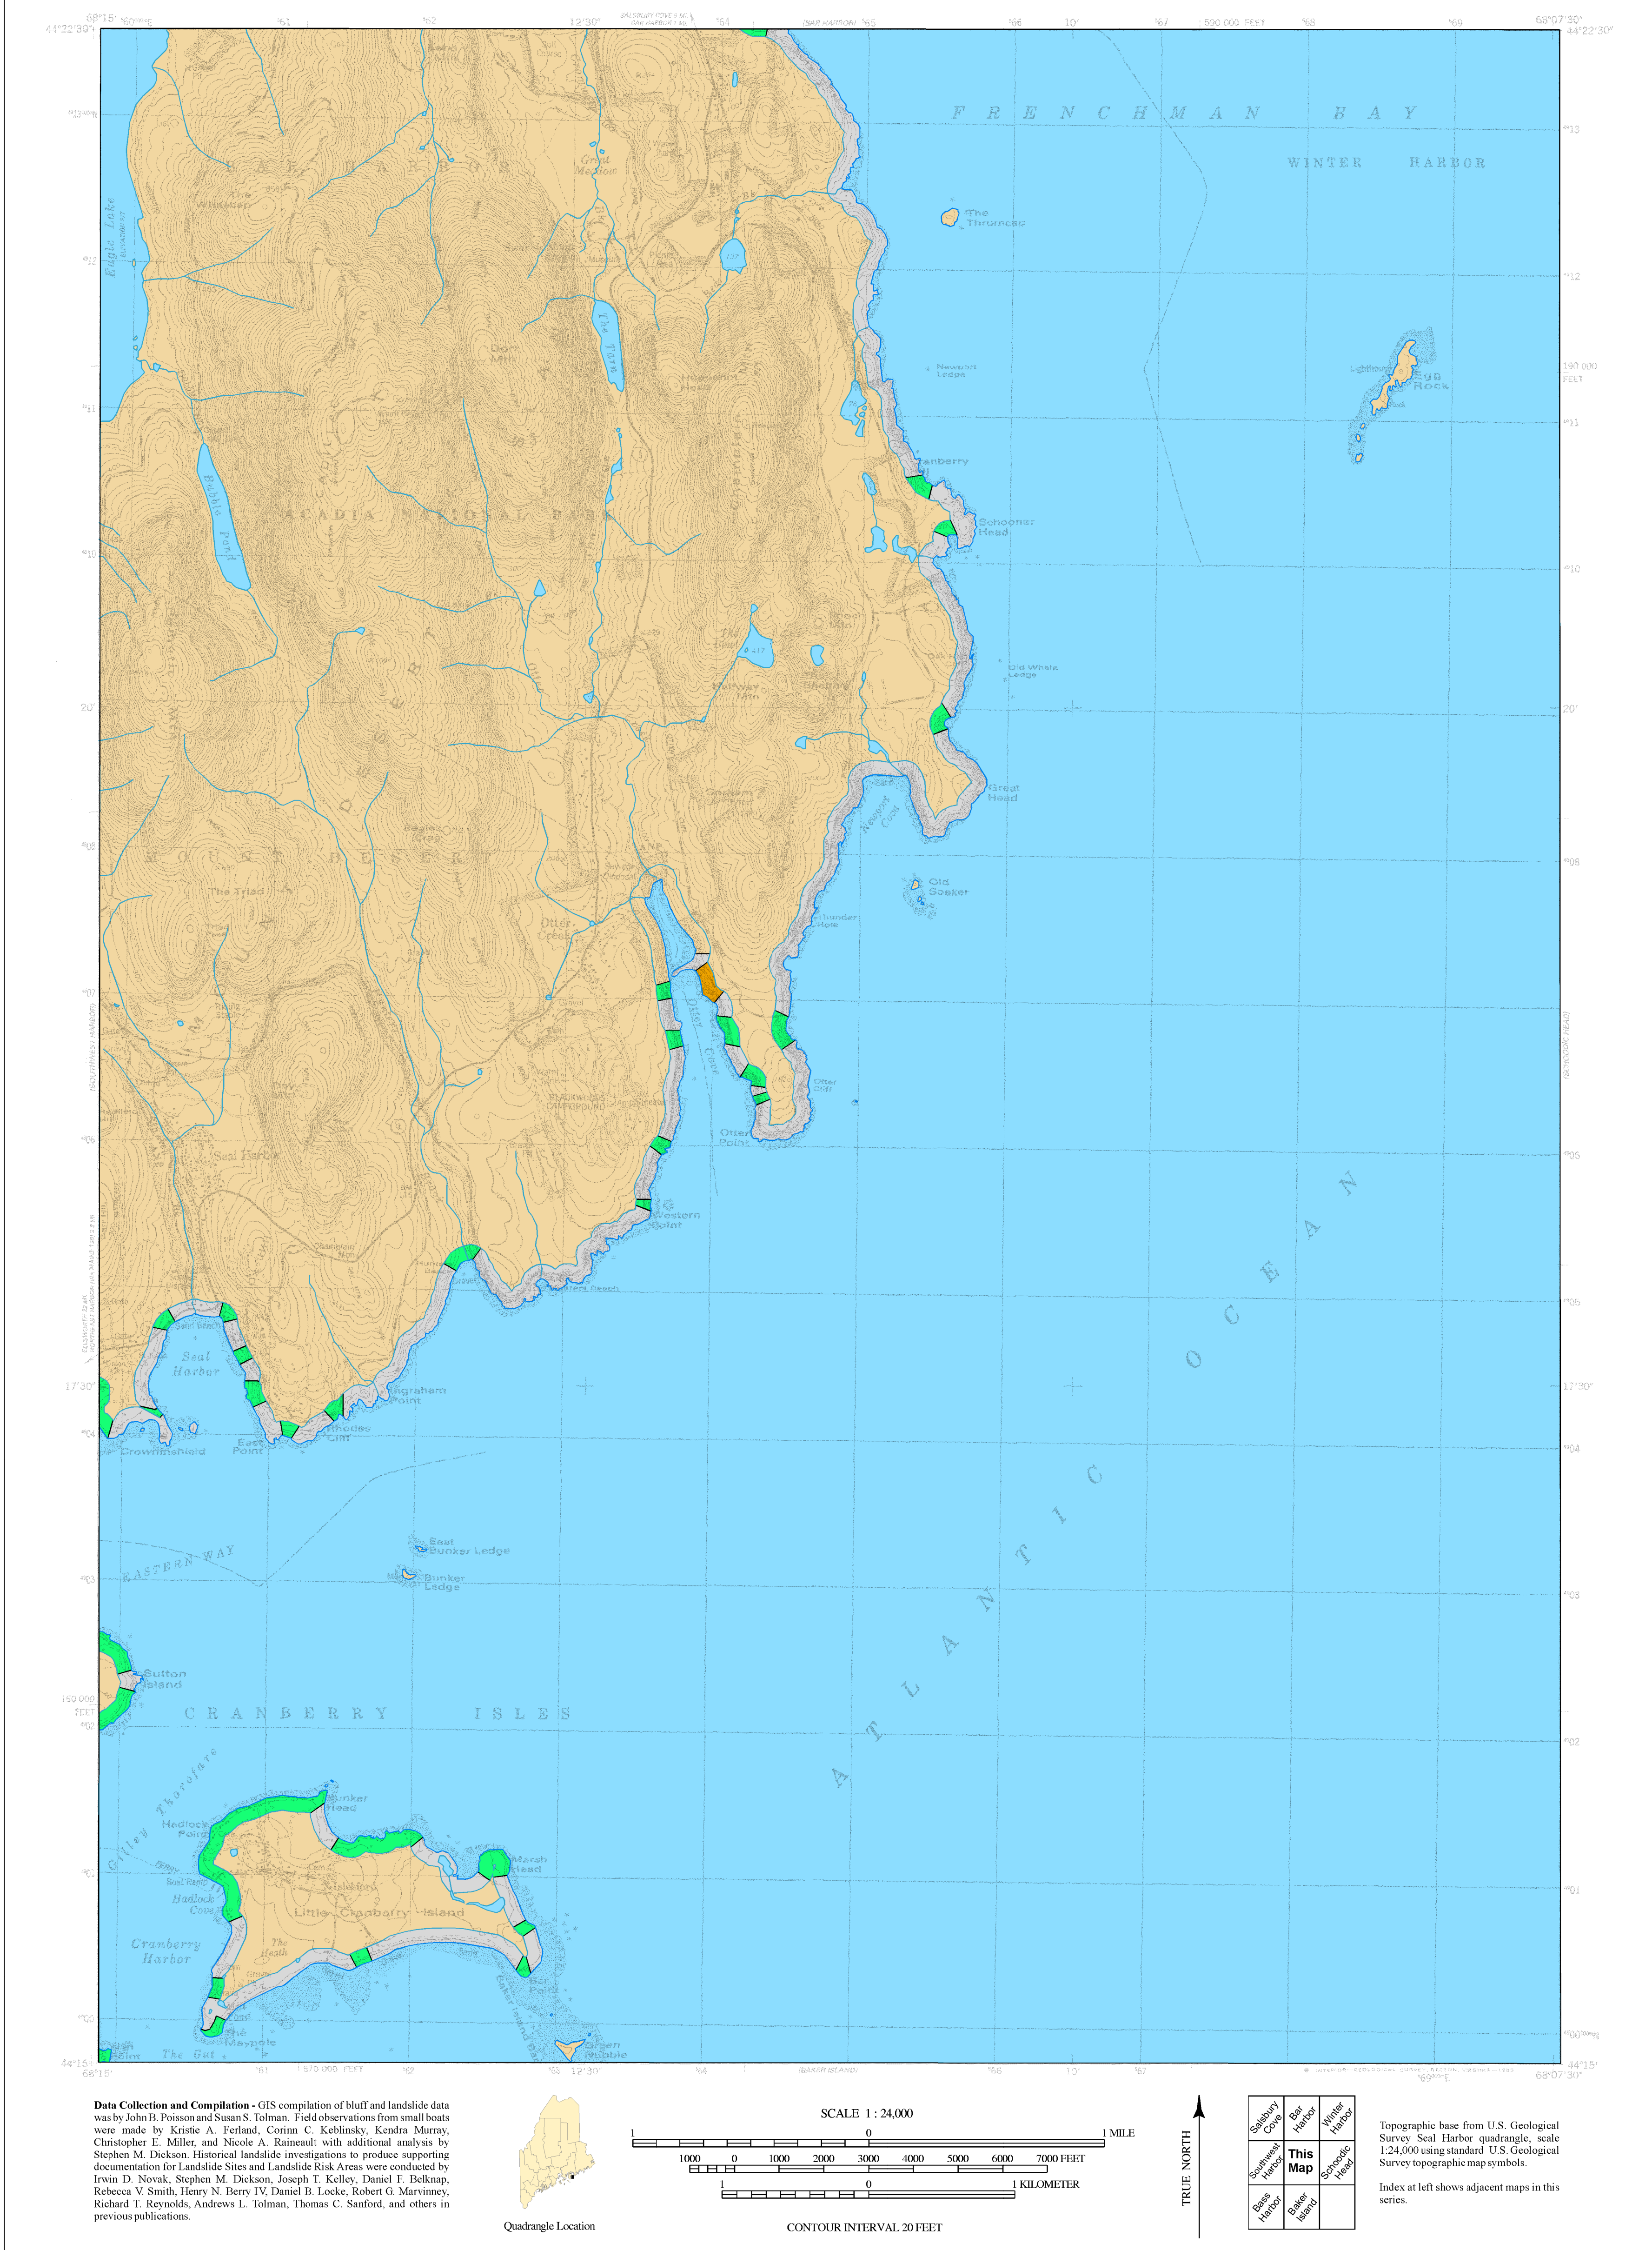
**Note:** The landslide hazard classification is indicated by a colored, patterned band extending landward from the shoreline (dark blue line). The width of the band does NOT indicate the distance inland that a landslide may occur. This distance is difficult to predict and will vary from site to site. The colored buffer is for illustration purposes only. Due to variations in coastal geology, not all units in the explanation below will appear on this map.

**Landslide Site:** Location of known or interpreted coastal landslide. Includes historically recorded landslides and slides interpreted from air photos.

**Landslide Risk Area:** Earth features indicate conditions that may be suitable for a landslide to occur. Features often include a steep or arcuate scarp, slump blocks, sediment lobes, or uneven land surfaces. Bluff sediments are usually muddy and twenty feet or more in thickness.

**Potential Landslide Area:** Shoreline with a sedimentary coastal bluff twenty or more feet high. These bluff areas have not had field investigations that are necessary to evaluate the risk of a landslide. However, some similar high coastal bluffs have experienced landslides.

**Low Coastal Bluff:** Shoreline with a sedimentary coastal bluff that has less than twenty feet of relief immediately adjacent to the shoreline. Some bluffs over twenty feet in height are included in this map unit if the bluff face is not steep. In general, low coastal bluffs are not at risk of failing in the form of a landslide.

**Non-Bluff Shoreline:** Coastal areas without extensive sedimentary bluffs. Corresponds to the no-bluff unit on MGS Coastal Bluff Maps.

**Unmapped Shoreline:** These sites generally are in the inland reaches of estuaries or beyond the scope of the field effort in this region.

**Landslide Site:** Includes the following: (1) Locations based on historical records and eyewitness accounts. In general, these earth movements have occurred in the last three centuries. (2) Locations based on interpretation of aerial photography. The age of these features is usually unknown. Some may have formed in the last few years, others in the last century, and some possibly sometime in the last few thousand years.

**Landslide Risk Area:** Includes the following: (1) Observations from land corroborated with geomorphology observed on air photos, sediment types shown on surficial geologic maps, and both elevation above sea level and steepness of bluff slopes shown on topographic maps. Bluff sediments are usually muddy and twenty feet or more in thickness. The slope on the bluff face appears steep and similar to areas where there have been landslides in the past. (2) Observations from a small boat. Primarily steeply-sloping sediment bluffs that were visually estimated to be twenty feet or more in elevation. Other instability characteristics included unvegetated slopes on the bluff face; leaning, fallen, or crooked tree trunks; and visible slump deposits at the base of the bluff near the high-tide line. The site may be adjacent to previous landslides. In this second category, aerial photographs were not used nor were the surficial geologic materials investigated.

**Potential Landslide Area:** This determination was based on the presence of a bluff as indicated on MGS Coastal Bluff Maps, the proximity of a bluff more than three feet high and 150 feet long. Within this category there may be short shoreline segments that contain bluffs. These small coastal bluffs are not illustrated on this map.

**Low Coastal Bluff:** This determination was based on the presence of a bluff as indicated on MGS Coastal Bluff Maps and the proximity of a bluff more than three feet high and 150 feet long. Within this category there may be short shoreline segments that contain bluffs. These small coastal bluffs are not illustrated on this map.

**Non-Bluff Shoreline:** This shoreline type was determined by visual observation from a small boat and corresponds to the no-bluff unit on MGS Coastal Bluff Maps. These shorelines can be composed of bedrock, salt marshes, beaches and dunes, or low-lying sediments without the presence of a bluff more than three feet high and 150 feet long. Within this category there may be short shoreline segments that contain bluffs. These small coastal bluffs are not illustrated on this map.

**Unmapped Shoreline:** In some locations, access to a shoreline was limited so some areas remain unmapped. These sites generally are in the inland reaches of estuaries or beyond the scope of the field effort in this region.

**Classification of bluffs:** shows the average condition inferred for each section of the shoreline. For an evaluation of specific shoreline erosion risks or landslide potential certified geologists or geotechnical engineers should conduct site-specific studies.

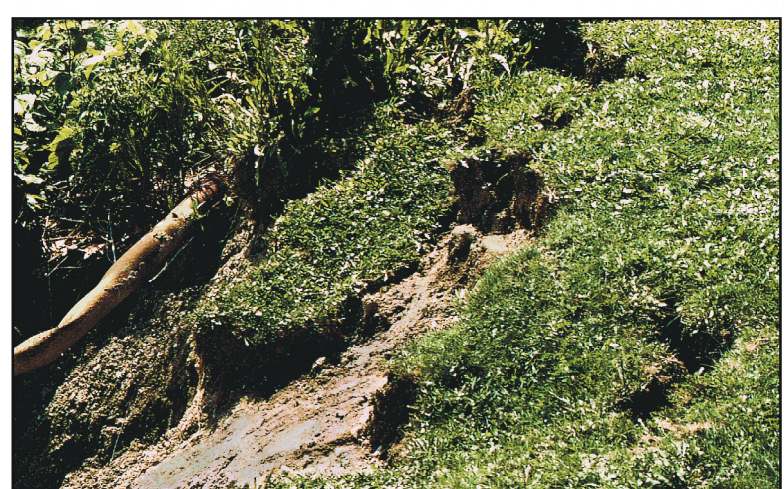
**Figure 4.** Downslope forces within a bluff cause surface layers to stretch. When the tension becomes great enough, a crack forms and the pressure is released. These "tension cracks" may form on the top edge of the bluff or on the bluff slope itself. They indicate instability and motion within the bluff. Some cracks are deep and extend below the soil layer.

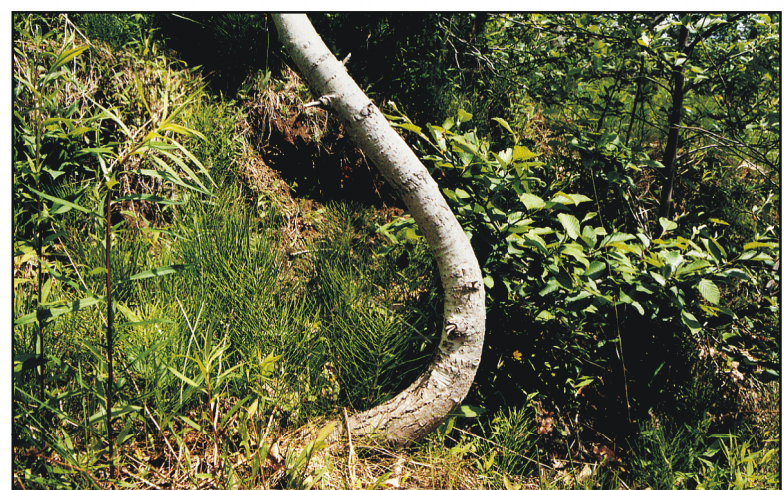
**Figure 6.** Soil "creep" or downslope movement of soil on a slope, will cause tree trunks to tilt toward the base of the slope. As a moving tree continues to grow, the trunk will curve as the tree tries to right itself by growth toward the sun. Landslides will also cause tree trunks to become curved.

**Vegetation.** Types, shapes, and distribution of vegetation above and on a bluff face can be used as an indication of site stability. In areas where the soil has shifted, either due to previous landslides or to gradual surface creep, many tree trunks can become tilted or twisted in the same direction. Curved tree trunks near the roots often indicate land movement down the face of a bluff. Large trees on the bluff face may be moved by wind and resulting root motion may loosen bluff sediment. Natural vegetation on the bluff face can help stabilize the bluff face. The elevation of bedrock at the shore and inland beneath a bluff is important in determining landslide risk. Bedrock exposures along the shoreline may slow erosion and make sediment less susceptible to landsliding. Beneath a sediment bluff, bedrock may rise toward the surface and reduce the overall thickness of sediment and thus reduce the risk of deep-seated movement below the ground surface.

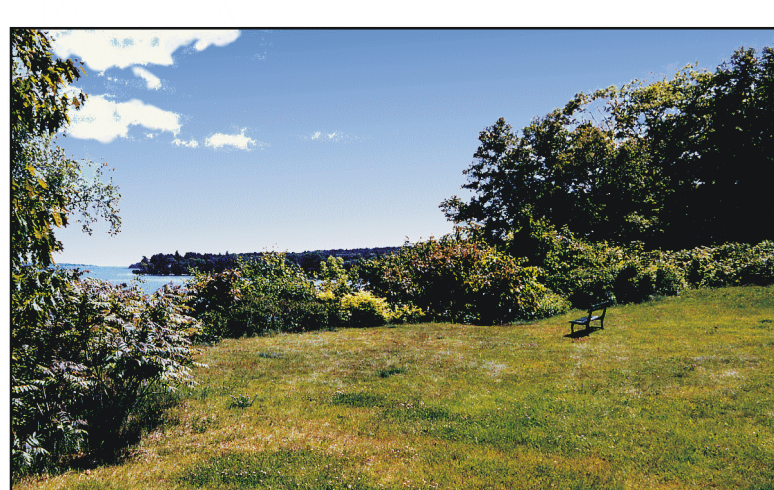
**Figure 3.** The shape of the top edge of a bluff can be an indicator of landslide risk. Clay bluffs often fail at points of weakness. Such a "slump" can expand into a larger landslide that cuts into the bluff and forms a curve around the original point of failure. Multiple slides and slumps will form an irregular or arcuate top edge to the bluff as shown in the photo above. Bluffs made of coarse materials or sand have a more even upper edge caused by a more constant rate of erosion along the bluff face.

Careful observation of the land surface, vegetation, and shape of a coastal bluff reveals evidence of instability. Starting at the top of a bluff, an irregular or arcuate edge can indicate past landslides or areas of increased coastal erosion (Figure 3). When a weak point on a bluff fails, the slide moves inward into the slope face forming a curve around the original point of failure. Tension cracks may form near a weak zone where the soil surface is moving downslope (Figure 4). These cracks appear as splits in the ground where the soil and vegetation have moved apart. Cracks may be visible along the top edge of the bluff or on the bluff face itself. On the slope of a bluff, a hummocky land surface or terraces indicate past slumping or landslides (Figure 5). Unvegetated slump scars or slopes are obvious evidence of rapid soil movement. A bowl-shaped slope often shows the location of a former landslide, with the center of the bowl as the area of greatest failure. Distorted vegetation provides evidence of soil creep or former landslides. Tree trunks curved near their base are evidence of downslope movement (Figure 6). Trees tilted at different angles are evidence of former slides or undercutting by erosion. At the base of a bluff, toppled trees and bare roots are evidence of erosion that steepens the bluff (Figure 7). Undercutting and steepening of the bluff may destabilize the slope and lead to increased erosion and possibly a landslide. Lobes or terraces of sediment in the intertidal zone are often remnants of old landslides. Although the evidence of earth movement listed above cannot predict a landslide, it is used to recognize unstable shorelines. This landform evidence is related to factors listed below that influence landslide risk.

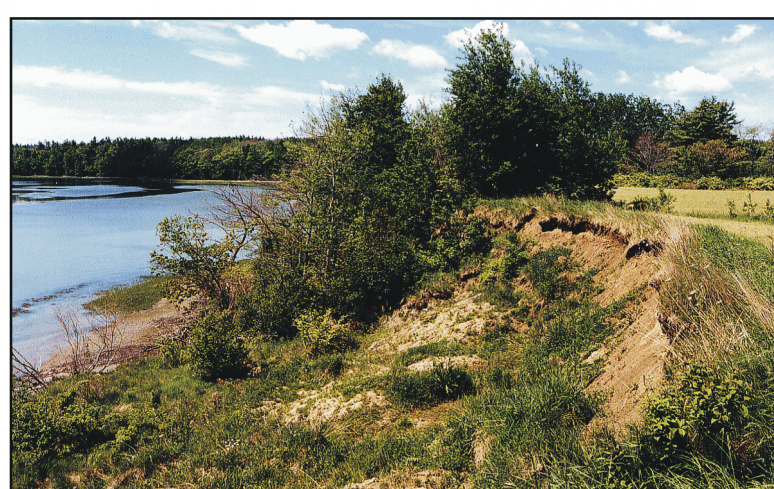
**Figure 5.** Terraces on a hummocky land surface on the slope of a bluff can indicate a former landslide. Terraces can be the surface of a downslope of blocks which moved during a slide. Vegetation on the surface of these blocks may be tilted in various directions. The irregular land surface may also occur in a bowl-shaped depression below an arcuate top edge of the bluff, additional evidence of a former landslide.

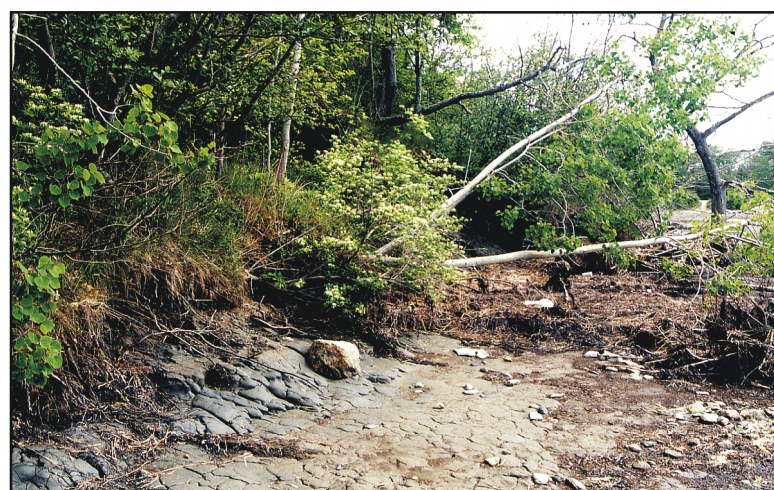
**Figure 7.** Wave erosion at the base of a bluff removes slope sediment and steepens the bluff. Erosion has undercut the trees in the photo above and caused them to tilt toward the ocean. This steepening reduces the stability of the bluff, and a landslide may result. Ongoing sea-level rise along the Maine coast will cause wave erosion at the base of coastal bluffs and continue to make some coastal bluffs at risk of experiencing a landslide.

**Waves, tides, and sea level.** Several marine processes affect the risk of landslides along a coastal bluff. A gradual, but ongoing rise in sea level at a rate of about an inch per decade is causing chronic erosion along the base of many bluffs. As sea level rises, wave action and coastal flooding can reach higher and farther inland and scour more sediment from a bluff. Sea ice erodes tidal flats and the base of bluffs by abrasion and freezing sediment in ice blocks. Erosion can increase a bluff slope and make it more susceptible to landsliding. Tides are also important in washing away eroded bluff sediment which helps wave action move inland. Storms that create wind, waves, and flooding can cause more extreme erosion at the base of a bluff, increase the bluff slope, and make a landslide more likely.
