# Coastal Bluffs

## Classification and Mapping of Maine's Coastal Bluffs

## Portsmouth Quadrangle, Maine

Open-File No. 02-207

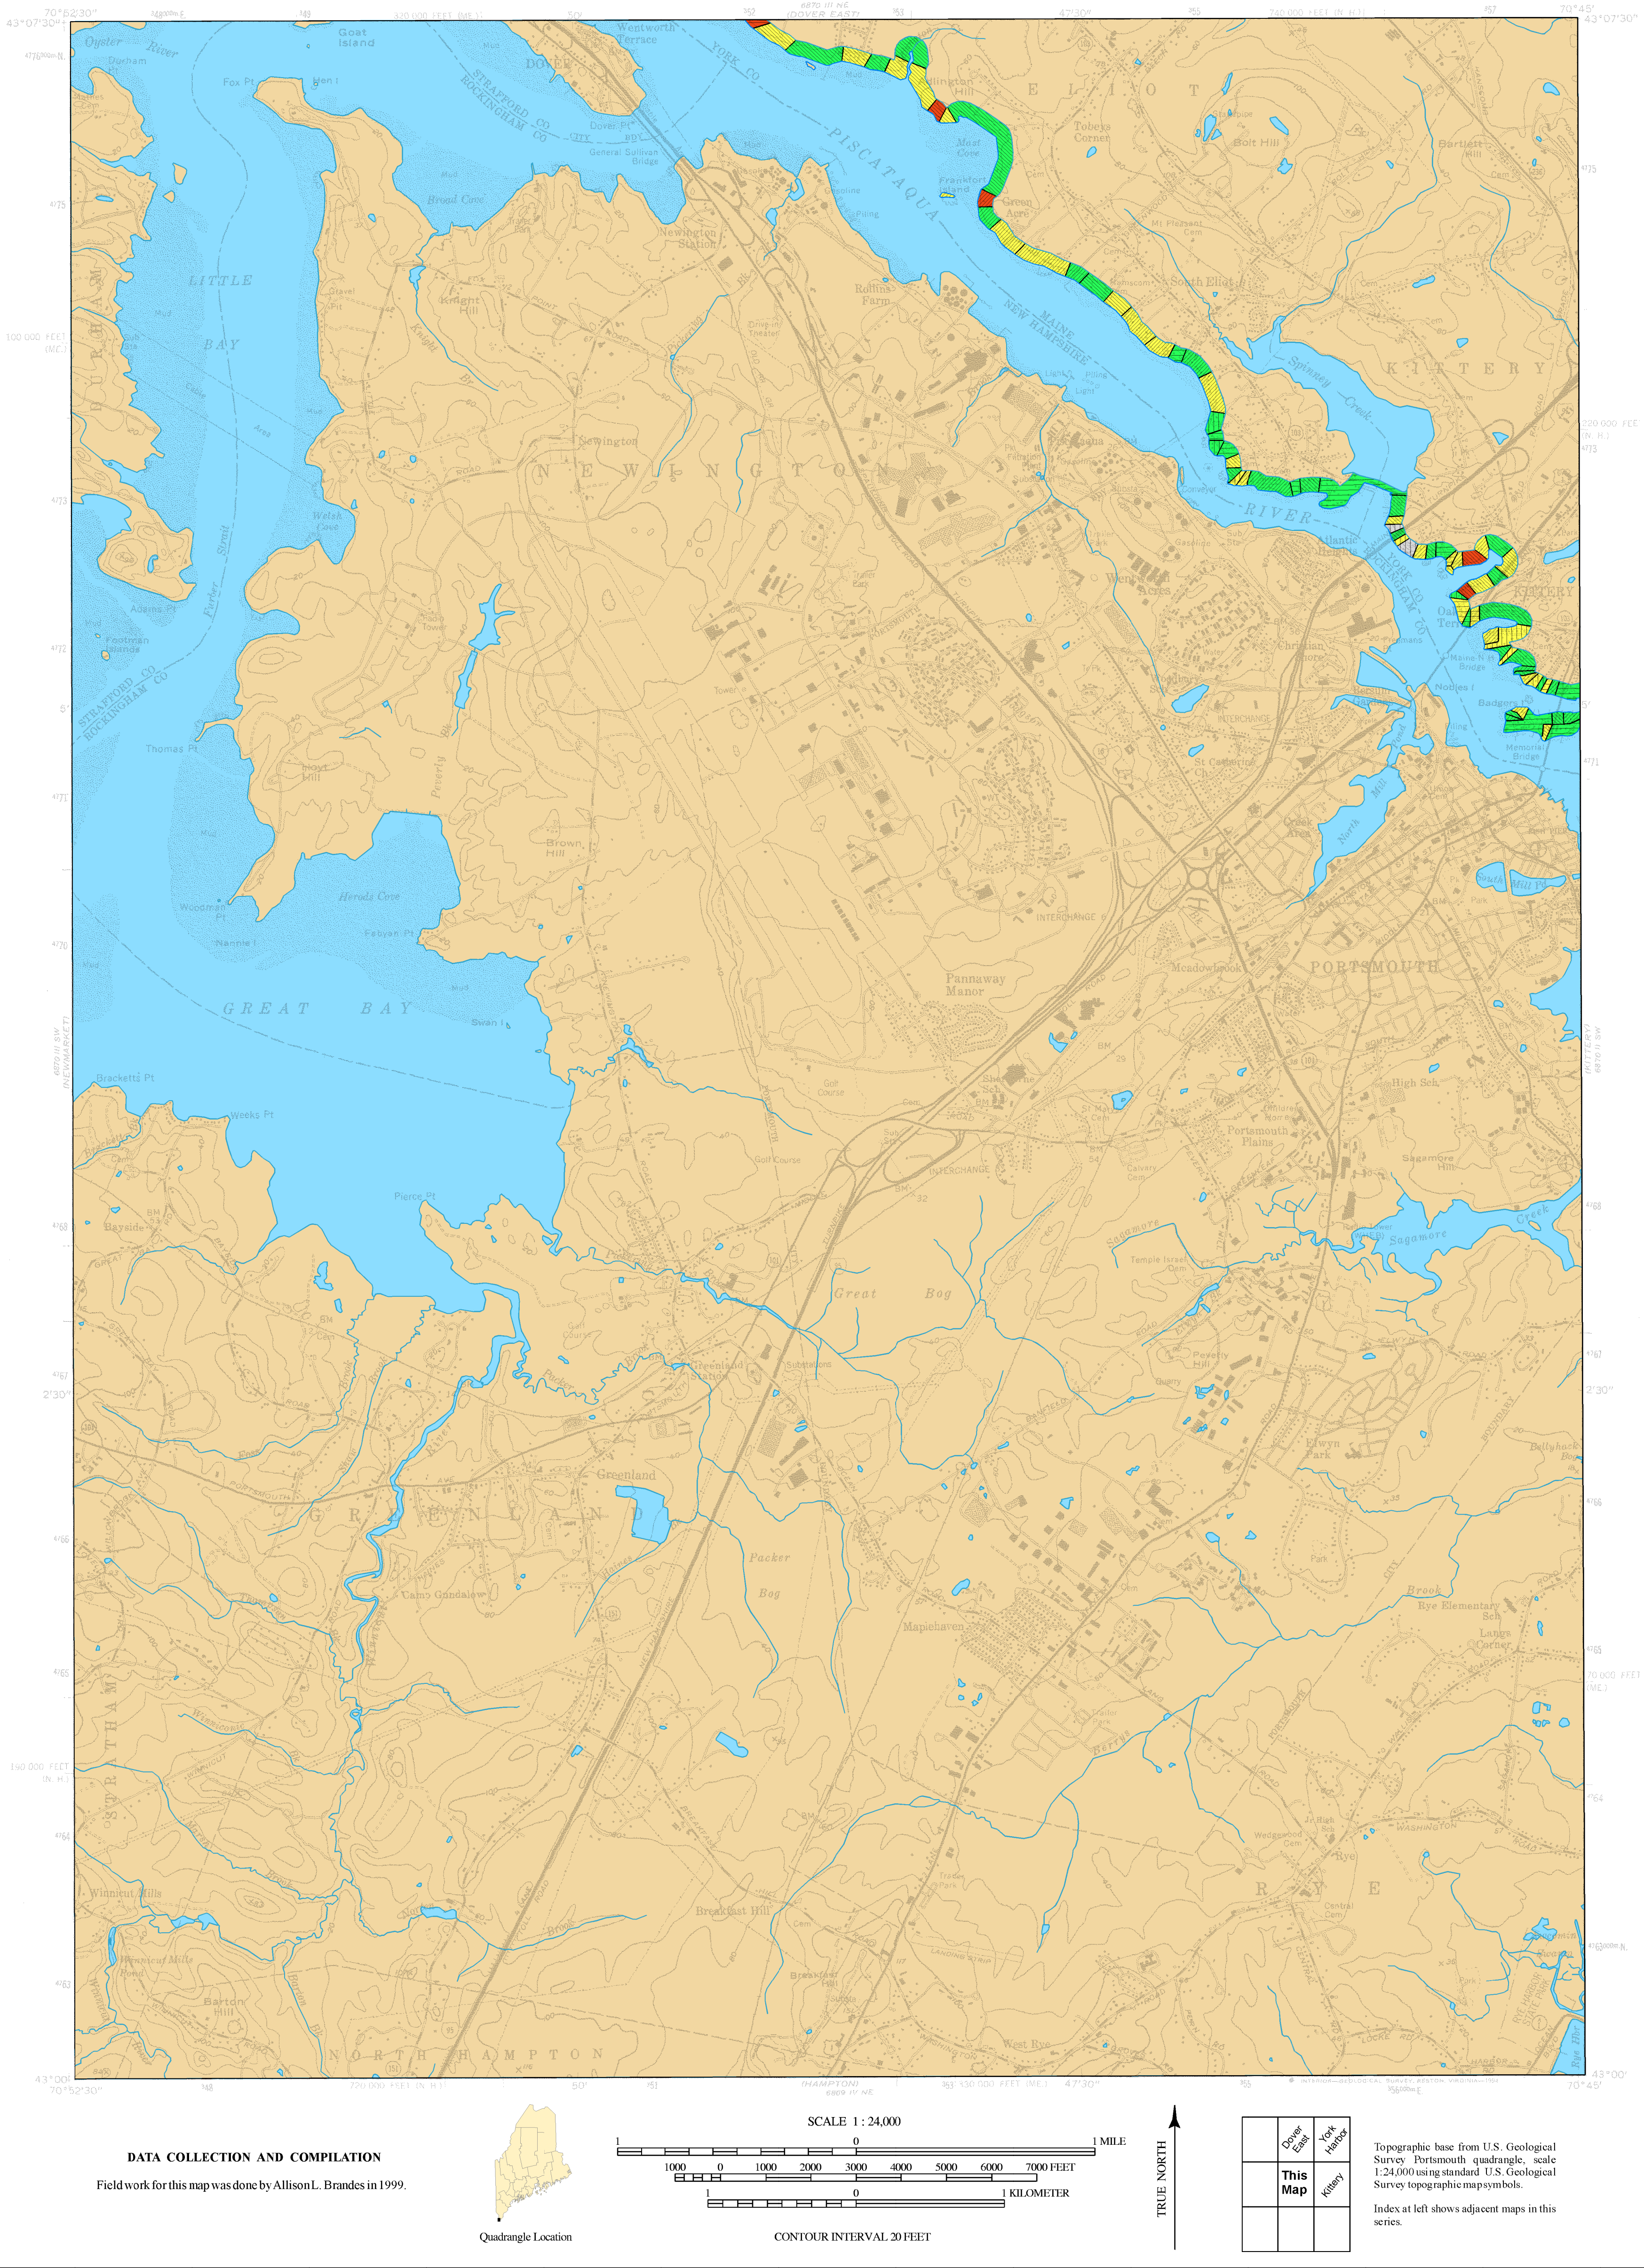
Note: The classification of the bluff is indicated by a colored, patterned band extending landward from the shoreline (dark blue line). The width of the band is NOT related to the width of the bluff. Stability rank refers to RECENT bluff face activity.

This map can help identify shorelines with increased risk of coastal erosion. Review the legend below in order to understand what the map shows and does not show. The colored categories correspond to field conditions when the map was made. Conditions may have changed in the last few years. Comparison of the information on this map with current conditions may indicate that a stability category is different now. Since bluff erosion may be cyclical, the change may only be temporary. If coastal development is near any bluff we recommend a professional evaluation be made to determine the risk to structures.

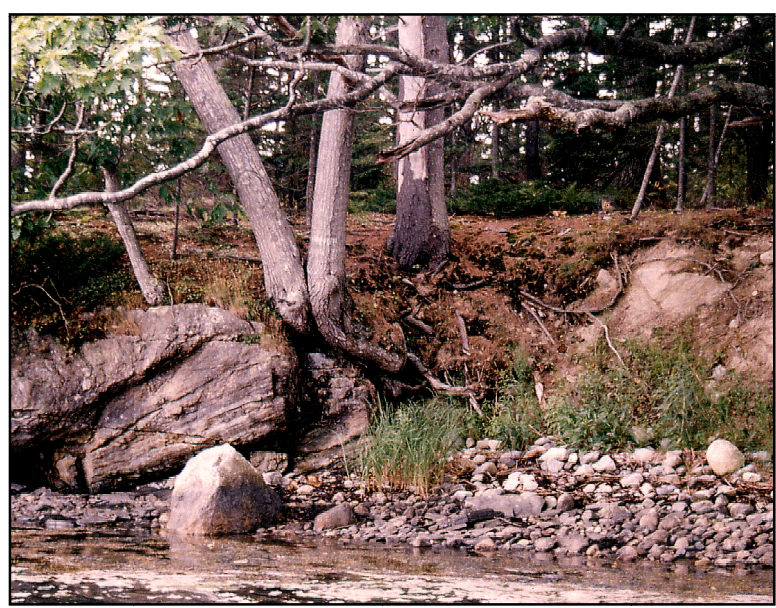
Since these are regional maps, some shores mapped as stable may contain small areas that are unstable. A bluff, too small to appear on the map, is shown in the photo. This bluff exhibits the characteristics of an unstable bluff: curved tree trunks, exposed roots, and bare ground on a steep slope. It is an area to be concerned about on a local scale. However, this degree of detail is not shown on the map above.

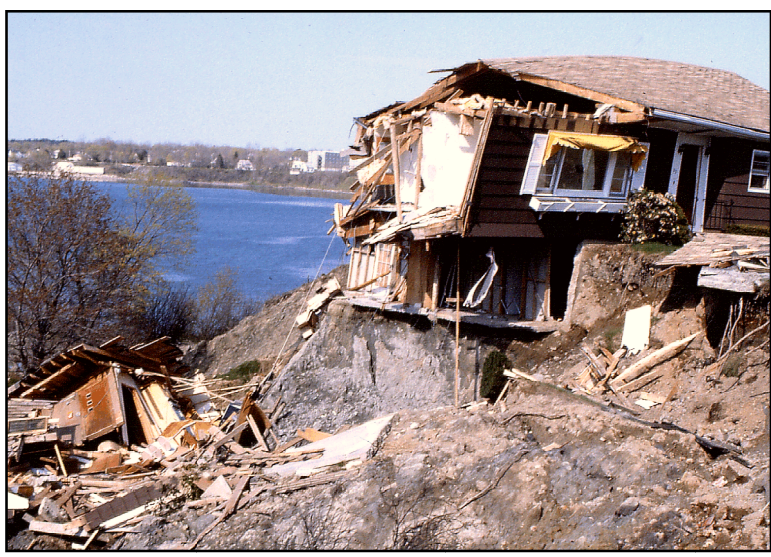
A 1996 landslide in Rockland Harbor (photo below) occurred in an area where the bluff face is classified as unstable. The hazard to development on or above the bluff can be better evaluated using long-term erosion rates. Once the risk is evaluated, then appropriate solutions to reduce the risk can be considered and balanced with cost and environmental consequences.
