Coastal Bluffs

Phippsburg Quadrangle, Maine

Open-File No. 02-204
 2002
 This map supersedes Open-File Map 00-80.

Types of Bluffs Along Maine's Coast

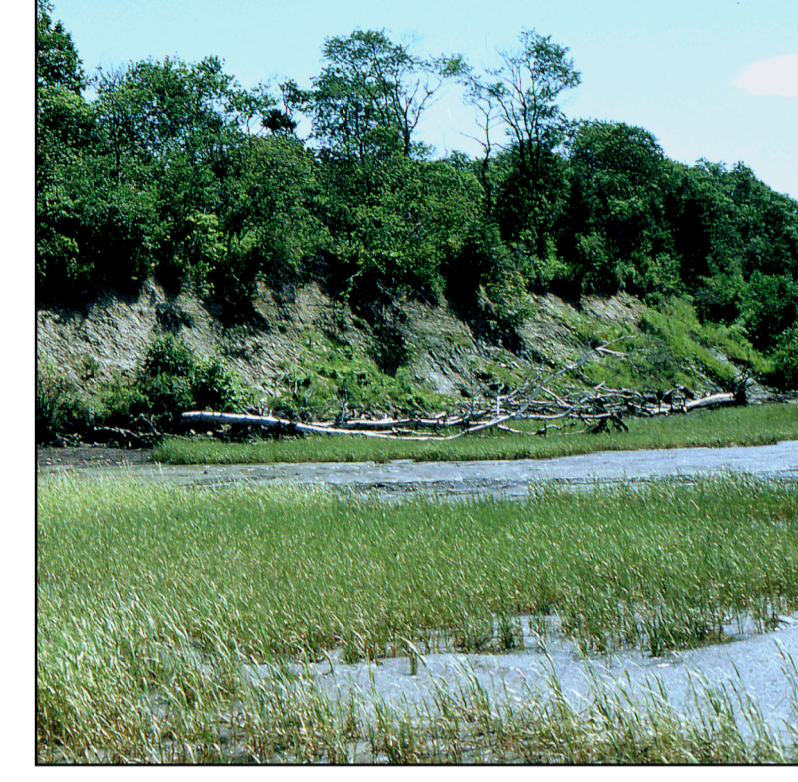
Highly unstable bluff with an unvegetated bluff face and a salt marsh shoreline. Sediments on the bluff face are exposed and fallen tree trunks lie at the base of the bluff. A salt marsh has recently formed on the tidal flat, partly on the top of an old landslide deposit.

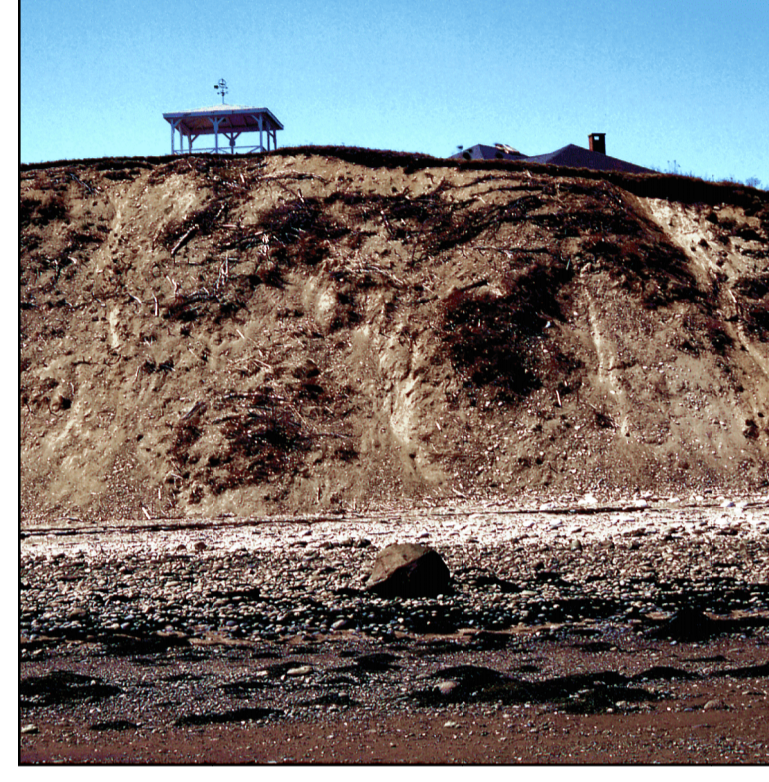
Highly unstable bluff with an unvegetated bluff face and a beach/gravel flat shoreline. The bluff face is too unstable to support vegetation. This bluff, a glacial esker, is eroded by waves to create a mixed sand and gravel beach in front of the bluff.

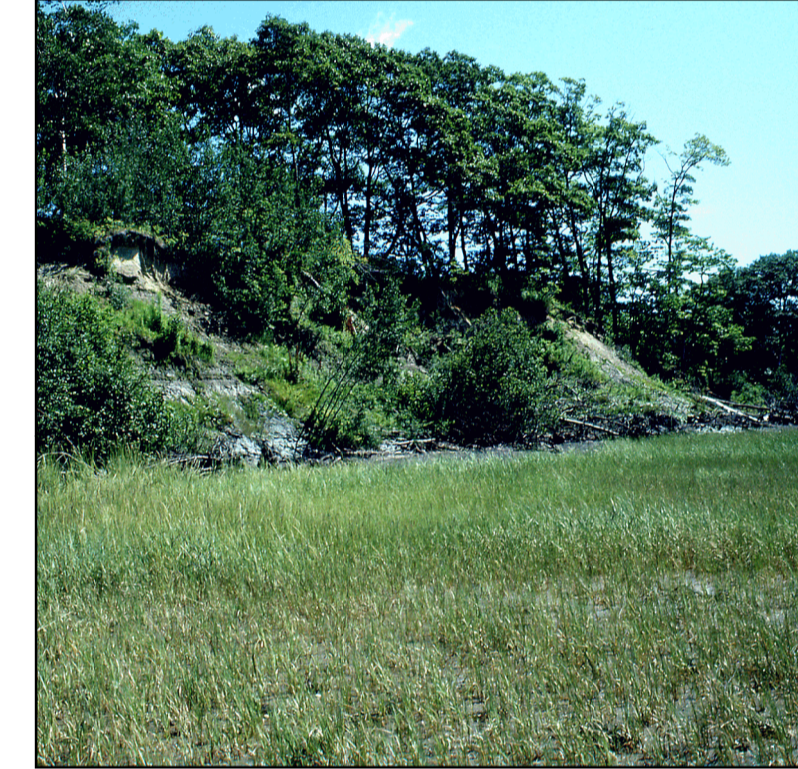
Unstable bluff with a partially vegetated bluff face and a salt marsh shoreline. This bluff, protected by a salt marsh, remains unstable. There are small bushes on the bluff as well as small non-vegetated areas that indicate continuing bluff retreat.

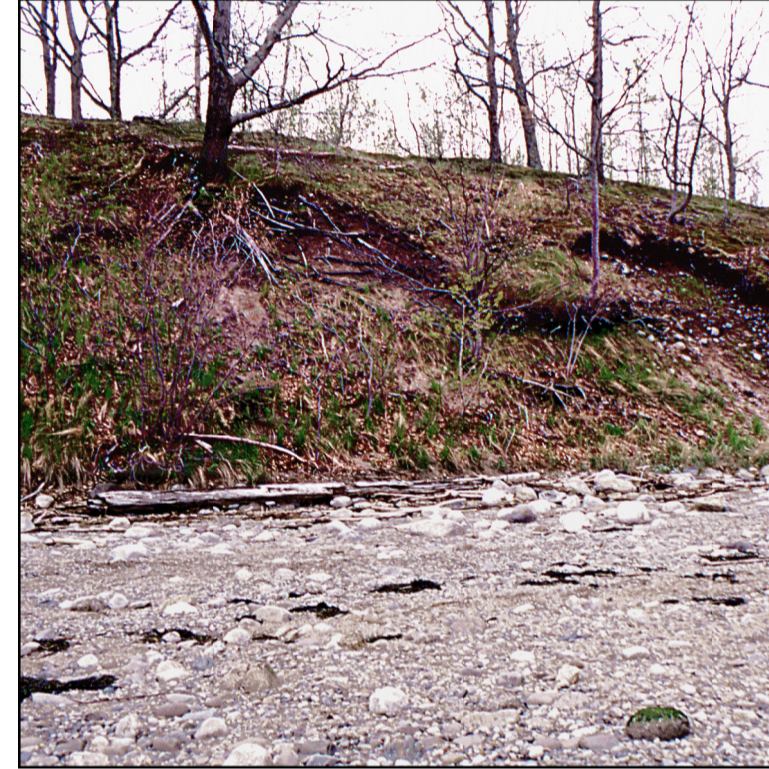
Unstable bluff with a partially vegetated bluff face and a beach/gravel flat shoreline. Slump scars on the bluff face expose sand, gravel, and roots. Fine sediments are removed by waves and currents, leaving gravel to form a beach at the base of the bluff.

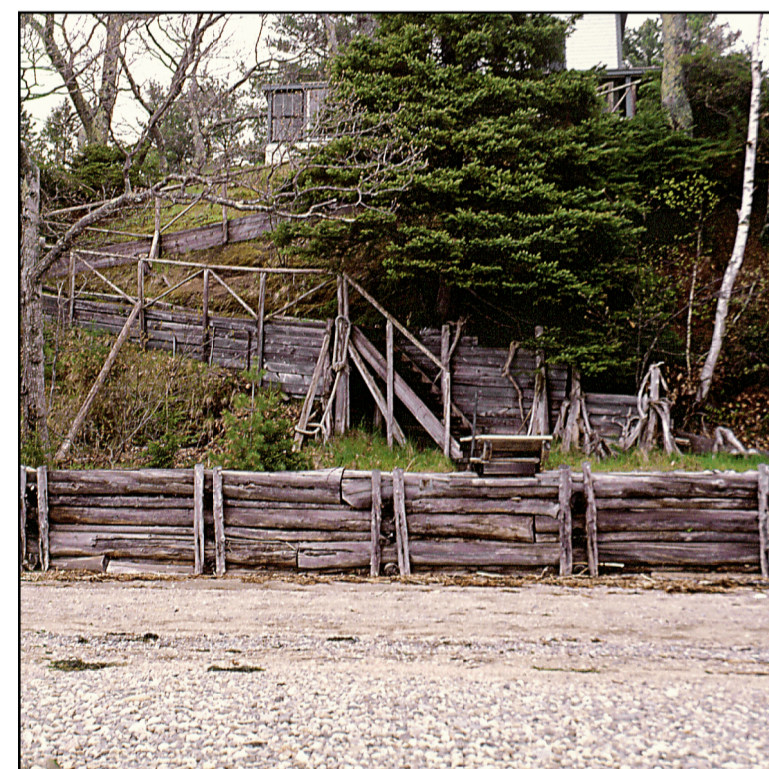
Stable bluff with a vegetated bluff face and an armored shoreline. The bluff face is fully vegetated and supports a mature stand of trees with vertical trunks. The presence of a wooden bulkhead suggests that erosion has occurred in the past.

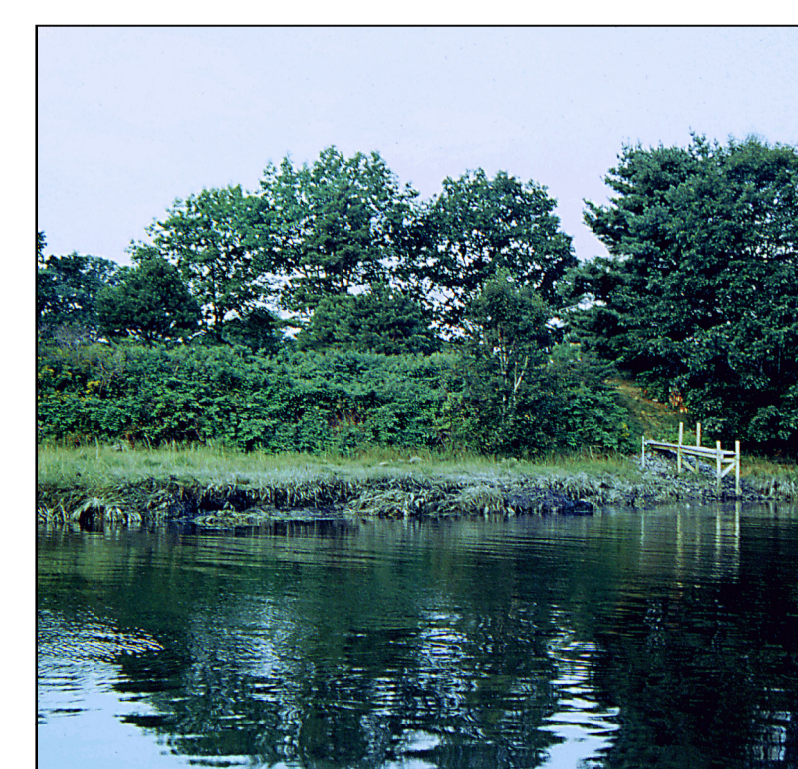
Stable bluff with a vegetated bluff face and a salt marsh shoreline. A low bluff face is covered by shrubs landward of a salt marsh terrace. In this location the mature marsh protects the base of the bluff from rapid erosion and slows bluff recession or retreat.

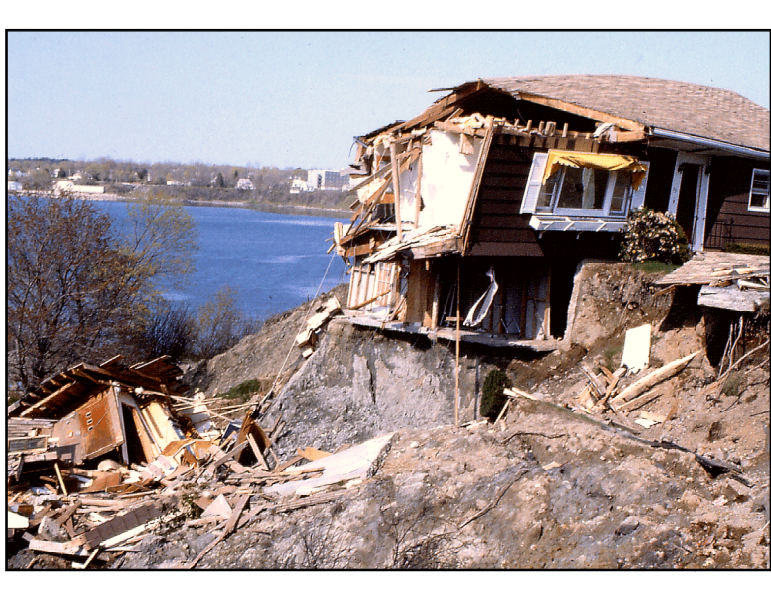
A 1996 landslide in Rockland Harbor (photo below) occurred in an area where the bluff face is classified as unstable. In addition, the bluff had all the characteristics (a-d) listed above. This fact emphasizes that the map above does not indicate sites with a potential for catastrophic landslides. Additional factors need to be considered beyond the appearance of the bluff face and type of shoreline below the bluff. Maps of 1:60,000 scale, published by the Maine Geological Survey and Coastal Landslide Hazards are available from the Maine Geological Survey to help assess the landslide potential in an area.
