Coastal Bluffs

Portland East Quadrangle, Maine

**Open-File No. 02-205
2002**
This map supersedes
Open-File Map 98-101.

Types of Bluffs Along Maine's Coast **SUPERSEDED**

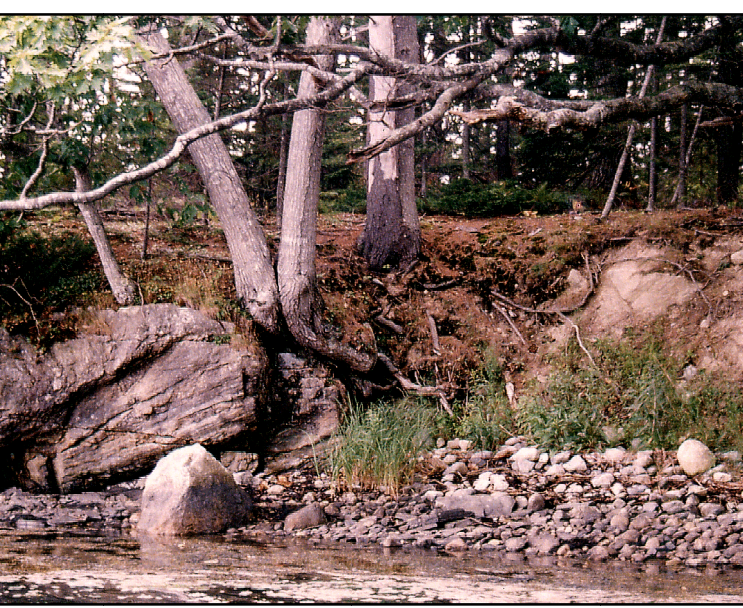
Since these are regional maps, some shore mapped as stable may contain small areas that are unstable. A bluff, too small to appear on the map, is shown in the photo. This bluff exhibits the characteristics of an unstable bluff: curved tree trunks, exposed roots, and bare ground on a steep slope. It is an area to be concerned about on a local scale. However, this degree of detail is not shown on the map above.

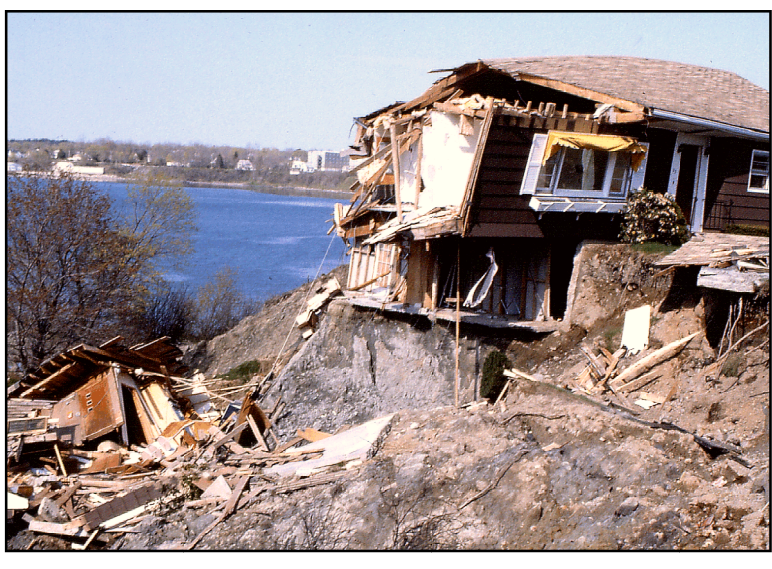
A 1996 landslide in Rockland Harbor (photo below) occurred in an area where the bluff face is classified as unstable. In addition, the bluff had all the characteristics (a-d) listed above. This fact emphasizes that the map above does not indicate sites with a potential for catastrophic landslides. Additional factors need to be considered beyond the appearance of the bluff face and type of shoreline below the bluff. Maps of topography, surficial sediments, and Coastal Landslide Hazards are available from the Maine Geological Survey to help assess the landslide potential in an area.

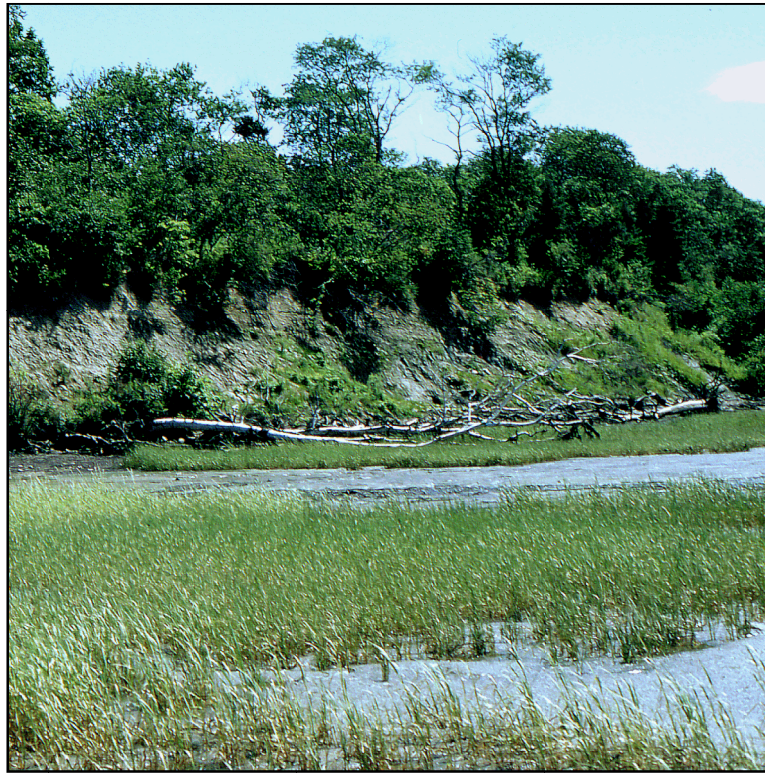
Highly unstable bluff with an unvegetated bluff face and a salt marsh shoreline. Sediments on the bluff face are exposed and fallen tree trunks lie at the base of the bluff. A salt marsh has recently formed on the tidal flat, partly on the top of an old landslide deposit.

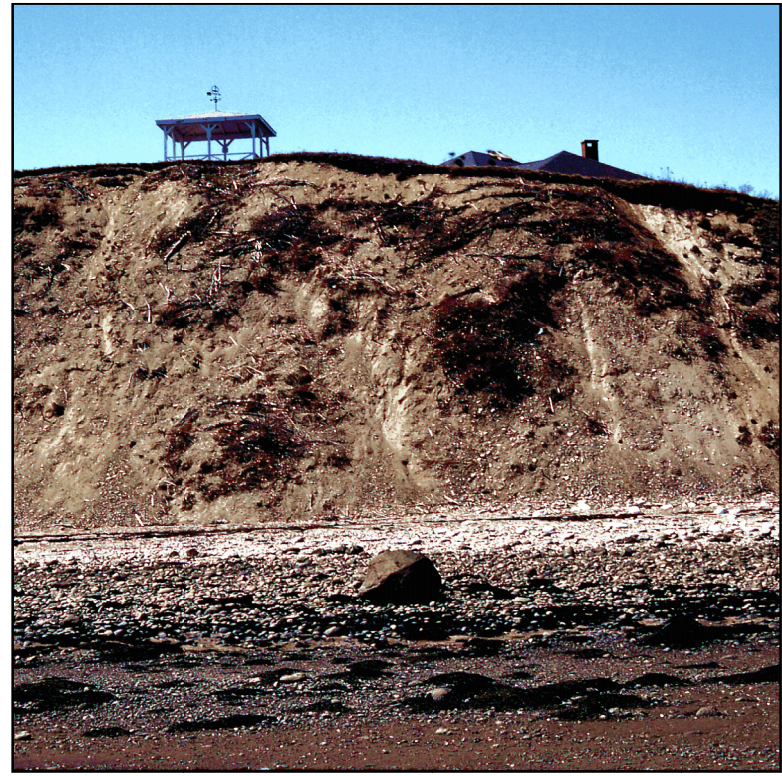
Highly unstable bluff with an unvegetated bluff face and a beach/gravel flat shoreline. The bluff face is too unstable to support vegetation. This bluff, a glacial esker, is eroded by waves to create a mixed sand and gravel beach in front of the bluff.

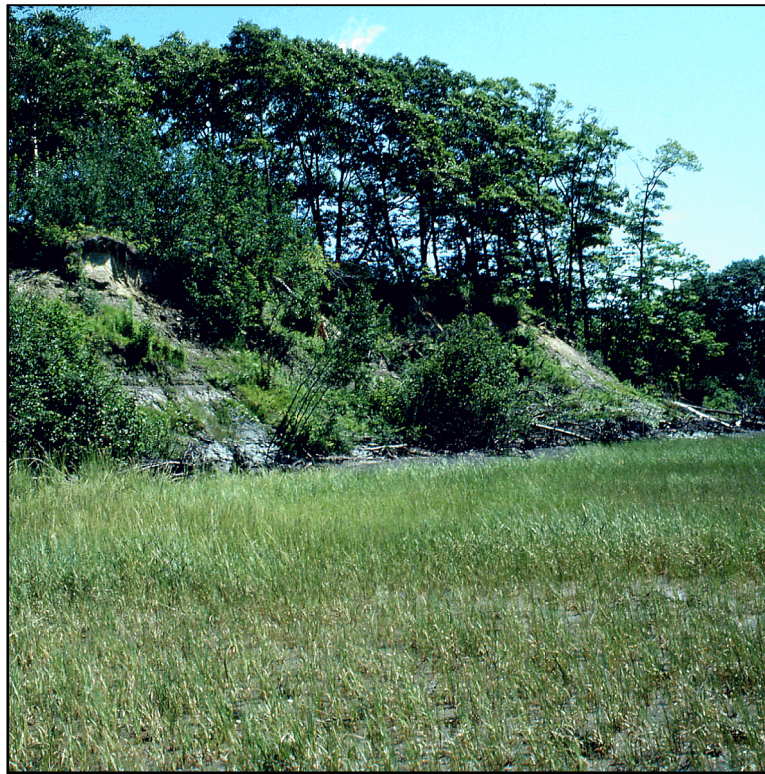
Unstable bluff with a partially vegetated bluff face and a salt marsh shoreline. This bluff, protected by a salt marsh, remains unstable. There are small bushes on the bluff as well as small non-vegetated areas that indicate continuing bluff retreat.

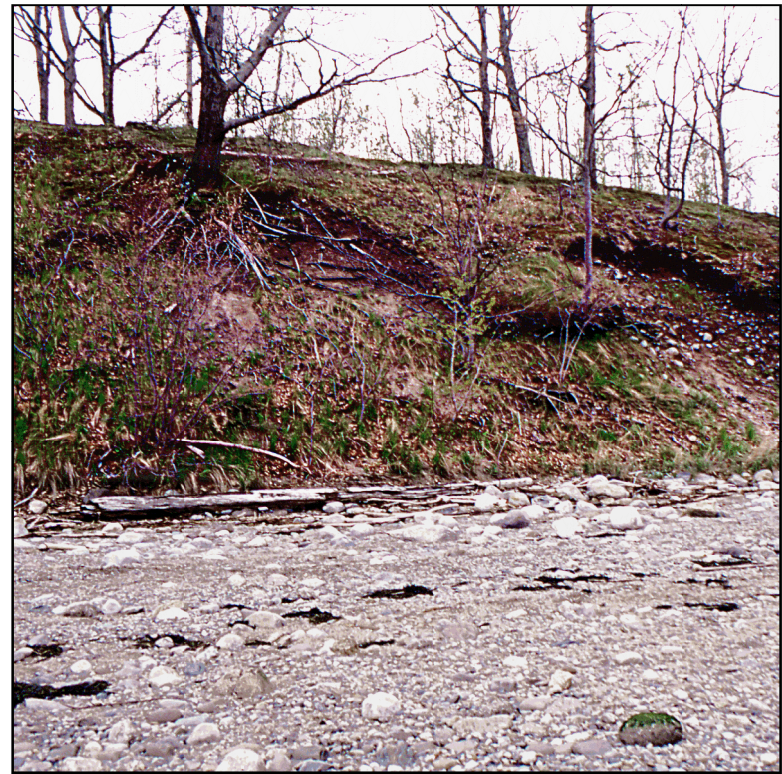
Unstable bluff with a partially vegetated bluff face and a beach/gravel flat shoreline. Slump scars on the bluff face expose sand, gravel, and roots. Fine sediments are removed by waves and currents, leaving gravel to form a beach at the base of the bluff.

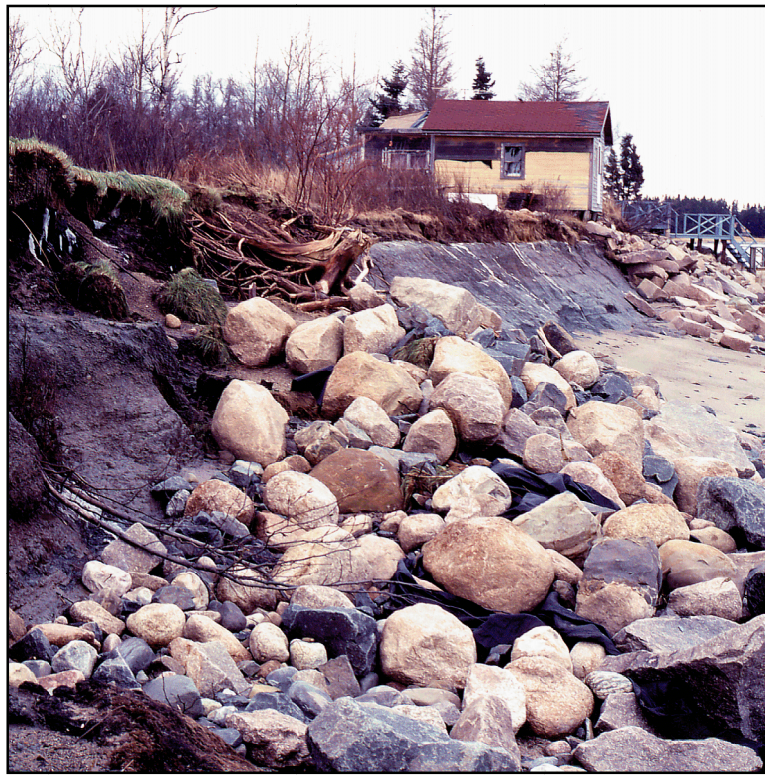
Highly unstable bluff with an unvegetated bluff face and an armored shoreline. This armored bluff is eroding despite an effort to shore it up with riprap, or loosely piled stone blocks. Maintenance at this site could improve bluff stability.

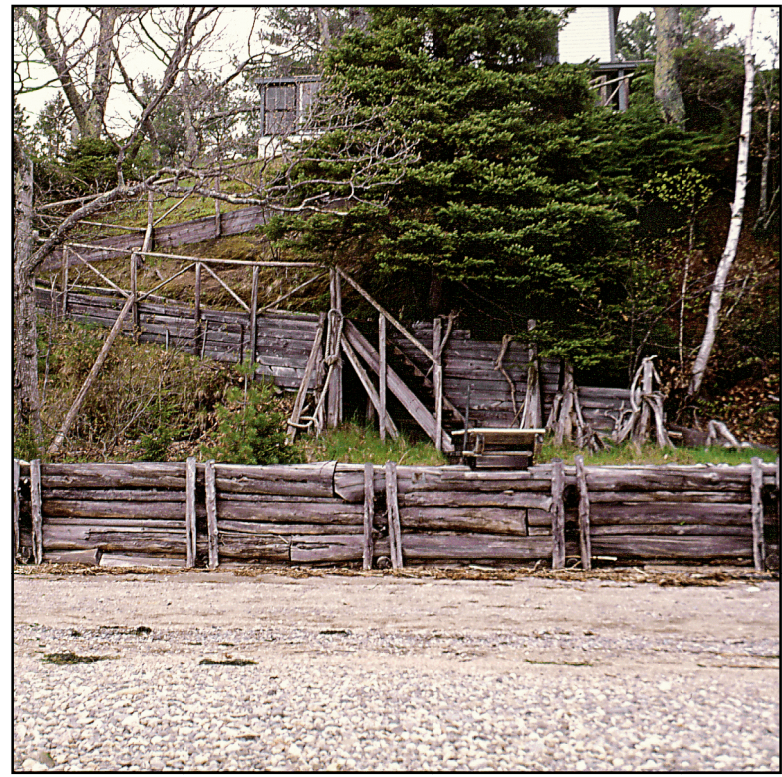
Stable bluff with a vegetated bluff face and an armored shoreline. The bluff face is fully vegetated and supports a mature stand of trees with vertical trunks. The presence of a wooden bulkhead suggests that erosion has occurred in the past.

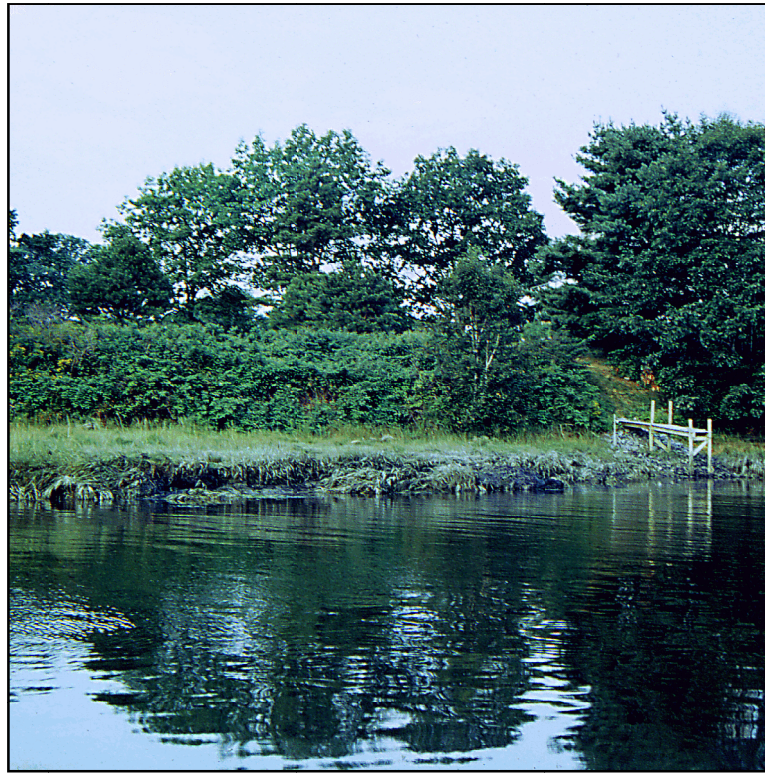
Stable bluff with a vegetated bluff face and a salt marsh shoreline. A low bluff face is covered by shrubs landward of a salt marsh terrace. In this location the mature marsh protects the base of the bluff from rapid erosion and slows bluff recession or retreat.

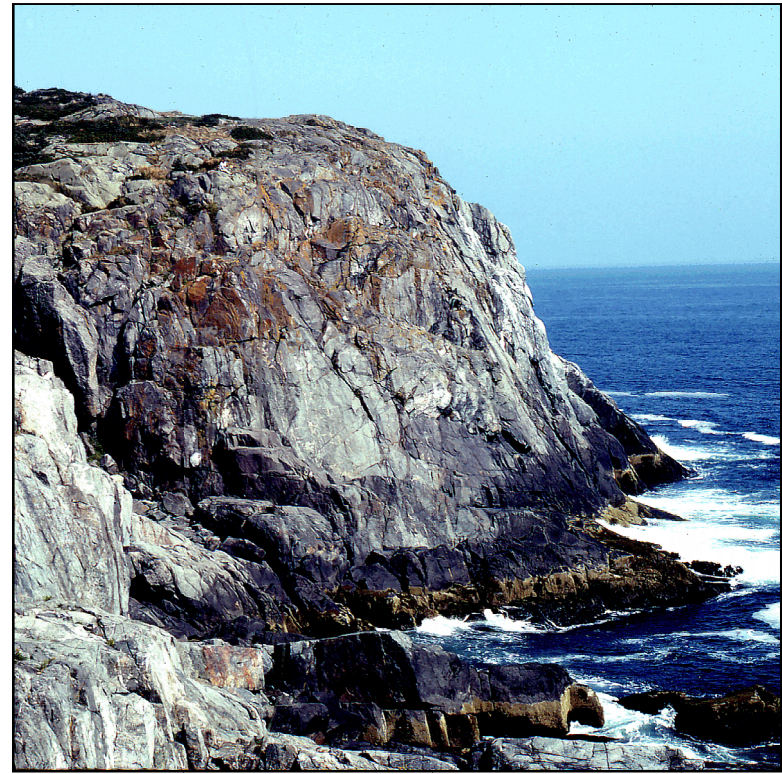
No bluff with a ledge shoreline. A steep slope on the bedrock surface is not a bluff. On this map, bluffs must be made of sedimentary material, generally with 3 feet or more relief. This shoreline type is very slow to change.
