# Coastal Landslide Hazards

## Newbury Neck Quadrangle, Maine

### Maine Geological Survey

Open-File No. 01-527  
2001

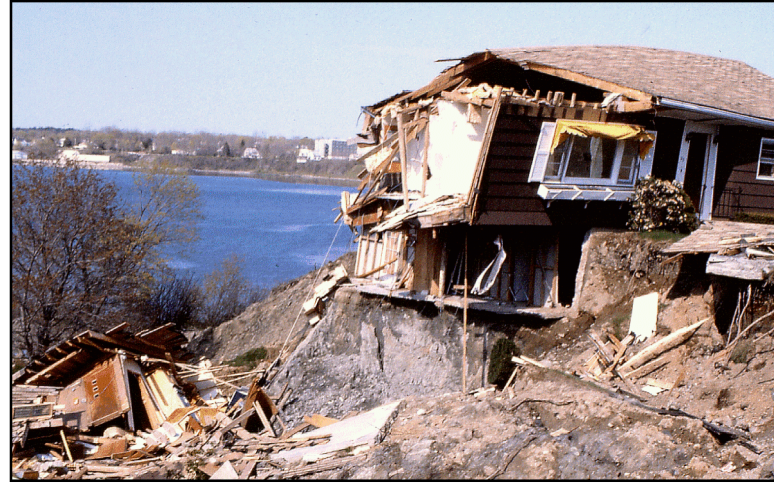
Figure 1. A clay bluff on the north shore of Rockland Harbor failed in 1996. This landslide formed a new scarp about 200 feet landward of the original top of the bluff in just a few hours. Two homes were destroyed as a result of this catastrophic slide (see Berry and others, 1996).

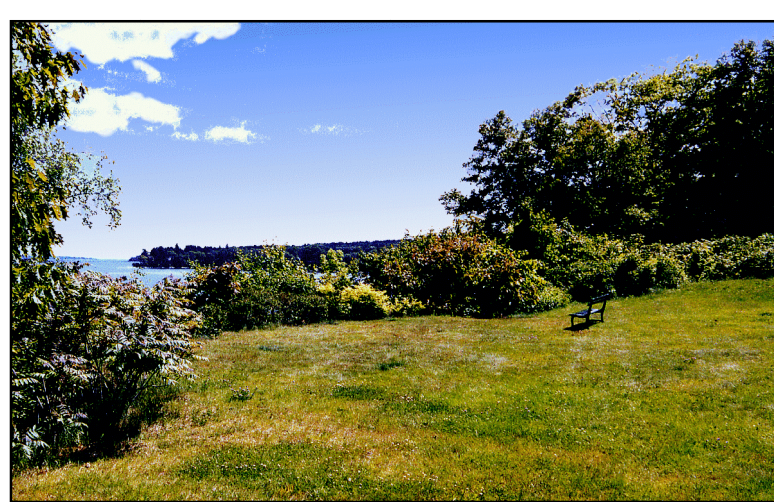
Figure 3. The shape of the top edge of a bluff can be an indicator of landslide risk. Clay bluffs often fail at points of weakness. Such a "slump" can expand into a larger landslide that cuts into the bluff and forms a curve around the original point of failure. Multiple slides and slumps will form an irregular or arcuate top edge to the bluff as shown in the photo above. Bluffs made of coarse materials or sand have a more even upper edge caused by a more constant rate of erosion along the bluff face.

Careful observation of the land surface, vegetation, and shape of a coastal bluff reveals evidence of instability. Starting at the top of a bluff, an irregular or arcuate edge can indicate past landslides or areas of increased coastal erosion (Figure 3). When a weak point on a bluff fails, the slide moves inward into the slope face forming a curve around the original point of failure. Tension cracks may form near a weak zone where the soil surface is moving downslope (Figure 4). These cracks appear as splits in the ground where the soil and vegetation have moved apart. Cracks may be visible along the top edge of the bluff or on the bluff face itself. On the slope of a bluff, a hummocky land surface or terraces indicate past slumping or landslides (Figure 5). Unvegetated slump scars or slopes are obvious evidence of rapid soil movement. A bowl-shaped slope often shows the location of a former landslide, with the center of the bowl as the area of greatest failure. Distorted vegetation provides evidence of soil creep or former landslides. Tree trunks curved near their base are evidence of downslope movement (Figure 6). Trees tilted at different angles are evidence of former slides or undercutting by erosion. At the base of a bluff, toppled trees and bare roots are evidence of erosion that steepens the bluff (Figure 7). Undercutting and steepening of the bluff may destabilize the slope and lead to increased erosion and possibly a landslide. Lobes or terraces of sediment in the intertidal zone are often remnants of old landslides. Although the evidence of earth movement listed above cannot predict a landslide, it is used to recognize unstable shorelines. This landform evidence is related to factors listed below that influence landslide risk.

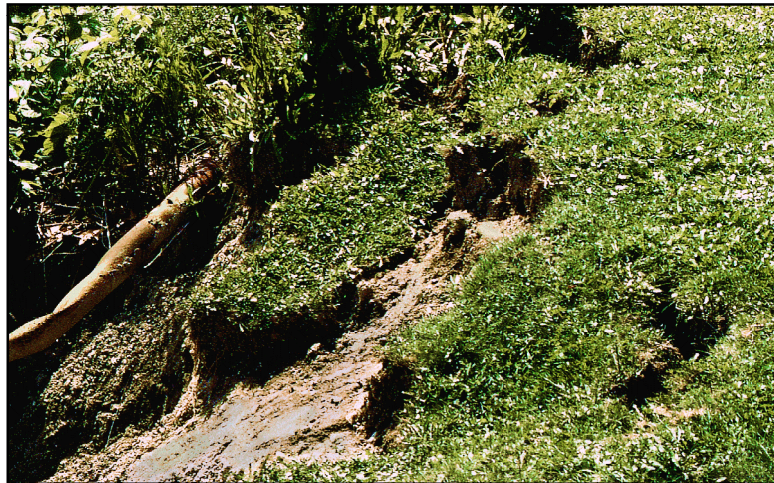
Figure 4. Downslope forces within a bluff cause surface layers to stretch. When the tension becomes great enough, a crack forms and the pressure is released. These "tension cracks" may form on the top edge of the bluff or on the bluff slope itself. They indicate instability and motion within the bluff. Some cracks are deep and extend below the soil layer.

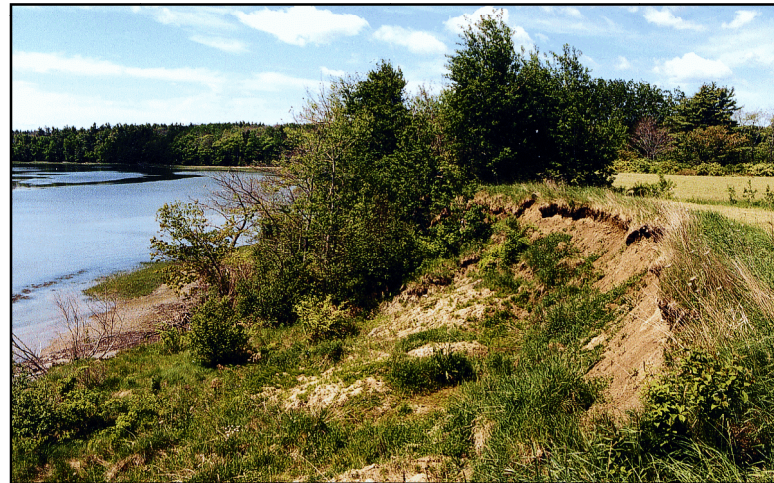
Figure 5. Terraces or a hummocky land surface on the slope of a bluff can indicate a former landslide. Terraces can be the surface of downslope blocks that moved during a slide. Vegetation on the surface of these blocks may be tilted in various directions. The irregular land surface may also occur in a bowl-shaped depression below an arcuate top edge of the bluff, additional evidence of a former landslide.

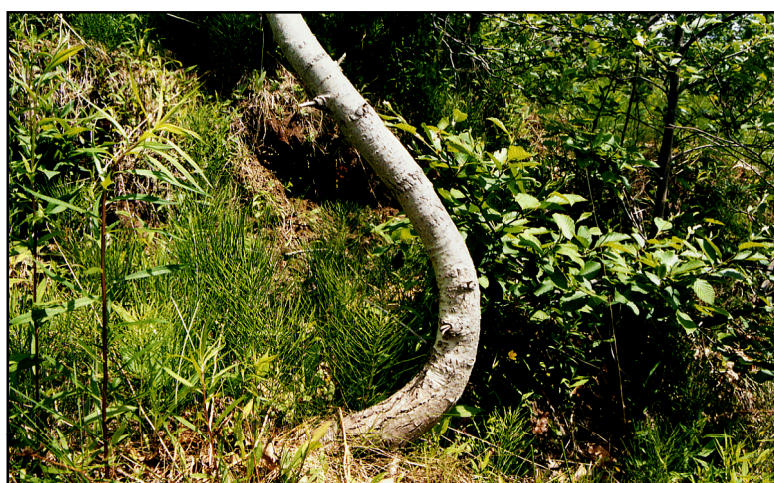
Figure 6. Soil "creep" or downslope movement of the soil on a slope, will cause tree trunks to tilt toward the base of the slope. As a moving tree continues to grow, the trunk will curve as the tree tries to right itself toward the sun. Landslides will also cause tree trunks to become curved.

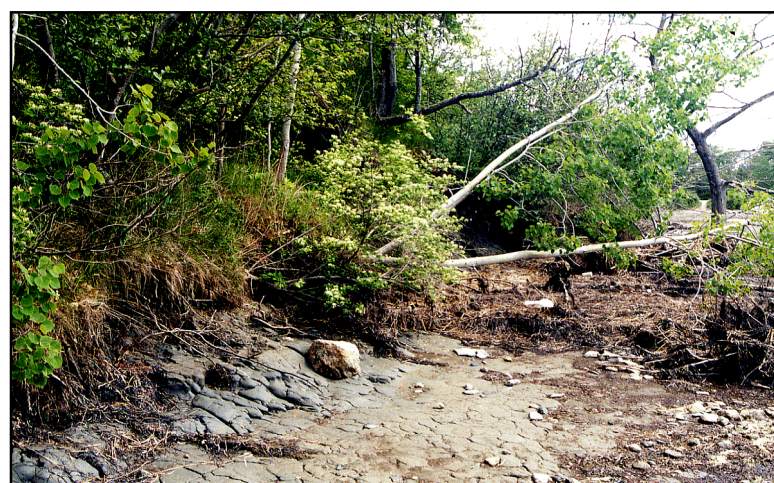
Figure 7. Wave erosion at the base of a bluff removes slope sediment and steepens the bluff. Erosion has undercut the trees in the photo above and caused them to tilt toward the ocean. This steepening reduces the stability of the bluff, and a landslide may result. Ongoing sea-level rise along the Maine coast will cause wave erosion at the base of coastal bluffs and continue to make some coastal bluffs at risk of experiencing a landslide.
