Coastal Bluffs

Classification and Mapping of Maine's Coastal Bluffs

Brunswick Quadrangle, Maine

Open-File No. 02-179

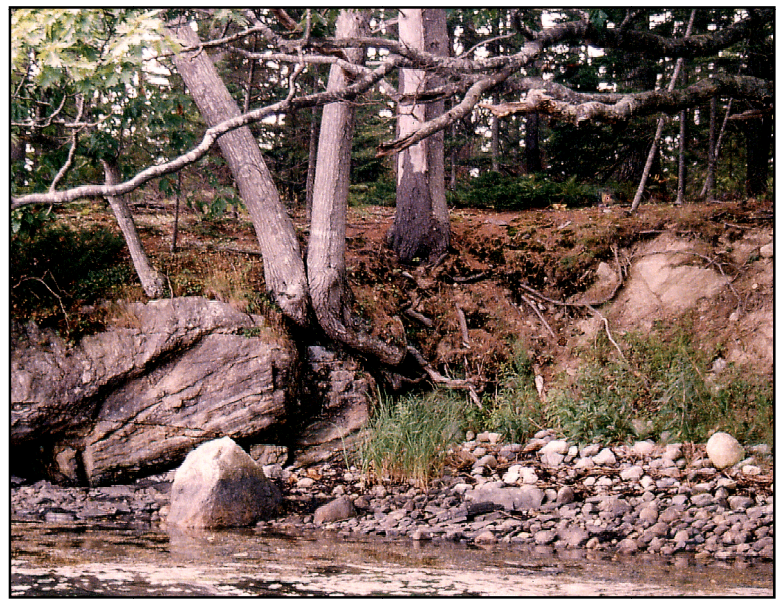
Map Resolution
Since these are regional maps, some shores mapped as stable may contain small areas that are unstable. A bluff, too small to appear on the map, is shown in the photo. This bluff exhibits the characteristics of an unstable bluff: curved tree trunks, exposed roots, and bare ground on a steep slope. It is an area to be concerned about on a local scale. However, this degree of detail is not shown on the map above.

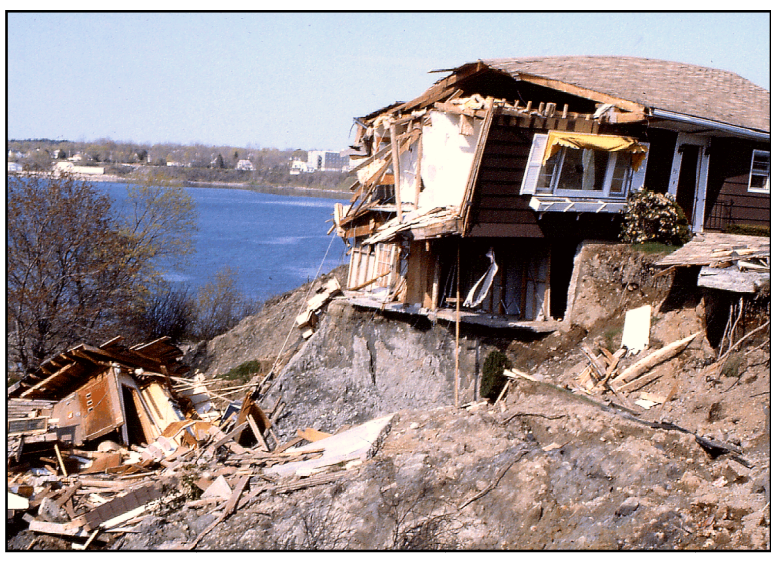
A 1996 landslide in Rockland Harbor (photo below) occurred in an area where the bluff face is classified as unstable. The hazard to development on or above the bluff can be better evaluated using long-term erosion rates. Once the risk is evaluated, then appropriate solutions to reduce the risk can be considered and balanced with cost and environmental consequences.

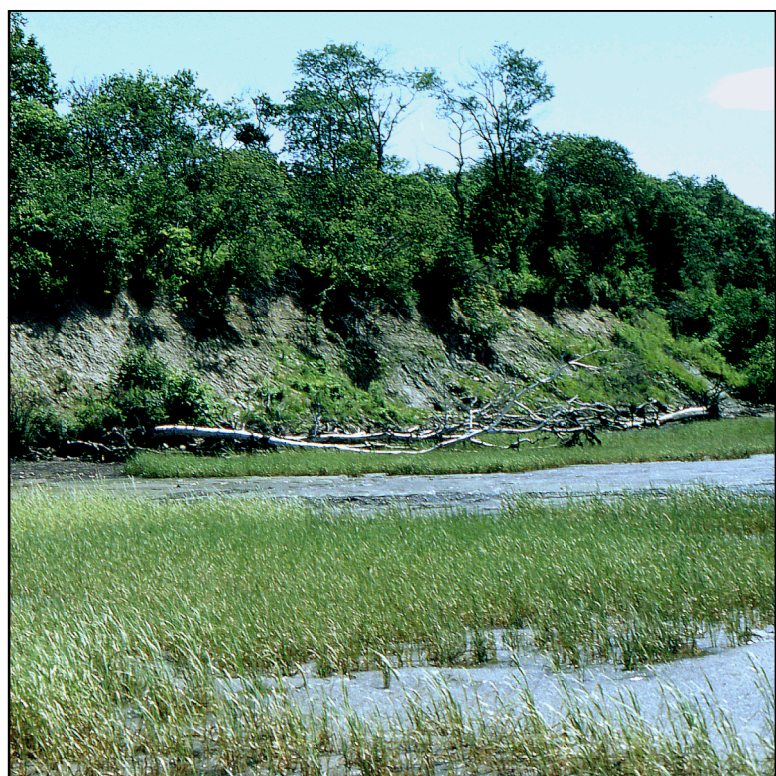
Highly unstable bluff with an unvegetated bluff face and a salt marsh shoreline. Sediments on the bluff face are exposed and fallen tree trunks lie at the base of the bluff. A salt marsh has recently formed on the tidal flat, partly on the top of an old landslide-deposit.

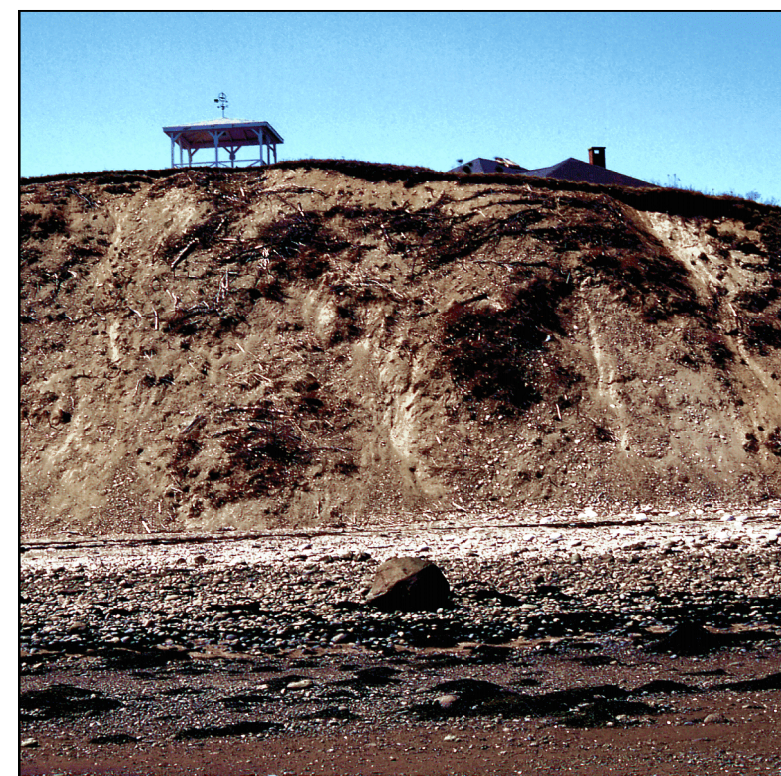
Highly unstable bluff with an unvegetated bluff face and a beach/gravel flat shoreline. The bluff face is too unstable to support vegetation. This bluff, a glacial esker, is eroded by waves to create a mixed sand and gravel beach in front of the bluff.

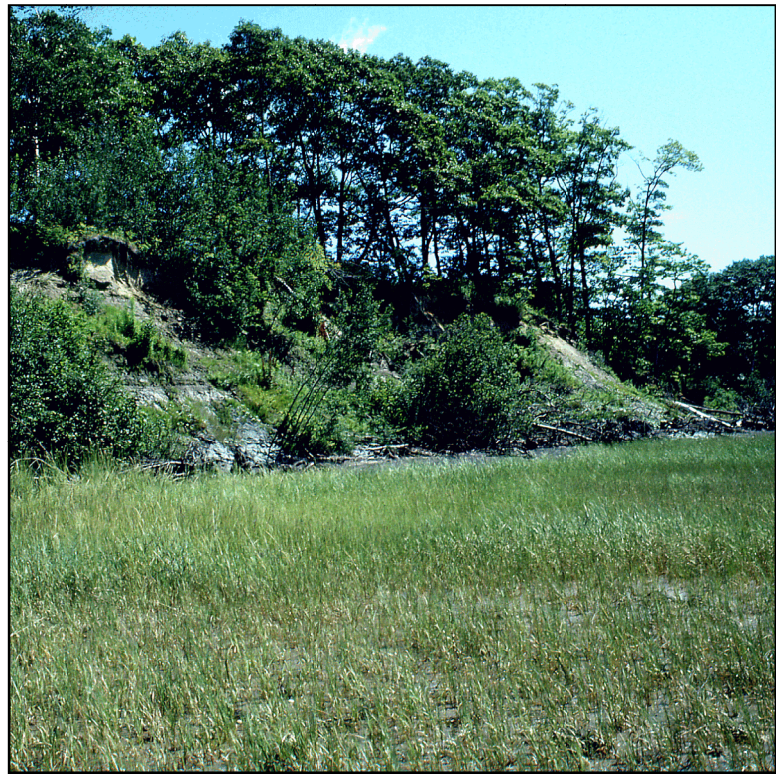
Unstable bluff with a partially vegetated bluff face and a salt marsh shoreline. This bluff, protected by a salt marsh, remains unstable. There are small bushes on the bluff as well as small non-vegetated areas that indicate continuing bluff retreat.

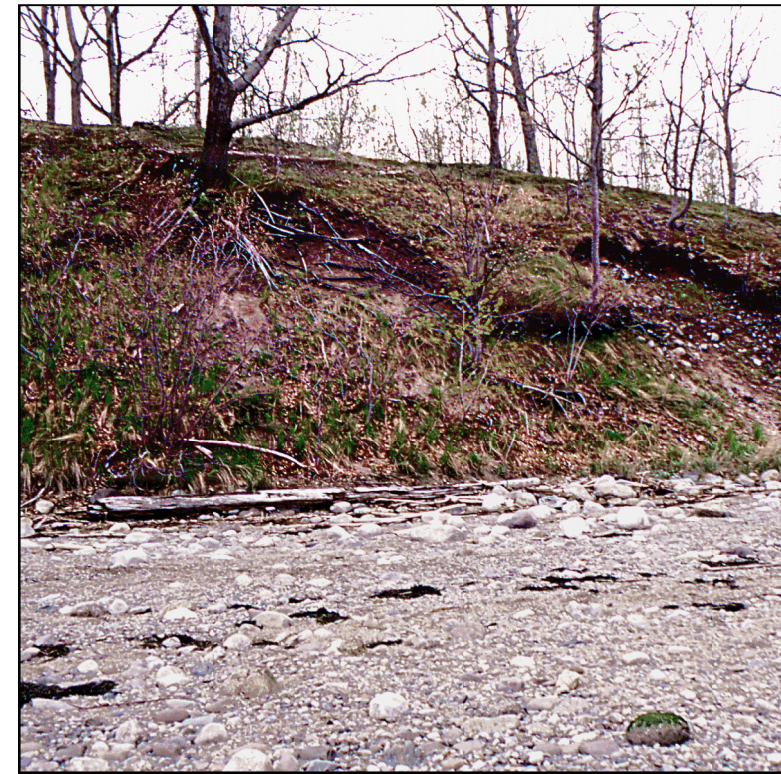
Unstable bluff with a partially vegetated bluff face and a beach/gravel flat shoreline. Slump scars on the bluff face expose sand, gravel, and roots. Fine sediments are removed by waves and currents, leaving gravel to form a beach at the base of the bluff.

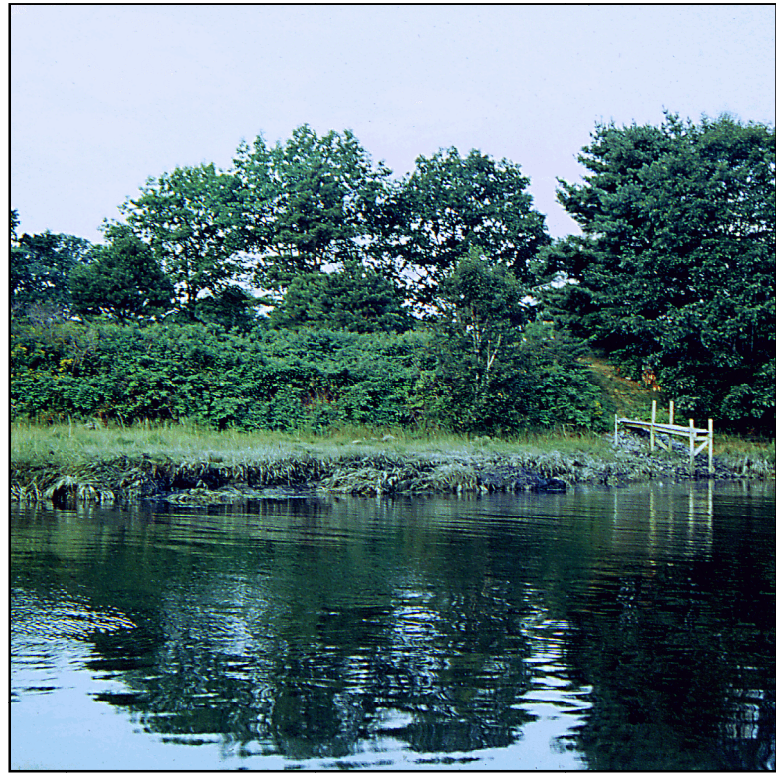
Stable bluff with a vegetated bluff face and a salt marsh shoreline. A low bluff face is covered by shrubs landward of a salt marsh terrace. In this location the mature marsh protects the base of the bluff from rapid erosion and slows bluff recession or retreat.

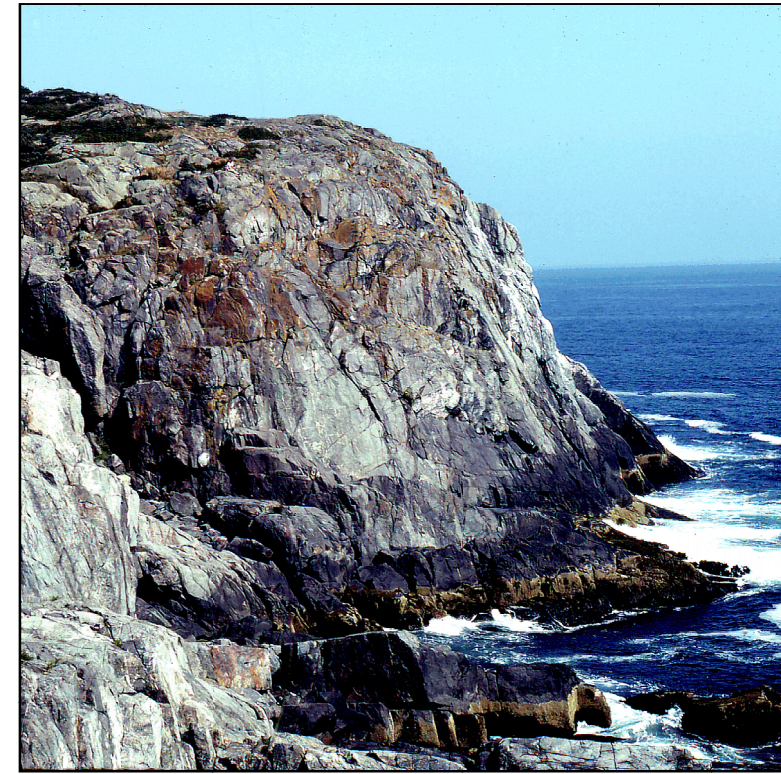
No bluff with a ledge shoreline. A steep slope on the bedrock surface is not a bluff. On this map, bluffs must be made of sedimentary material, generally with 3 feet or more of relief. This shoreline type is very slow to change.
