# Coastal Bluffs

## Classification and Mapping of Maine's Coastal Bluffs

# Hancock Quadrangle, Maine

## Open-File No. 05-41

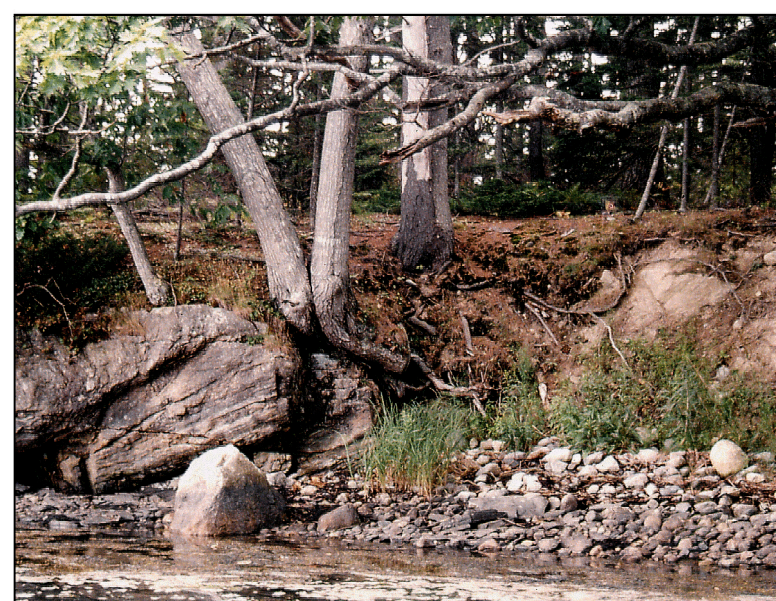
Since these are regional maps, some shores mapped as stable may contain small areas that are unstable. A bluff, too small to appear on the map, is shown in the photo. This bluff exhibits the characteristics of an unstable bluff: curved tree trunks, exposed roots, and bare ground on a steep slope. It is an area to be concerned about on a local scale. However, this degree of detail is not shown on the map above.

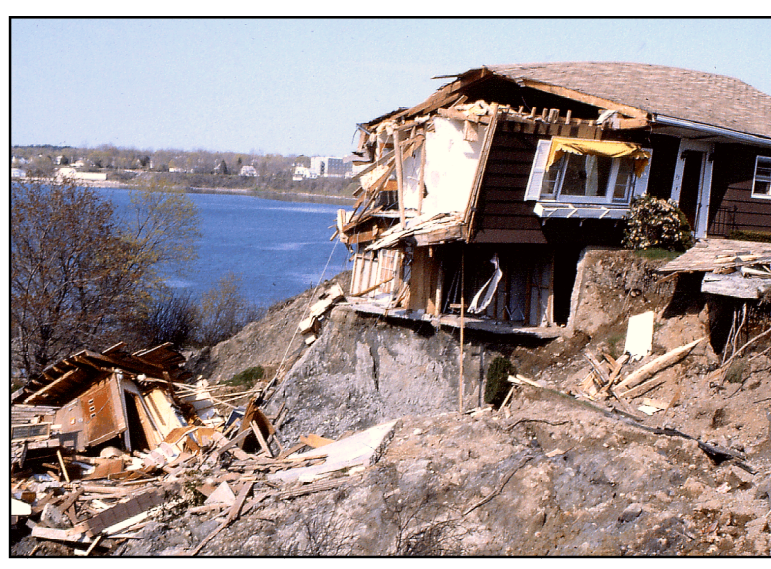
A 1996 landslide in Rockland Harbor (photo below) occurred in an area where the bluff face is classified as unstable. In addition, the bluff had all the characteristics (a-d) listed above. This fact emphasizes that the map above does not indicate sites with a potential for catastrophic landslides.

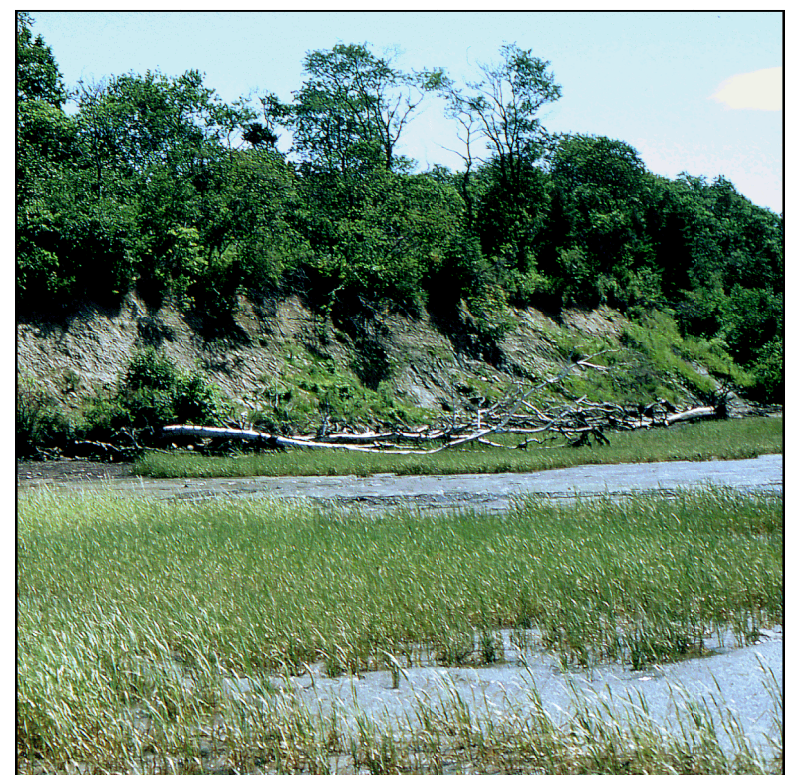
**Highly unstable bluff** with an unvegetated bluff face and a salt marsh shoreline. Sediments on the bluff face are exposed and fallen tree trunks lie at the base of the bluff. A salt marsh has recently formed on the tidal flat, partly on the top of an old landslide deposit.

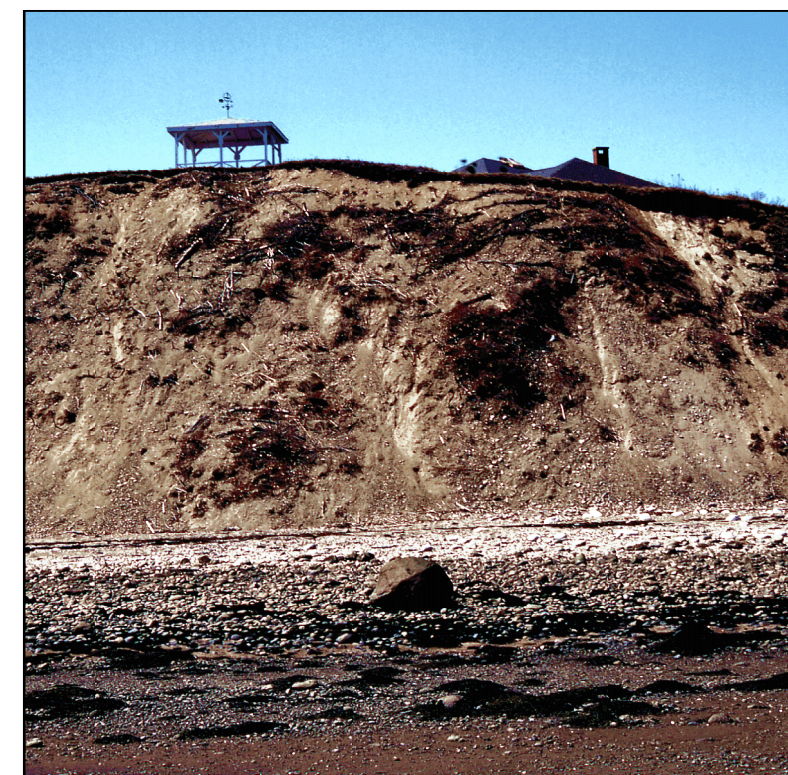
**Highly unstable bluff** with an unvegetated bluff face and a beach/gravel flat shoreline. The bluff face is too unstable to support vegetation. This bluff, a glacial esker, is eroded by waves to create a mixed sand and gravel beach in front of the bluff.

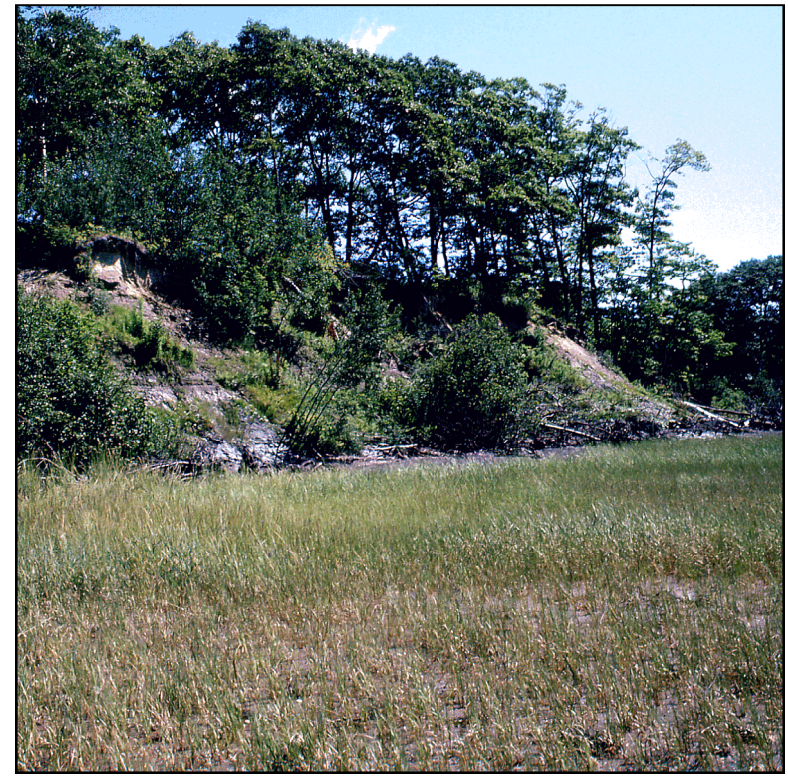
**Unstable bluff** with a partially vegetated bluff face and a salt marsh shoreline. This bluff, protected by a salt marsh, remains unstable. There are small bushes on the bluff as well as small non-vegetated areas that indicate continuing bluff retreat.

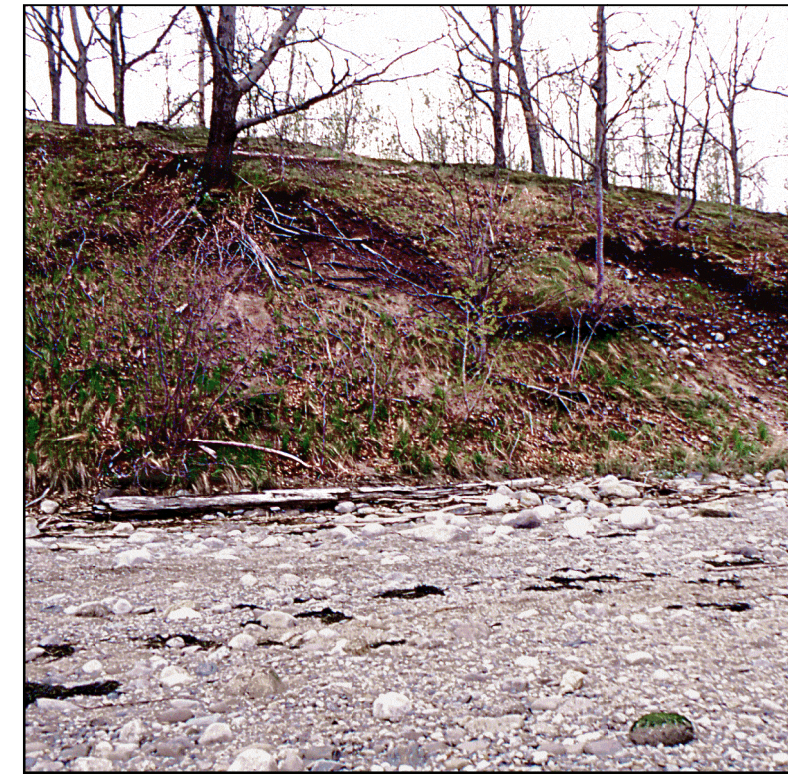
**Unstable bluff** with a partially vegetated bluff face and a beach/gravel flat shoreline. Slump scars on the bluff face expose sand, gravel, and roots. Fine sediments are removed by waves and currents, leaving gravel to form a beach at the base of the bluff.

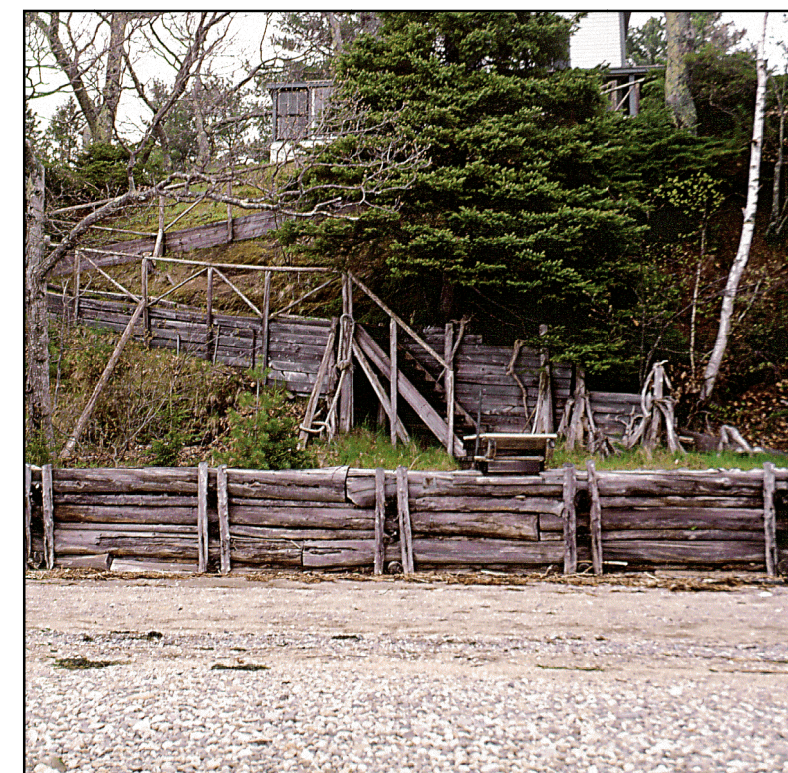
**Stable bluff** with a vegetated bluff face and an armored shoreline. The bluff face is fully vegetated and supports a mature stand of trees with vertical trunks. The presence of a wooden bulkhead suggests that erosion has occurred in the past.

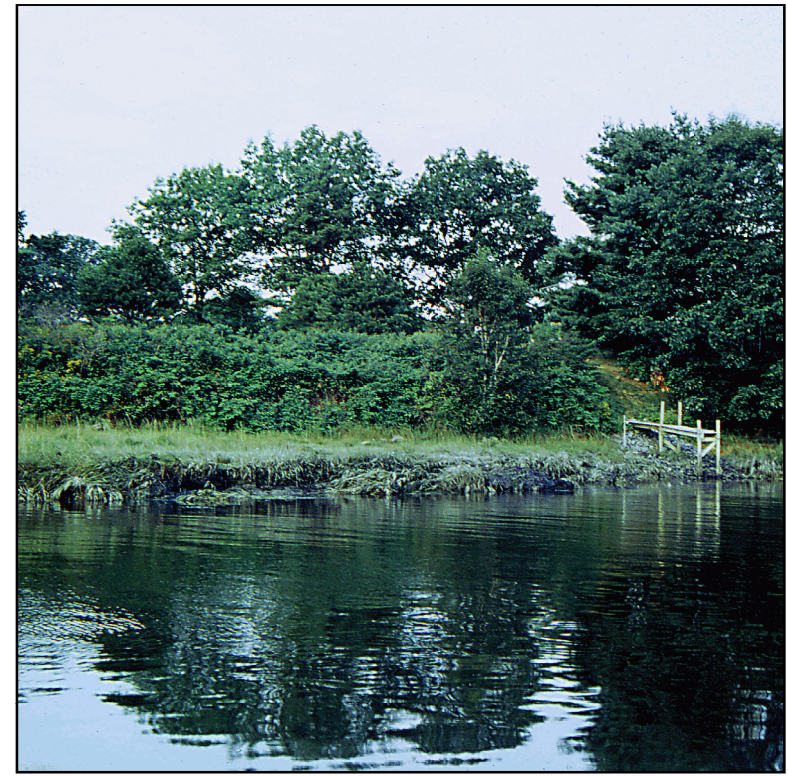
**Stable bluff** with a vegetated bluff face and a salt marsh shoreline. A low bluff face is covered by shrubs landward of a salt marsh terrace. In this location the mature marsh protects the base of the bluff from rapid erosion and slows bluff recession or retreat.

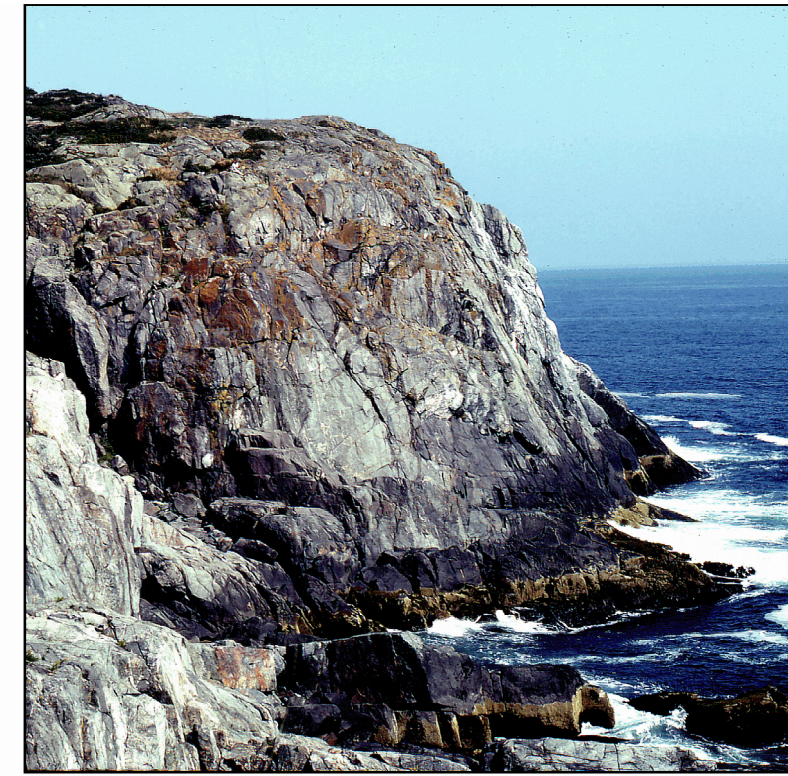
**No bluff** with a ledge shoreline. A steep slope on the bedrock surface is not a bluff. On this map, bluffs must be made of sedimentary material, generally with 3 feet or more relief. This shoreline type is very slow to change.
