# Coastal Landslide Hazards

# Schoodic Head Quadrangle, Maine

Open-File No. 06-69  
2006

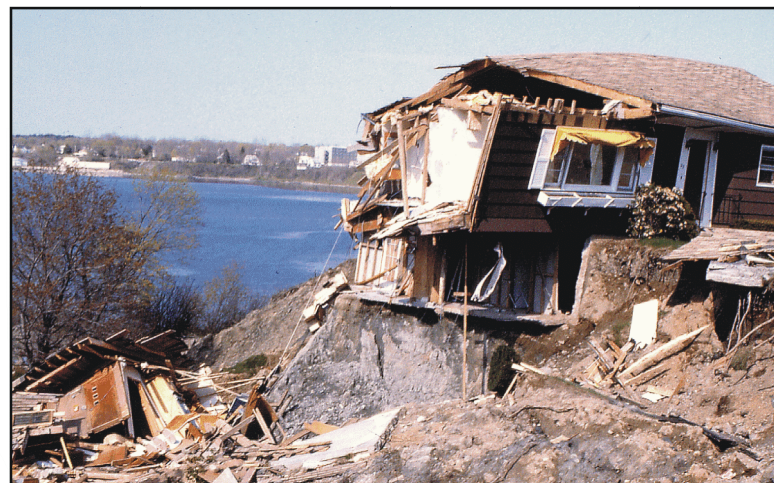
Figure 1. A clay bluff on the north shore of Rockland Harbor failed in 1996. This landslide formed a new scarp about 200 feet landward of the original top of the bluff in just a few hours. Two homes were destroyed as a result of this catastrophic slide (see Berry and others, 1996).

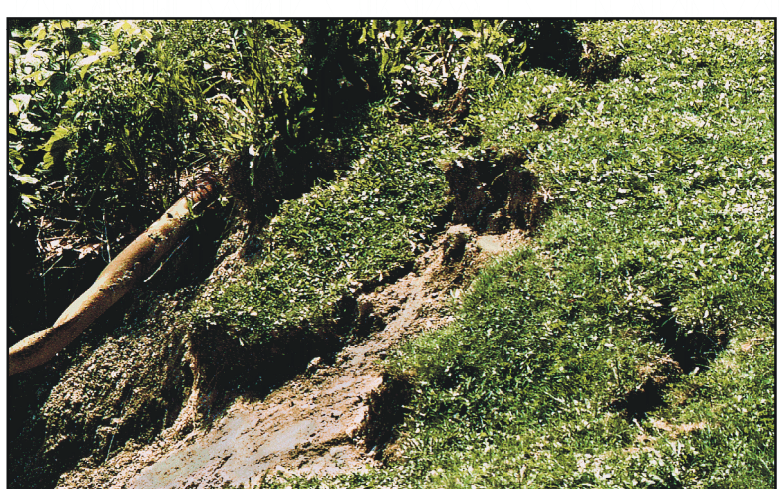
Figure 4. Downslope forces within a bluff cause surface layers to stretch. When the tension becomes great enough, a crack forms and the pressure is released. These "tension cracks" may form on the top edge of the bluff or on the bluff slope itself. They indicate instability and motion within the bluff. Some cracks are deep and extend below the soil layer.

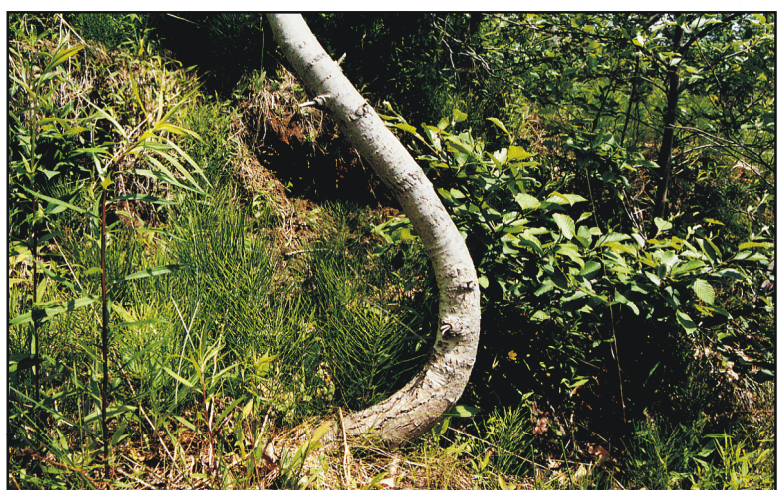
Figure 5. Soil "creep," or downslope movement of soil on a slope, will cause tree trunks to tilt toward the base of the slope. As a moving tree continues to grow, the trunk will curve as the tree tries to right itself over the ground toward the sun. Landslides will also cause tree trunks to become curved.

**Vegetation.** Types, shapes, and distribution of vegetation above and on a bluff face can be used as an indication of site stability. In areas where the soil has shifted, either due to previous landslides or to gradual surface creep, many tree trunks can become tilted or twisted in the same direction. Curved tree trunks near the roots often indicate land movement down the face of a bluff. Large trees on the bluff face may be moved by wind and resulting root motion may loosen bluff sediment. Natural vegetation consisting only of small shrubs and trees may indicate recent bluff erosion or a landslide.
