Coastal Bluffs

York Beach Quadrangle, Maine

Maine Geological Survey

Open-File No. 06-59

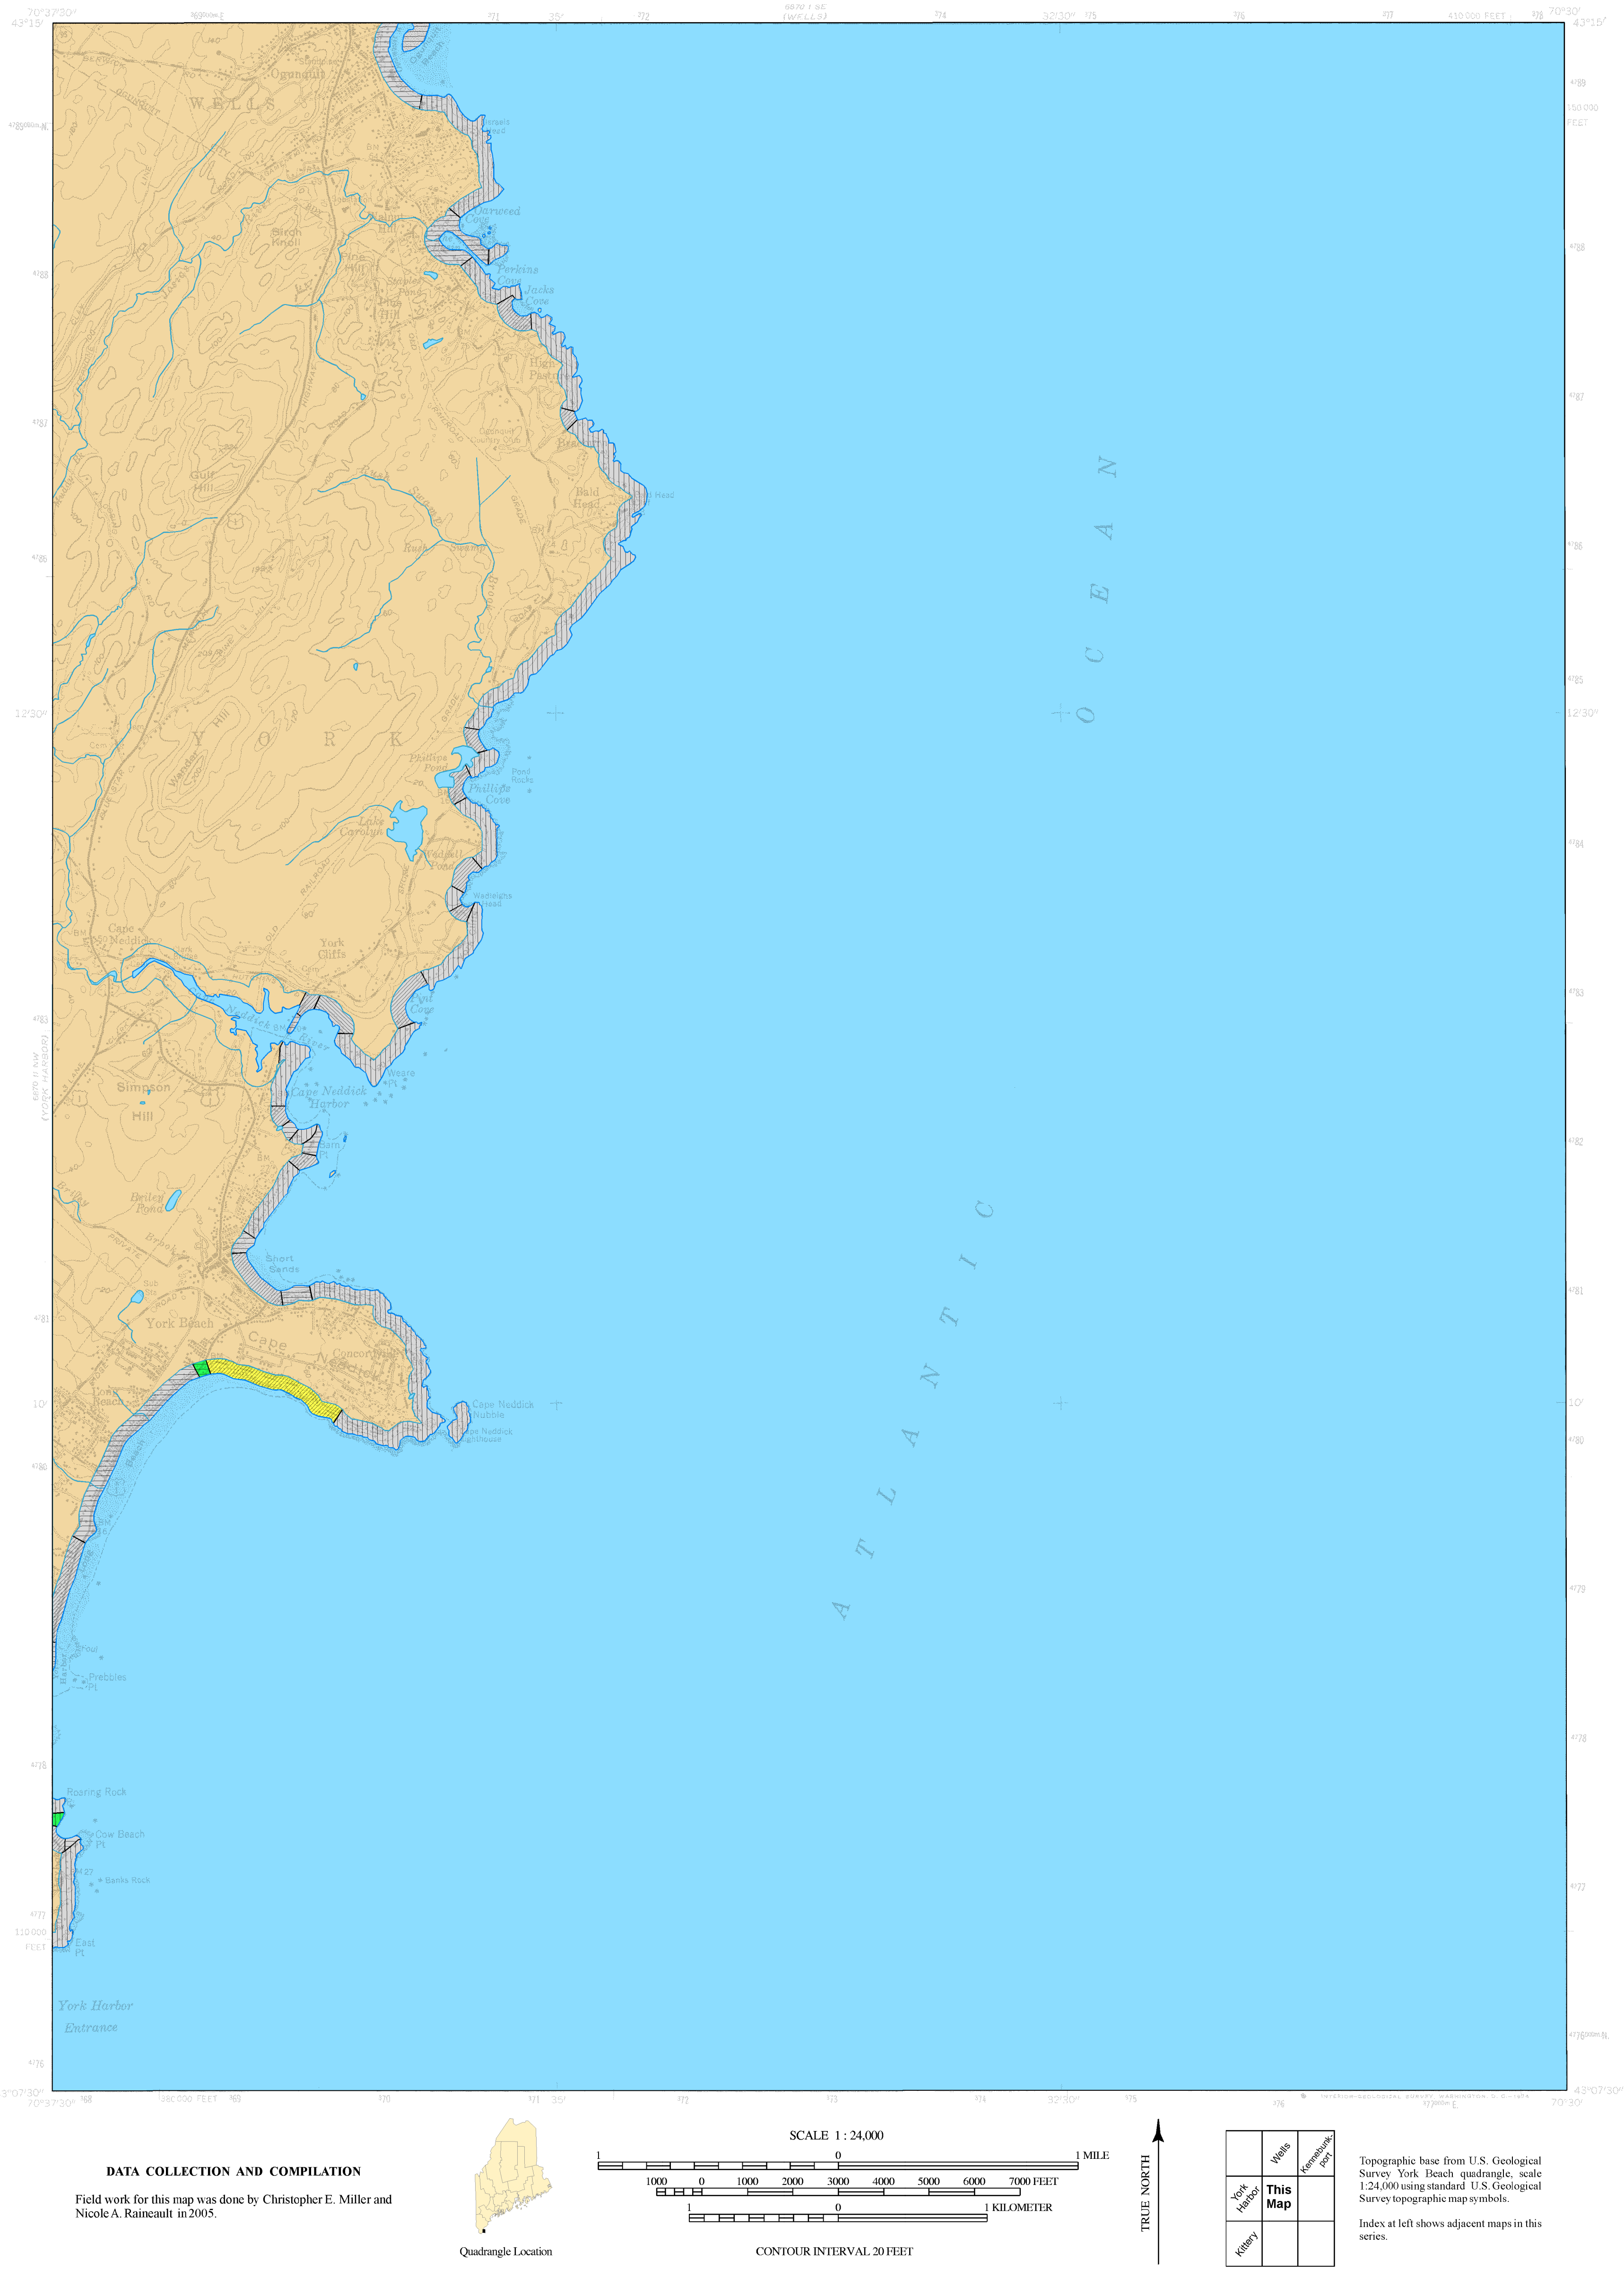
Note: The classification of the bluff is indicated by a colored, patterned band extending landward from the shoreline (dark blue line). The width of the band is NOT related to the width of the bluff. Stability rank refers to RECENT bluff face activity.

This map can help identify shorelines with increased risk of coastal erosion. Review the legend below in order to understand what the map shows and does not show. The colored categories correspond to field conditions when the map was made. Conditions may have changed in the last few years. Comparison of the information on this map with current conditions may indicate that a stability category is different now. Since bluff erosion may be cyclical, the change may only be temporary. If coastal development is nearby bluff we recommend a professional evaluation be made to determine the risk to structures.

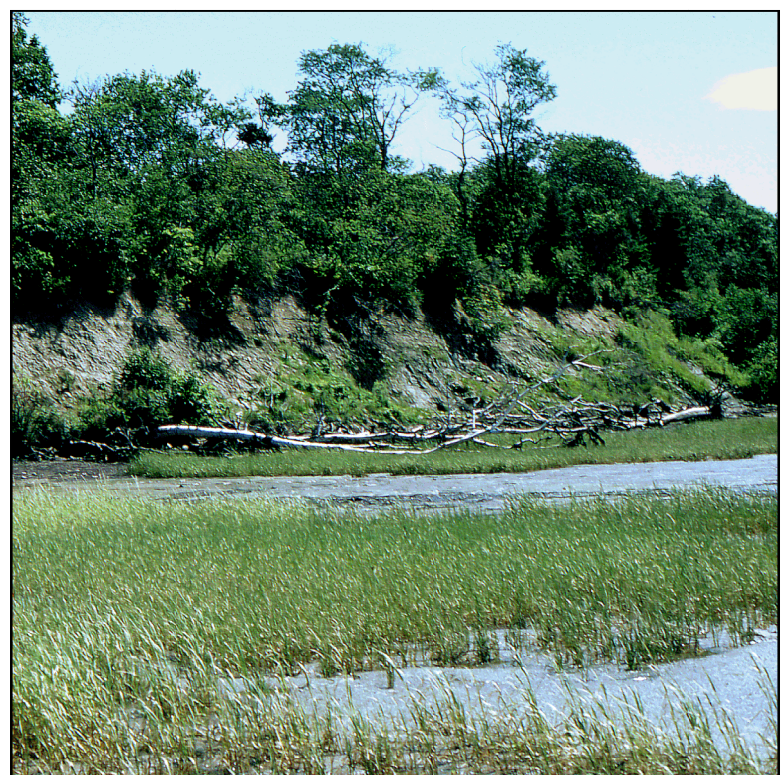
Highly unstable bluff with an unvegetated bluff face and a salt marsh shoreline. Sediments on the bluff face are exposed and fallen tree trunks lie at the base of the bluff. A salt marsh has recently formed on the tidal flat, partly on the top of an old landslide deposit.

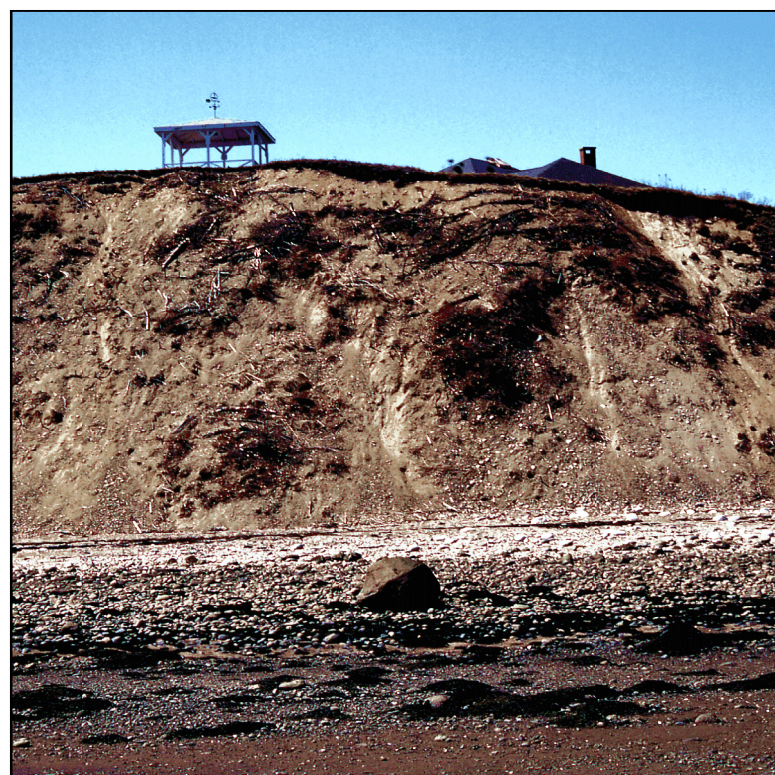
Highly unstable bluff with an unvegetated bluff face and a beach/gravel flat shoreline. The bluff face is too unstable to support vegetation. This bluff, a glacial esker, is eroded by waves to create a mixed sand and gravel beach in front of the bluff.

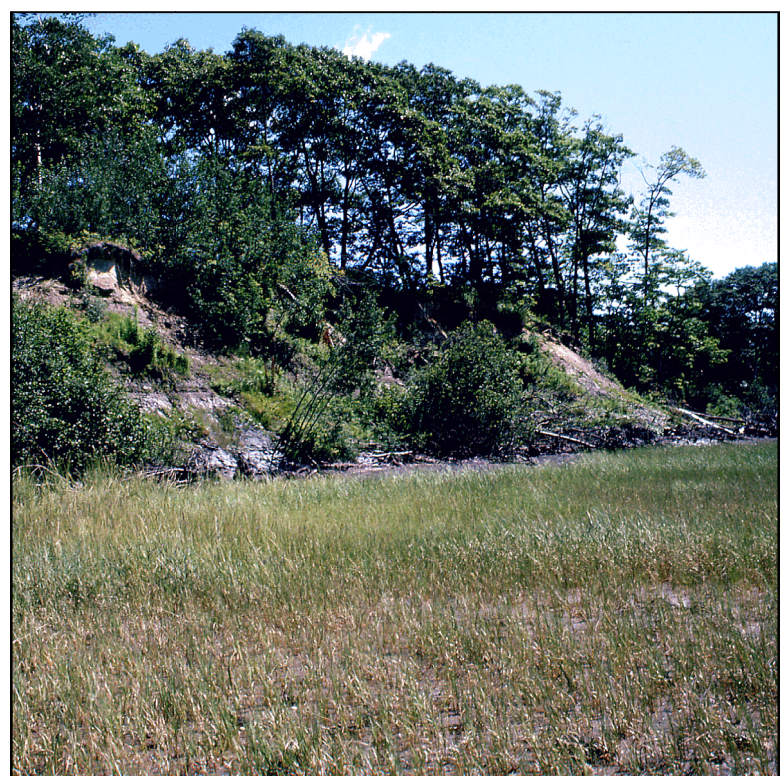
Unstable bluff with a partially vegetated bluff face and a salt marsh shoreline. This bluff, protected by a salt marsh, remains unstable. There are small bushes on the bluff as well as small non-vegetated areas that indicate continuing bluff retreat.

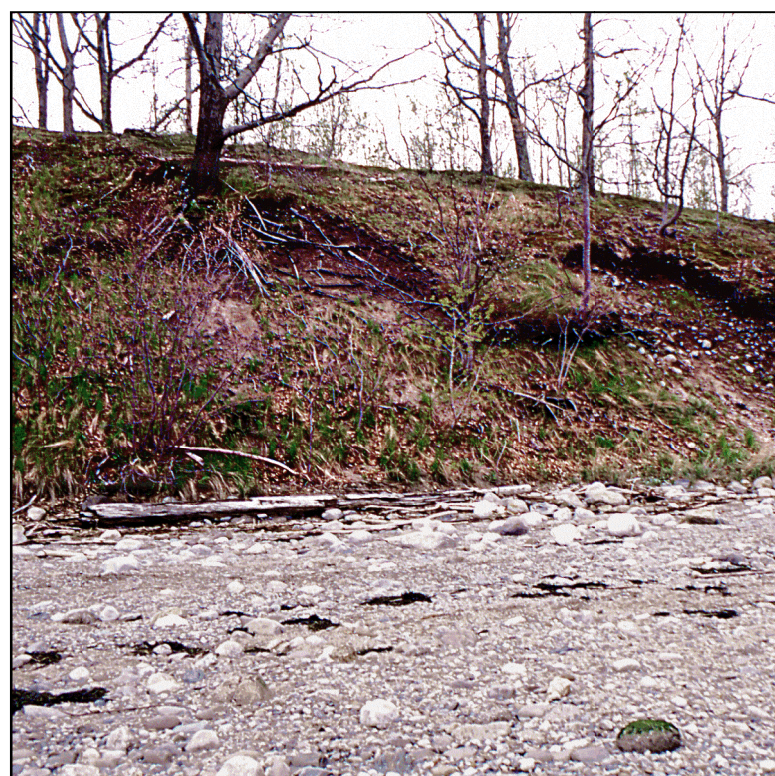
Unstable bluff with a partially vegetated bluff face and a beach/gravel flat shoreline. Slump scars on the bluff face expose sand, gravel, and roots. Fine sediments are removed by waves and currents, leaving gravel to form a beach at the base of the bluff.

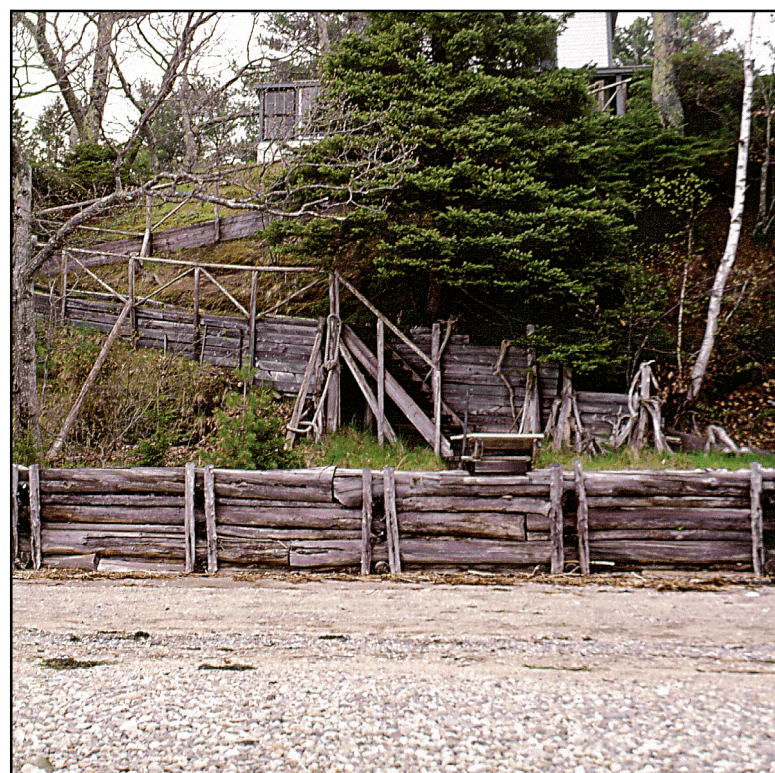
Stable bluff with a vegetated bluff face and an armored shoreline. The bluff face is fully vegetated and supports a mature stand of trees with vertical trunks. The presence of a wooden bulkhead suggests that erosion has occurred in the past.

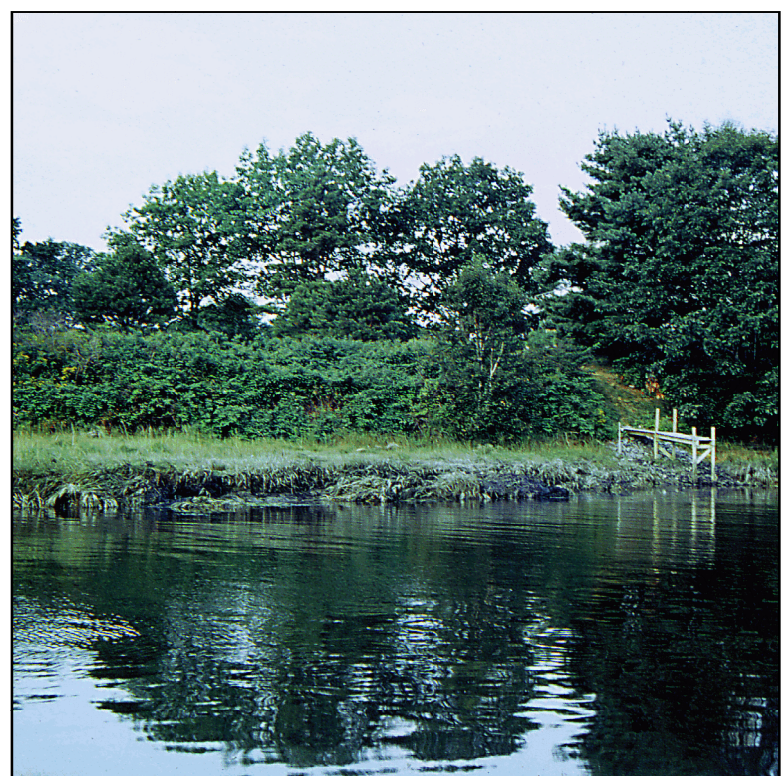
Stable bluff with a vegetated bluff face and a salt marsh shoreline. A low bluff face is covered by shrubs landward of a salt marsh terrace. In this location the mature marsh protects the base of the bluff from rapid erosion and slows bluff recession or retreat.

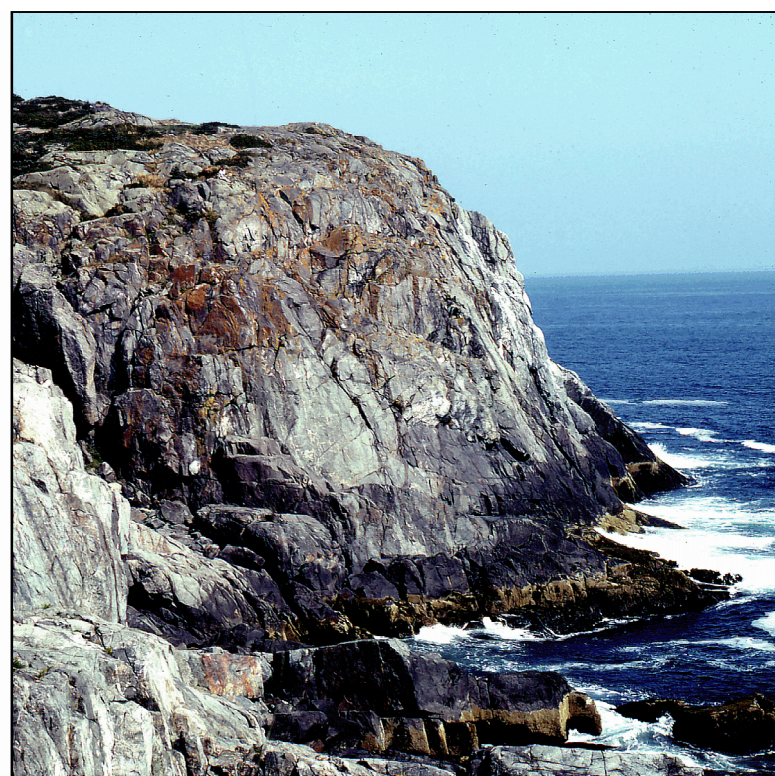
No bluff with a ledge shoreline. A steep slope on the bedrock surface is not a bluff. On this map, bluffs must be made of sedimentary material, generally with 3 feet or more relief. This shoreline type is very slow to change.

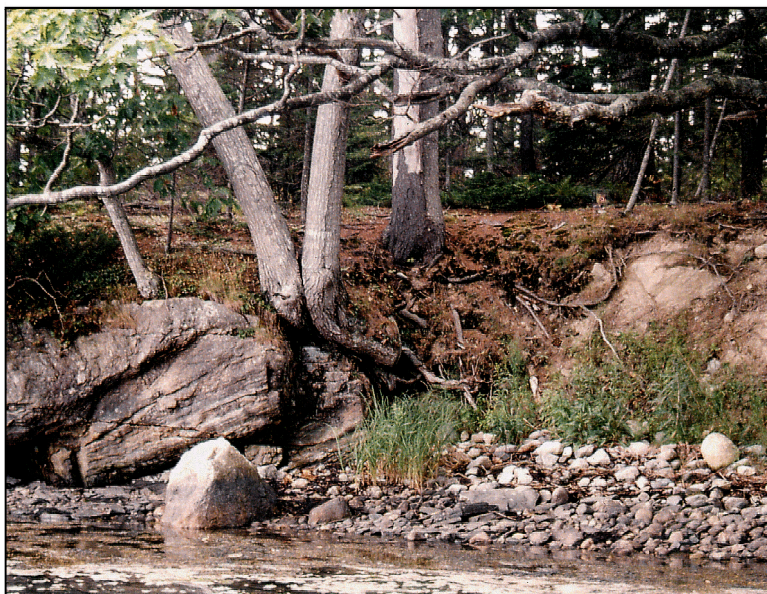
A 1996 landslide in Rockland Harbor (photo below) occurred in an area where the bluff face is classified as unstable. In addition, the bluff had all the characteristics (a-d) listed above. This fact emphasizes that the map above does not indicate sites with a potential for catastrophic landslides.
