**Snowplowable Pavement Market Test Deck Installation :
Scarborough Connector, Northbound, September 29, 2004**

Scarborough Connector, northbound

September 29, 2004, 8:30 – 11:30 AM
Overcast, temperature: 52-56°F, breezy

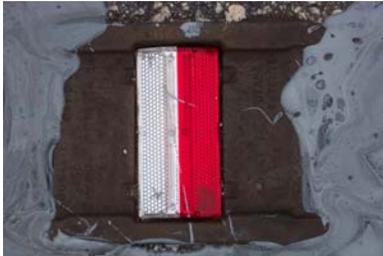
Clear/Red Reflector in housing

All reflectors were clear/red except for Avery Dennison's which were one-way clear due to their clear/reds not arriving on time. Avery has requested replacing with clear/red and has been granted permission providing the work is done in a timely manner so that all units may weather alike. This work is planned within the next two weeks.

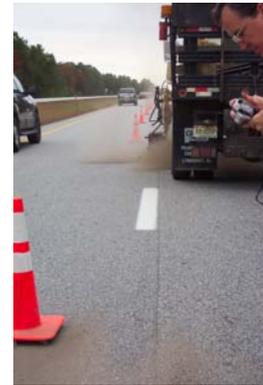
*G
Grinding Operation*

MaineDOT personnel began setting up the lane closure at 8:30 AM. As soon as the closure was in place, grinding operations began. Thirty locations were ground adjacent to the center line joint in preparation for the markers. Locations were evenly spaced on center line between "skips", which placed them 40' apart. Truck-mounted grinder unit proceeded in direction of traffic grinding on average 2 locations per minute.

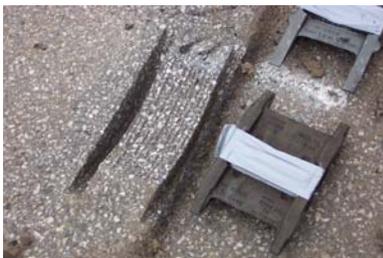
Location ready for installation

After grinding, marker housings were "dry-fit" to ensure proper depth for placement of snowplowable markers. Upon completion of grinding operations and inspection, locations were then blown out with compressed air by MaineDOT personnel. Crew members used a moving truck-mounted compressor and wand for this procedure.

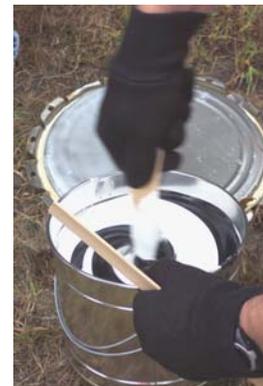
Mixing epoxy

Thermoset EP-87 epoxy, a two part adhesive was used for anchoring the units in the road. Dark colored resin was first poured into steel paint pots followed by an equal amount of the white colored hardener. The epoxy was then mixed thoroughly by hand until blended into a grayish color indicating a thorough mix.

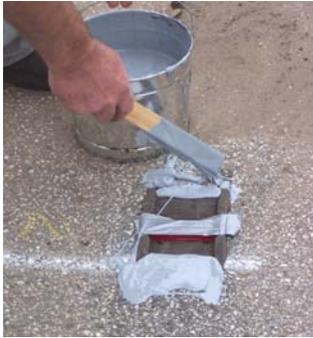
Cementing marker in roadway

Material was then immediately placed into ground-out areas of the pavement. Typically, epoxy is blended on the truck and then injected into the cut-outs on large installation projects. But, in this particular installation with only a relatively few markers installed, everything was done by hand. I am told that with the injected method there is minimal epoxy on the road surface after placement of the marker. Note the duct tape over the reflector during the cementing process to avoid smudging the reflector. The duct tape is removed after cementing and prior to final "set-up" of adhesive.

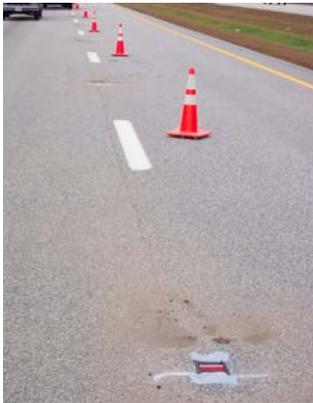
Ready for traffic

Work proceeded in this manner for all 30 units. The epoxy was stiff enough (although still slightly tacky) to allow traffic at about 11:15. The lane closure was taken down and installation was complete at about 11:30.

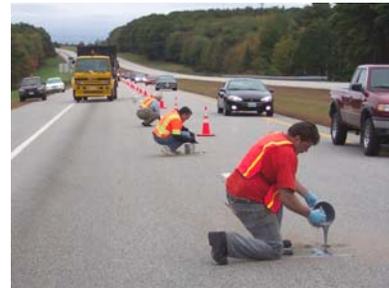
Tag team marker installation
