Coastal Landslide Hazards

Old Orchard Beach Quadrangle, Maine

Coastal landslide hazard mapping by
Stephen M. Dickinson

Open-File No. 01-528
2001

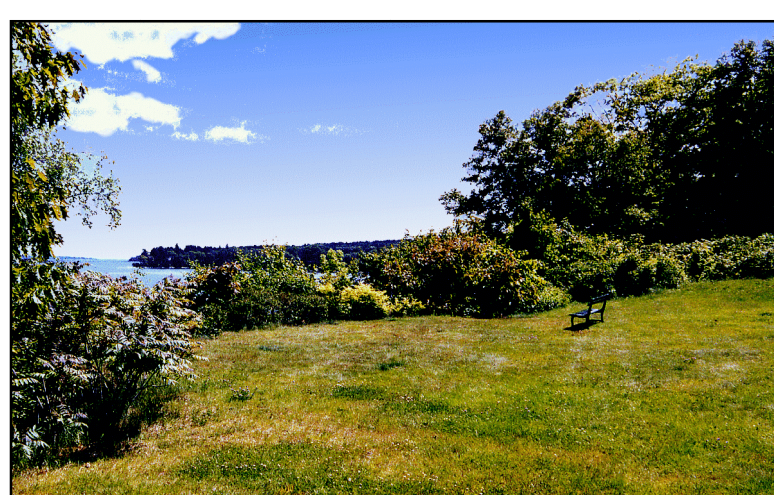
Figure 3. The shape of the top edge of a bluff can be an indicator of landslide risk. Clay bluffs often fail at points of weakness. Such a "slump" can expand into a larger landslide that cuts into the bluff and forms a curve around the original point of failure. Multiple slides and slumps will form an irregular or arcuate top edge to the bluff as shown in the photo above. Bluffs made of coarse materials or sand have a more even upper edge caused by a more constant rate of erosion along the bluff face.

Careful observation of the land surface, vegetation, and shape of a coastal bluff reveals evidence of instability. Starting at the top of a bluff, an irregular or arcuate edge can indicate past landslides or areas of increased coastal erosion (Figure 3). When a weak point on a bluff fails, the slide moves inward into the slope face forming a curve around the original point of failure. Tension cracks may form near a weak zone where the soil surface is moving downslope (Figure 4). These cracks appear as splits in the ground where the soil and vegetation have moved apart. Cracks may be visible along the top edge of the bluff or the bluff face itself. On the slope of a bluff, a hummocky land surface or terraces indicate past slumping or landslides (Figure 5). Unvegetated slump scars or slopes are obvious evidence of rapid soil movement. A bowl-shaped slope often shows the location of a former landslide, with the center of the bowl as the area of greatest failure. Distorted vegetation provides evidence of soil creep or former landslides. Tree trunks curved near their base are evidence of downslope movement (Figure 6). Trees tilted at different angles are evidence of former slides or undercutting by erosion. At the base of a bluff, toppled trees and bare roots are evidence of erosion that steepens the bluff (Figure 7). Undercutting and steepening of the bluff may destabilize the slope and lead to increased erosion and possibly a landslide. Lobes or terraces of sediment in the intertidal zone are often remnants of old landslides. Although the evidence of earth movement listed above cannot predict a landslide, it is used to recognize unstable shorelines. This landform evidence is related to factors listed below that influence landslide risk.

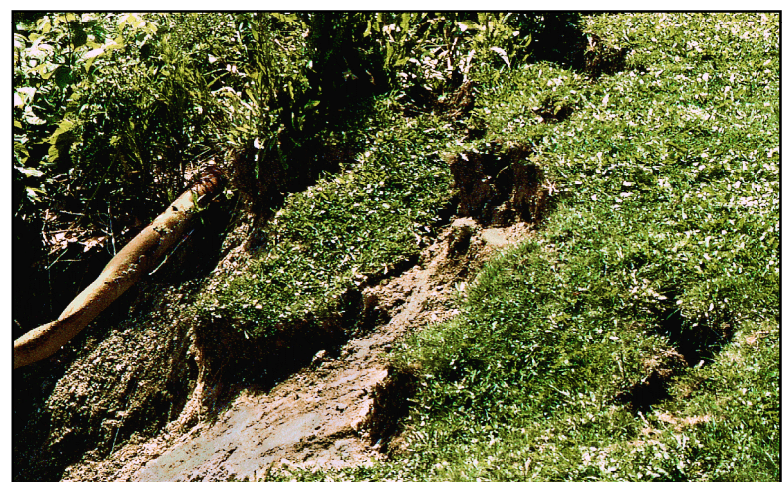
Figure 4. Downslope forces within a bluff cause surface layers to stretch. When the tension becomes great enough, a crack forms and the pressure is released. These "tension cracks" may form on the top edge of the bluff or on the bluff slope itself. They indicate instability and motion within the bluff. Some cracks are deep and extend below the soil layer.

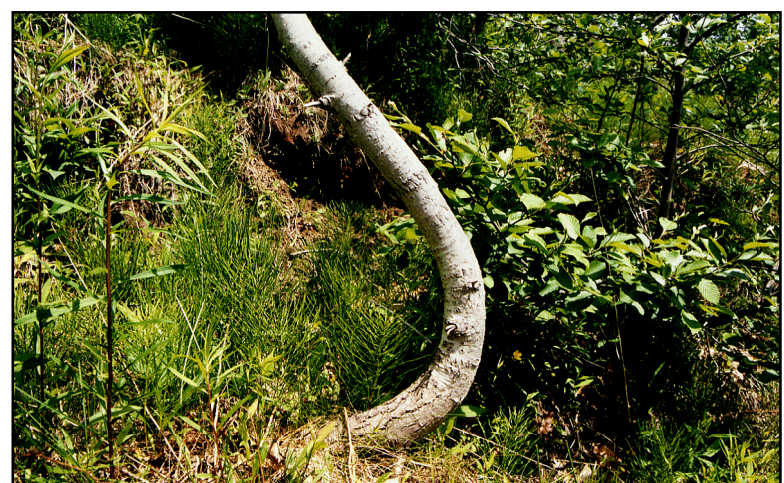
Figure 5. Soil "creep," or downslope movement of soil on a slope, will cause tree trunks to tilt toward the base of the slope. As a moving tree continues to grow, the trunk will curve as the tree tries to right itself toward the sun. Landslides will also cause tree trunks to become curved.

Vegetation. Types, shapes, and distribution of vegetation above and on a bluff face can be used as an indication of site stability. In areas where the soil has shifted, either due to previous landslides, or to gradual surface creep, many tree trunks can become tilted or twisted in the same direction. Curved tree trunks near the roots often indicate land movement down the face of a bluff. Large trees on the bluff face may be moved by wind and resulting root motion may loosen bluff sediment. Natural vegetation that consists only of small shrubs and trees may indicate recent bluff erosion or a landslide.
