Coastal Landslide Hazards

Cape Elizabeth Quadrangle, Maine

Maine Geological Survey

Open-File No. 01-511
2001

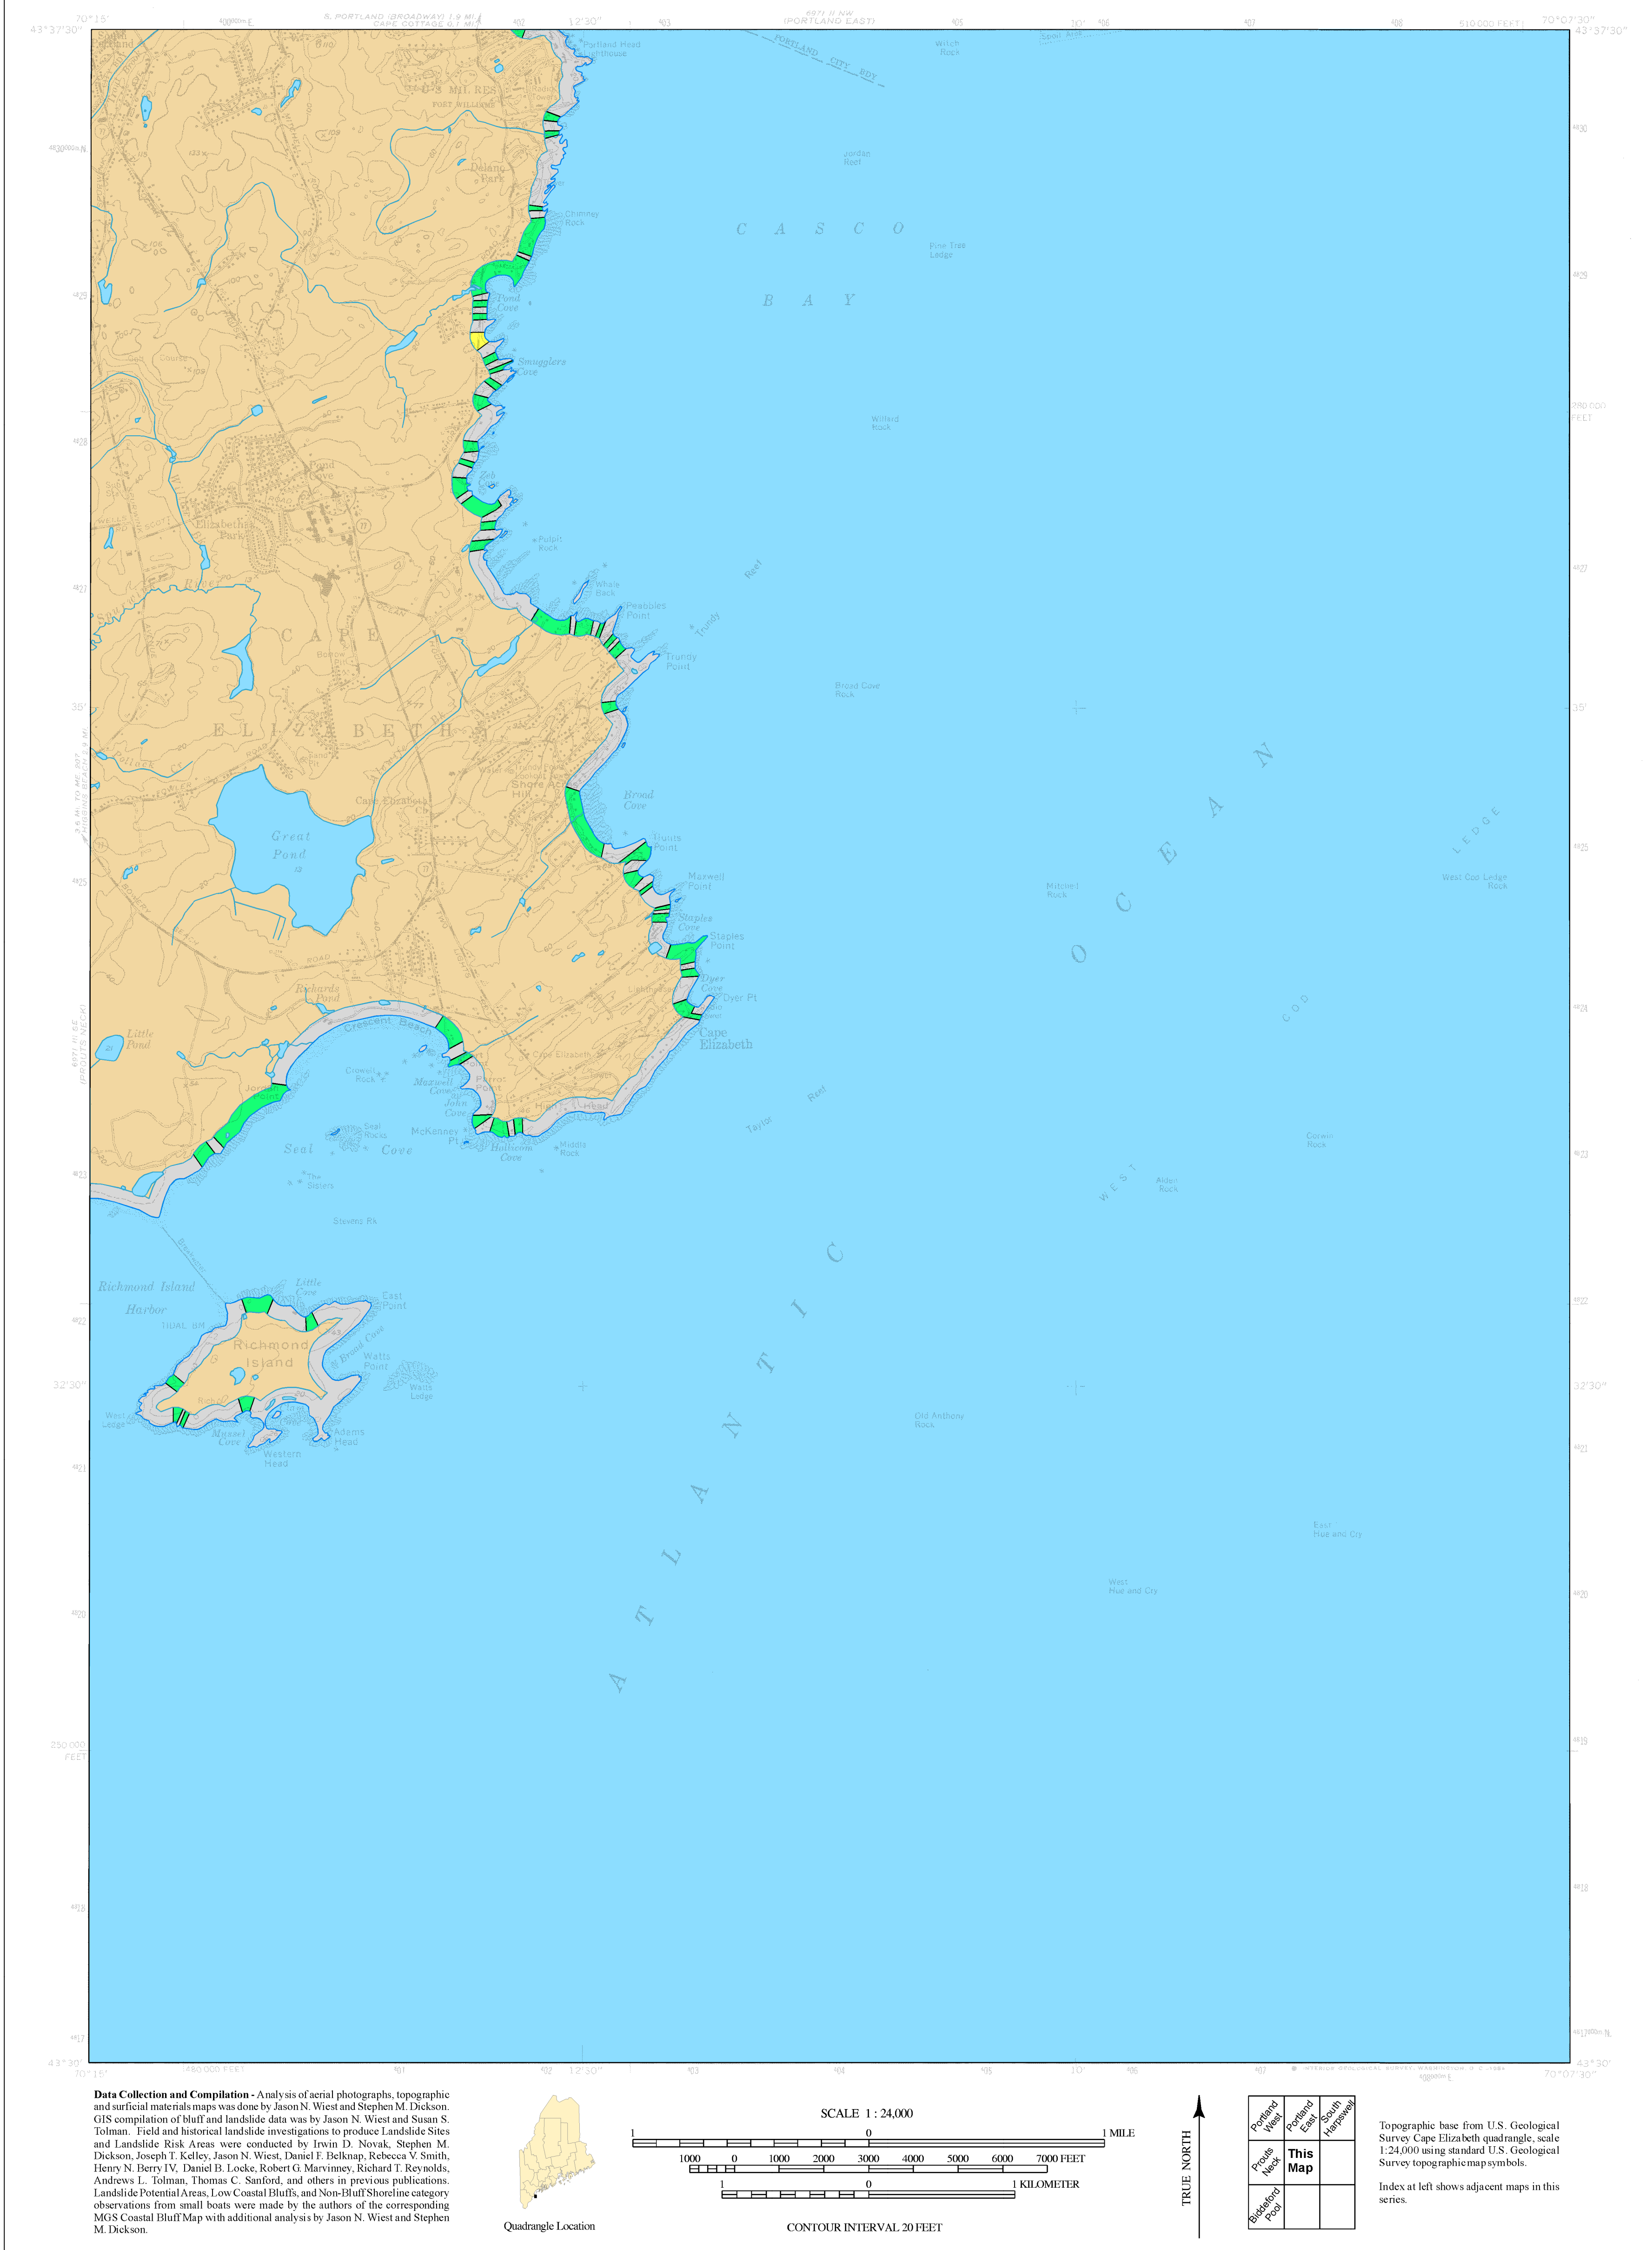
Note: The landslide hazard classification is indicated by a colored, patterned band extending landward from the shoreline (dark blue line). The width of the band does NOT indicate the distance inland that a landslide may occur. This distance is difficult to predict and will vary from site to site. The colored buffer is for illustration purposes only. Due to variations in coastal geology, not all units in the explanation below will appear on this map.

Landslide Site - Location of known or interpreted coastal landslide. Includes historically recorded landslides and slides interpreted from airphotos.

Landslide Risk Area - Earth features indicate conditions that may be suitable for a landslide to occur. Features often include a steep or arcuate scarp, slump blocks, sediment lobes, or uneven land surfaces. Bluff sediments are usually muddy and twenty feet or more in thickness.

Potential Landslide Area - Shoreline with a sedimentary coastal bluff twenty or more feet high. These bluff areas have not had field investigations that are necessary to evaluate the risk of a landslide. However, some similar high coastal bluffs have experienced landslides.

Low Coastal Bluff - Shoreline with a sedimentary coastal bluff that has less than twenty feet of relief immediately adjacent to the shoreline. Some bluffs over twenty feet in height are included in this map unit if the bluff face is not steep. In general, low coastal bluffs are not at risk of failing in the form of a landslide.

Non-Bluff Shoreline - Coastal areas without extensive sedimentary bluffs. Corresponds to the no-bluff unit on MGS Coastal Bluff Maps.

Unmapped Shoreline - These sites generally are in the inland reaches of estuaries or beyond the scope of the field effort in this region.

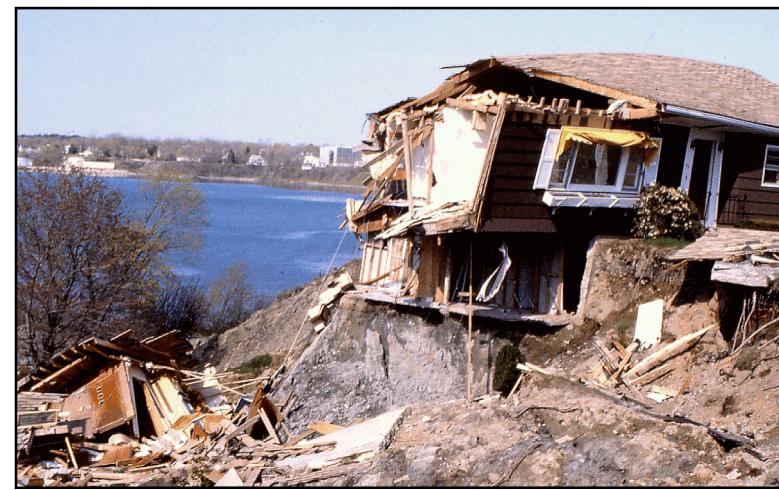
Figure 1. A clay bluff on the north shore of Rockland Harbor failed in 1996. This landslide formed a new scarp about 200 feet landward of the original top of the bluff in just a few hours. Two homes were destroyed as a result of this catastrophic slide (see Berry and others, 1996).

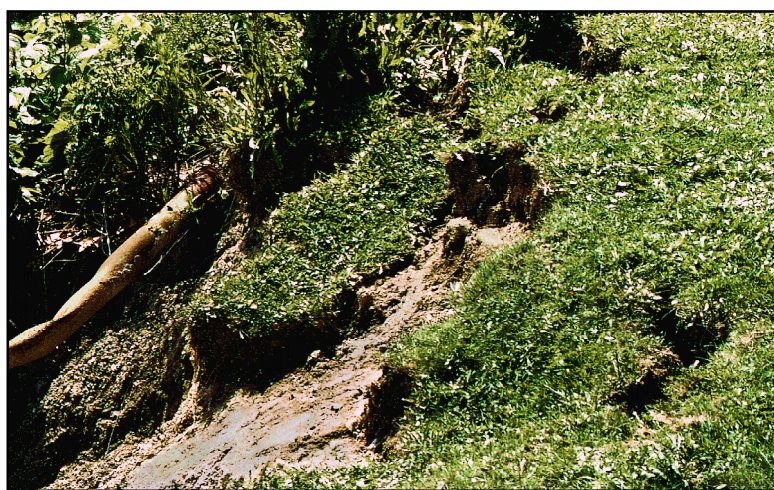
Figure 4. Downslope forces within a bluff cause surface layers to stretch. When the tension becomes great enough, a crack forms and the pressure is released. These "tension cracks" may form on the top edge of the bluff or on the bluff slope itself. They indicate instability and motion within the bluff. Some cracks are deep and extend below the soil layer.

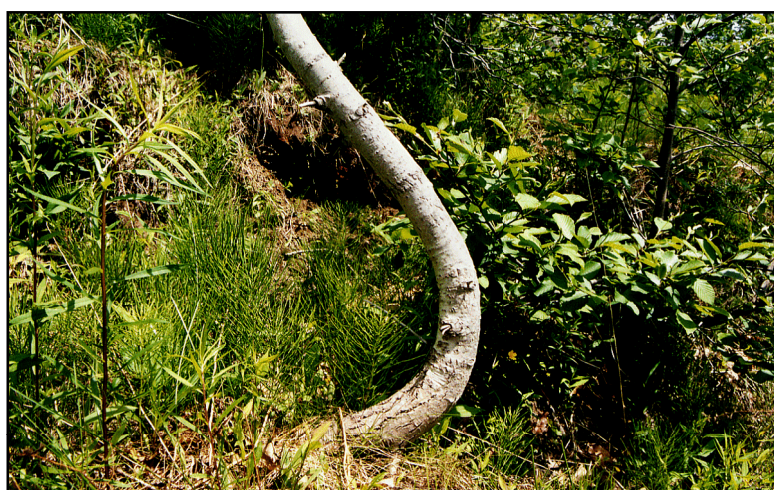
Figure 6. Soil "creep" or downslope movement of soil on a slope, will cause tree trunks to tilt toward the base of the slope. As a moving tree continues to grow, the trunk will curve as the tree tries to right itself and grow toward the sun. Landslides will also cause tree trunks to become curved.

Vegetation. Types, shapes, and distribution of vegetation above and on a bluff face can be used as an indication of site stability. In areas where the soil has shifted, either due to previous landslides or to gradual surface creep, many tree trunks can become tilted or twisted in the same direction. Curved tree trunks near the roots often indicate land movement down the face of a bluff. Large trees on the bluff face may be moved by wind and resulting root motion may loosen bluff sediment. Natural vegetation that consists only of small shrubs and trees may indicate recent bluff erosion or a landslide.

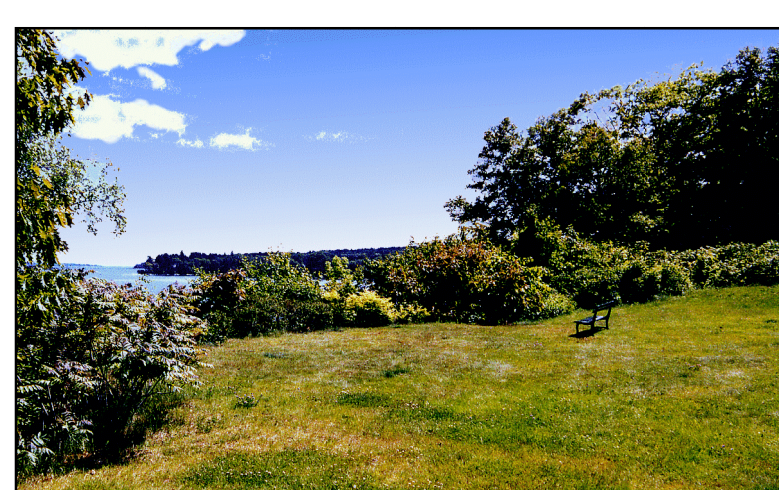
Figure 3. The shape of the top edge of a bluff can be an indicator of landslide risk. Clay bluffs often fail at points of weakness. Such a "slump" can expand into a larger landslide that cuts into the bluff and forms a curve around the original point of failure. Multiple slides and slumps will form an irregular or arcuate top edge to the bluff as shown in the photo above. Bluffs made of coarse materials or sand have a more even upper edge caused by a more constant rate of erosion along the bluff face.

Careful observation of the land surface, vegetation, and shape of a coastal bluff reveals evidence of instability. Starting at the top of a bluff, an irregular or arcuate edge can indicate past landslides or evidence of increased coastal erosion (Figure 3). When a weak point on a bluff fails, the slide moves inward into the slope face forming a curve around the original point of failure. Tension cracks may form near a weak zone where the soil surface is moving downslope (Figure 4). These cracks appear as splits in the ground where the soil and vegetation have moved apart. Cracks may be visible along the top edge of the bluff or on the bluff face itself. On the slope of a bluff, a hummocky land surface or terraces indicate past slumping or landslides (Figure 5). Unvegetated slump scars or slopes are obvious evidence of rapid soil movement. A bowl-shaped slope often shows the location of a former landslide, with the center of the bowl as the area of greatest failure. Distorted vegetation provides evidence of soil creep or former landslides. Tree trunks curved near their base are evidence of downslope movement (Figure 6). Trees tilted at different angles are evidence of former slides or undercutting by erosion. At the base of a bluff, toppled trees and bare roots are evidence of erosion that steepens the bluff (Figure 7). Undercutting and steepening of the bluff may destabilize the slope and lead to increased erosion and possibly a landslide. Lobes or terraces of sediment in the intertidal zone are often remnants of old landslides. Although the evidence of earth movement listed above cannot predict a landslide, it is used to recognize unstable shorelines. This landform evidence is related to factors listed below that influence landslide risk.

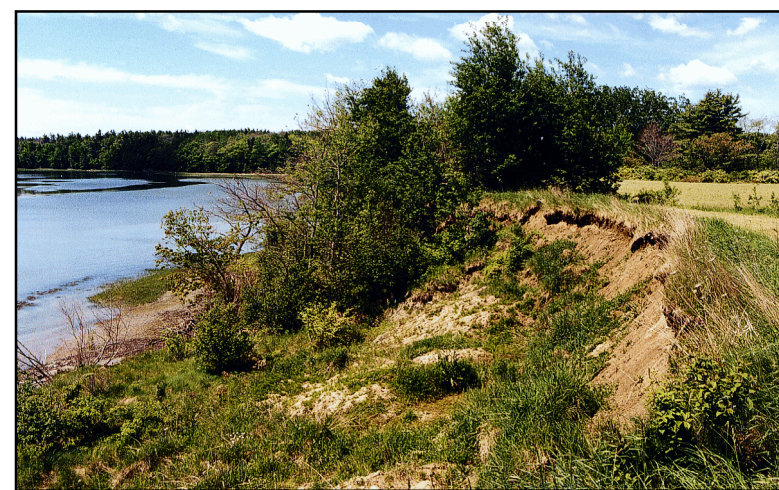
Figure 5. Terraces or a hummocky land surface on the slope of a bluff can indicate a former landslide. Terraces can be the surface of downslope blocks that moved during a slide. Vegetation on the surface of these blocks may be tilted in various directions. The irregular land surface may also occur in a bowl-shaped depression below an arcuate top edge of the bluff, additional evidence of a former landslide.

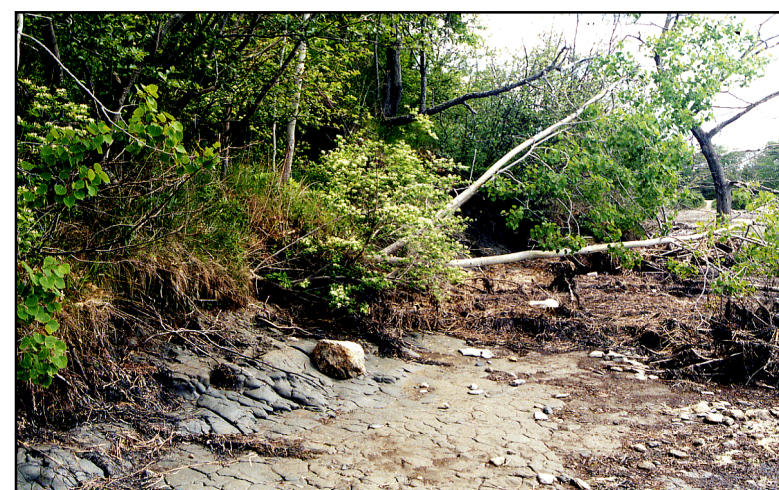
Figure 7. Wave erosion at the base of a bluff removes slope sediment and steepens the bluff. Erosion has undercut the trees in the photo above and caused them to tilt toward the ocean. This steepening reduces the stability of the bluff, and a landslide may result. Ongoing sea-level rise along the Maine coast will cause wave erosion at the base of coastal bluffs and continue to make some coastal bluffs at risk of experiencing a landslide.
