Coastal Landslide Hazards

Maine Geological Survey

Portland West Quadrangle, Maine

Open-File No. 01-535
2001

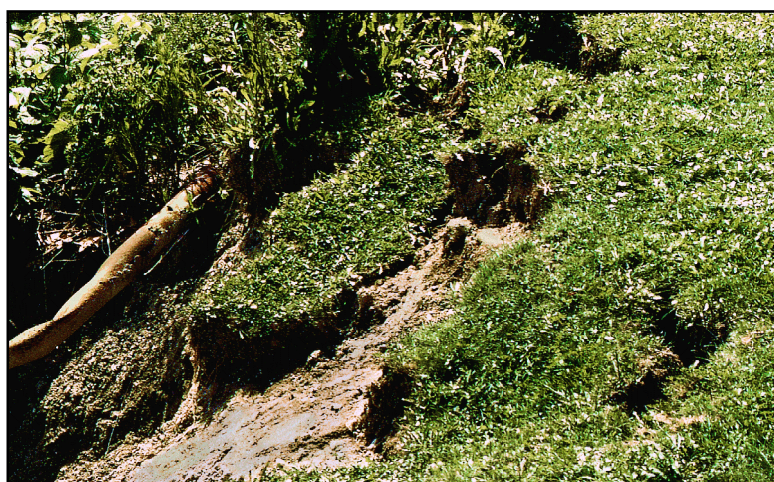
Figure 4. Downslope forces within a bluff cause surface layers to stretch. When the tension becomes great enough, a crack forms and the pressure is released. These "tension cracks" may form on the top edge of the bluff or on the bluff slope itself. They indicate instability and motion within the bluff. Some cracks are deep and extend below the soil layer.
