Coastal Bluffs

Classification and Mapping of Maine's Coastal Bluffs

Ellsworth Quadrangle, Maine

Open-File No. 02-187
2002

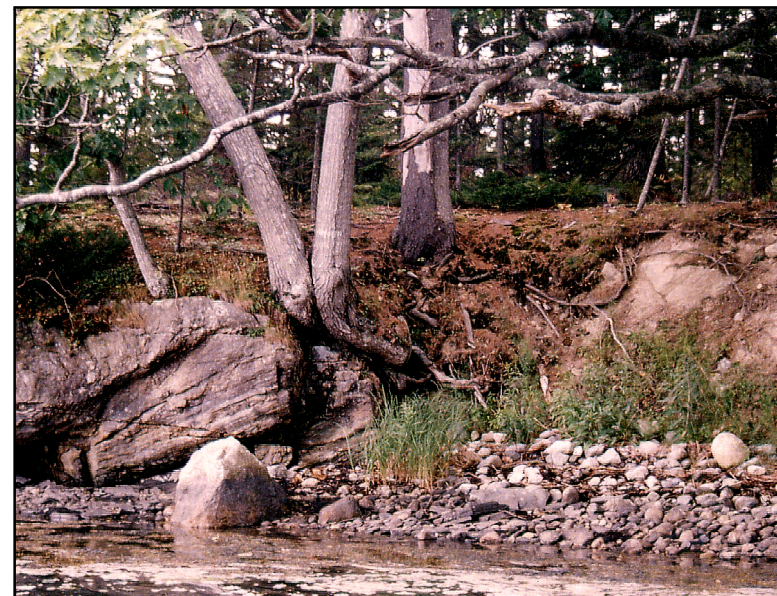
Since these are regional maps, some shores mapped as stable may contain small areas that are unstable. A bluff, too small to appear on the map, is shown in the photo. This bluff exhibits the characteristics of an unstable bluff: curved tree trunks, exposed roots, and bare ground on a steep slope. It is an area to be concerned about on a local scale. However, this degree of detail is not shown on the map above.

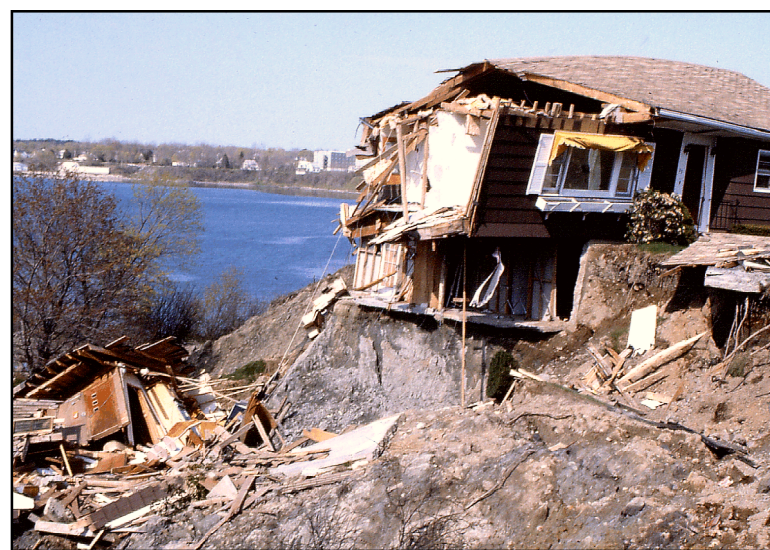
A 1996 landslide in Rockland Harbor (photo below) occurred in an area where the bluff face is classified as unstable. In addition, the bluff had all the characteristics (a-d) listed above. This fact is emphasized by the map above does not indicate sites with a potential for catastrophic landslides. Additional factors need to be considered beyond the appearance of the bluff face and type of shoreline below the bluff. Maps of topography, surficial sediments, and Coastal Landslide Hazards are available from the Maine Geological Survey to help assess the landslide potential in an area.

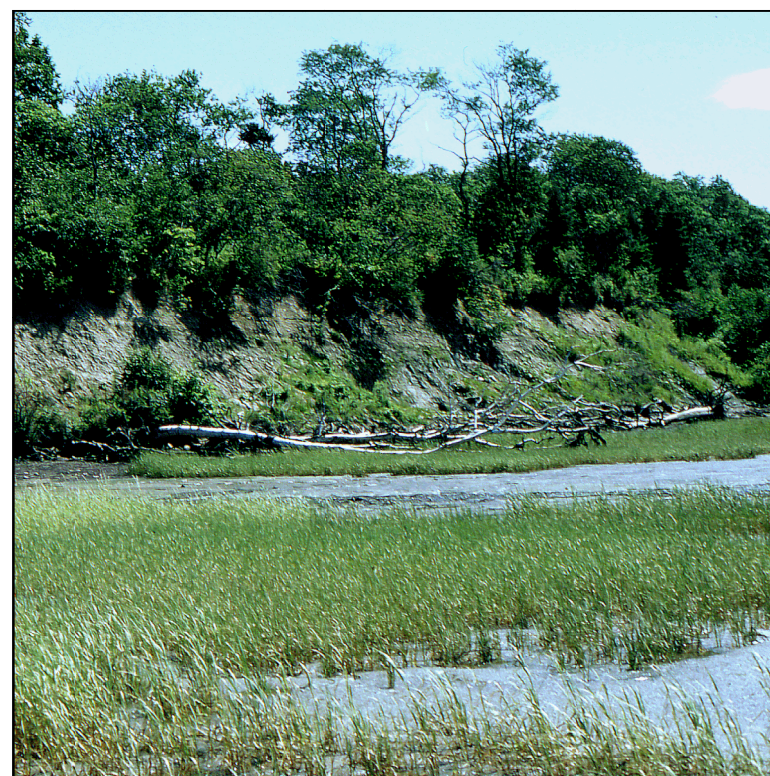
Highly unstable bluff with an unvegetated bluff face and a salt marsh shoreline. Sediments on the bluff face are exposed and fallen tree trunks lie at the base of the bluff. A salt marsh has recently formed on the tidal flat, partly on the top of an old landslide deposit.

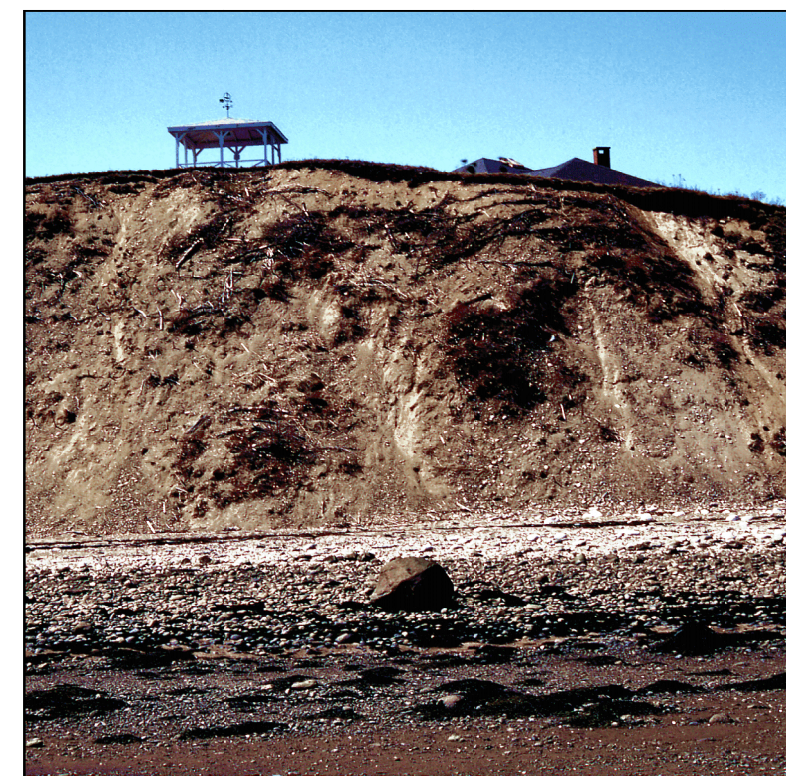
Highly unstable bluff with an unvegetated bluff face and a beach/gravel flat shoreline. The bluff face is too unstable to support vegetation. This bluff, a glacial esker, is eroded by waves to create a mixed sand and gravel beach in front of the bluff.

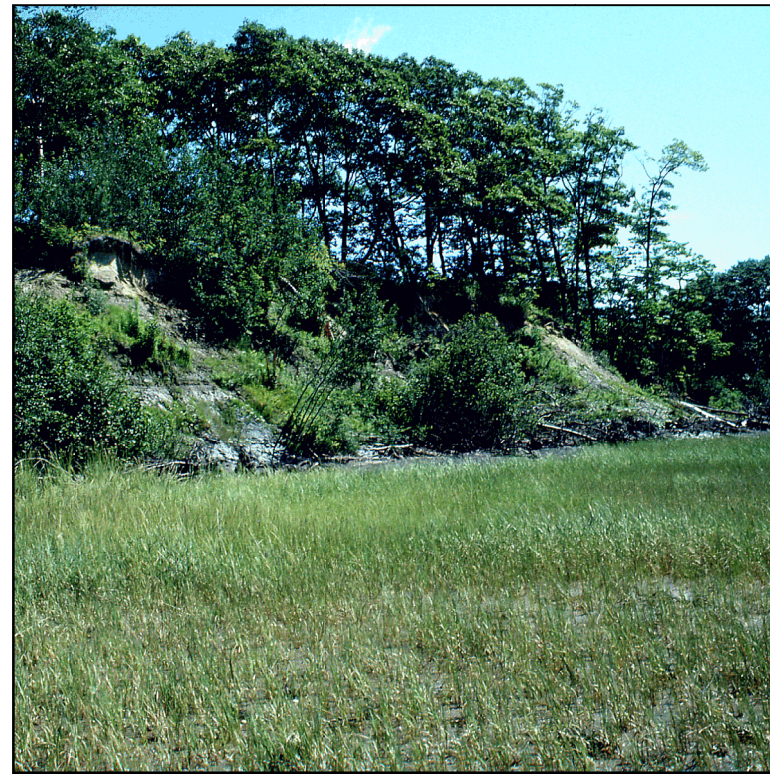
Unstable bluff with a partially vegetated bluff face and a beach/gravel flat shoreline. This bluff, protected by a salt marsh, remains unstable. There are small bushes on the bluff as well as small non-vegetated areas that indicate continuing bluff retreat.

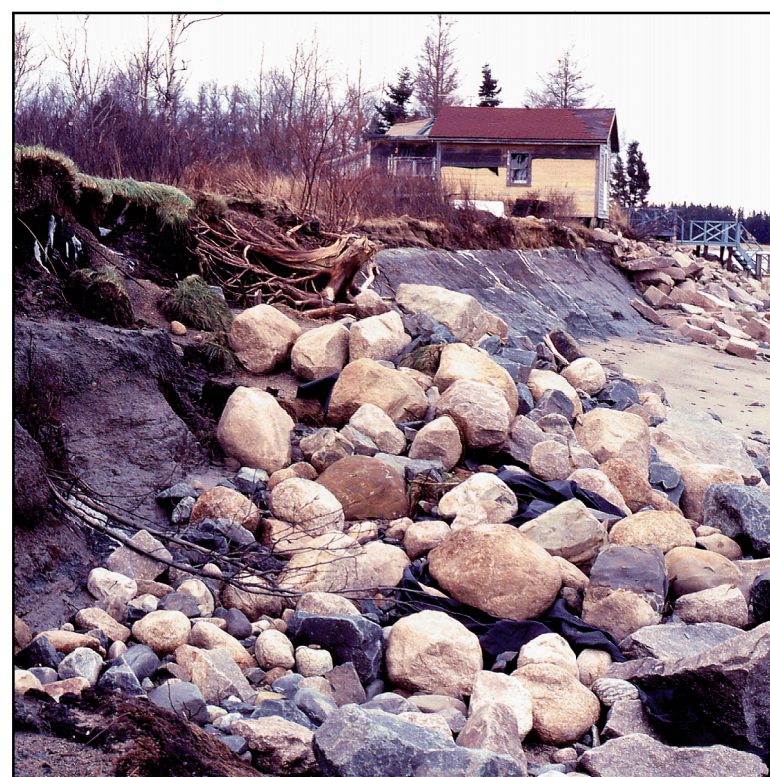
Highly unstable bluff with an unvegetated bluff face and an armored shoreline. This armored bluff is eroding despite an effort to shore it up with riprap, or loosely piled stone blocks. Maintenance at this site could improve bluff stability.

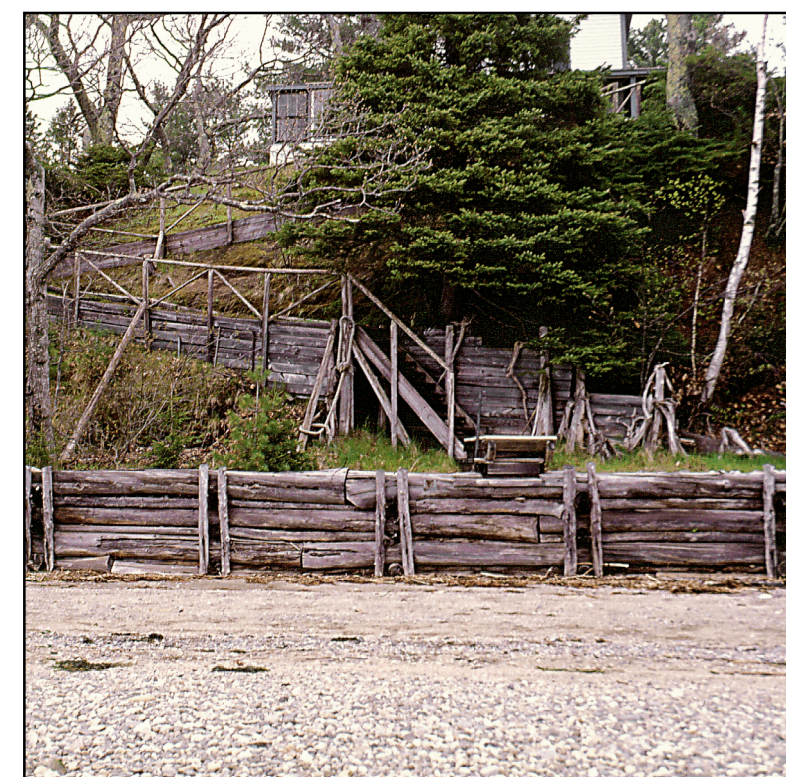
Stable bluff with a vegetated bluff face and an armored shoreline. The bluff face is fully vegetated and supports a mature stand of trees with vertical trunks. The presence of a wooden bulkhead suggests that erosion has occurred in the past.

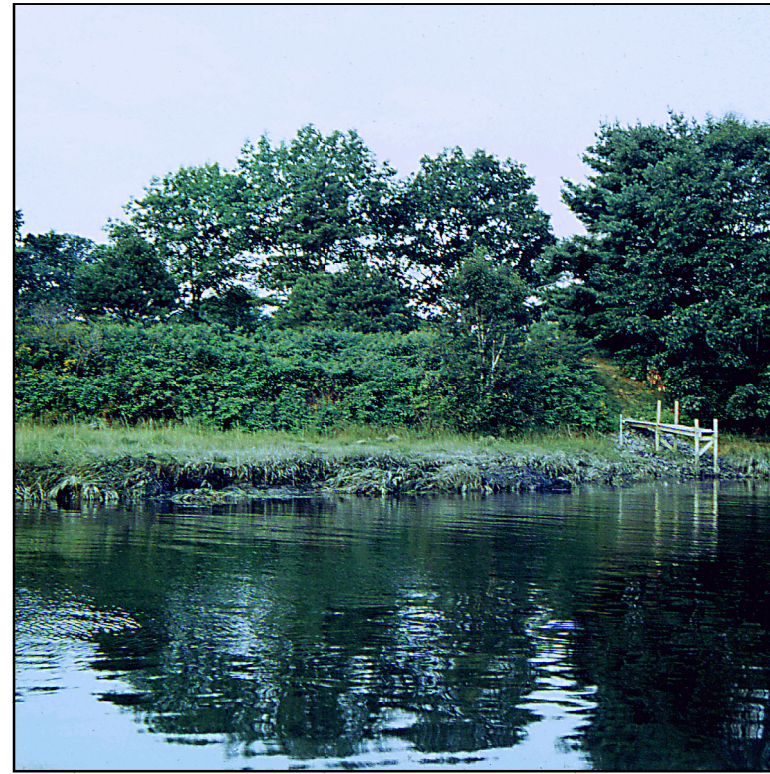
Stable bluff with a vegetated bluff face and a salt marsh shoreline. A low bluff face is covered by shrubs landward of a salt marsh terrace. In this location the mature marsh protects the base of the bluff from rapid erosion and slows bluff recession or retreat.

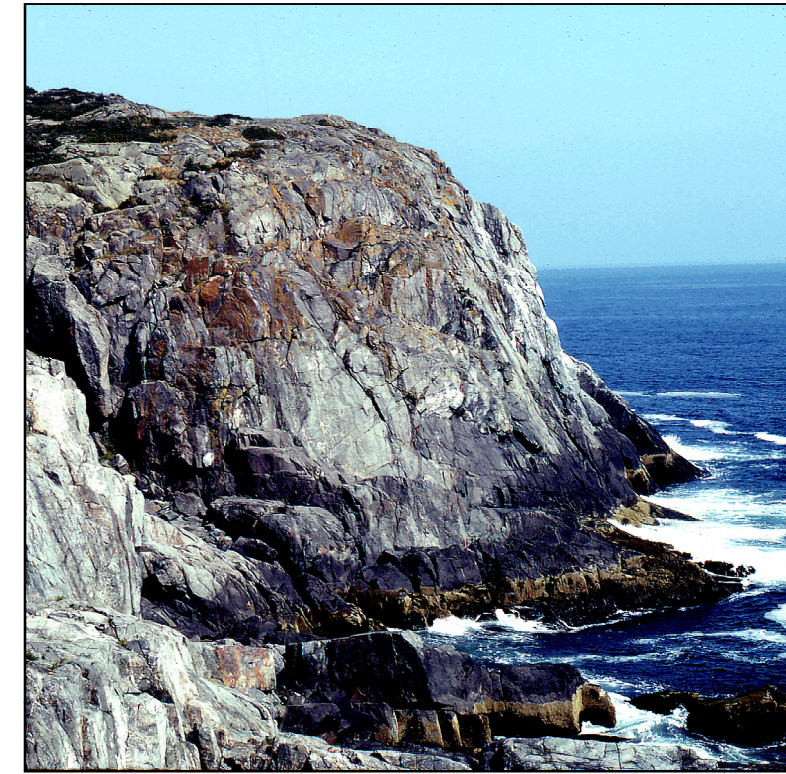
No bluff with a ledge shoreline. A steep slope on the bedrock surface is not a bluff. On this map, bluffs must be made of sedimentary material, generally with 3 feet or more of relief. This shoreline type is very slow to change.
