Coastal Bluffs

Friendship Quadrangle, Maine

Open-File No. 02-189
2002

Types of Bluffs Along Maine's Coast

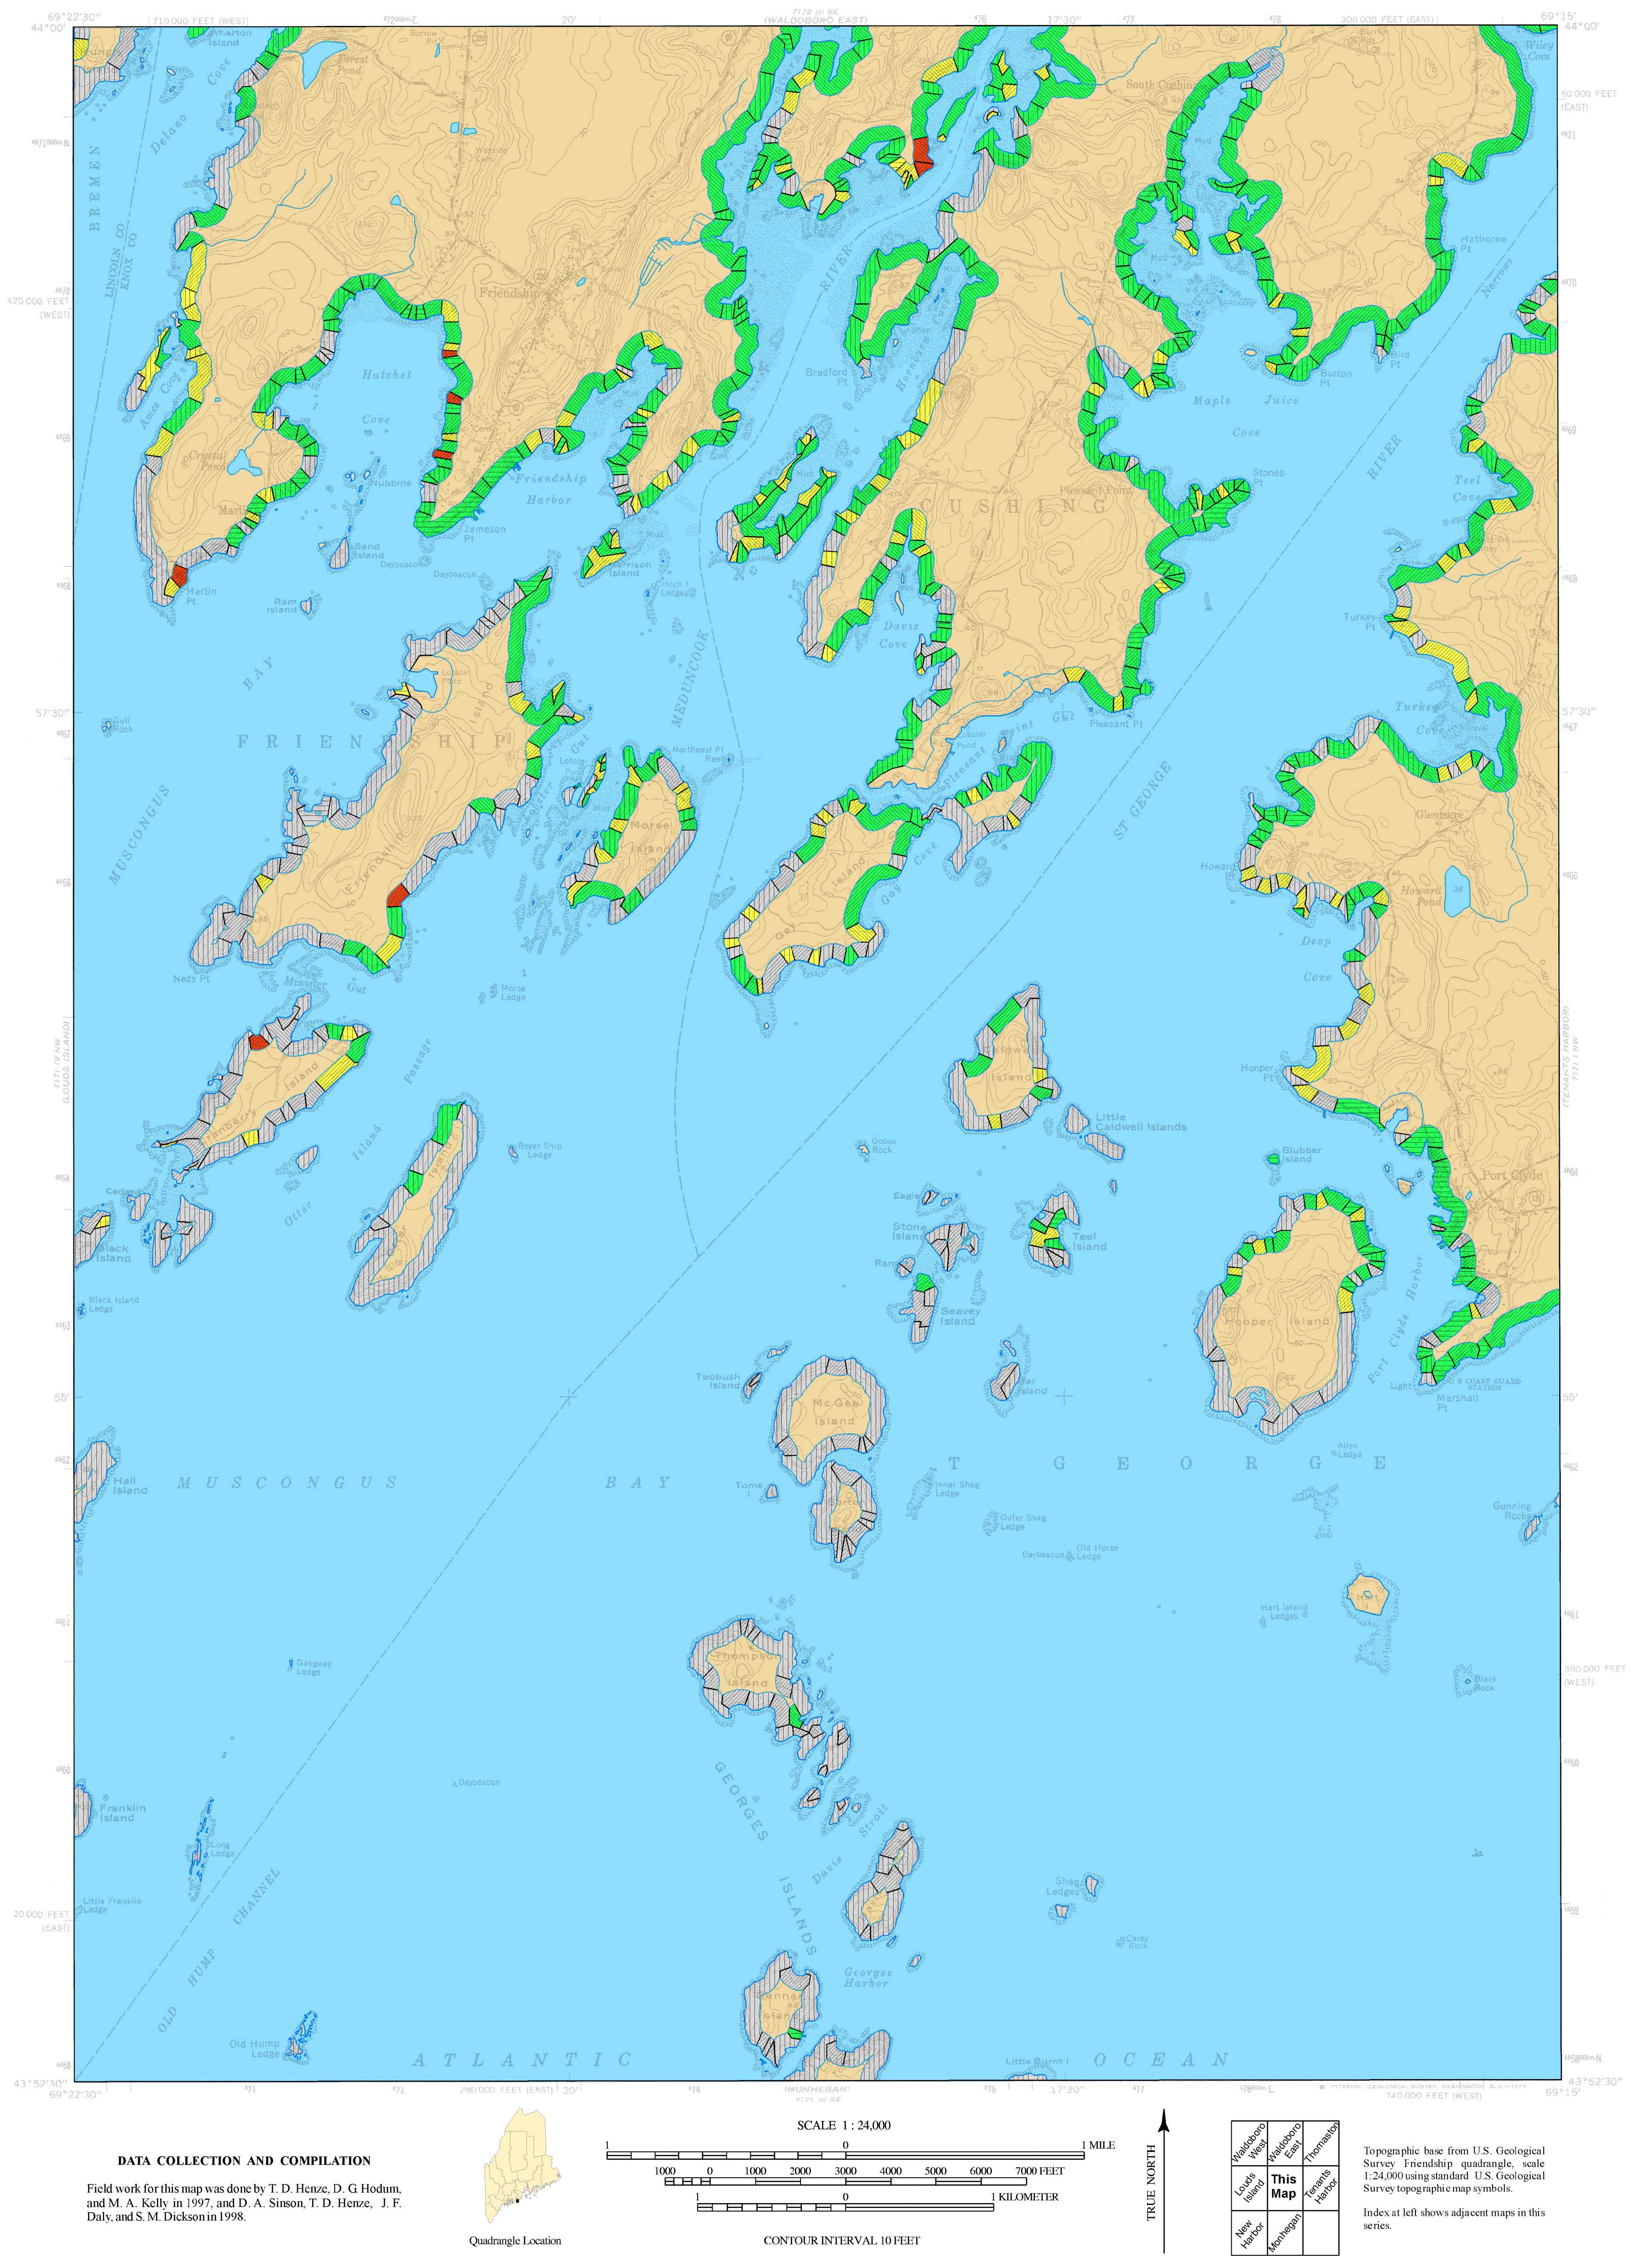
This map shows the shoreline type and relative stability of bluffs along a section of the Maine coast. The slope, shape, and amount of vegetation covering a coastal bluff and the adjacent shoreline are directly related to the susceptibility of the bluff face to ongoing erosion. As might be expected, less vegetated bluffs are more likely to be eroding than completely vegetated bluffs. Another important factor related to bluff stability is the material which makes up the bluff. Materials such as clay, gravel, and sand react differently to erosion and, when combined with variations in vegetation and slope, affect the rate of erosion for an individual bluff. When planning to reduce the risks of coastal erosion, it is important to take vegetation, slope, erosion rate, and sediment types into consideration.

This map can help identify shorelines with increased risk of coastal erosion. Review the legend below in order to understand what the map shows and does not show. The colored categories correspond to field conditions when the map was made. Conditions may have changed in the last few years. Comparison of the information on this map with current conditions may indicate that a stability category is different now. Since bluff erosion may be cyclical, the category may only be temporary. If coastal development is nearby bluff we recommend a professional evaluation be made to determine the risk to structures.

Geologists classified the coastal bluffs on this quadrangle map by observing the shoreline from small boats. They assigned one of the following categories to the type of shoreline seen below the high tide line: (1) ledge (exposed bedrock outcrops); (2) armored (seawall, riprap, gabion, bulkhead, etc.); (3) salt marsh; or (4) beach, mud flat, or other loose sediment. Ruled patterns on the map indicate the shoreline type. Gray areas on the map indicate segments of the shoreline without significant coastal bluffs. Where significant bluffs were present, geologists noted various characteristics of the bluff face such as the slope of the bluff (steep to gentle), features on the bluff face indicating recent movement of material down the slope (slumped blocks of sediment, landslide scars, fallen trees), and the amount and type of vegetation (bare sediment, grass, shrubs, mature trees). From this information, geologists assessed the relative stability of each bluff face as being: (1) stable (green), (2) unstable (yellow), or (3) highly unstable (red). This classification is based on observed features that reflect recent activity on the bluff face. Examples of bluff faces with different stabilities are shown in the panel of photographs to the right.

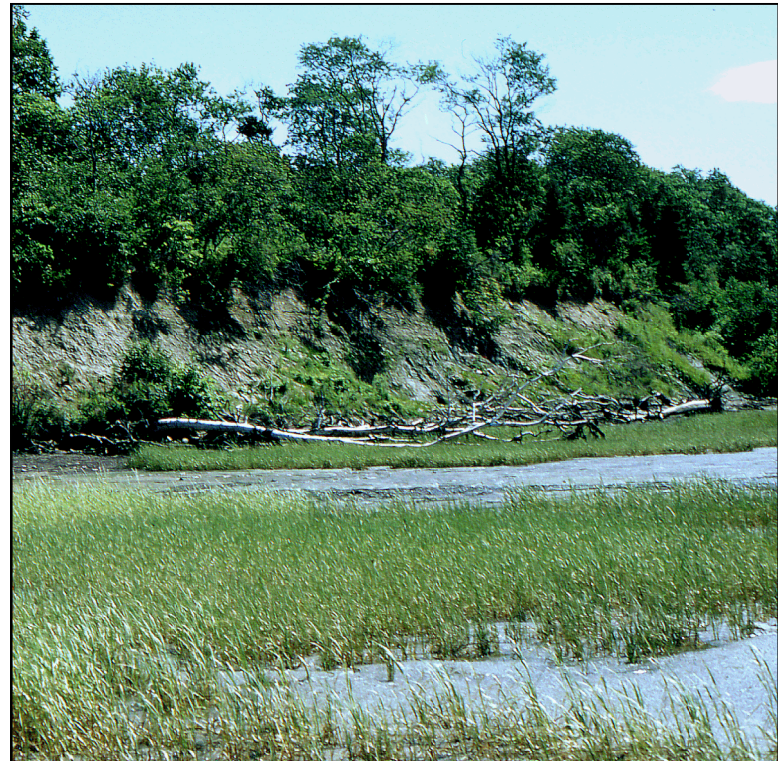
Highly unstable bluff with an unvegetated bluff face and a salt marsh shoreline. Sediments on the bluff face are exposed and fallen tree trunks lie at the base of the bluff. A salt marsh has recently formed on the tidal flat, partly on the top of an old landslide deposit.

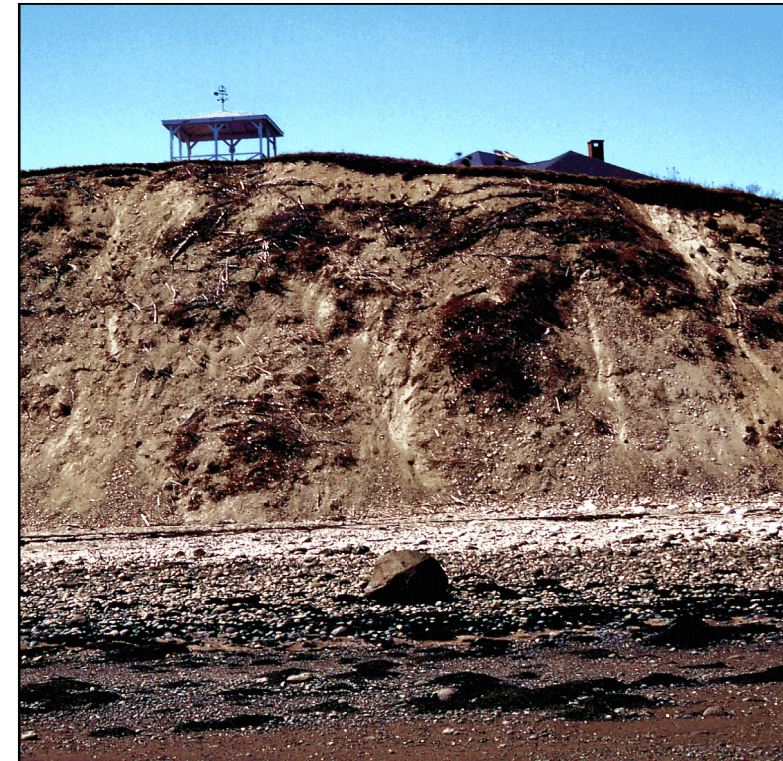
Highly unstable bluff with an unvegetated bluff face and a beach/gravel flat shoreline. The bluff face is too unstable to support vegetation. This bluff, a glacial esker, is eroded by waves to create a mixed sand and gravel beach in front of the bluff.

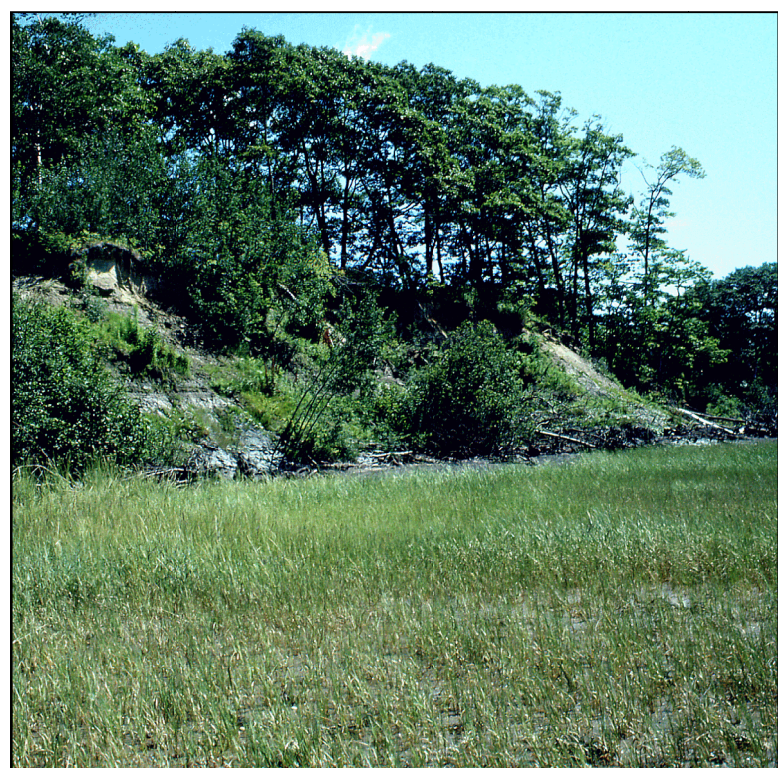
Unstable bluff with a partially vegetated bluff face and a salt marsh shoreline. This bluff, protected by a salt marsh, remains unstable. There are small bushes on the bluff as well as small non-vegetated areas that indicate continuing bluff retreat.

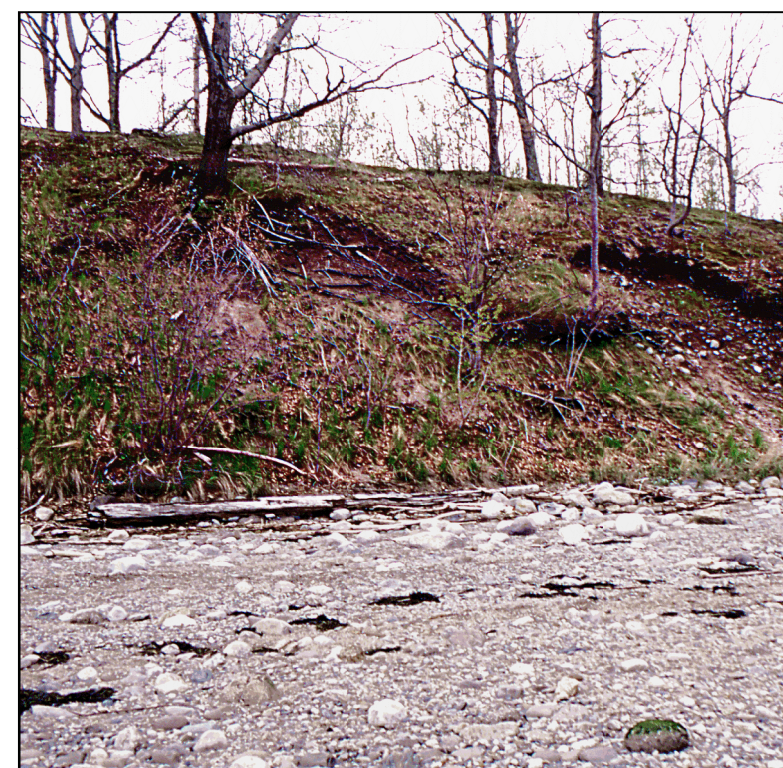
Unstable bluff with a partially vegetated bluff face and a beach/gravel flat shoreline. Slump scars on the bluff face expose sand, gravel, and roots. Fine sediments are removed by waves and currents, leaving gravel to form a beach at the base of the bluff.

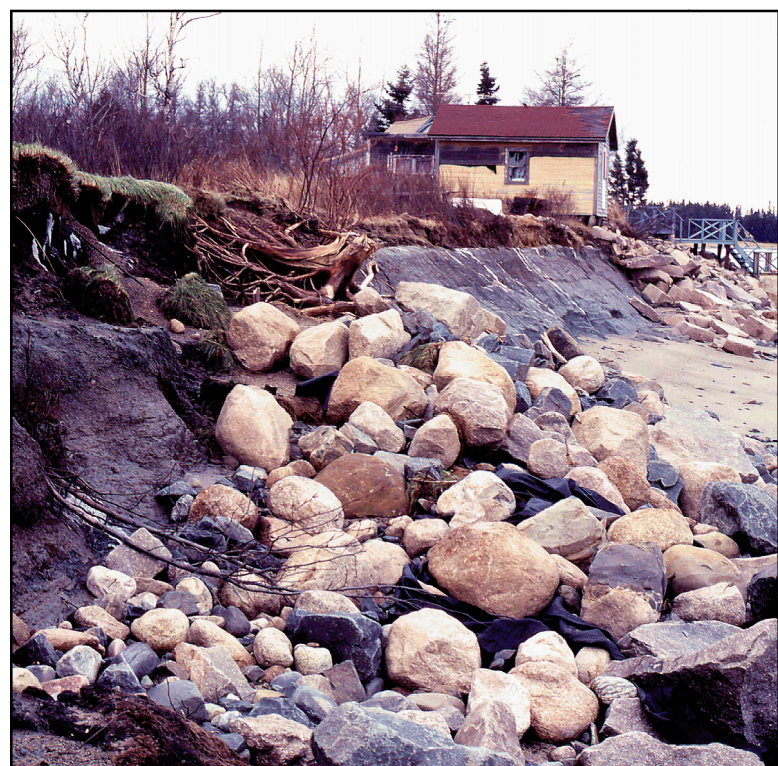
Highly unstable bluff with an unvegetated bluff face and an armored shoreline. This armored bluff is eroding despite an effort to shore it up with riprap, or loosely piled stone blocks. Maintenance at this site could improve bluff stability.

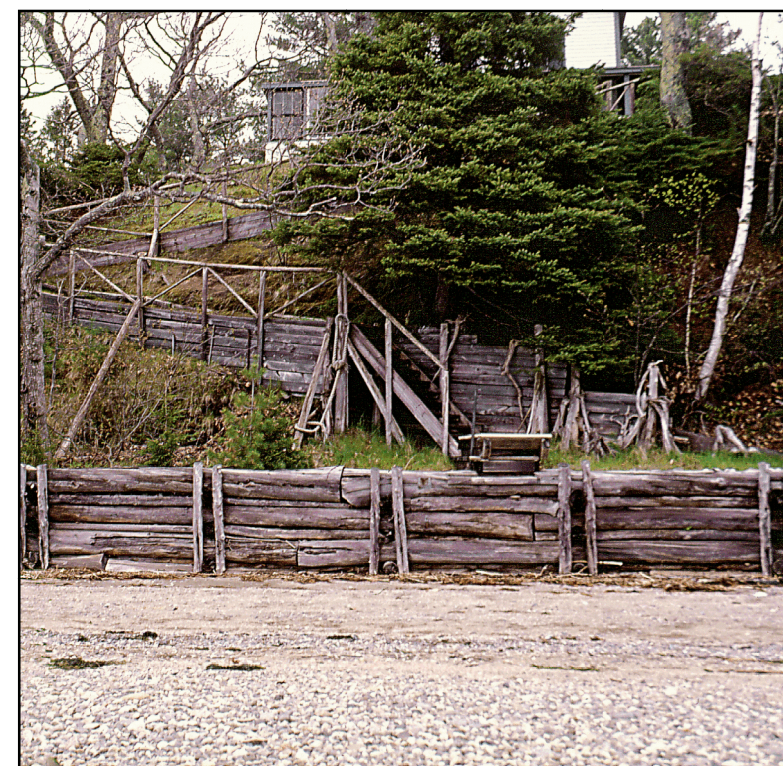
Stable bluff with a vegetated bluff face and an armored shoreline. The bluff face is fully vegetated and supports a mature stand of trees with vertical trunks. The presence of a wooden bulkhead suggests that erosion has occurred in the past.

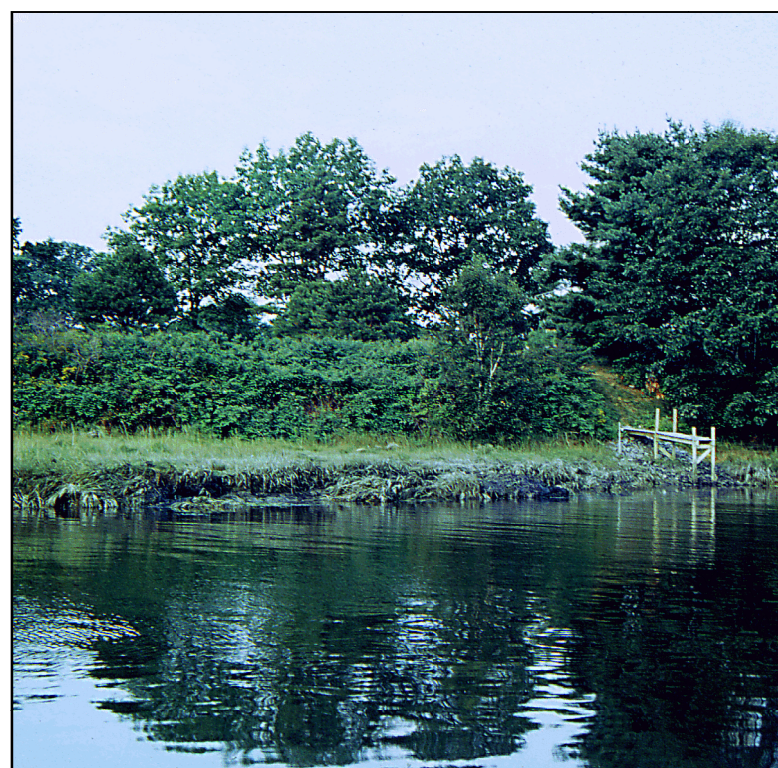
Stable bluff with a vegetated bluff face and a salt marsh shoreline. A low bluff face is covered by shrubs landward of a salt marsh terrace. In this location the mature marsh protects the base of the bluff from rapid erosion and slows bluff recession or retreat.

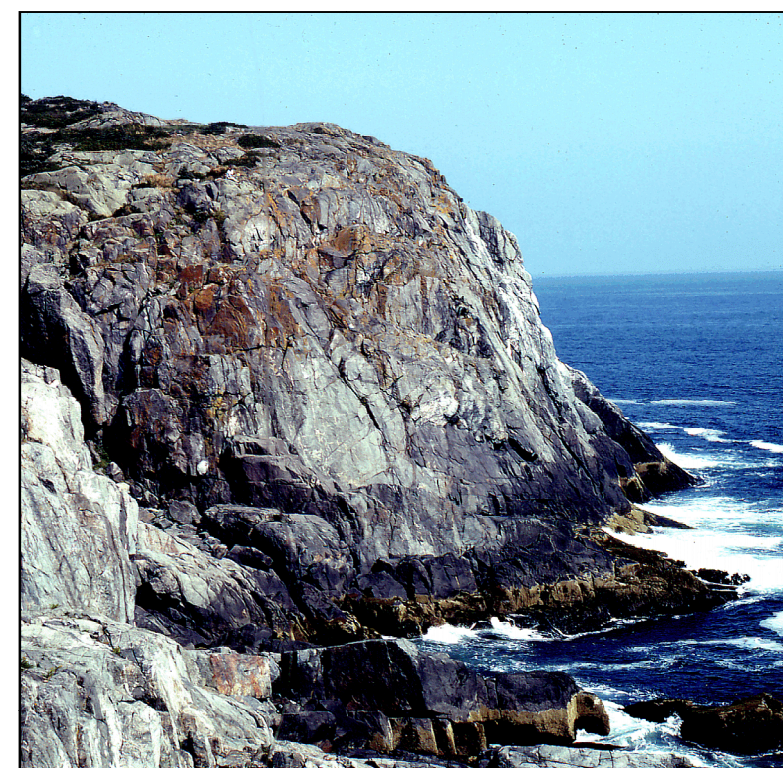
No bluff with a ledge shoreline. A steep slope on the bedrock surface is not a bluff. On this map, bluffs must be made of sedimentary material, generally with 3 feet or more relief. This shoreline type is very slow to change.

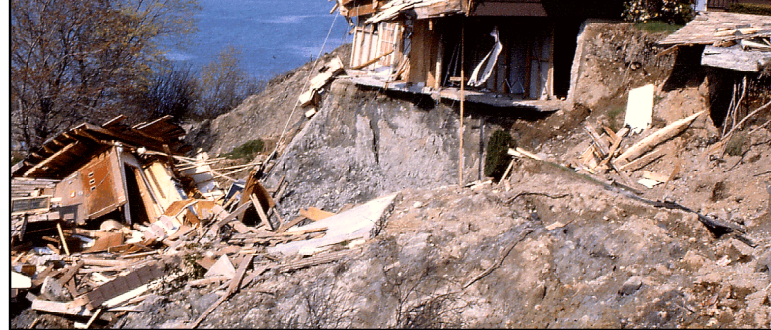
A 1996 landslide in Rockland Harbor (photo below) occurred in an area where the bluff face is classified as unstable. In addition, the bluff had all the characteristics (a-d) listed above. This fact emphasizes that the map above does not indicate sites with a potential for catastrophic landslides.
