Coastal Bluffs

Biddeford Quadrangle, Maine

Open-File No. 02-173
2002

Types of Bluffs Along Maine's Coast

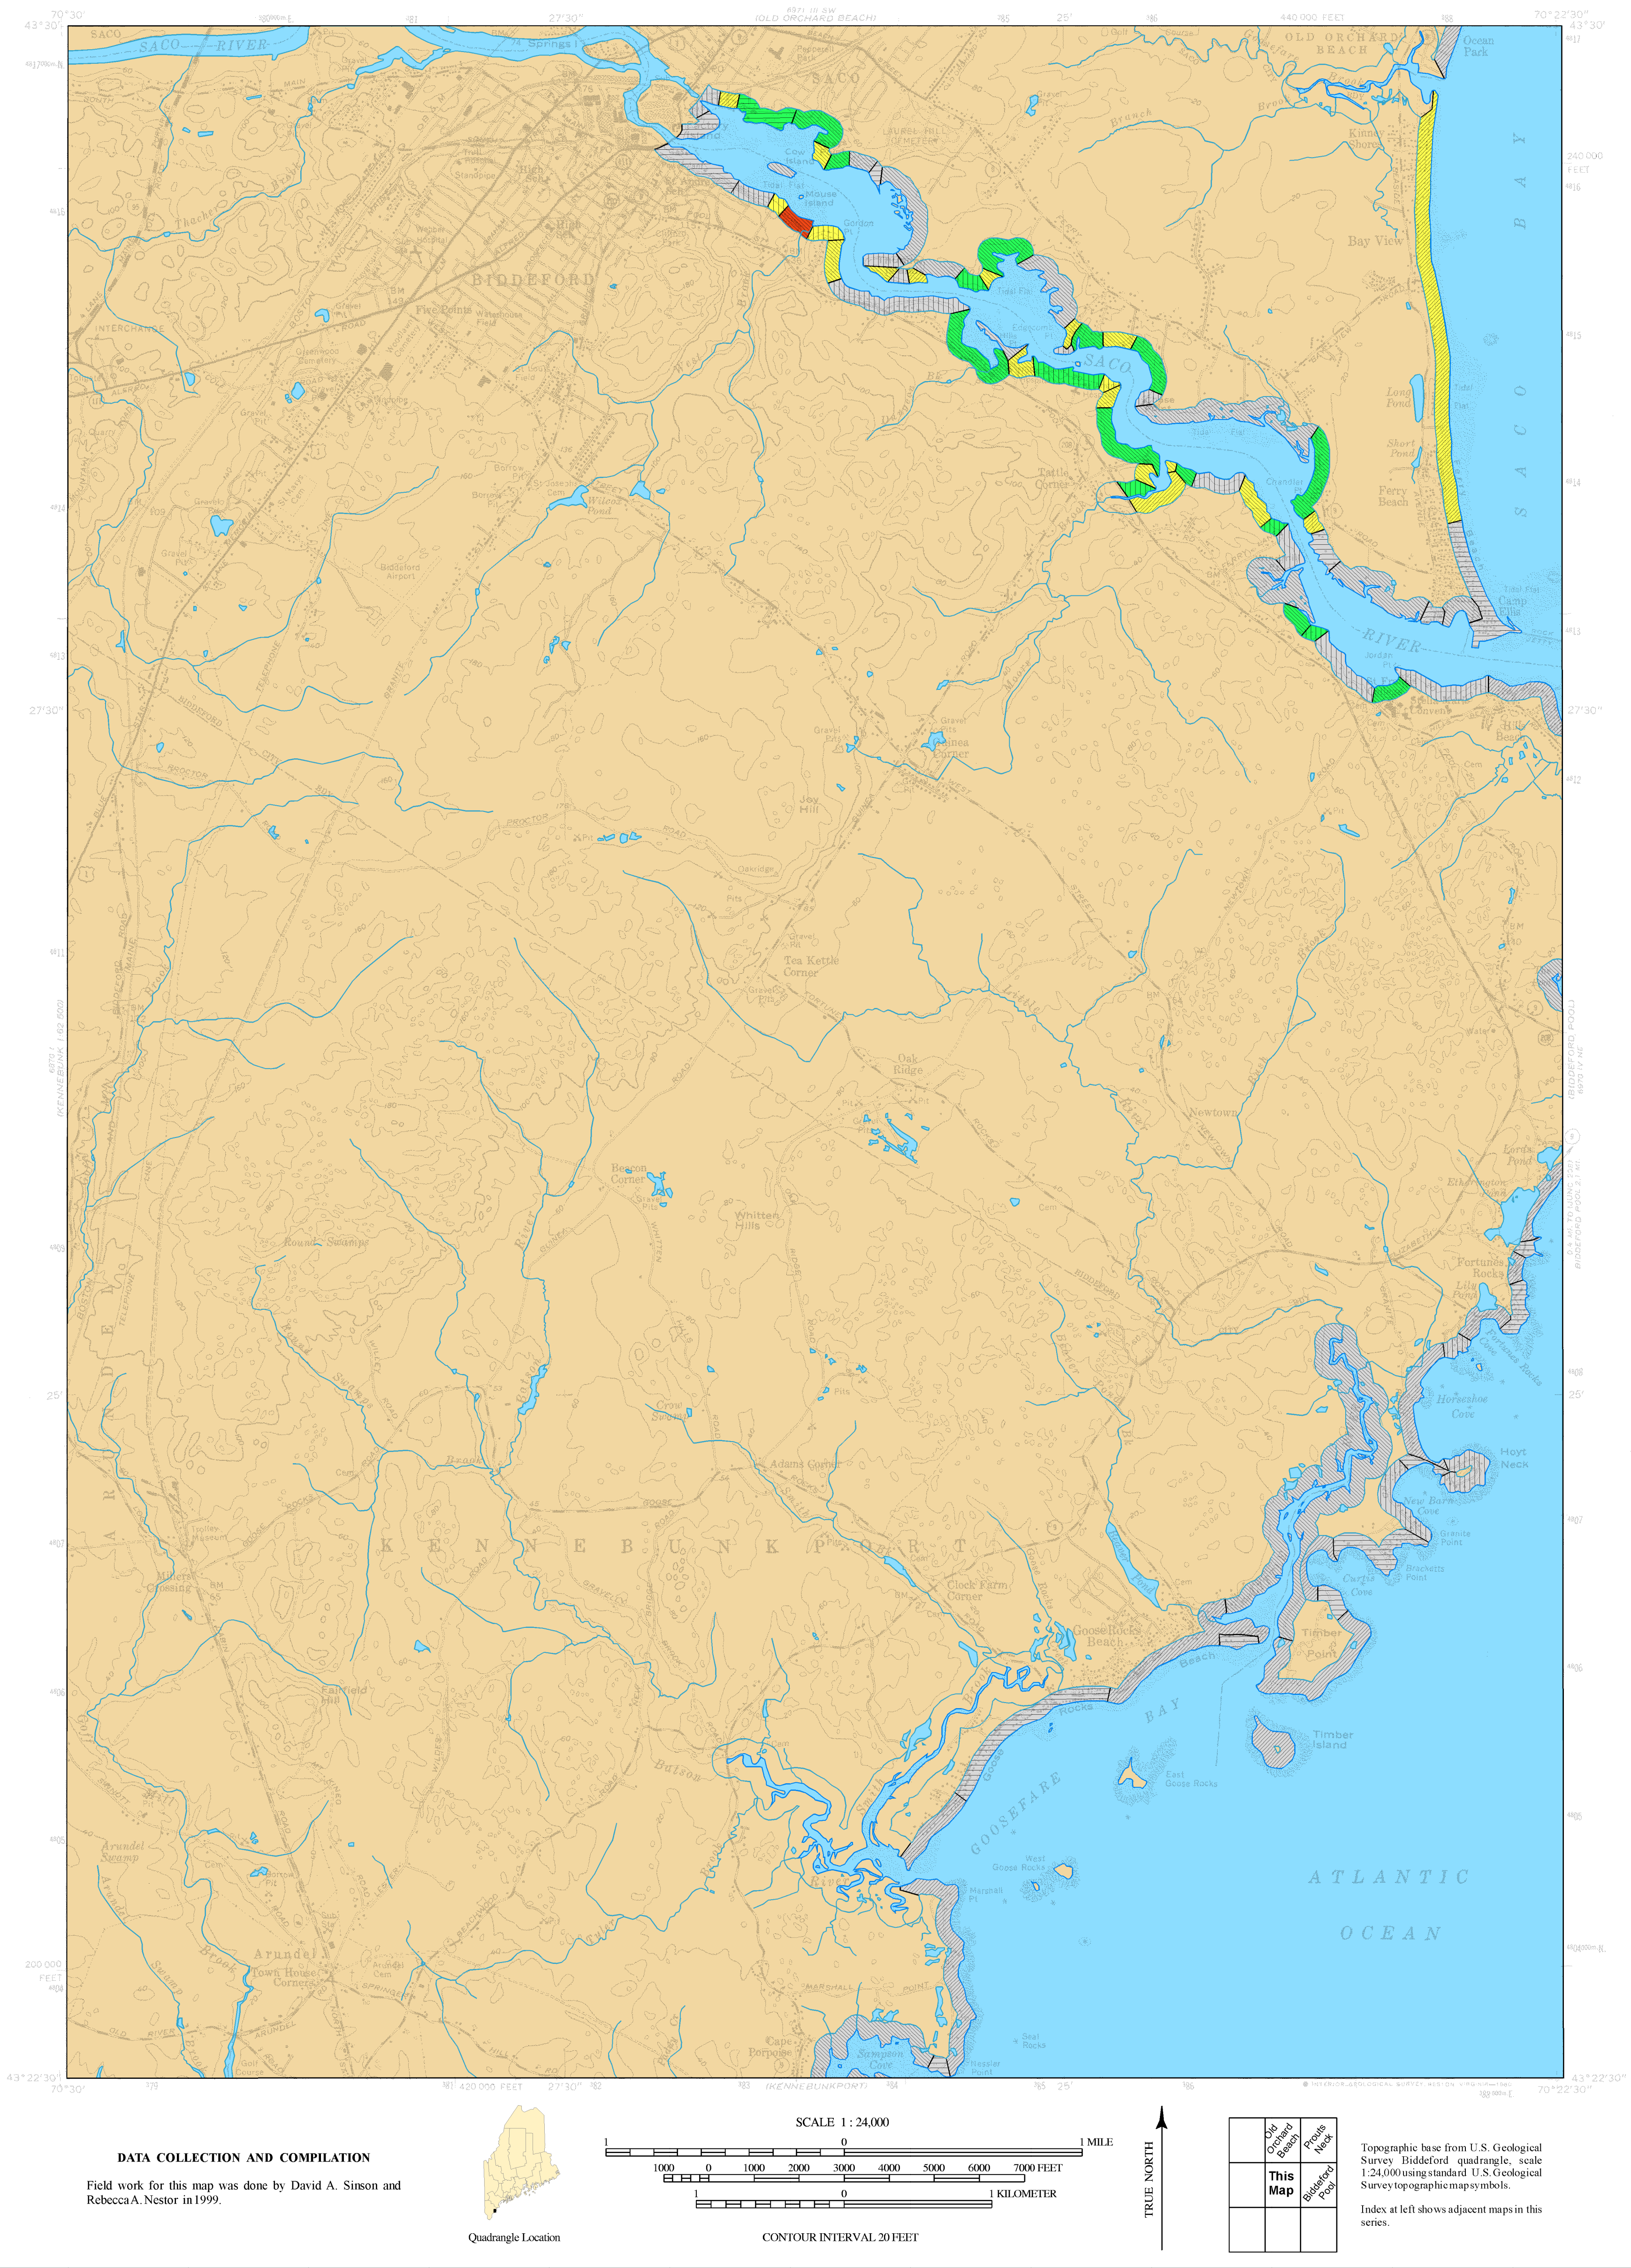
Note: The classification of the bluff is indicated by a colored, patterned band extending landward from the shoreline (dark blue line). The width of the band is NOT related to the width of the bluff. Stability rank refers to RECENT bluff face activity.

This map shows the shoreline type and relative stability of bluffs along a section of the Maine coast. The slope, shape, and amount of vegetation covering a coastal bluff and the adjacent shoreline are directly related to the susceptibility of the bluff face to ongoing erosion. As might be expected, less vegetated bluffs are more likely to be eroding than completely vegetated bluffs. Another important factor related to bluff stability is the material which makes up the bluff. Materials such as clay, gravel, and sand react differently to erosion and, when combined with variations in vegetation and slope, affect the rate of erosion for an individual bluff. When planning to reduce the risks of coastal erosion, it is important to take vegetation, slope, erosion rate, and sediment types into consideration.

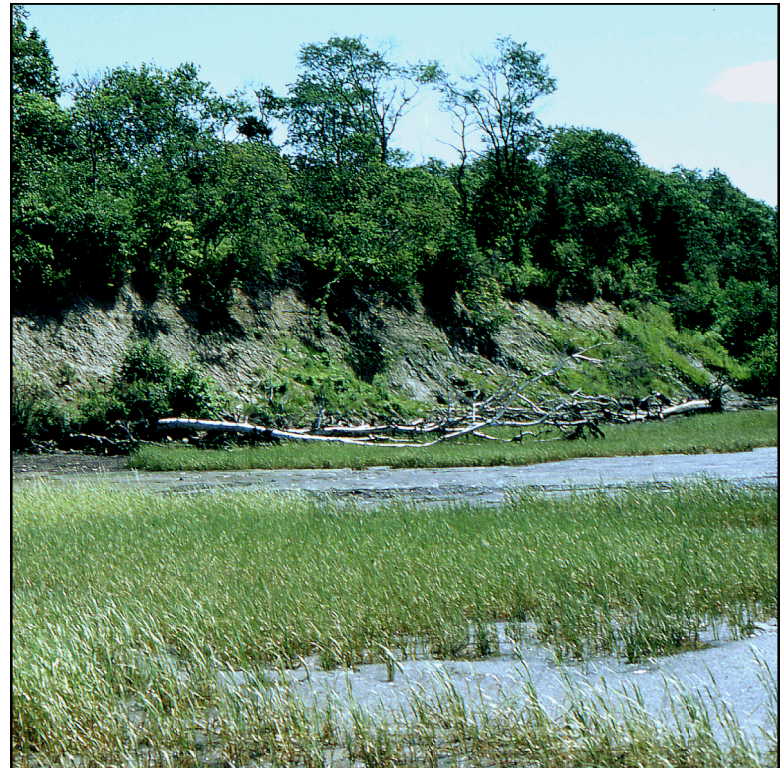
Highly unstable bluff with an unvegetated bluff face and a salt marsh shoreline. Sediments on the bluff face are exposed and fallen tree trunks lie at the base of the bluff. A salt marsh has recently formed on the tidal flat, partly on the top of an old landslide deposit.

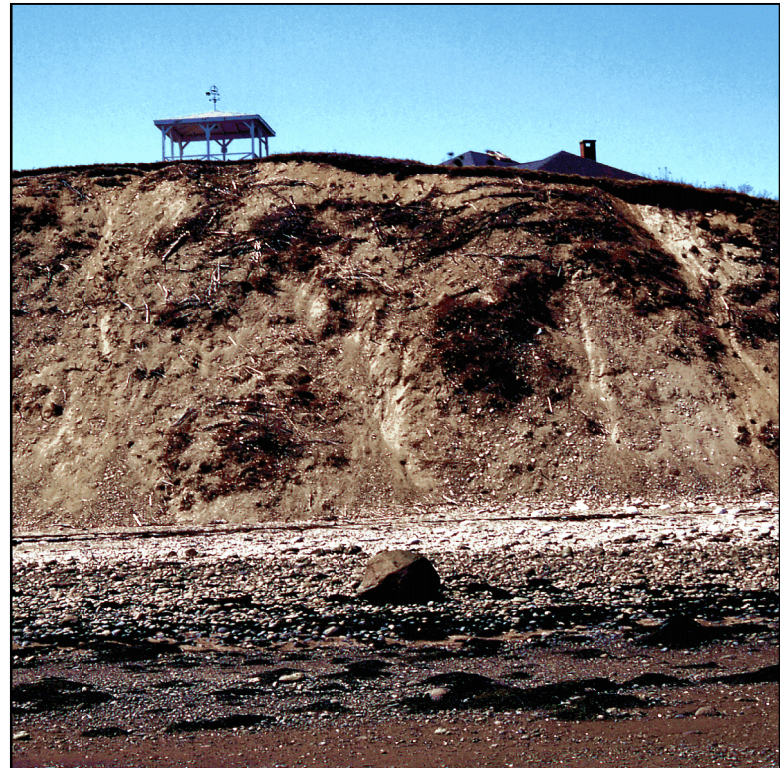
Highly unstable bluff with an unvegetated bluff face and a beach/gravel flat shoreline. The bluff face is too unstable to support vegetation. This bluff, a glacial esker, is eroded by waves to create a mixed sand and gravel beach in front of the bluff.

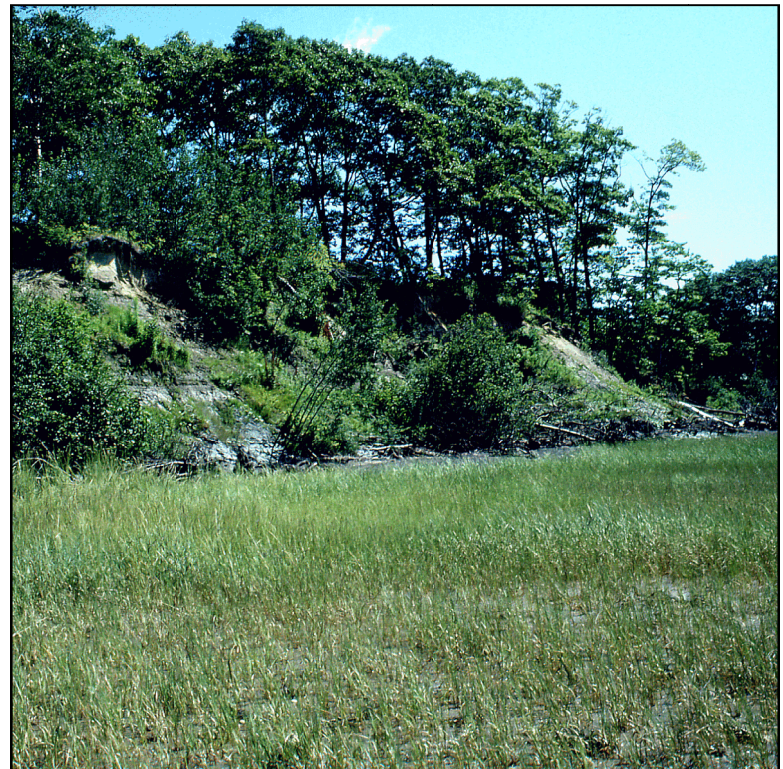
Unstable bluff with a partially vegetated bluff face and a salt marsh shoreline. This bluff, protected by a salt marsh, remains unstable. There are small bushes on the bluff as well as small non-vegetated areas that indicate continuing bluff retreat.

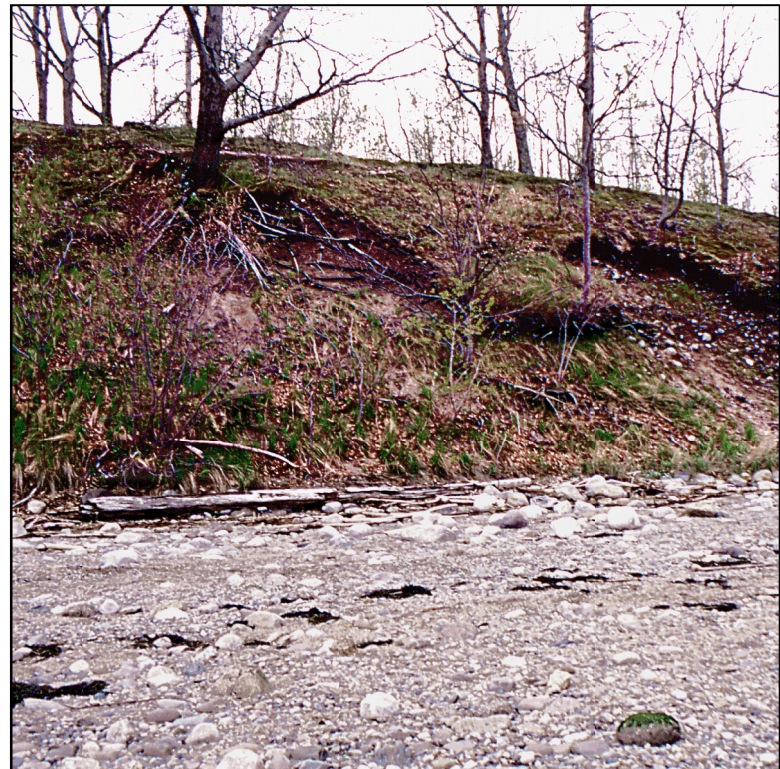
Unstable bluff with a partially vegetated bluff face and a beach/gravel flat shoreline. Slump scars on the bluff face expose sand, gravel, and roots. Fine sediments are removed by waves and currents, leaving gravel to form a beach at the base of the bluff.

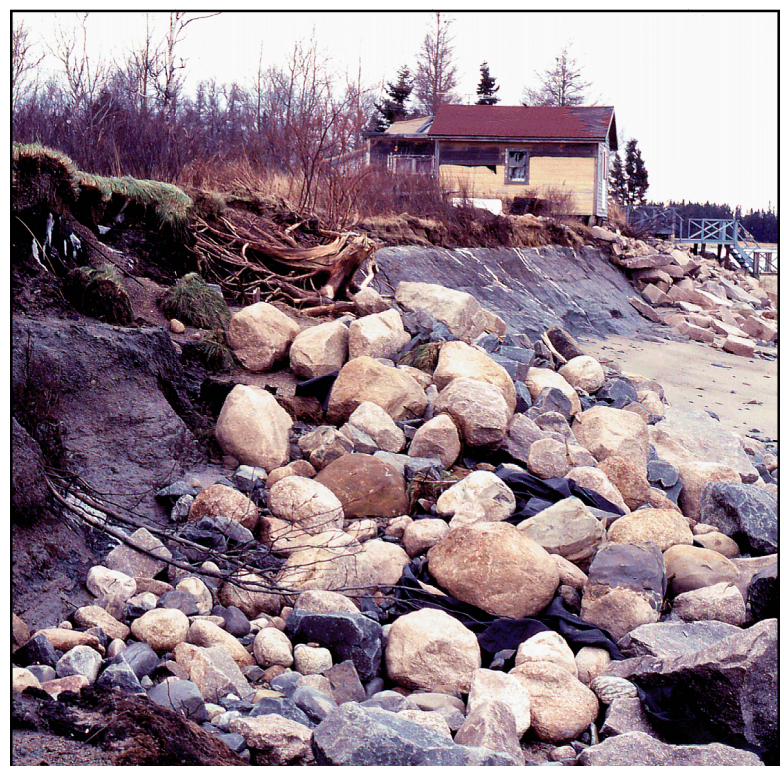
Highly unstable bluff with an unvegetated bluff face and an armored shoreline. This armored bluff is eroding despite an effort to shore it up with riprap, or loosely piled stone blocks. Maintenance at this site could improve bluff stability.

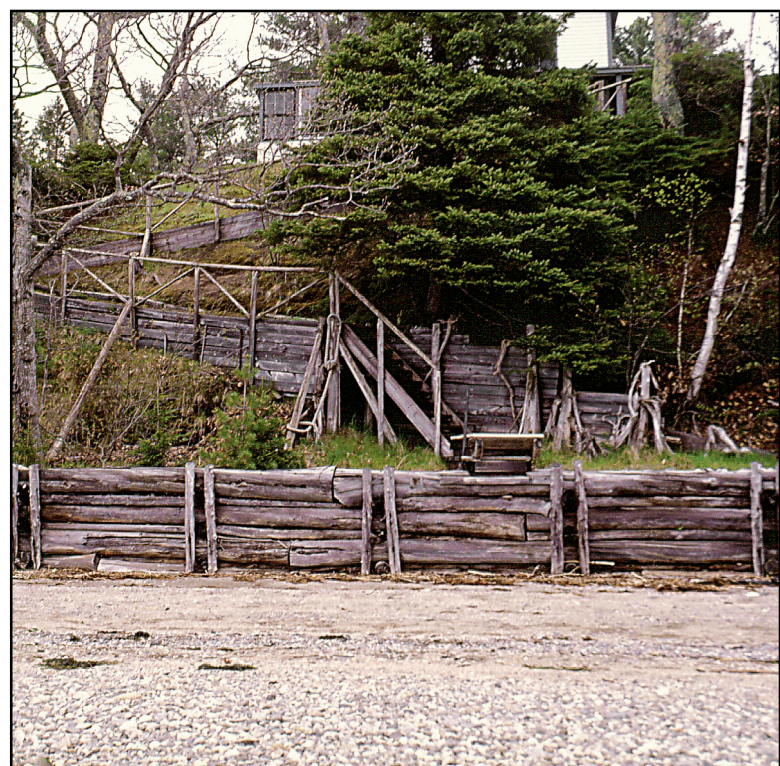
Stable bluff with a vegetated bluff face and an armored shoreline. The bluff face is fully vegetated and supports a mature stand of trees with vertical trunks. The presence of a wooden bulkhead suggests that erosion has occurred in the past.

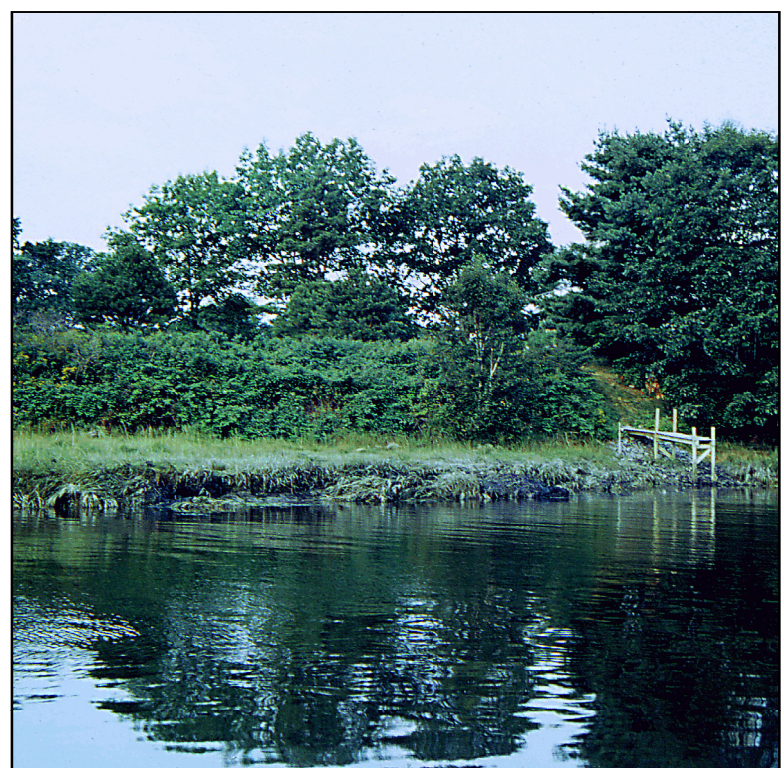
Stable bluff with a vegetated bluff face and a salt marsh shoreline. A low bluff face is covered by shrubs landward of a salt marsh terrace. In this location the mature marsh protects the base of the bluff from rapid erosion and slows bluff recession or retreat.

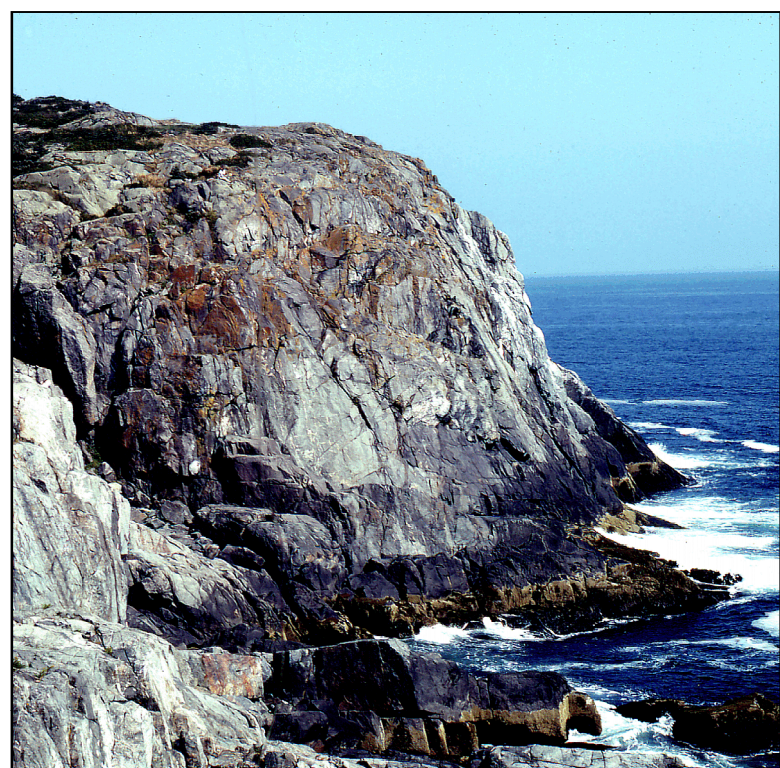
No bluff with a ledge shoreline. A steep slope on the bedrock surface is not a bluff. On this map, bluffs must be made of sedimentary material, generally with 3 feet or more relief. This shoreline type is very slow to change.
