Coastal Bluffs

Classification and Mapping of Maine's Coastal Bluffs

New Harbor Quadrangle, Maine

**Open-File No. 02-197
2002**
This map supersedes
Open-File Map 00-92.

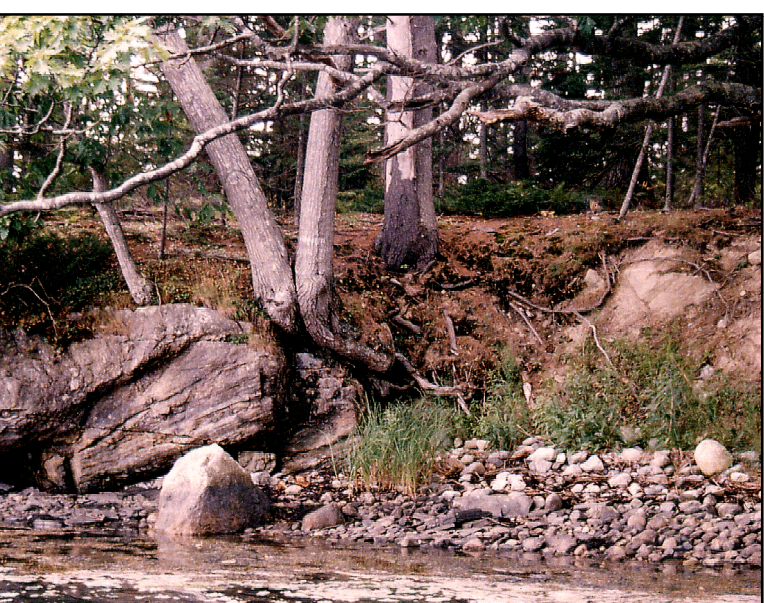
Since these are regional maps, some shores mapped as stable may contain small areas that are unstable. A bluff, too small to appear on the map, is shown in the photo. This bluff exhibits the characteristics of an unstable bluff: curved tree trunks, exposed roots, and bare ground on a steep slope. It is an area to be concerned about on a local scale. However, this degree of detail is not shown on the map above.

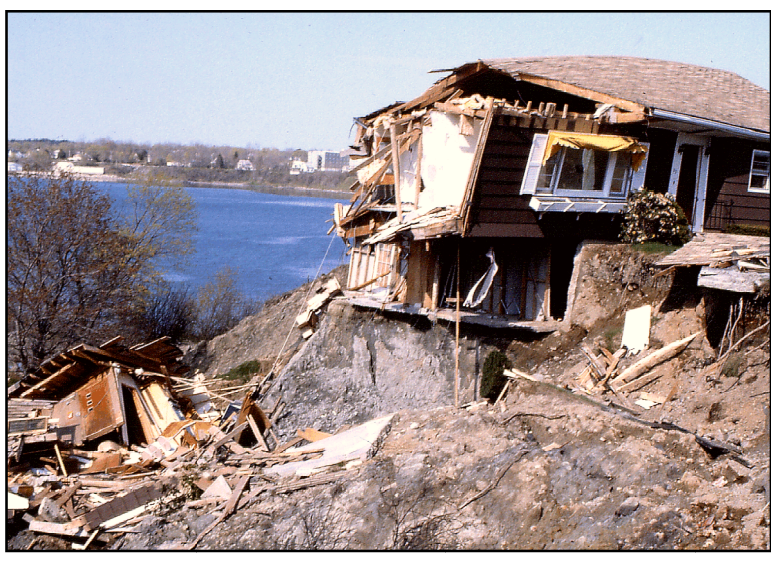
A 1996 landslide in Rockland Harbor (photo below) occurred in an area where the bluff face is classified as unstable. In addition, the bluff had all the characteristics (a-d) listed above. This fact emphasizes that the map above does not indicate sites with a potential for catastrophic landslides. Additional factors need to be considered beyond the appearance of the bluff face and type of shoreline below the bluff. Maps of topography, surficial sediments, and Coastal Landslide Hazards are available from the Maine Geological Survey to help assess the landslide potential in an area.

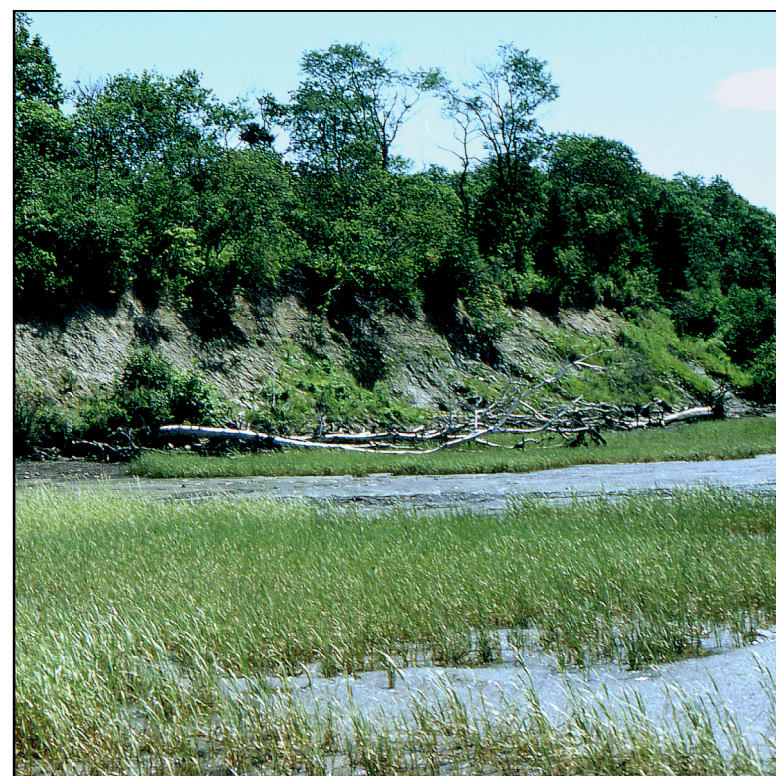
Highly unstable bluff with an unvegetated bluff face and a salt marsh shoreline. Sediments on the bluff face are exposed and fallen tree trunks lie at the base of the bluff. A salt marsh has recently formed on the tidal flat, partly on the top of an old landslide deposit.

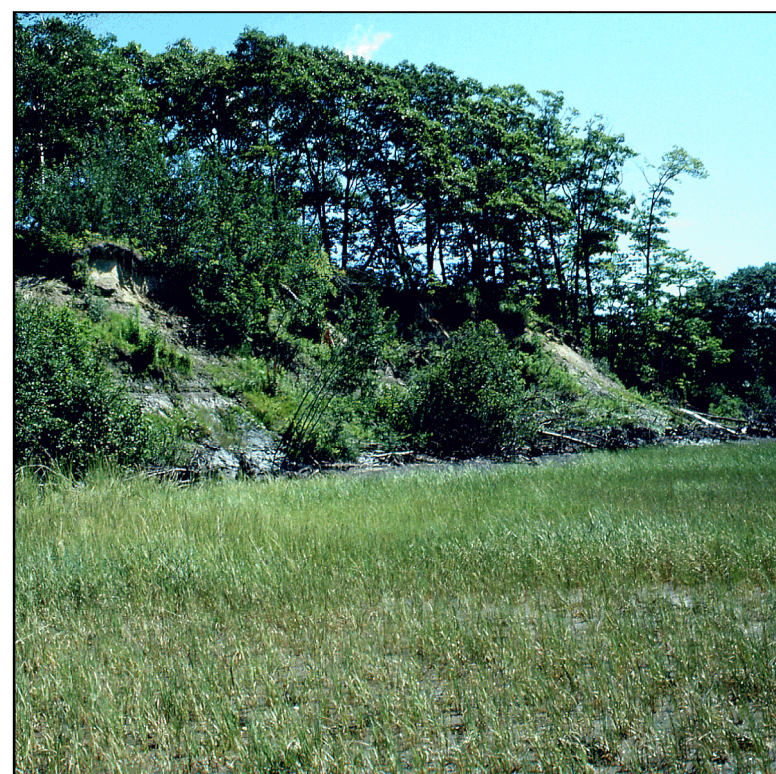
Unstable bluff with a partially vegetated bluff face and a salt marsh shoreline. This bluff, protected by a salt marsh, remains unstable. There are small bushes on the bluff as well as small non-vegetated areas that indicate continuing bluff retreat.

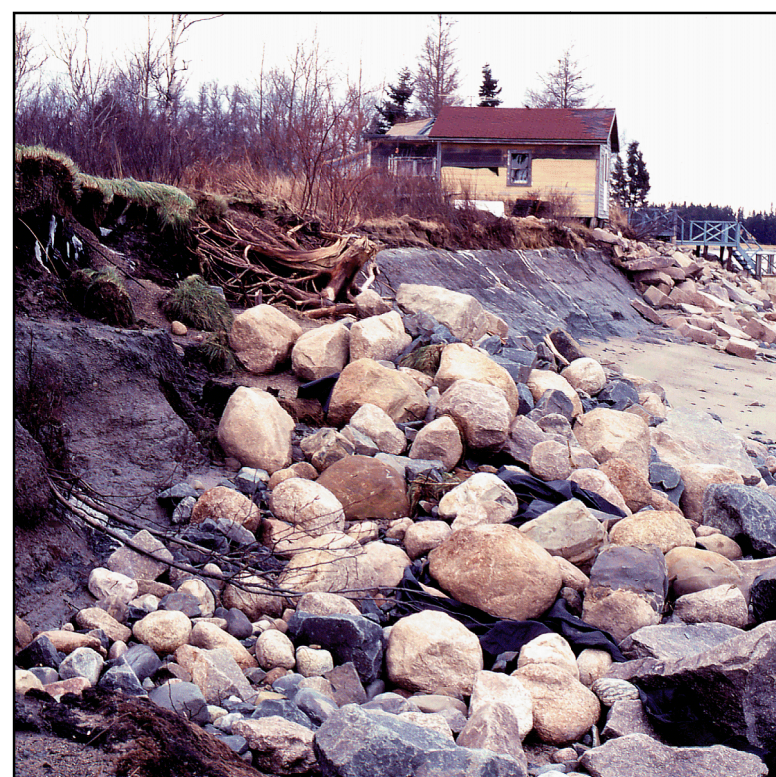
Highly unstable bluff with an unvegetated bluff face and an armored shoreline. This armored bluff is eroding despite an effort to shore it up with riprap, or loosely piled stone blocks. Maintenance at this site could improve bluff stability.

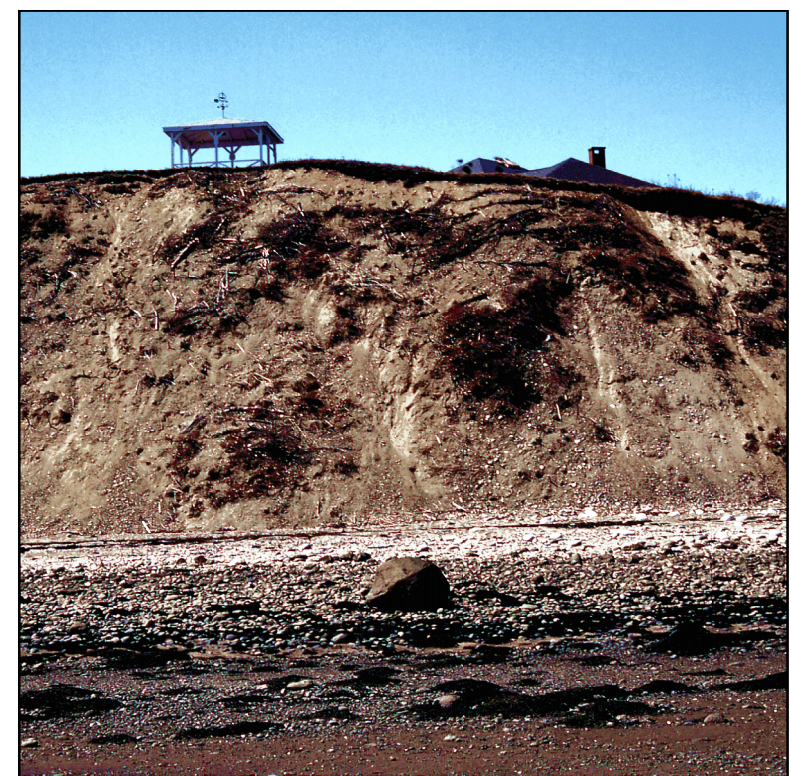
Highly unstable bluff with an unvegetated bluff face and a beach/gravel flat shoreline. The bluff face is too unstable to support vegetation. This bluff, a glacial esker, is eroded by waves to create a mixed sand and gravel beach in front of the bluff.

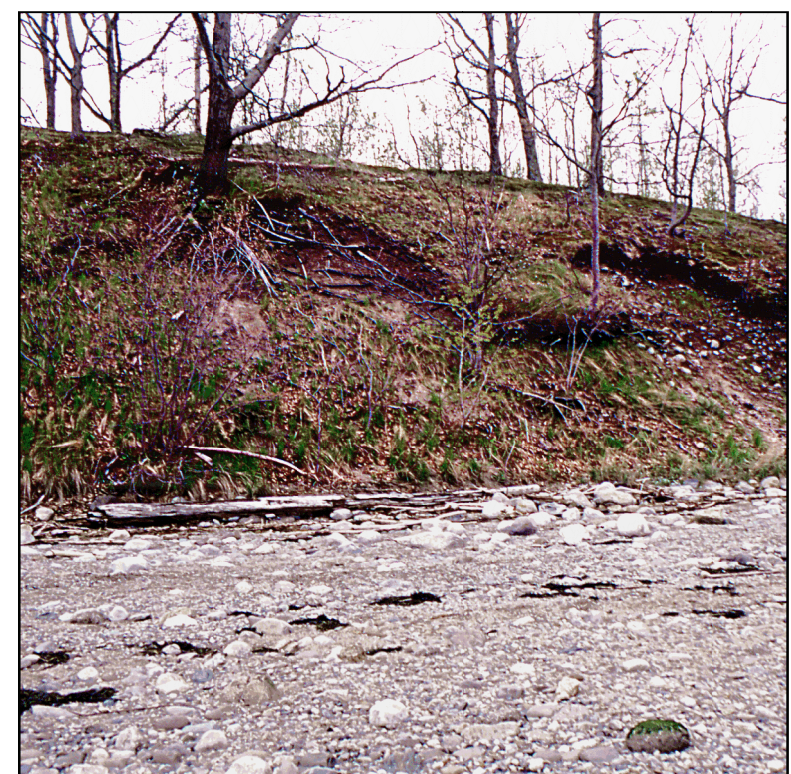
Unstable bluff with a partially vegetated bluff face and a beach/gravel flat shoreline. Slump scars on the bluff face expose sand, gravel, and roots. Fine sediments are removed by waves and currents, leaving gravel to form a beach at the base of the bluff.

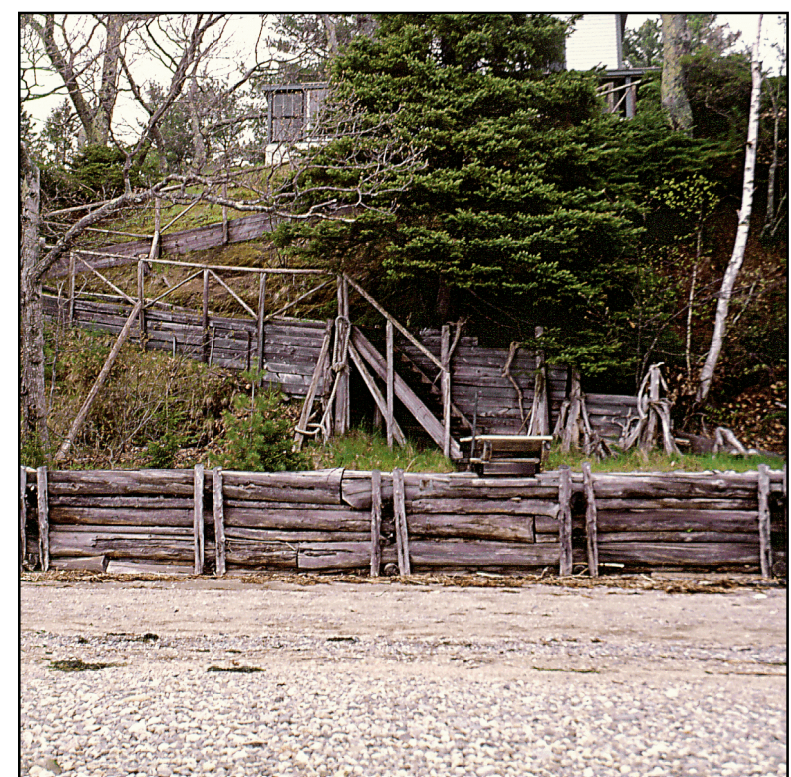
Stable bluff with a vegetated bluff face and an armored shoreline. The bluff face is fully vegetated and supports a mature stand of trees with vertical trunks. The presence of a wooden bulkhead suggests that erosion has occurred in the past.
